6. COA-054512-2019

401 North 27th Street

Commission of Architectural Review

STAFF REPORT

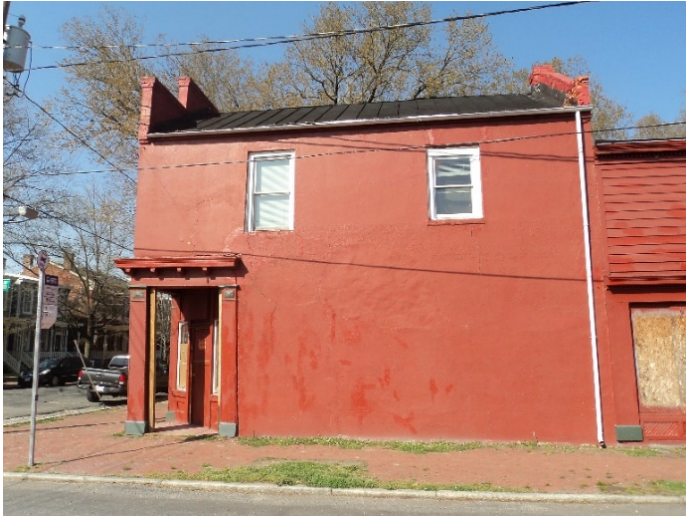
Figure 1. South wall, April 2018.

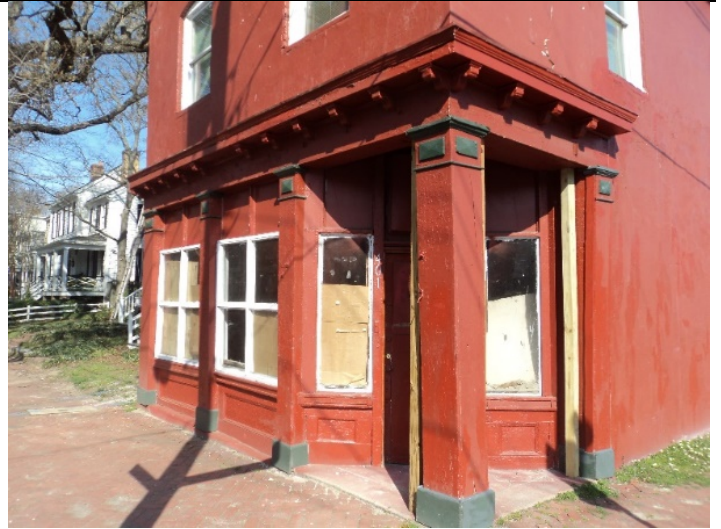
Figure 2. Corner detail, April 2018.

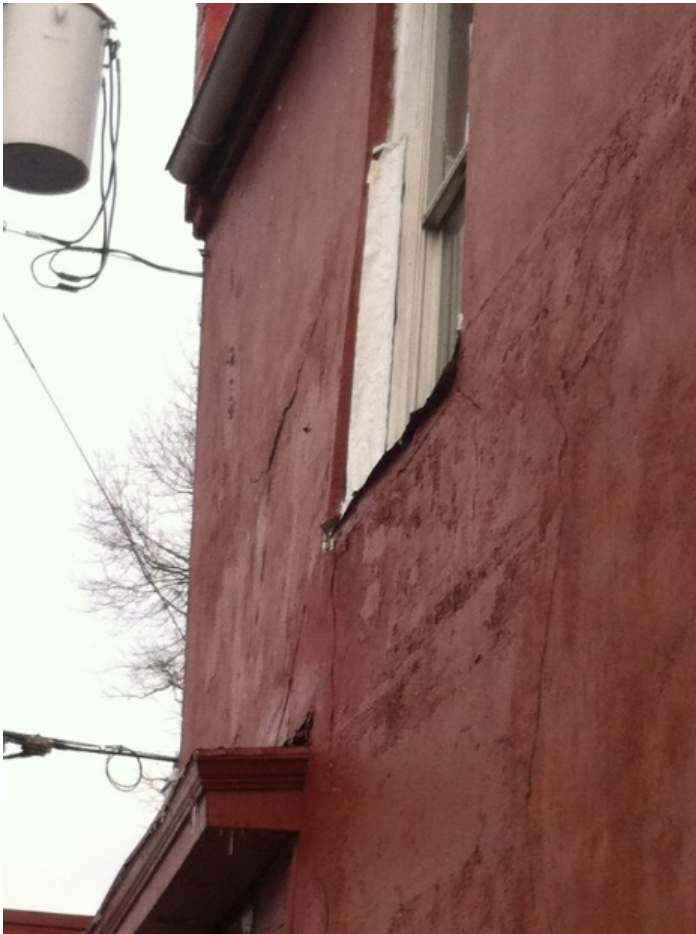
Figure 3. Evidence of cracking, January 2019.

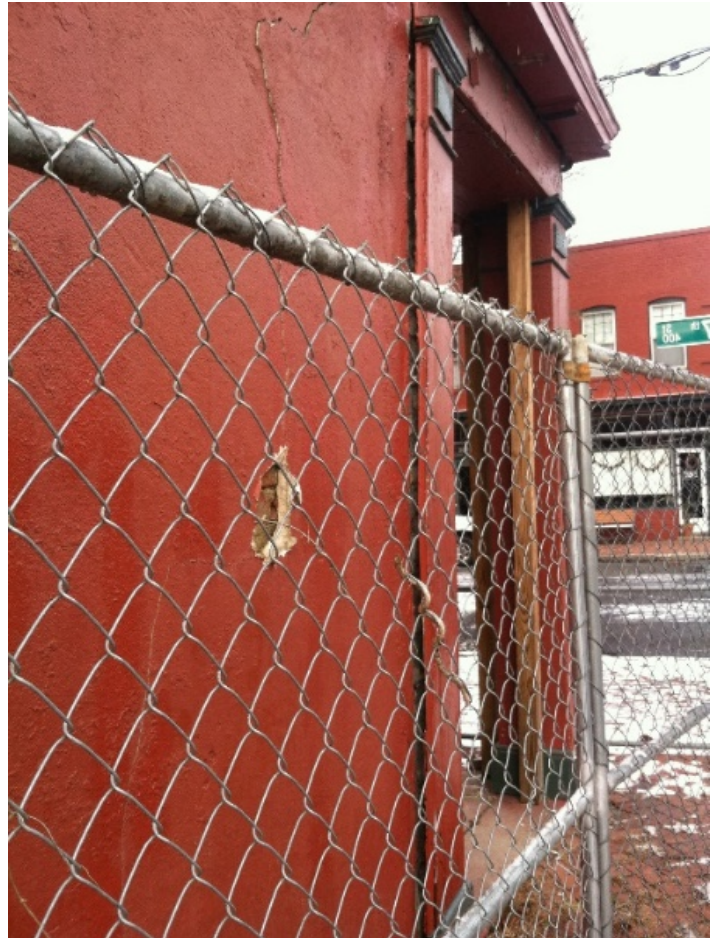
Figure 4. Hole and cracking, corner supports, January 2019.

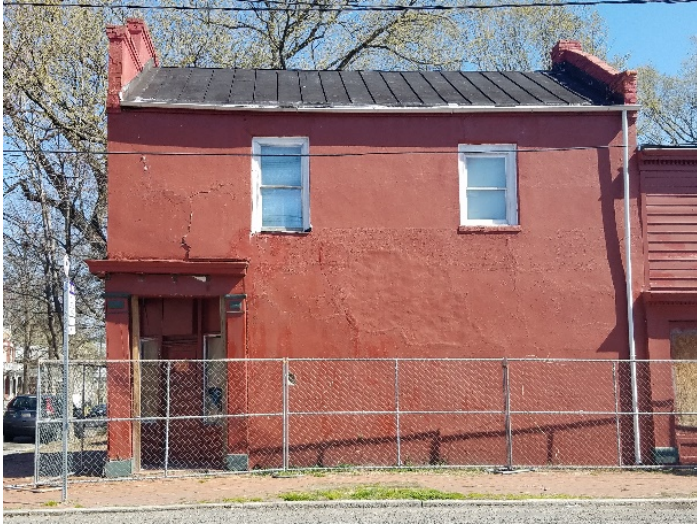
Figure 5. Cracking, March 2019.

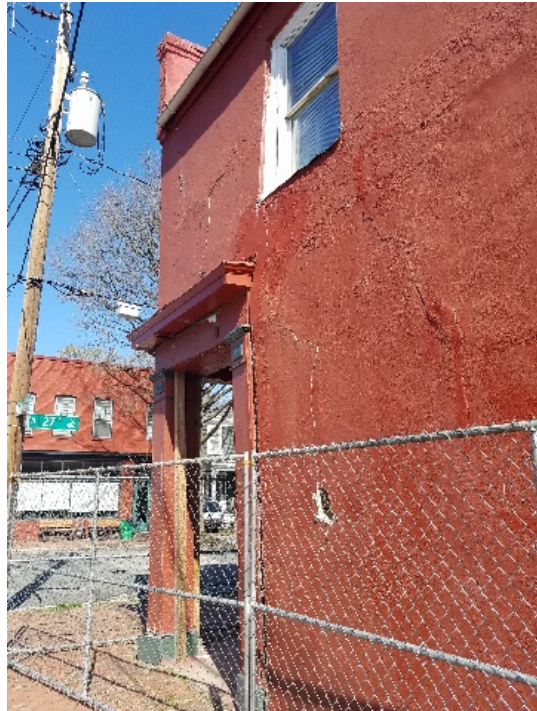
Figure 6. Cracking, March 2019.

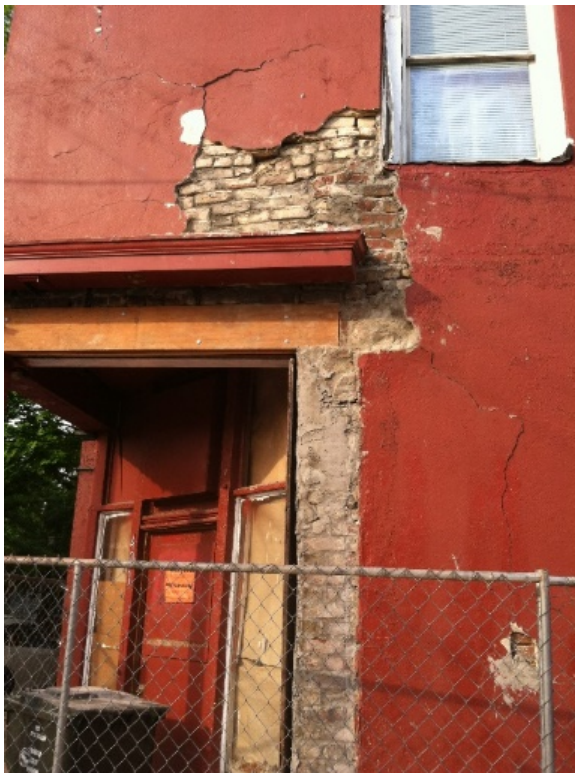
Figure 7. Deterioration around the door, April 2019.

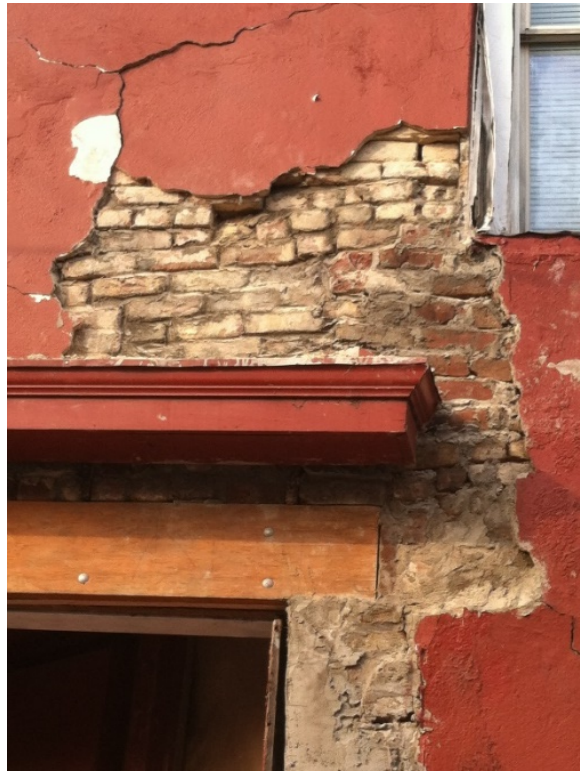
Figure 8. Detail of deterioration around the door, April 2019.

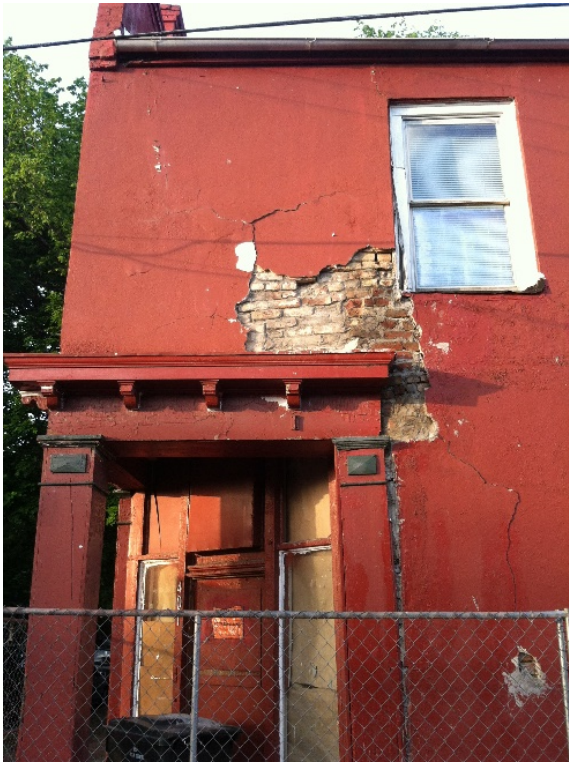
Figure 9. Additional deterioration, May 2019.

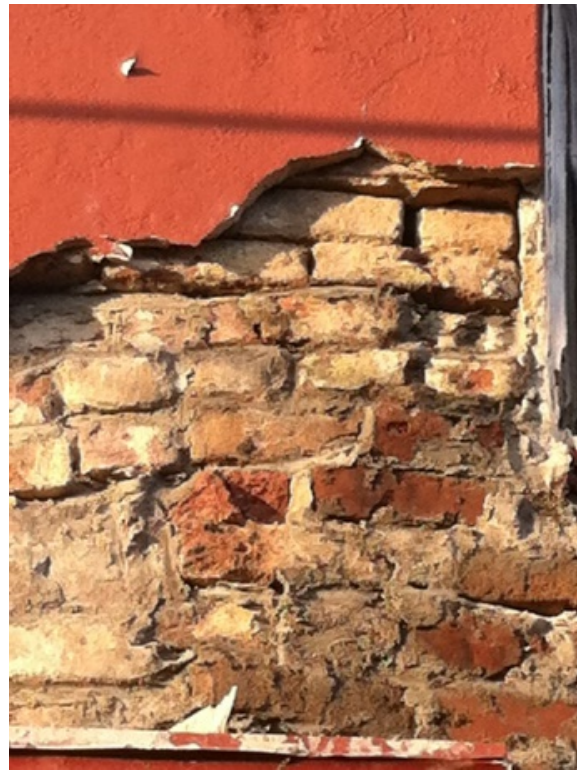
Figure 10. Detail, of additional deterioration, May 2019.

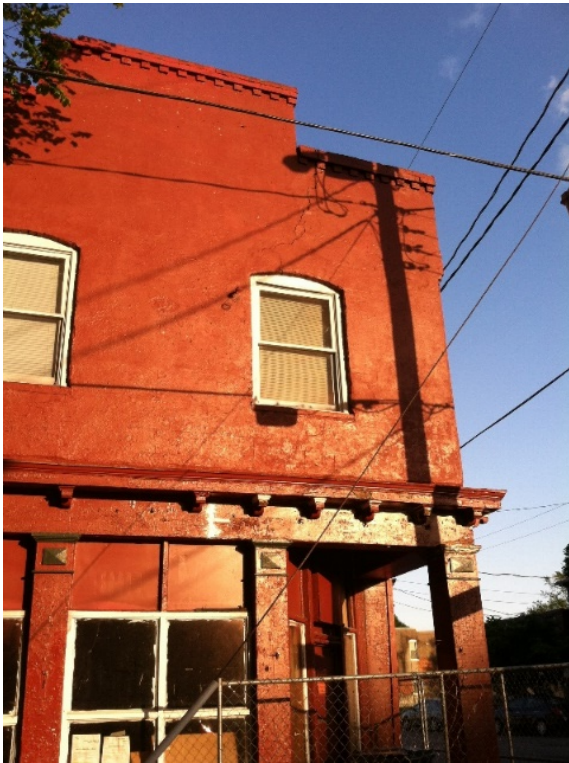
Staff has serious concerns about the cracking evident on the west exterior wall that has visibly expanded over the last several months. Staff believes that the cracking is an indication of greater structural damage. Staff recommends the applicant

Figure 11. Additional cracking on the west wall, May 2019.

submit additional information and an application to address any structural problems with the building.

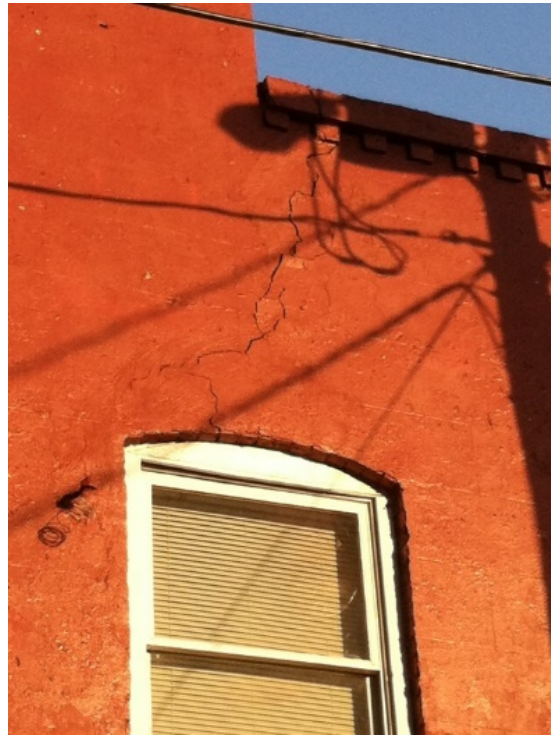
Figure 12. Detail of additional cracking on the west wall, May 2019.
