APPLICATION / CERTIFICATE OF APPROPRIATENESS

Project Description: Application for Revised Certificate of Appropriateness and Partial Demolition:

Additions and Rehabilitation at
125 N 25th Street
 St John's National Historic District
 Richmond, VA 23223

Application for Certificate of Appropriateness
COMMISSION OF ARCHITECTURAL REVIEW
 submitted Jan 27, 2017
 [revised from previous approved application]

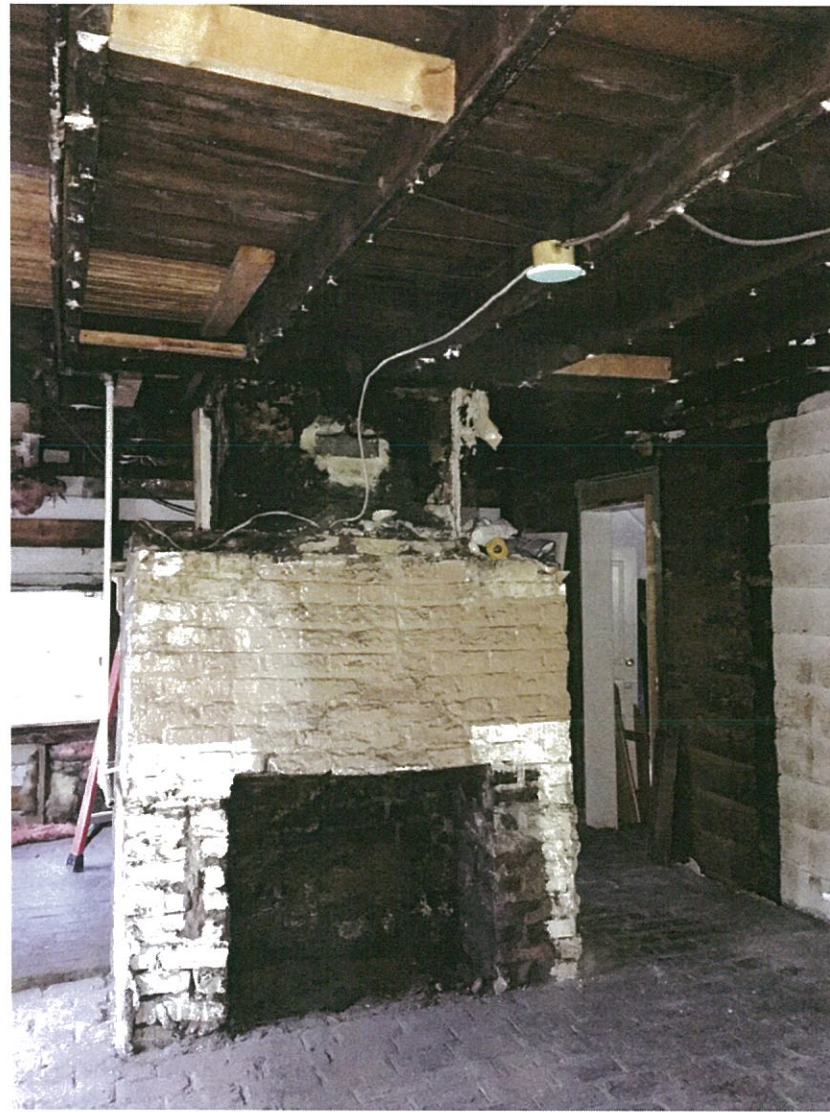
Existing Rear Section, Photographs 1 & 3 - 1st level north section

Photographs of this area show the underside of the second level floor framing including repaired areas. Referring also to photograph 10 on page 4, the structure and decking were severely bowed do to over-spanning, particularly in the area north of the existing chimney shown in photos 1, 3 and 10.

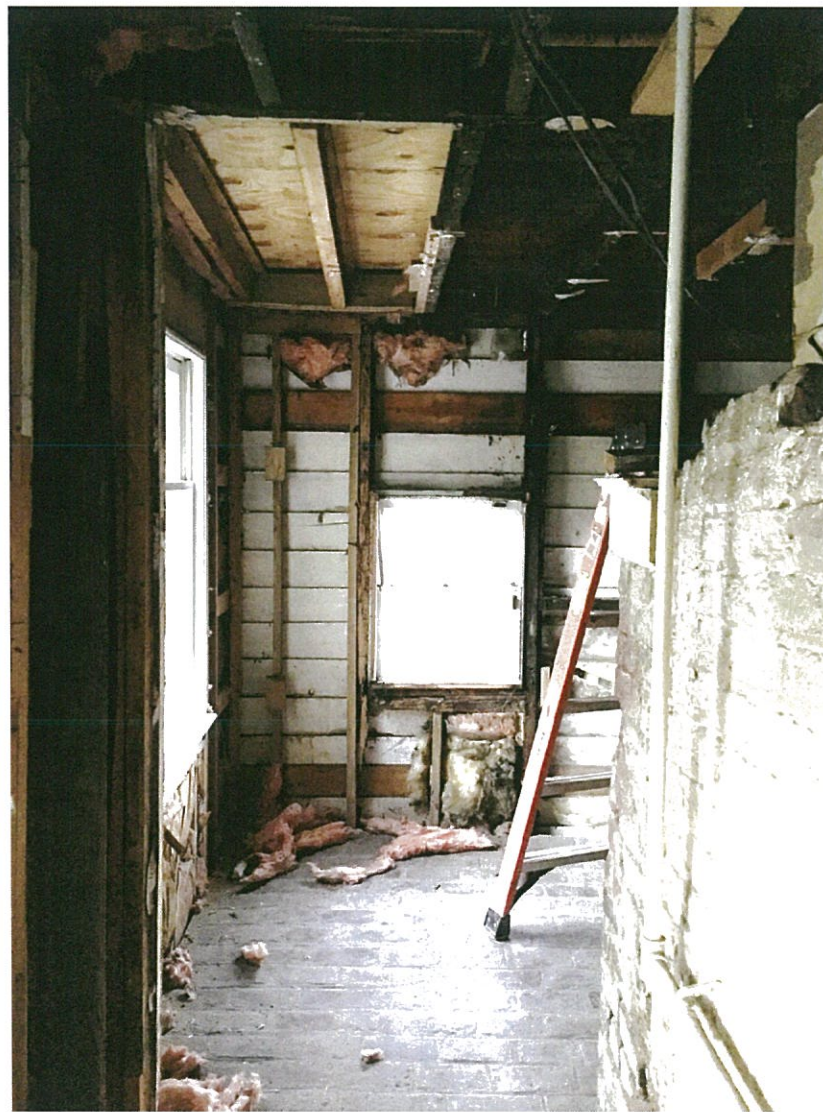
Existing Rear Section, Photograph 2 - 1st level south section

This view of the 1st level southeast corner shows localized repair of stud framing, joists and decking. While these repairs are presumed to have removed rotted and damaged material, the extent of additional damage adjacent to repairs, and in particular at the sill plates, even at this repaired area, made additional repairs to existing damaged structure infeasible and impractical.

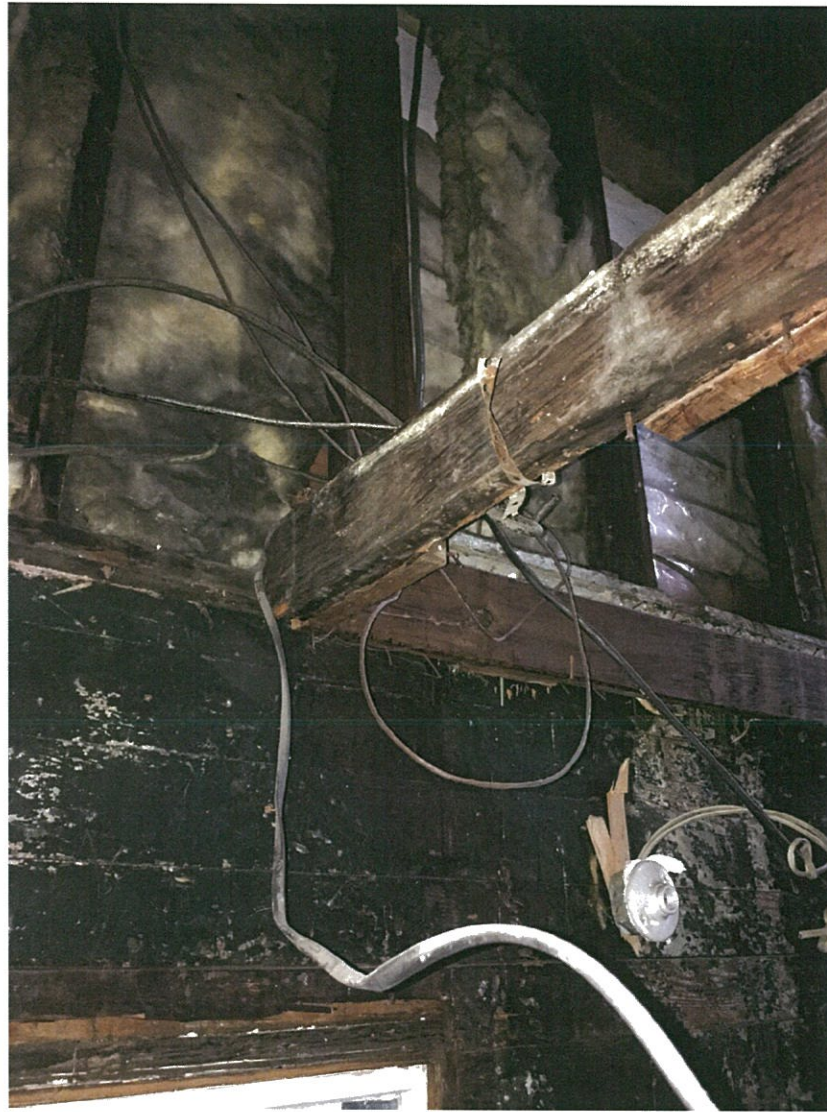
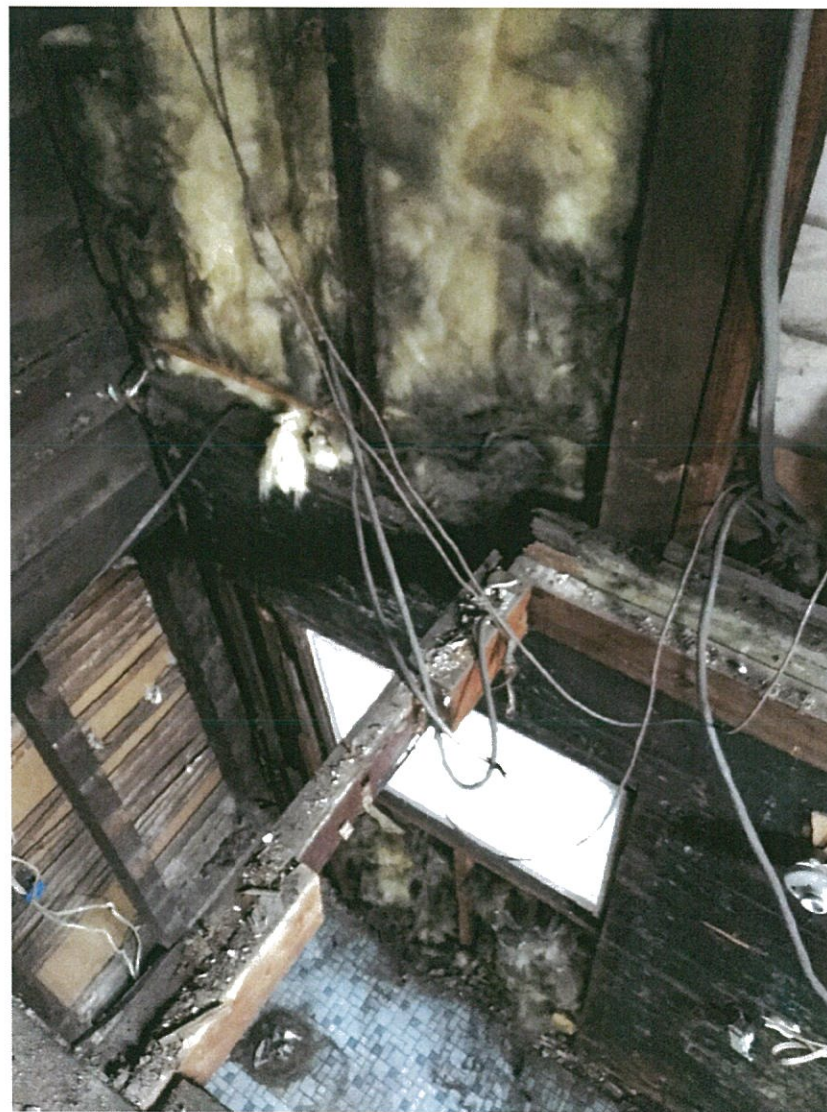
Existing Rear Section, Photographs 4, 5

Photographs are taken along the north wall from 1st and 2nd level and show condition at wood joist bearing ends. This condition was the extreme however it can be assessed relative to typical joist end conditions shown in photograph 8 on Page 4. The location shown in these photos had an attempt at repair by installing new 2x6 lumber nailed to the side wall. However, as shown, this repair was not adequate to fully capture the damaged end nor to brace the frame including stud bases above.

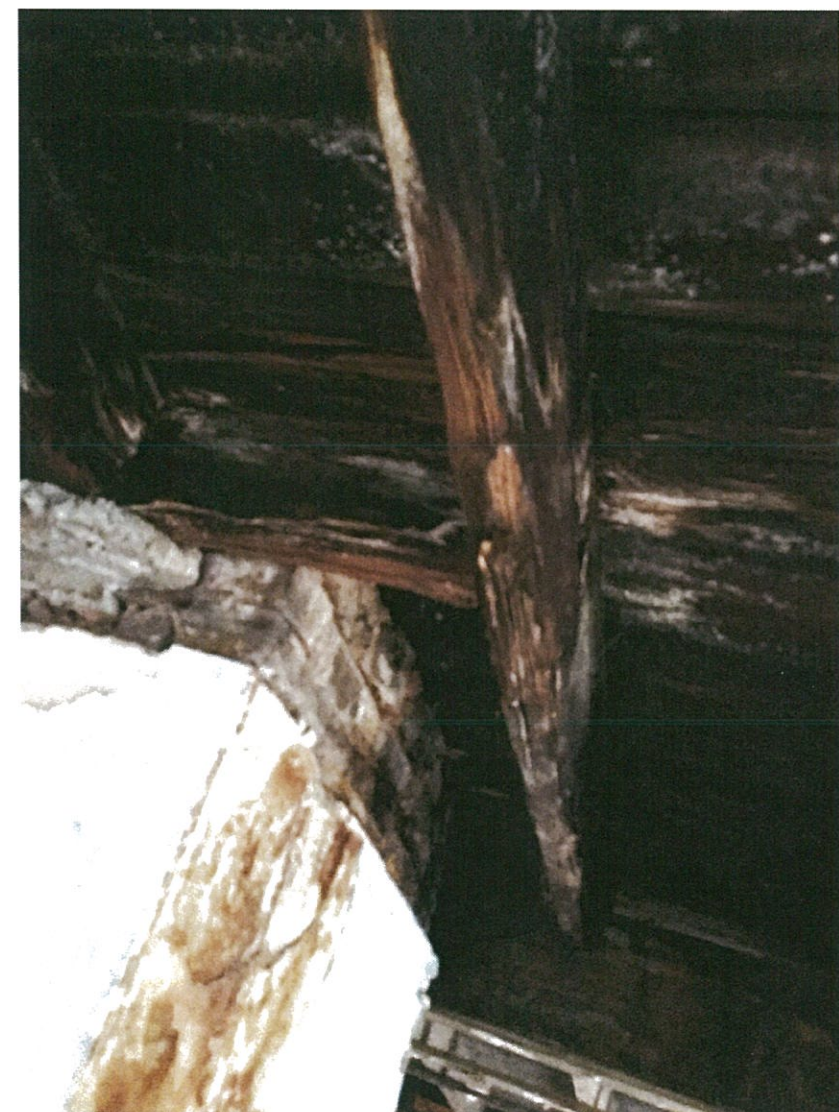
Existing Rear Section, Photograph 6

This photo shows roof framing and decking adjacent to the masonry chimney penetration. This area could have feasibly been corrected in and of itself however the extent of adjacent and additional damage and rot rendered even localized corrections impractical for long-term stability of the structure.

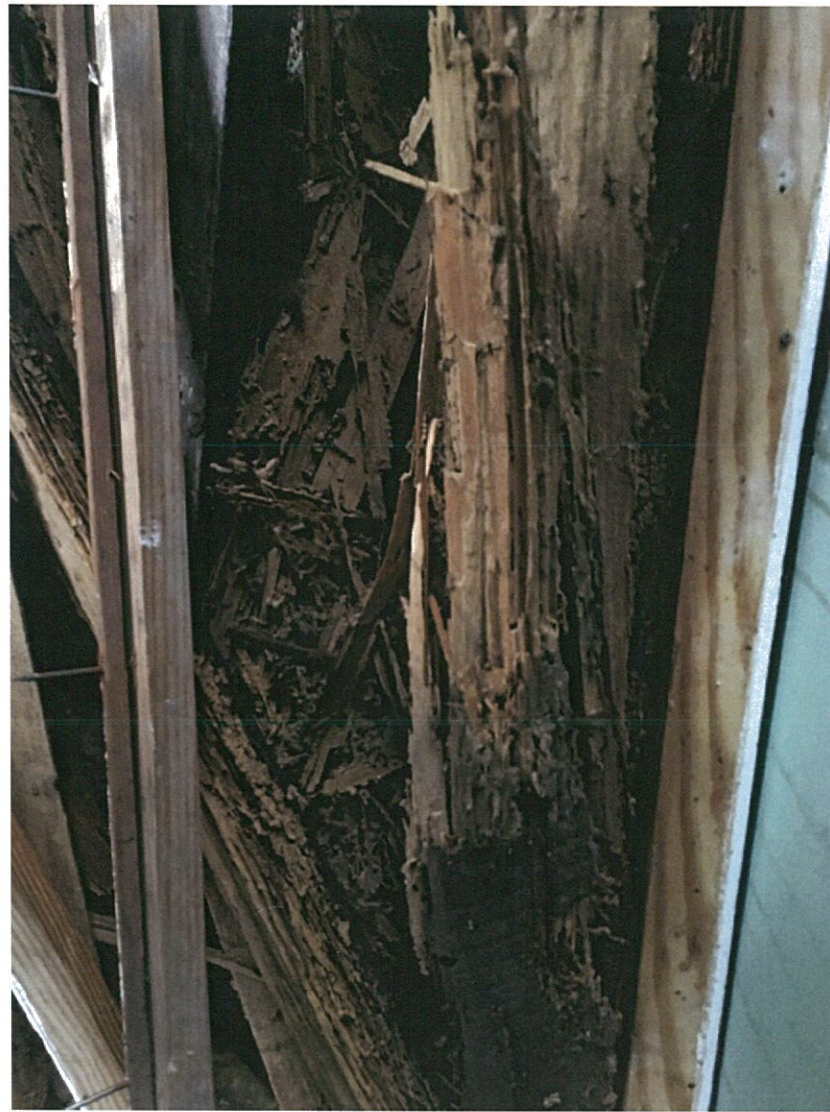
Existing Rear Section, Photograph 7

This photograph was at the 1st level south east corner and shows deteriorated framing lumber. This was a severe instance yet, as noted throughout this section, the overall condition of the structure made removal and repair of specific instances of damage such as this impractical.

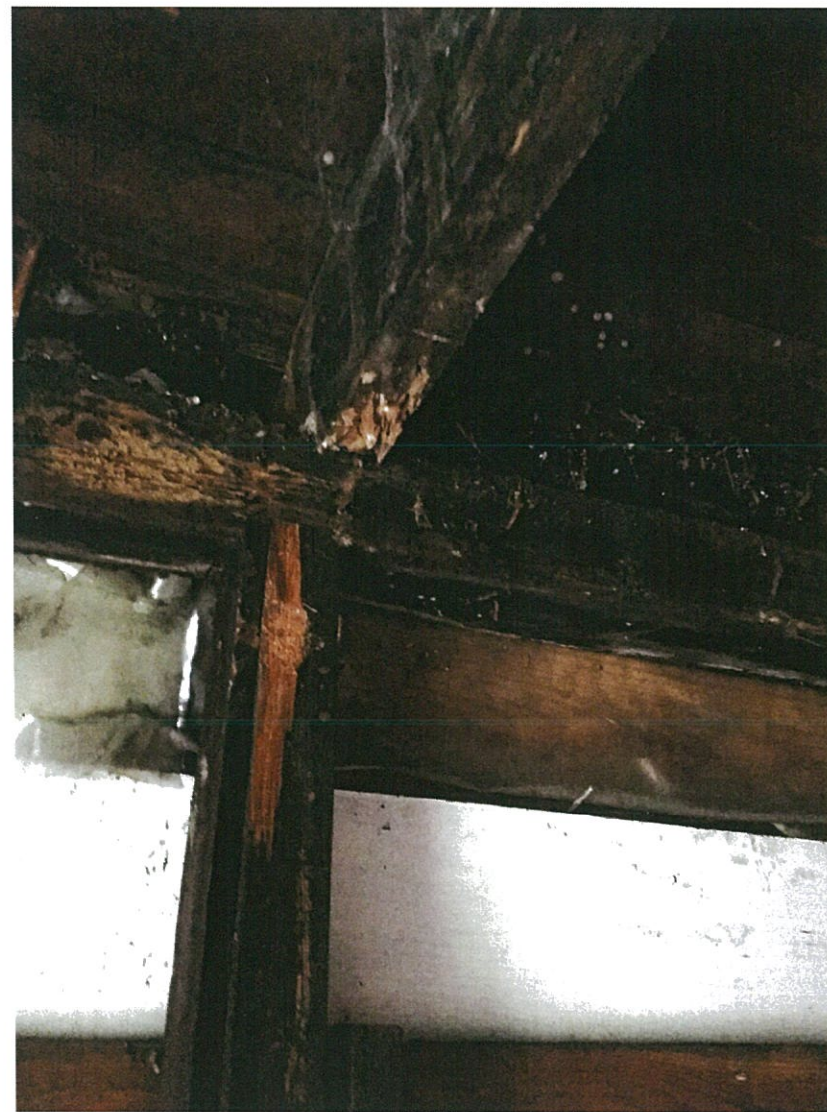
Existing Rear Section, Photograph 8

Photograph 8 shows the condition at a joist bearing end and top plate. This specific instance is at the south wall however it represents the typical condition at all joists bearing locations on both the south and north walls.

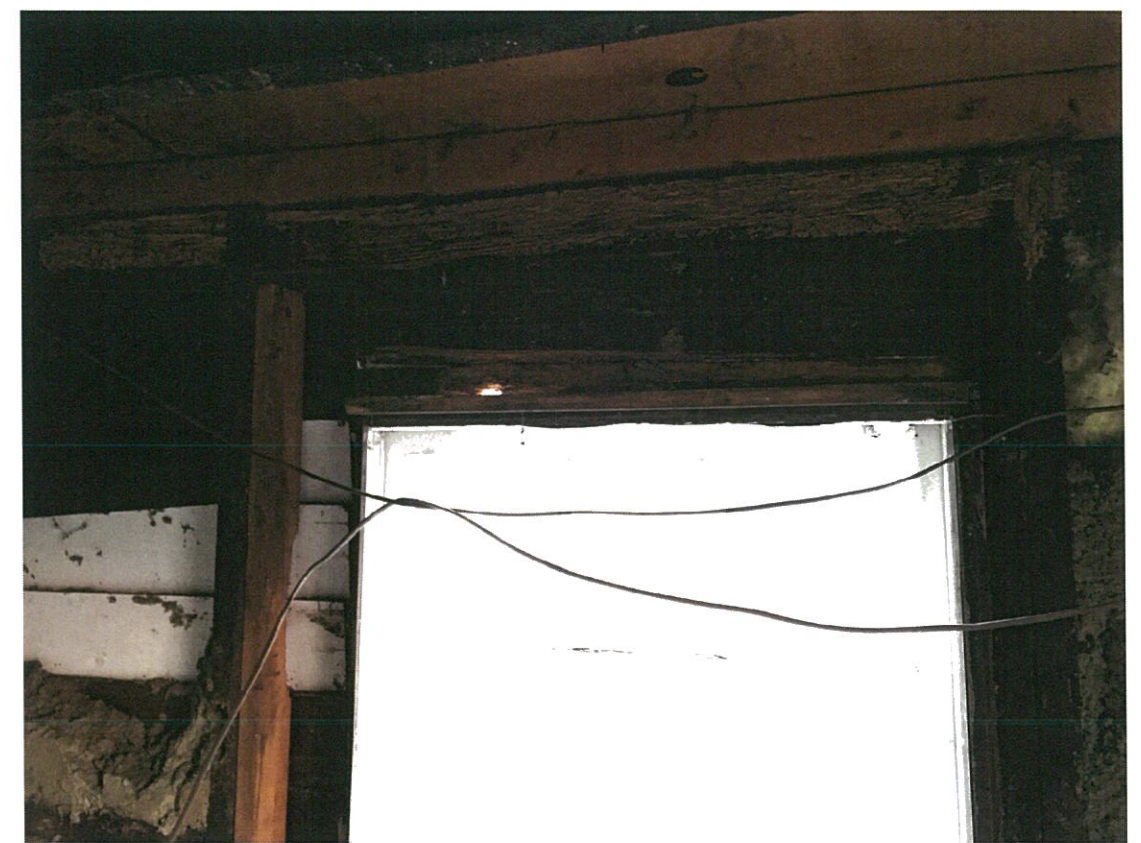
Existing Rear Section, Photograph 9 [upper right]

Photograph 9 shows the condition at the top plate in the area adjacent to that shown in Photograph 8. As with Photograph 8, This specific instance is along the south wall however it represents the typical condition at all joists bearing locations on both the south and north walls.

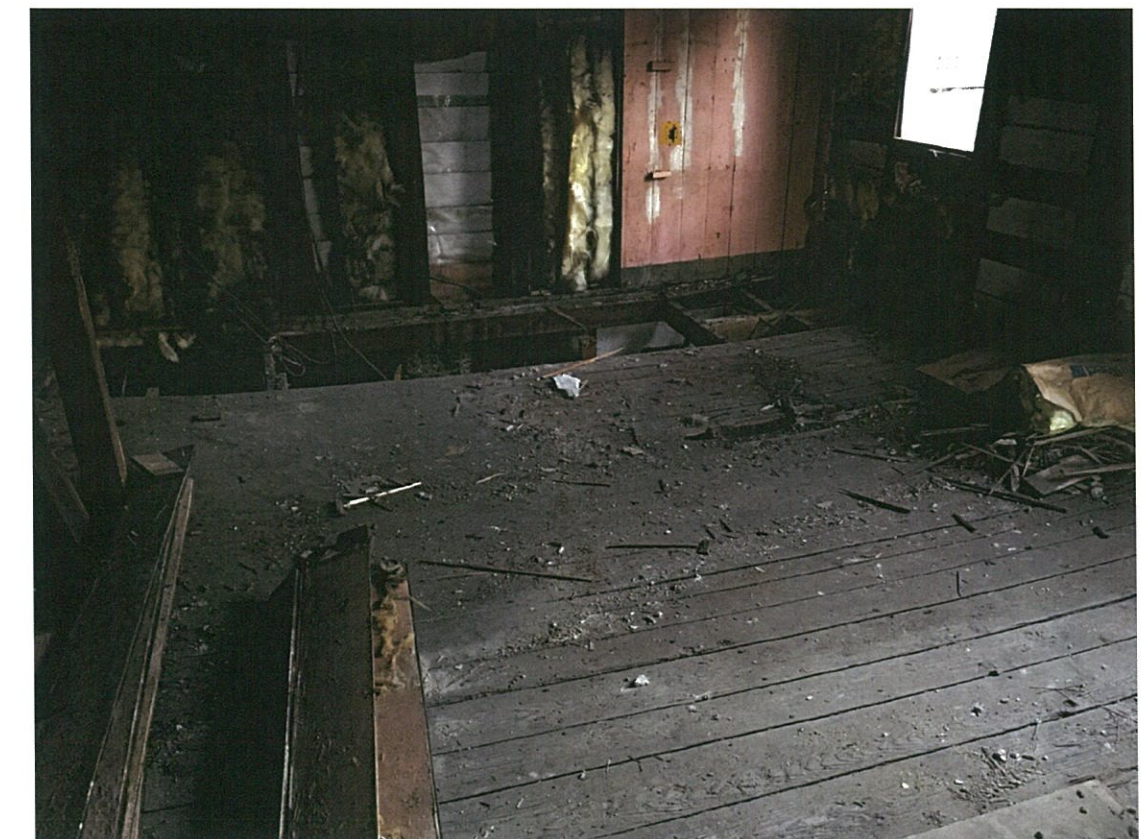
Existing Rear Section, Photograph 10 [lower right]

Photograph 10 is taken on the 2nd level and shows the condition of wood decking which had been encapsulated under plywood without first being leveled or structurally corrected. The open area at the end has evidence of being a stair opening at some point and had been infilled with t&g strip flooring that had largely rotted owing to the presence of a bathtub and associated plumbing at this location.

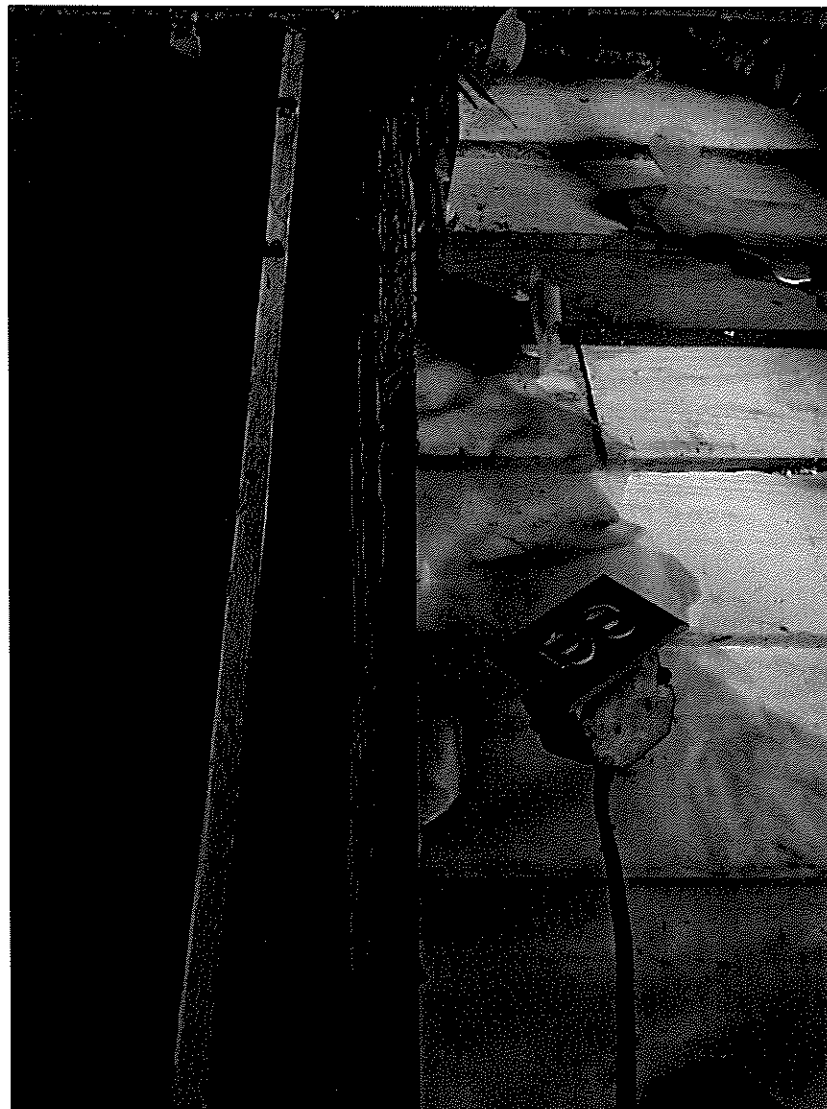
Existing Rear Section, Photographs 11, 12 [left and center]

Photographs 11 & 12 show general types of damage and wear found throughout the shed-roof section. Photograph 12 shows an area of existing wood clapboard siding that was uncovered and is proposed to be removed and, if possible, relocated to the north wall of the historic gable section of the residence.
