PK and Rec Inventory 2016-2017

# Property Condition Assessment

**3000 E. Belt Blvd  
Richmond, VA 23224**

**Inspection Date: 01/12/2018**

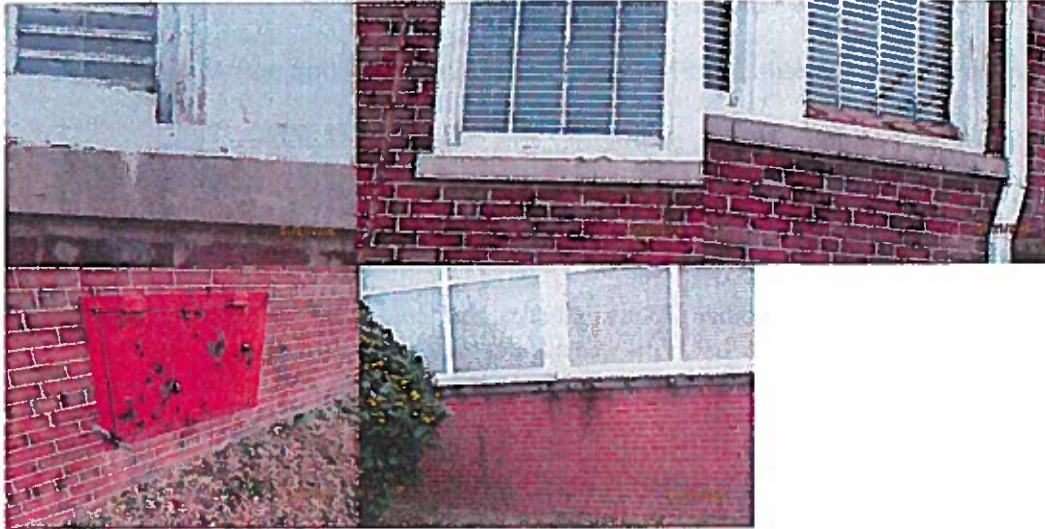
- 3.2.1 No major structural defects were noted.
- 3.2.2 Power wash, clean & paint exterior wall surface

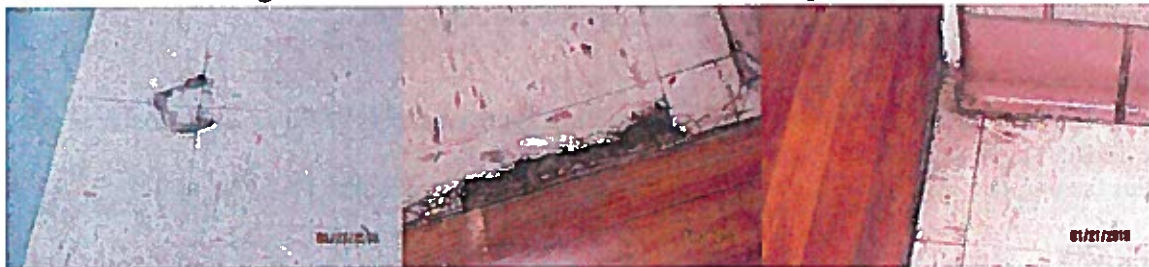
- 3.2.3 Interior flooring on has several crack tiles that need to be replaced

<b>Recommendations</b>	<b>COSTS</b>	<b>PRIORITIES (Time Frame)</b>
Repair hallway floor	\$350.00	6 mos

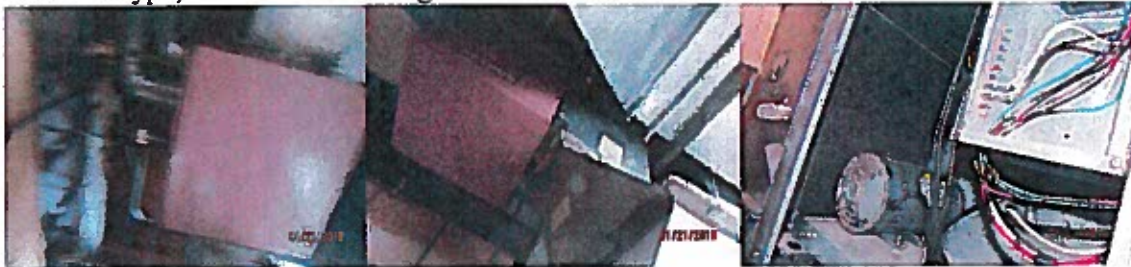
5.2.7 The supply air ducts in the general area are located throughout the building is a cathedral type, which make PMing difficult at times.

Recommendations	COSTS	PRIORITIES (Time Frame)
Replace in-line gas units	\$2500.00 ea.	Immediate
Replace gas furnace	\$30,000.00	12 mos

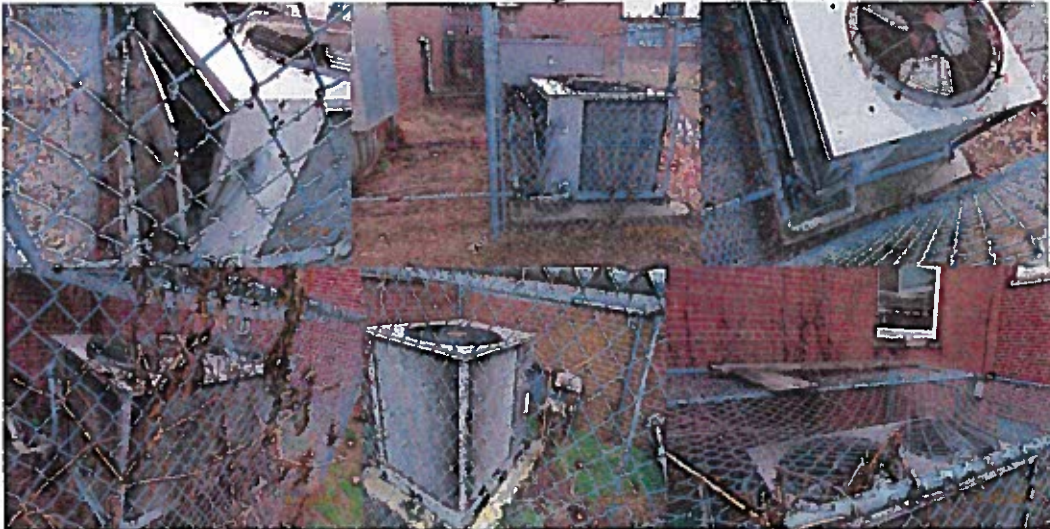
6.2.5 The air distribution is considered to be good in the throughout the building.

Recommendations	Costs	PRIORITIES (Time Frame)
Replace main unit in the multi-use areas	\$65,000.00	immediate
Replace main unit in the multi-office areas	\$65,000.00	immediate
Replace 7 ton unit in the office areas	\$30,000.00	immediate

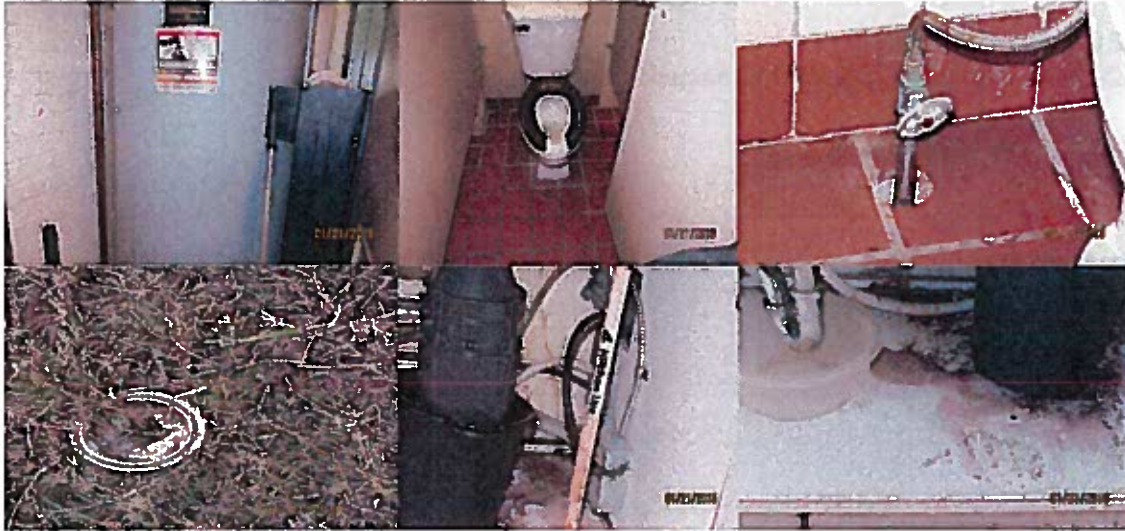
There is a 1 1/2 inch-diameter, copper, domestic water supply line to the building.  
 (1) 110 gallons electric hot water heater.

<b>Recommendations</b>	<b>COSTS</b>	<b>PRIORITIES (Time Frame)</b>
Service all interior drain lines	\$650.00	Quarterly PM
Repair leaking drain line under kitchen sink	\$300.00	immediate
Replace missing cap on drain line in rear yard	\$200.00	immediate
Repair bathroom toilet in older section of the building	\$600.00	immediate
Replace water shut-off valve in bathroom	\$400.00	6 mos.

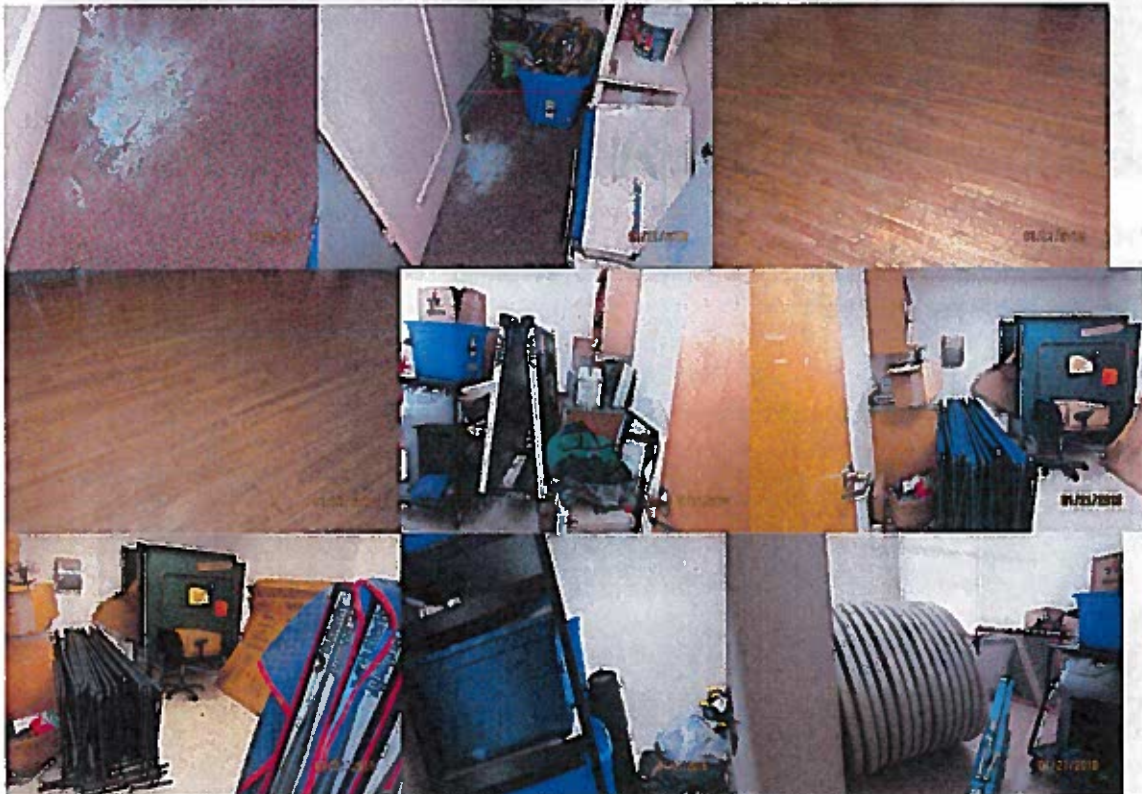
10.2.3 There was mildew found on the walls and under the sinks in the kitchen.

Also around toilet fixtures in most of the bathrooms

<b>RECOMMENDATIONS</b>	<b>COSTS</b>	<b>Time Frame</b>
Replace damaged ceiling tiles as needed	\$1500.00	immediate
General cleaning to CC is needed	\$15,000.00	immediate
Prep, clean, repair and service all interior floor areas	\$15000.00	6 mos

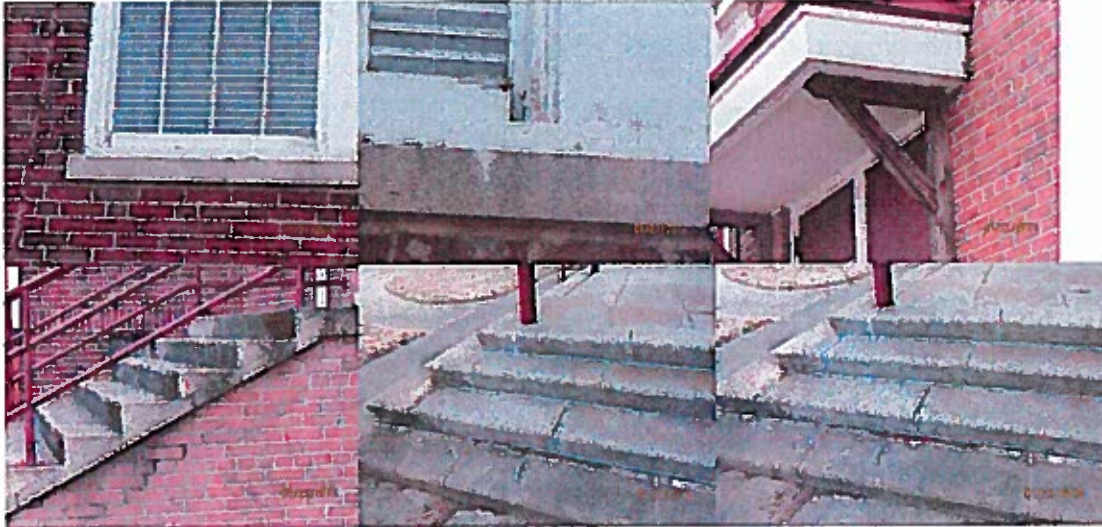
3.1.2 Repair exterior wall surface

3.2.3 Power wash, clean & paint exterior wall surface

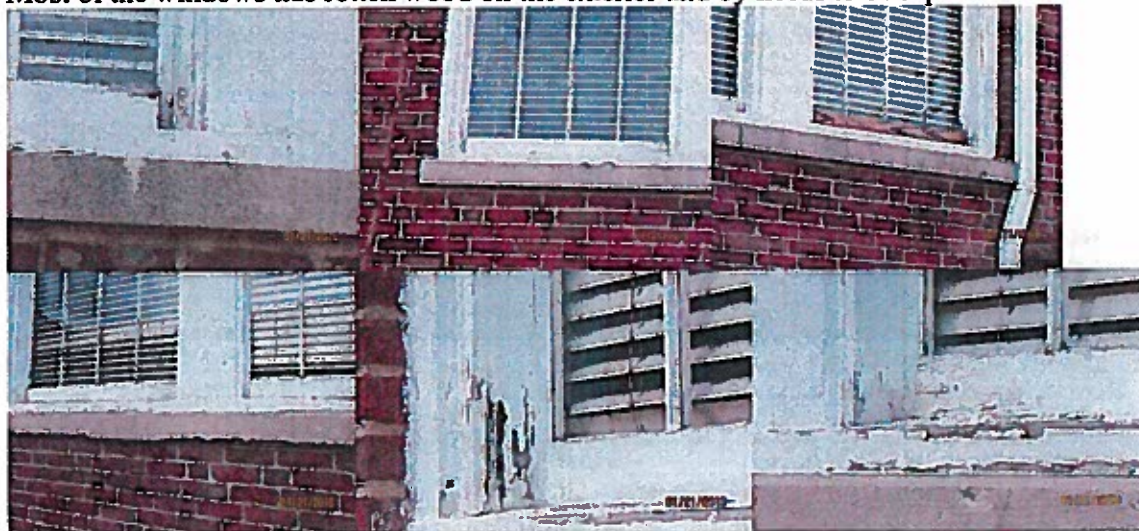
Most of the windows has rotten wood on the exterior and by needs to be replace.

<b>RECOMMENDATIONS</b>	<b>COSTS</b>	<b>Time Frame</b>
Repair exterior gutters	\$2500.00	6 mos
Paint exterior wood trim and window trim	\$5000.00	6 mos
Replace exterior windows, that has rotten wood on the frame	\$75000.00	24 mos.
Replace broken/cracked windows	\$2000.00	10 mos
Replace loose/missing mortar/caulking on exterior steps (side)	\$1500.00	6 mos
Repair gutters downspouts	\$350.00	12 mos.

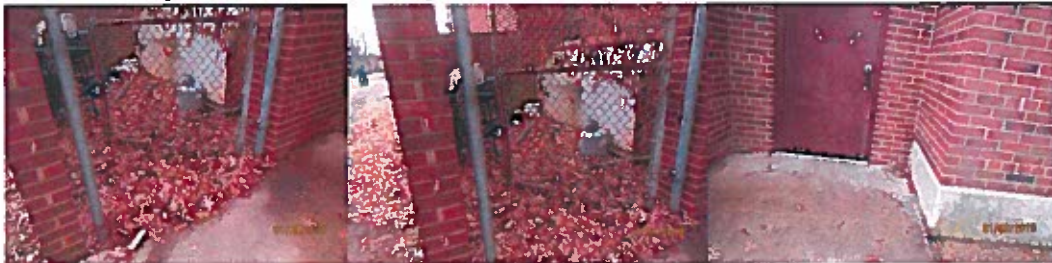
- 3.2.1 No major structural defects were noted.
- 3.2.2 Power wash and clean exterior wall surface
- 3.2.3 Clean up exterior surroundings

Recommendations	COSTS	PRIORITIES (Time Frame)
Power wash exterior	\$4000.00	Routine

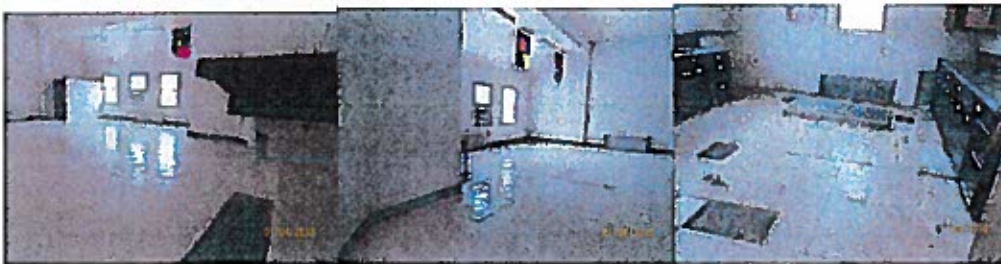
3.2.3 Interior flooring on main level needs to be replaced in kitchen area and repair in the assembly section

Recommendations	COSTS	PRIORITIES (Time Frame)
Paint interior walls, throughout center	\$6000.00	Routine
Replace entire kitchen floor	\$5500.00	Immediate
Repair buckling floor and loose tiles in assembly area	\$15,000.00	Immediate

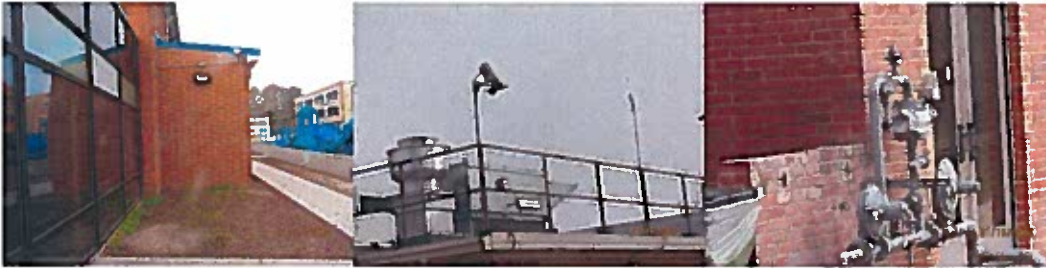
3.2.1 No major structural defects were noted.

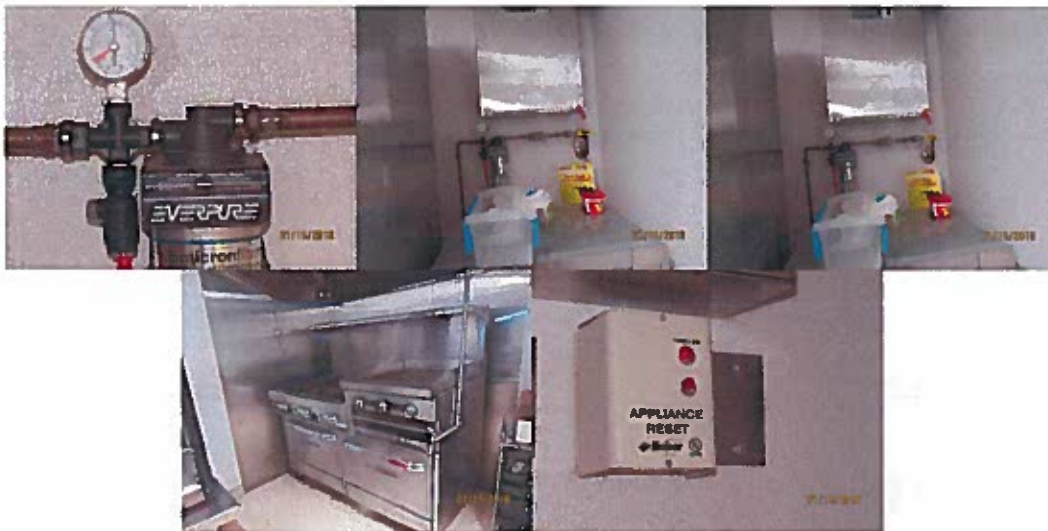
7.2.2 Several exhaust fans or vents in every ceiling of the restrooms

Recommendations	Costs	PRIORITIES (Time Frame)
Service, inspect and clean entire fire suppression system	\$2500.00	immediate

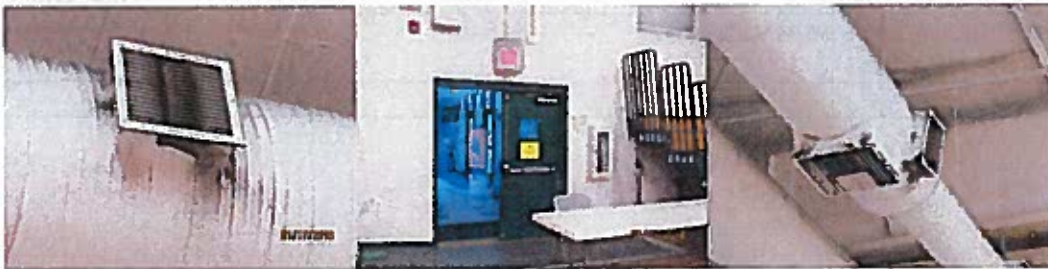
7.2.2 Several exhaust fans or vents in every ceiling of the restrooms

Recommendations	Costs	PRIORITIES (Time Frame)
Clean out entire duct system, throughout center	\$15,000.00	24 Months

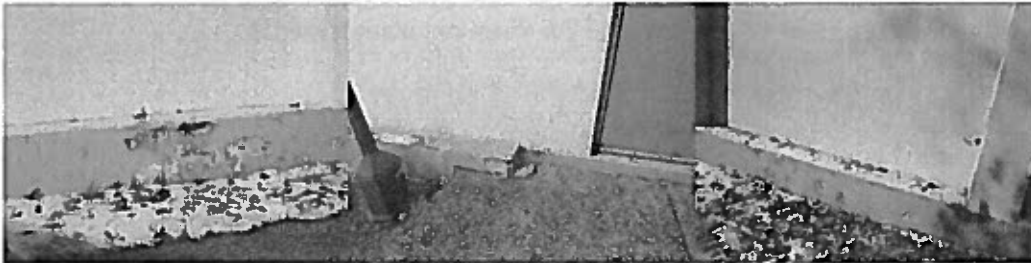
3.2.2 Minor exterior cracking to concrete retaining wall

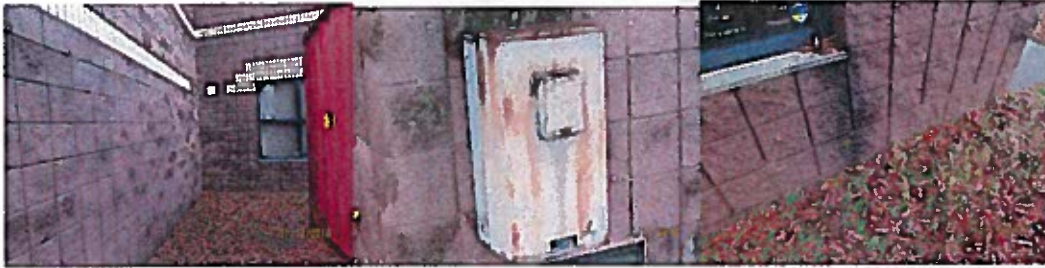
- 3.2.1 No major structural defects were noted.
- 3.2.2 Power wash, clean & paint exterior wall surface

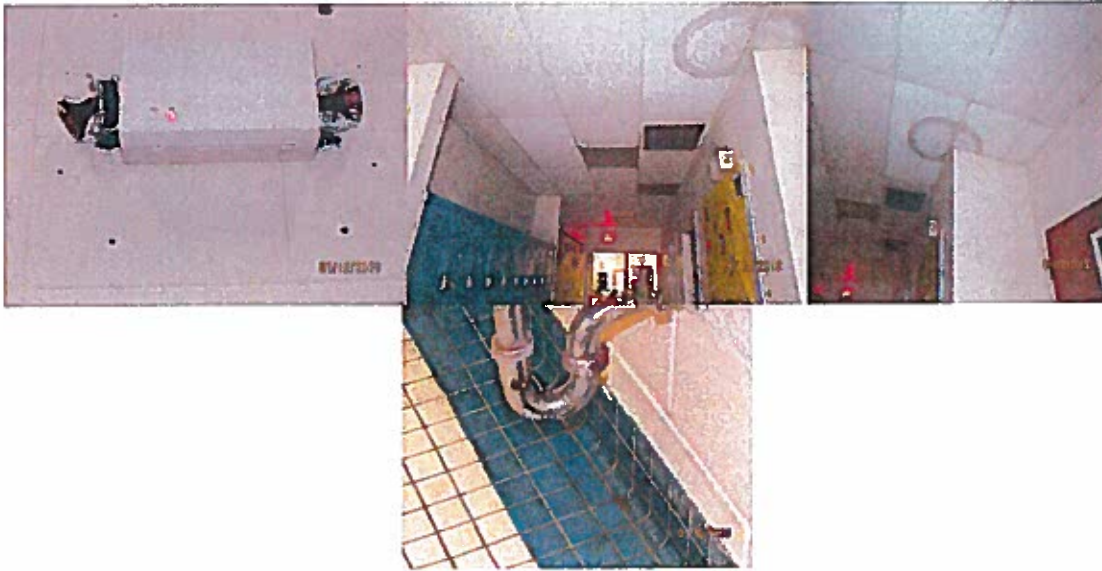
10.2.2 Some of the walls, ceilings, and floors show cosmetic imperfections.

10.2.3 There was mildew found on the walls and under the sinks in the kitchen.

<b>RECOMMENDATIONS</b>	<b>COSTS</b>	<b>Time Frame</b>
<b>Replace damaged ceiling tiles as needed</b>	<b>\$1500.00</b>	<b>immediate</b>
<b>Replace emergency light fixtures in the gym</b>	<b><u>5@\$500.00</u></b>	<b>immediate</b>
<b>Replace drain pipe under bathroom sink</b>	<b>\$100.00</b>	<b>6 mos</b>

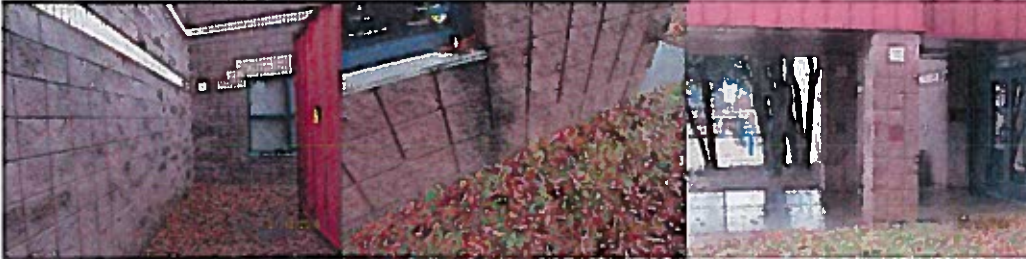
3.1.2 Repair exterior wall surface

3.2.3 Power wash, clean & paint exterior wall surface

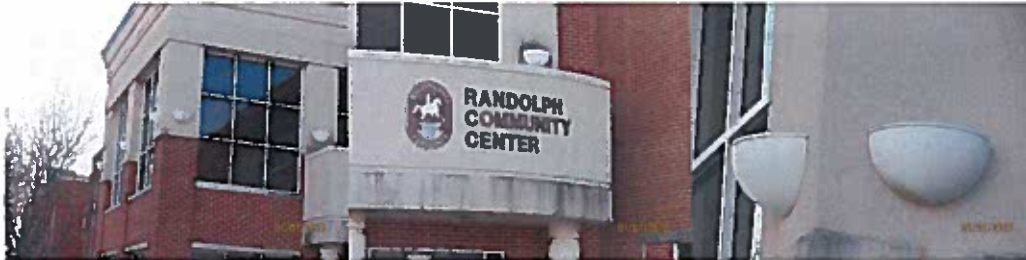
- 3.2.1 No major structural defects were noted.
- 3.2.2 Power wash, clean & paint exterior wall surface

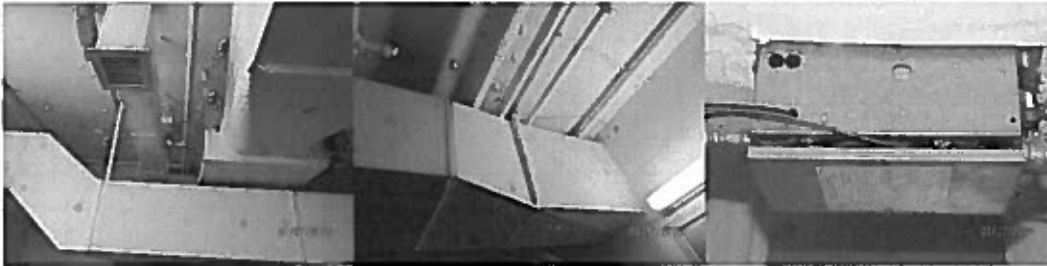
7.2.2 Several exhaust fans or vents in every ceiling of the restrooms

<b>Recommendations</b>	<b>Costs</b>	<b>PRIORITIES (Time Frame)</b>
<b>Clean entire ventilation system throughout center</b>	<b>\$15,000.00</b>	<b>12 mos</b>

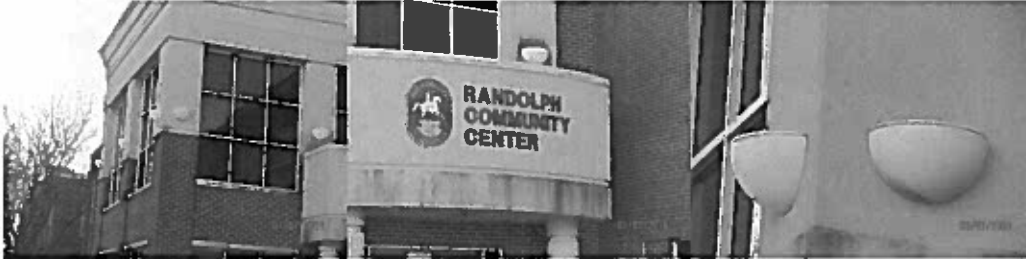
3.1.2 Repair exterior wall surface

3.2.3 Power wash, clean & paint exterior wall surface

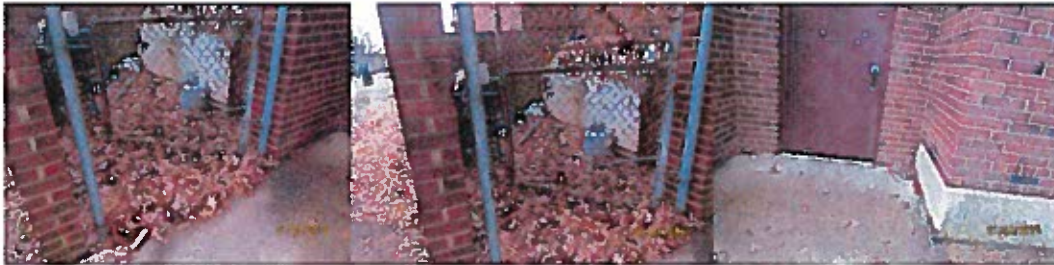
3.2.2 Power wash and clean exterior wall surface

3.2.3 Clean up exterior surroundings
