# Commission of Architectural Review SUBMISSION APPLICATION

LOCATION OF WORK: 600 W 19th St DATE: 08/28/2015

Exterior of house had years of deferred maintenance causing the deterioration of windows, siding, fencing and brick work. Additions to garage have completely rotted and need to be removed. Our intention is to rehabilitate the structure with products that will provide the look and feel of the original. These products will be more energy efficient to help keep costs down for all future inhabitants.

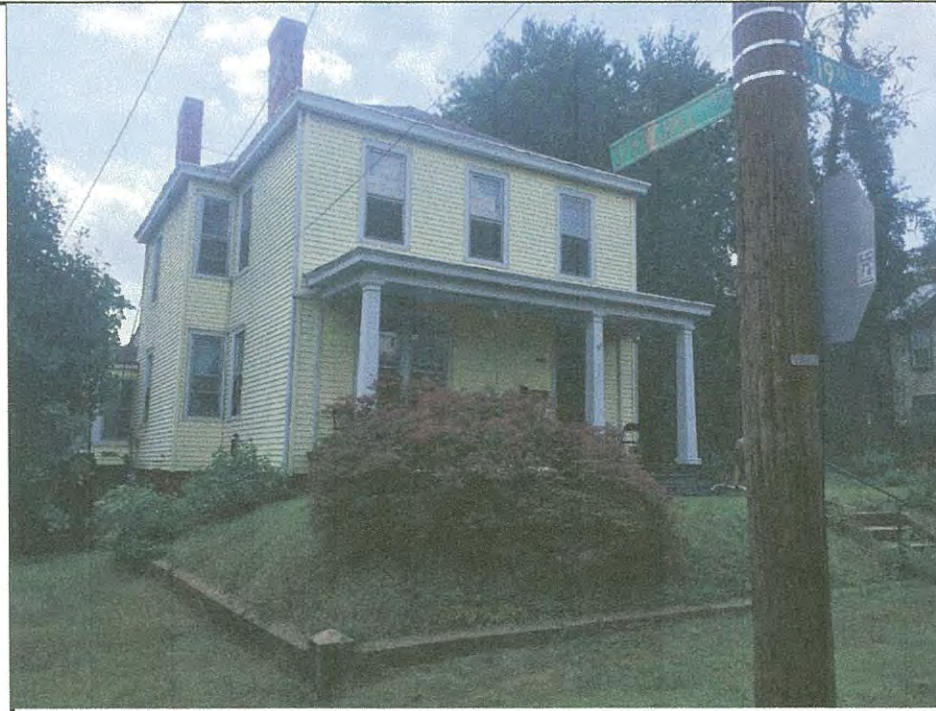
Architectural Feature: Vinyl Siding  
Approximate Date of Feature: 1980's

Siding is faded, brittle and sagging. Original application was of poor quality lacking attention to detail. Missing pieces of existing siding would be difficult to replace because of age.

Our intent is to refresh the exterior siding by replacing the dilapidated, faded, and poorly installed viny which is currently in a state of disrepair, with a more energy efficient, durable, and period appropriate look using Hardie-Plank fiber cement board. We plan to pay special attention to the appearance by matching the original siding profile dimension with the same reveal and a smooth Hardie-Plank (non-wood grain) finish. We request approval to use #5 - Colonial Revival Gray (SW#2832) from the CAR pre-approved color pallete; Trim color # 41 - Classic Light Buff (SW#0050).

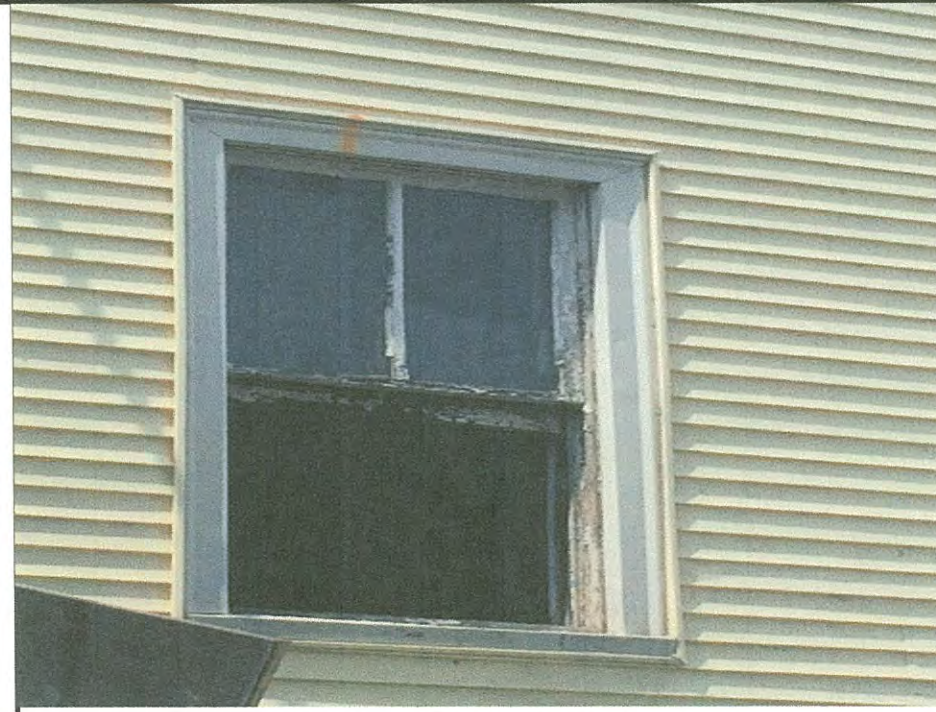
Architectural Feature: Windows  
Approximate Date of Feature: \_\_\_\_\_

All windows are in severe disrepair. Wood around windows is rotten and should be replaced. Many of the glass pains have been vandalized. Many of the original windows have obviously been replaced. However, a few windows still have a two-over-one configuration which appears to have been original to the house.

We intend to replace all windows with the original two over one configuration, energy efficient Vinyl.

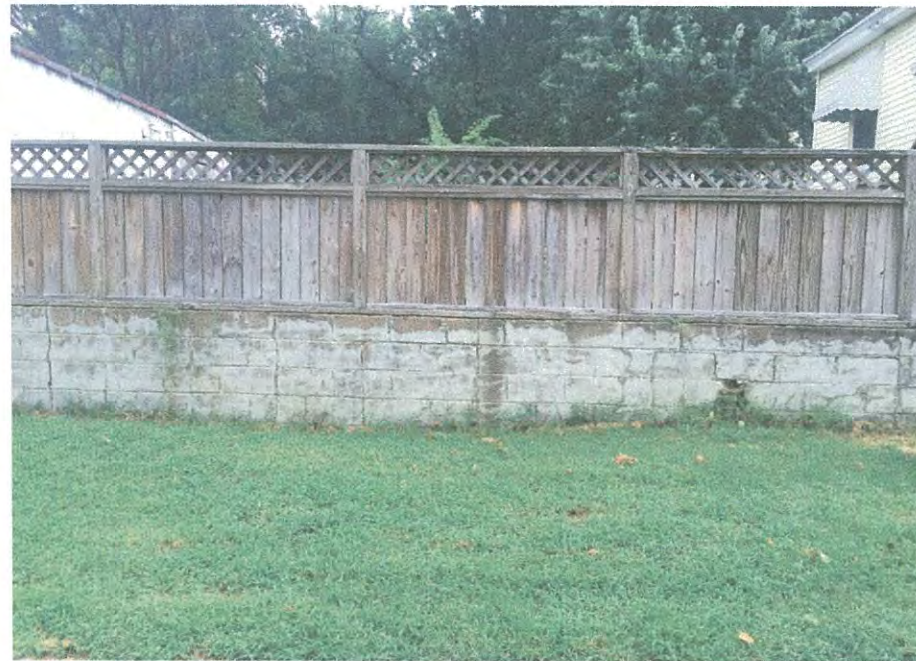
Architectural Feature: Fence

Cinder block retaining wall has cracks that need to be repaired. Wood fencing has warped/rotten board that need to be replaced. Chain link fence falling over

Tuck pointing will be completed foundation and chimney brick. Both foundation and chimney will be painted to conform to a CAR approved brick red. Either 29 - Roycroft Copper Red, SW #2839, RGB (123, 49, 30); or 30 - Deep Maroon, SW #0072, RGB (99, 63, 68).

Warped/Rotten fence board to be replaced with similar board and stained with 27 - Rookwood Terra Cotta, SW #2803, RGB (152, 90, 61) or painted with Color # 41 - Classic Light Buff (SW#0050). Chain link fence to be removed. Cinderblock retaining wall to be parged and painted with 51 - Craftsman Brown, SW #2835, RGB (173, 149, 120).

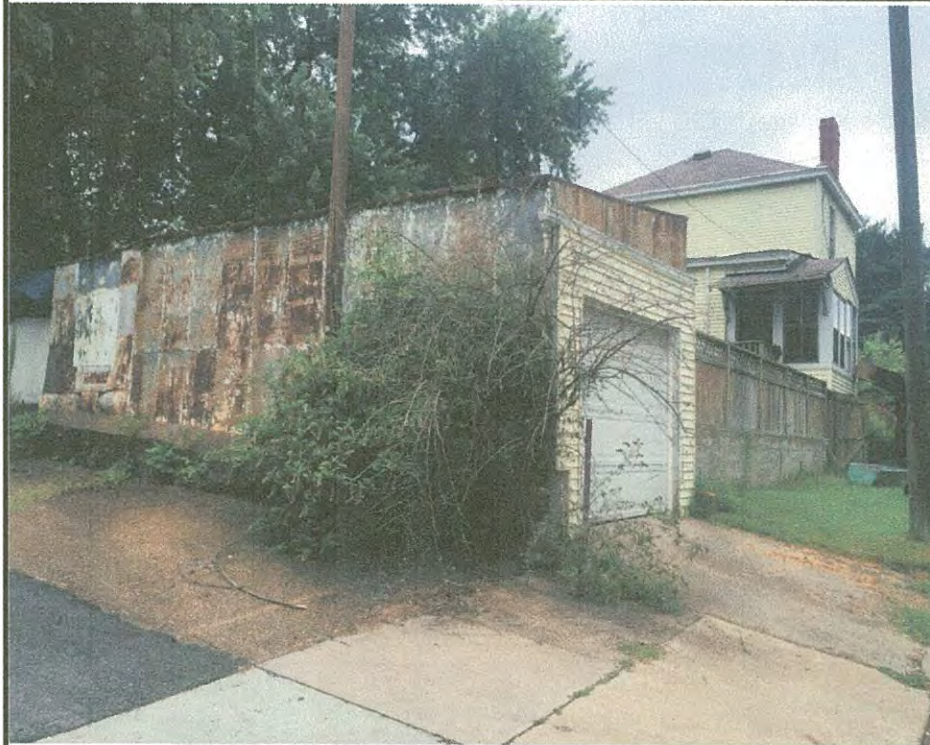
Garage: is on cinder block foundation, wood frame construction, and metal clad siding. Flat roof with metal sheeting that is leaking. Broken gutters causing flooding and rot on interior and exterior of the garage.

Install new V-crimp metal or membrane roof.

Resurface sides of detached garage with same proposed Hardi-

Remove 2 planters sheds additions and restore garage to original dimension.

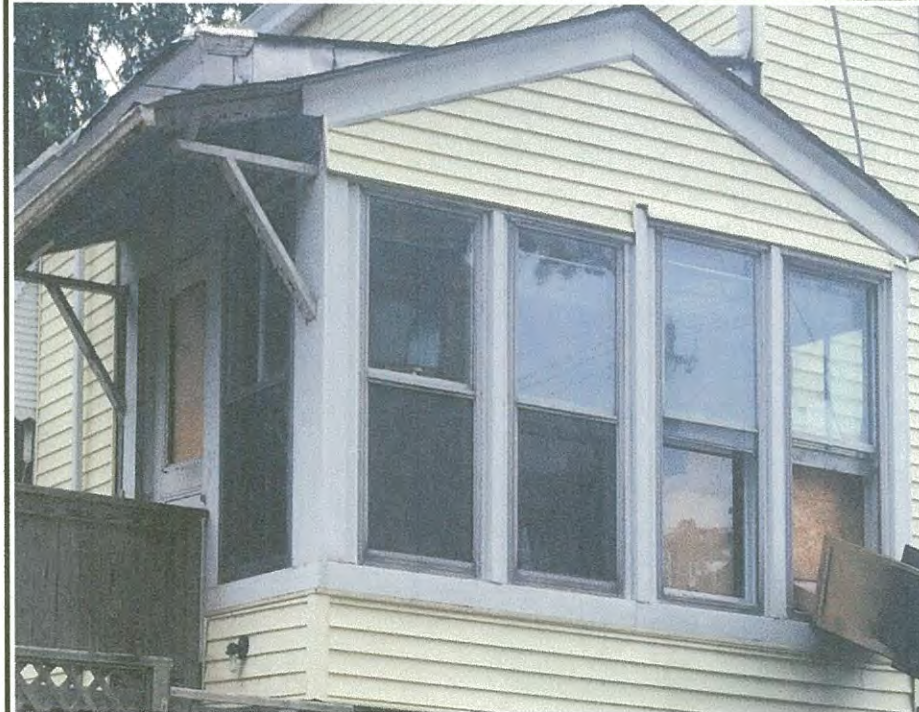
Window elevations are not symmetrical. Interior bottom of windows too low to meet code requirements.

Kitchen-Porch Roof -- We've spoken with CAR preliminary review and since this lower roof is not visible it should be outside of the purview of the Commission and therefore, use EPDM or other membrane roofing material would be permitted material for repair.

Repair/replace with same style (1 over 1).

Ensure windows are uniformly dimensioned and framed.

Retain the existing window head and raise the sill.

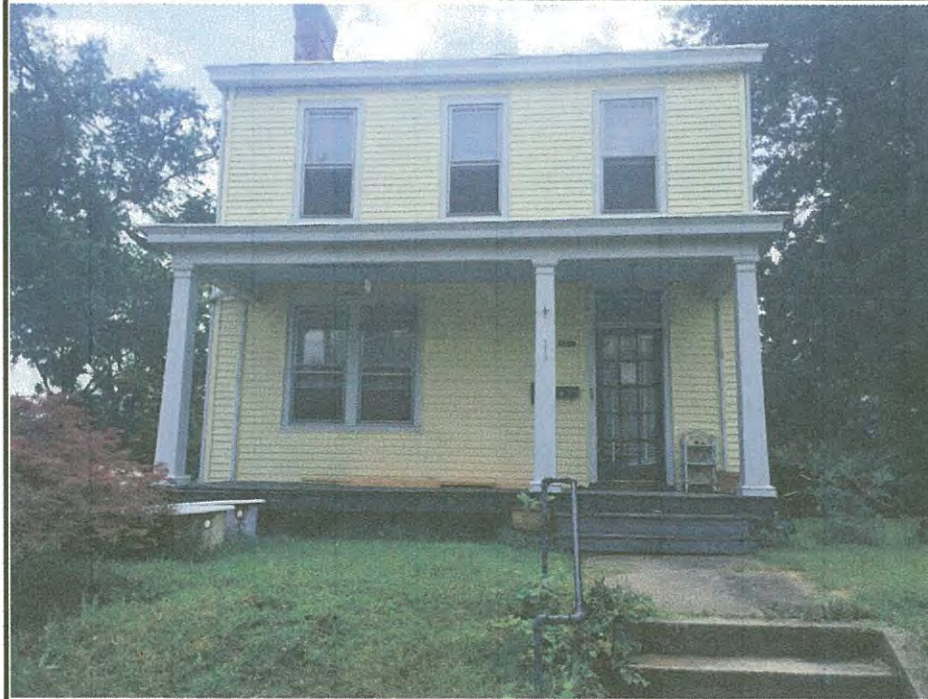
Sidewalk from front steps leading to porch is cracked and elevated in some areas.

Repair (or replace with like kind) front concrete walkway leading to steps/front door. Would like to extend house walkway from bottom of steps to city sidewalk if city continues current active sidewalk installations in our neighborhood.

Install simple powder coated, square tube profile stair rail on each side of steps.

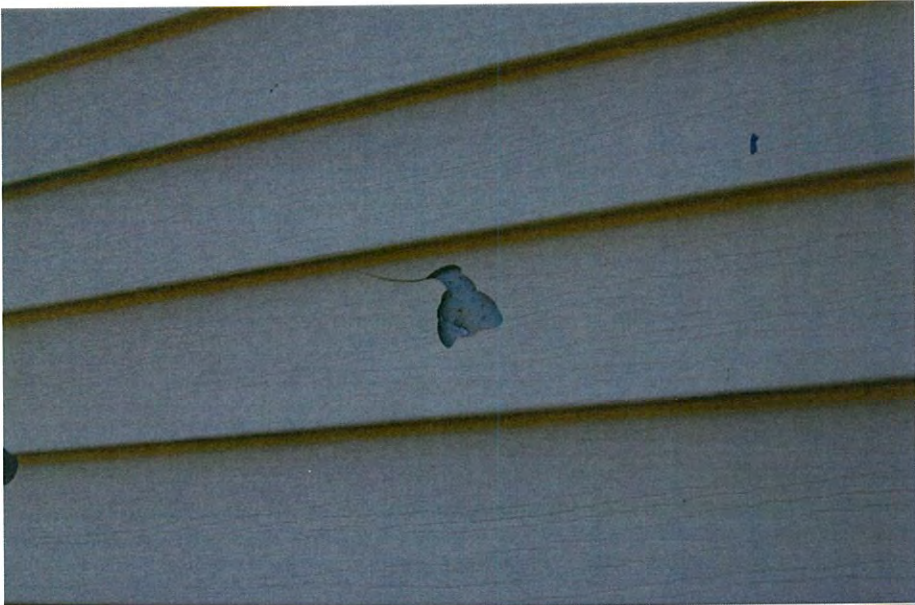
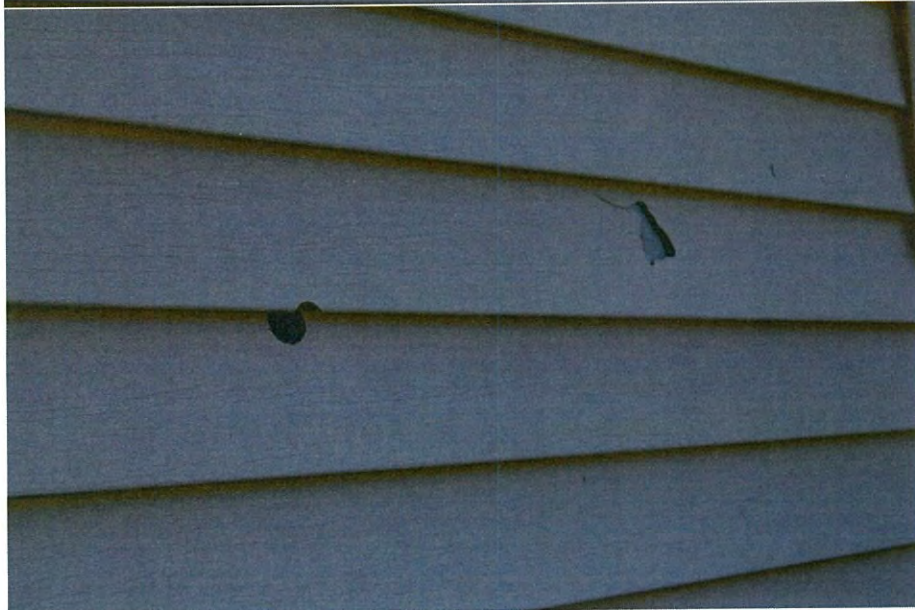
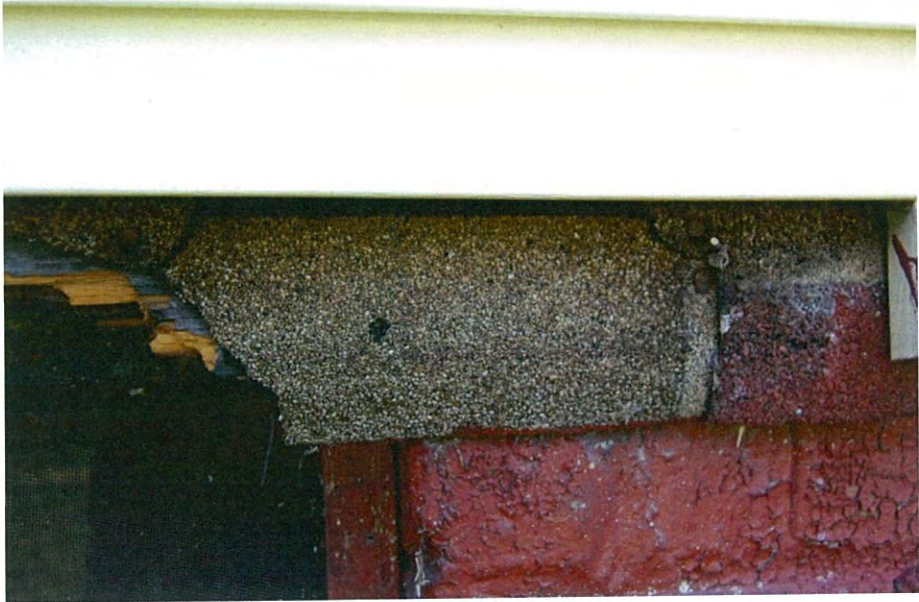
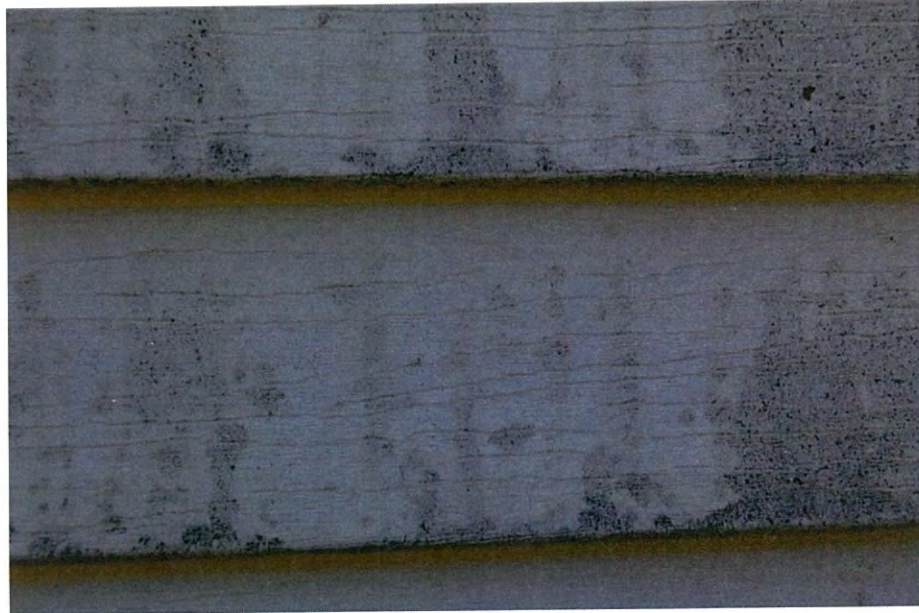
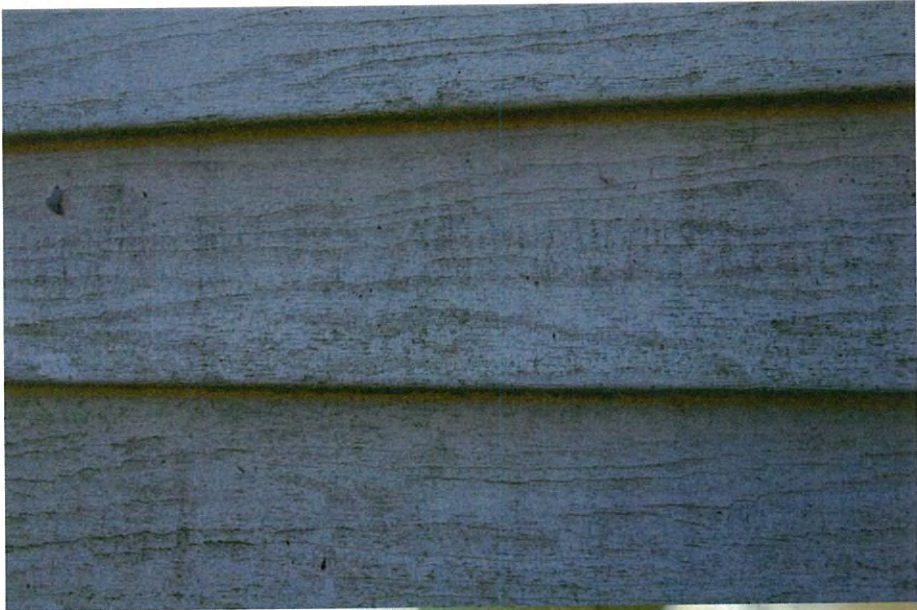
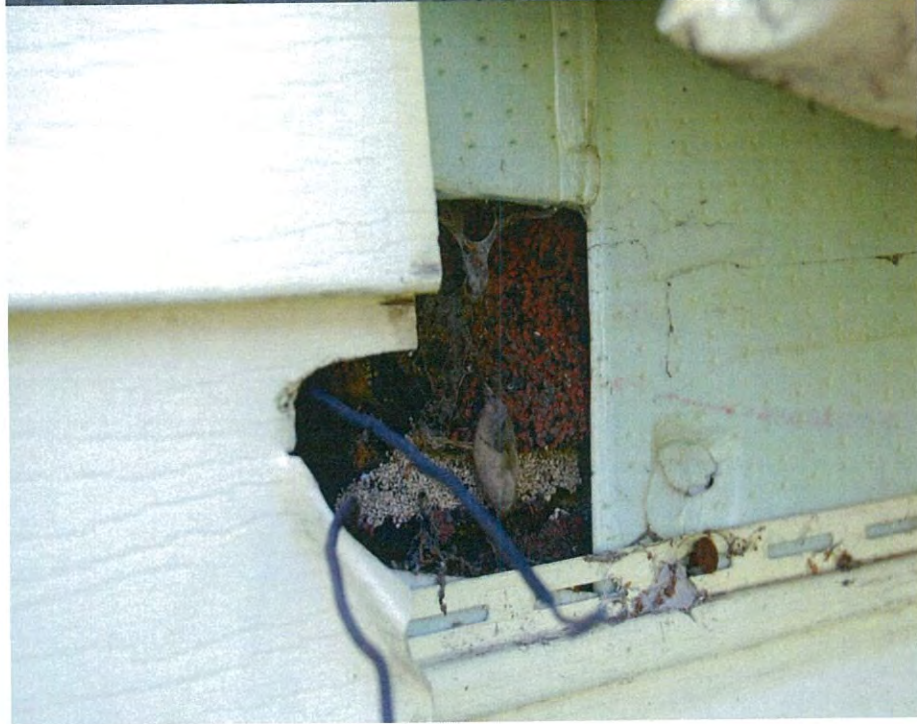
1. VINYL SIDING

**Original wood siding covered with asphalt shingled then covered with vinyl. Vinyl is brittle and can't be replaced.**

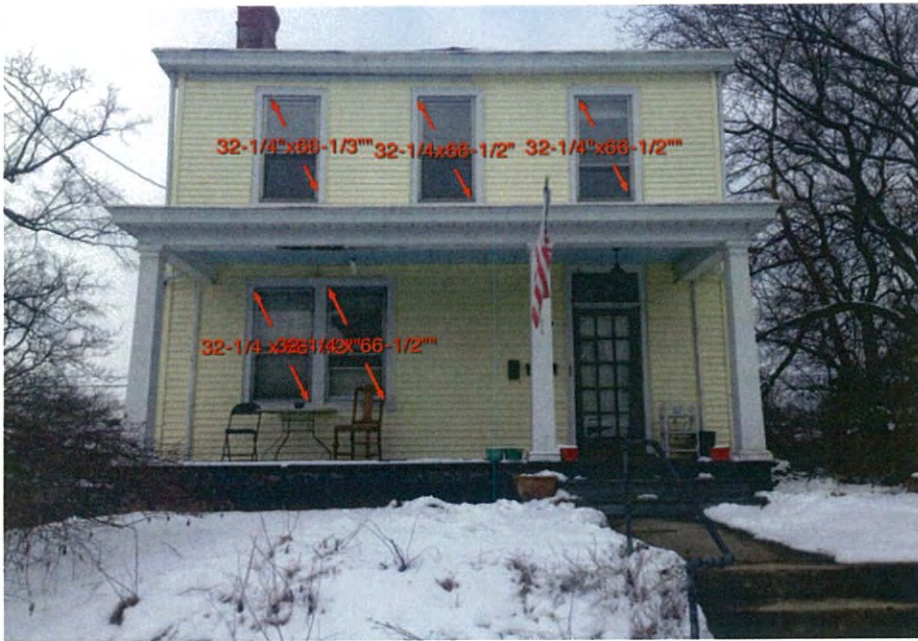
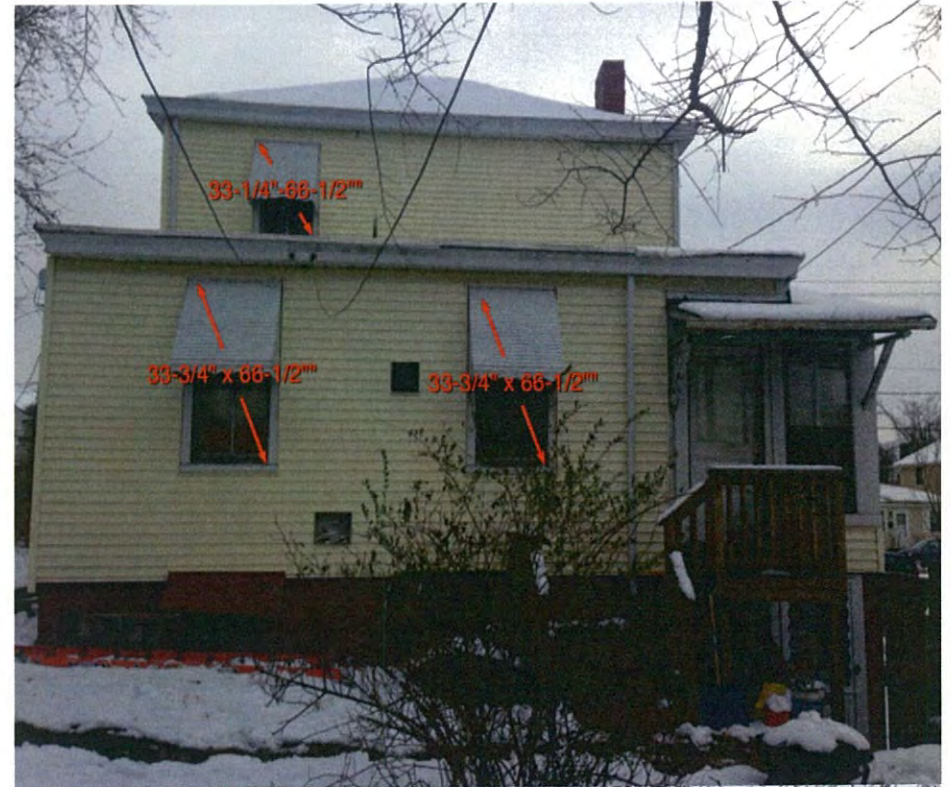
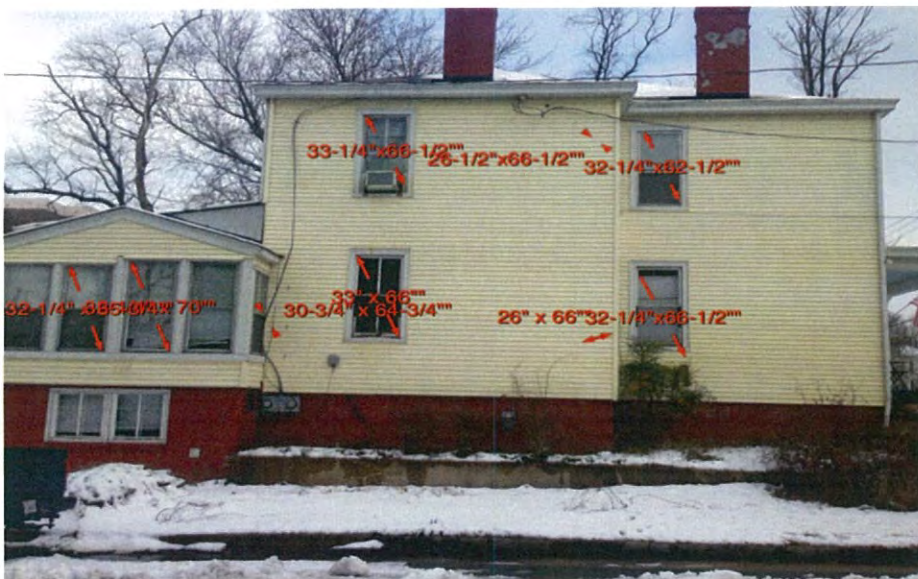
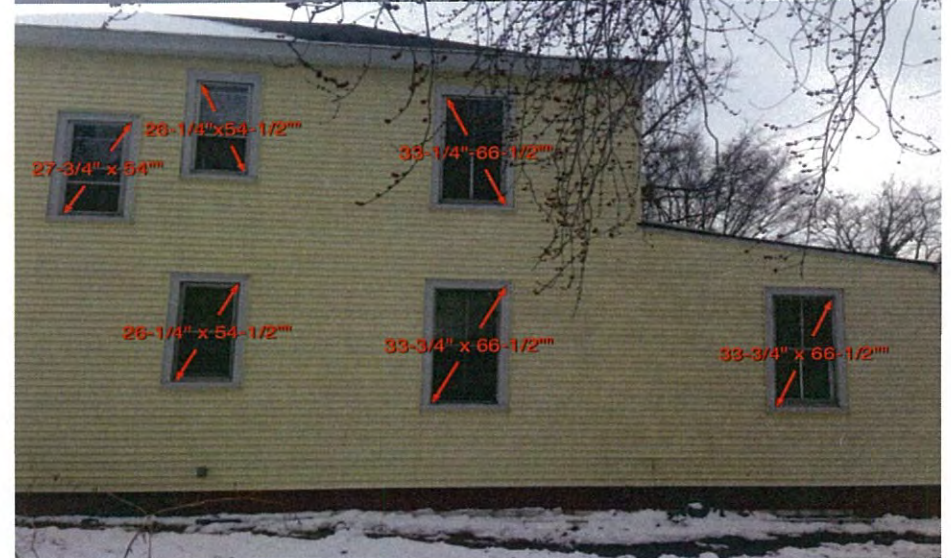
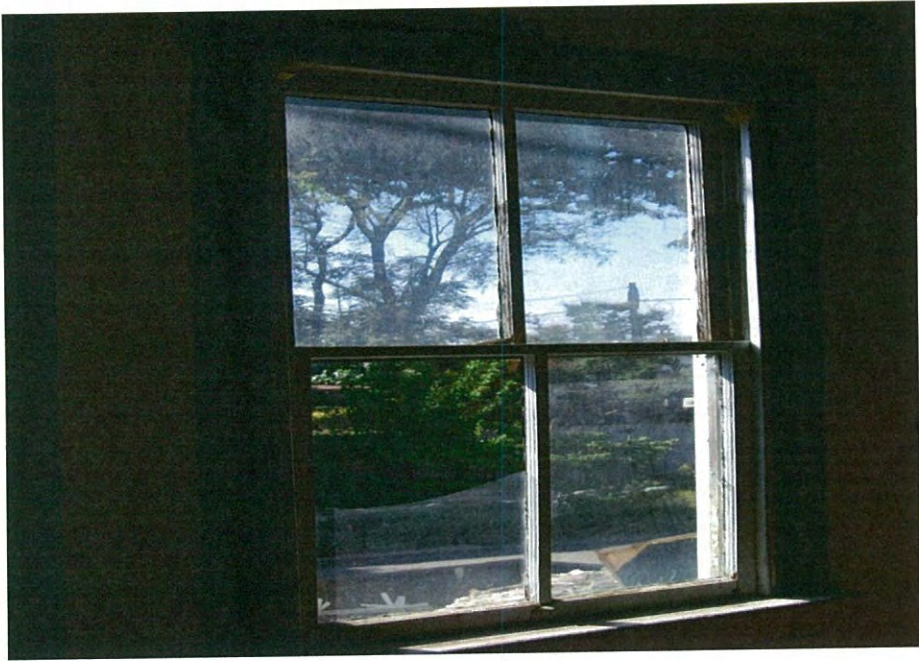
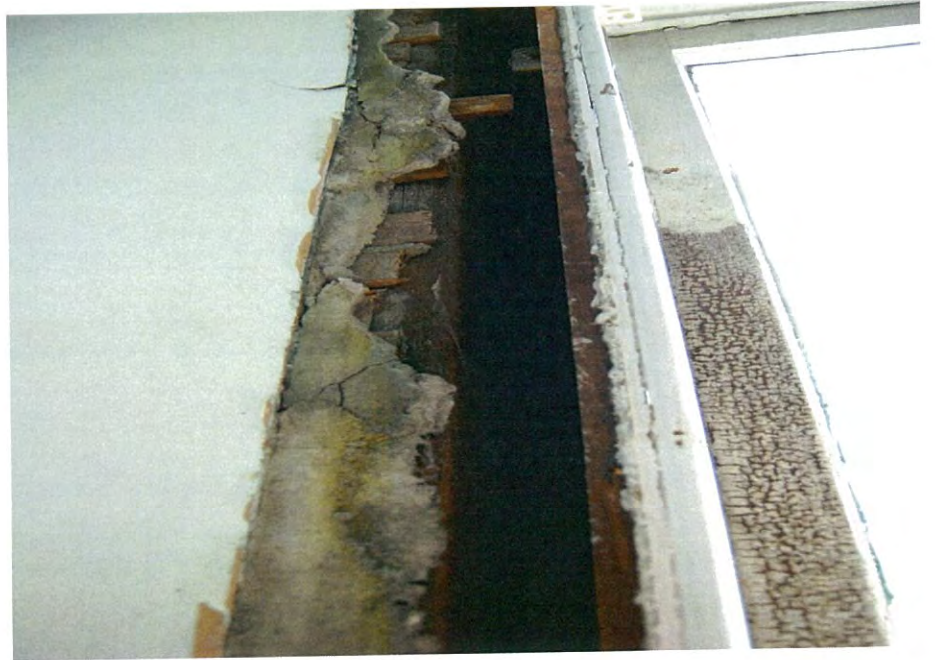
## 2. Windows

**Windows have been leaking for years, most windows have either rotten boards or have mold growing on them. Leaks were so bad that the wall beneath have to be removed and replaced along with several of the interior framing boards.**

**Front Windows are 1 over 1.**

**Side Windows 2 over 1 or 2 over 2**

**Back Windows are 2 over 2**

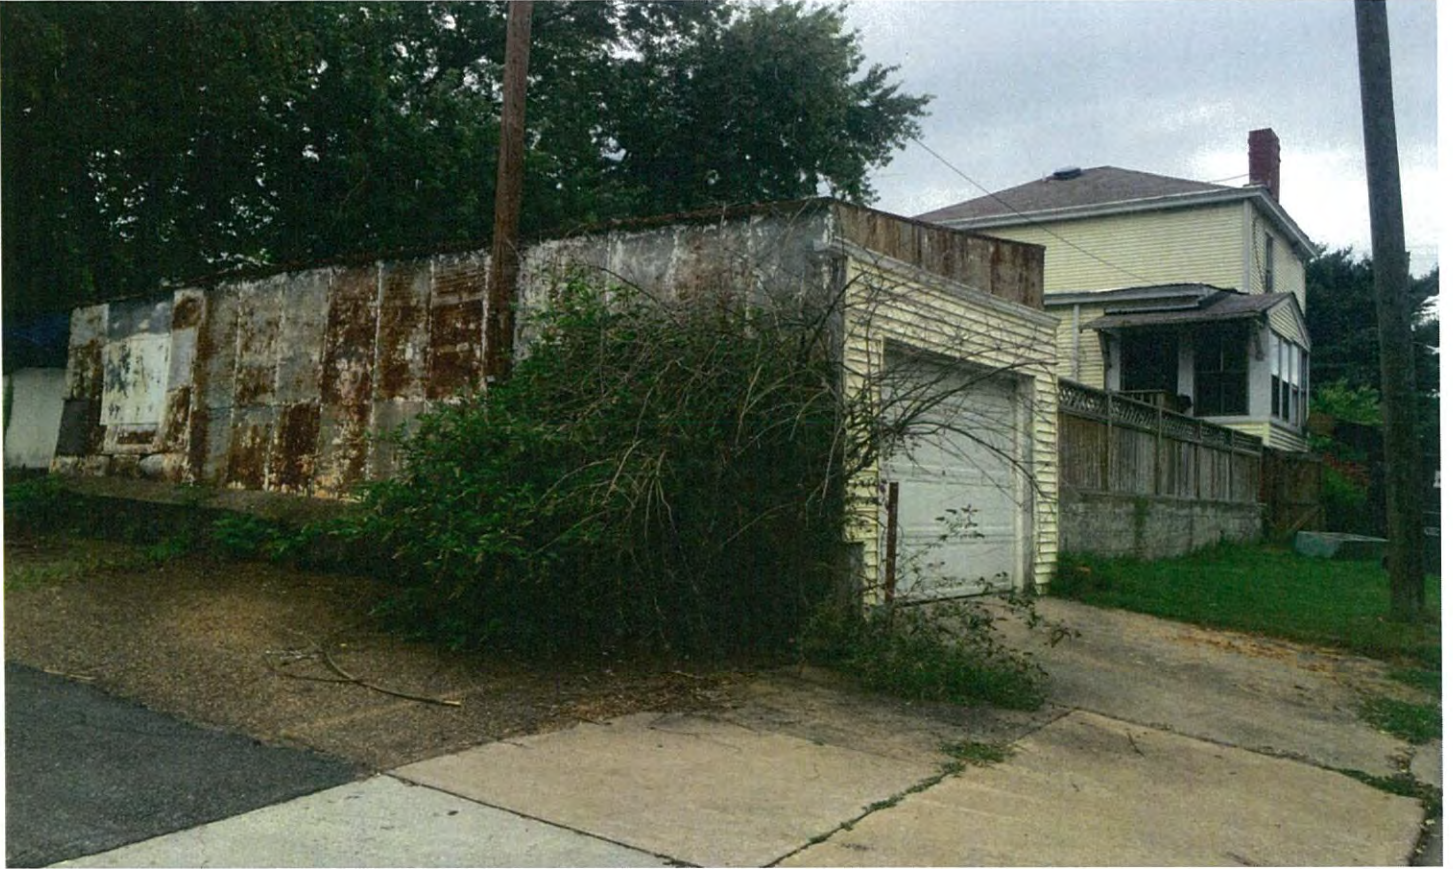
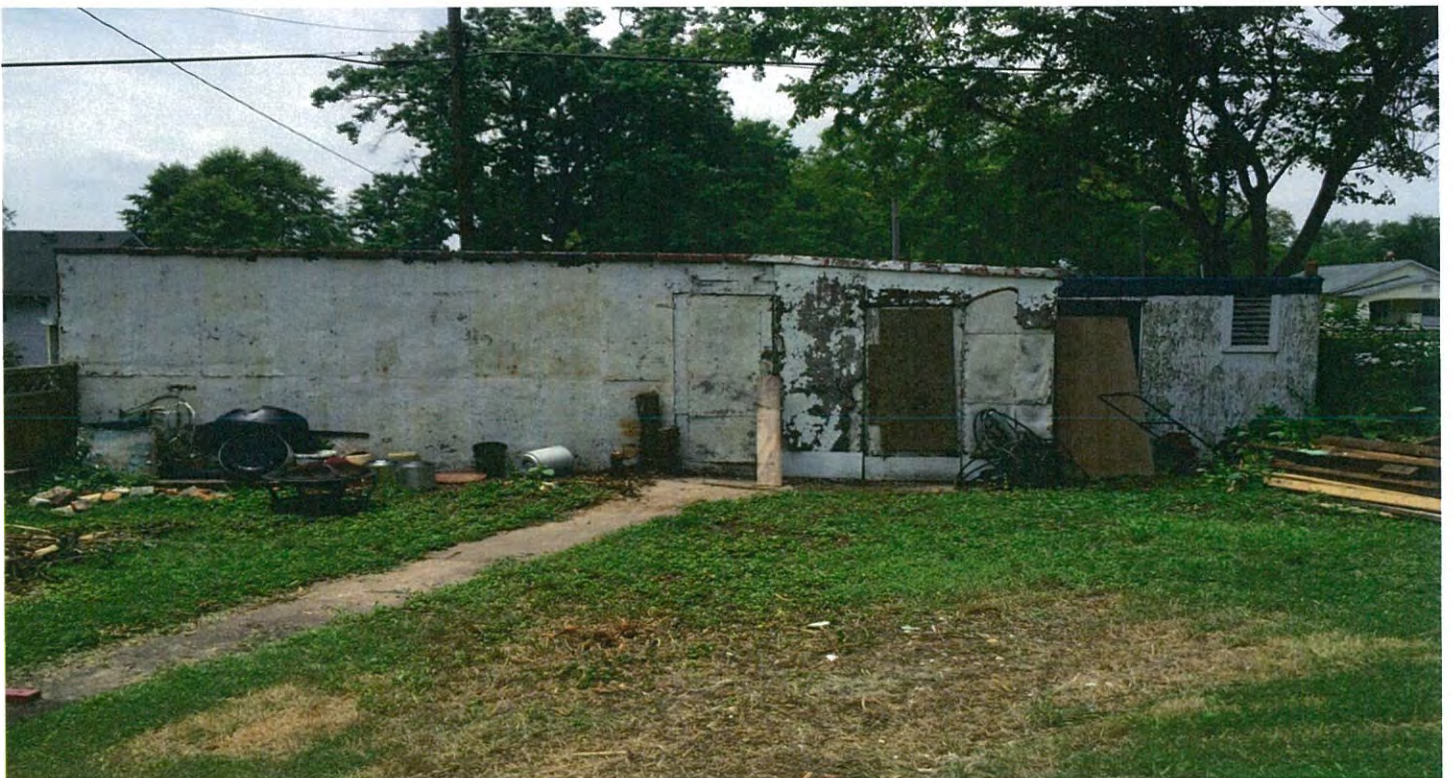
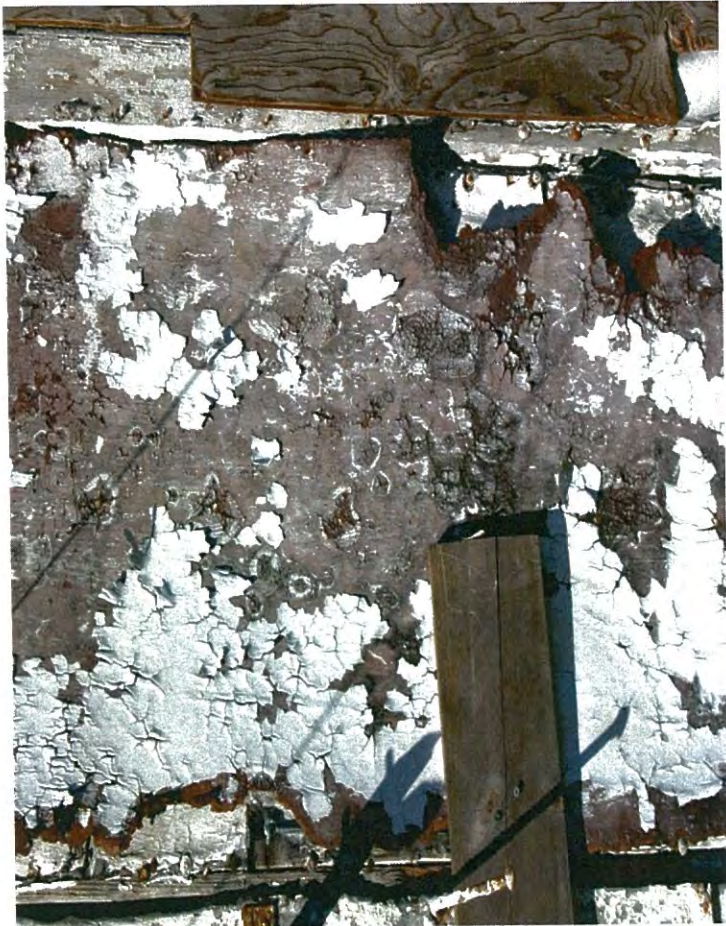
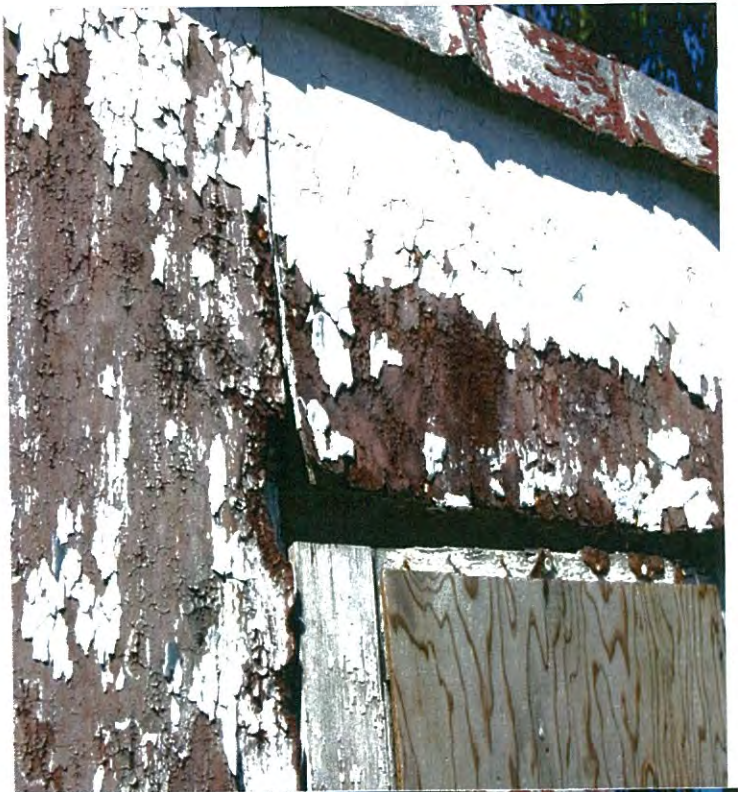
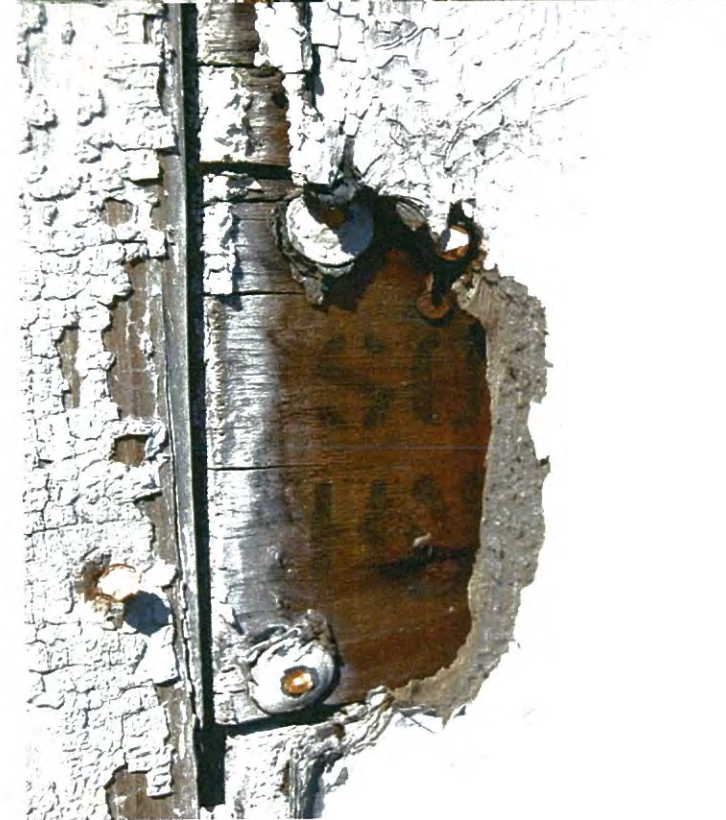
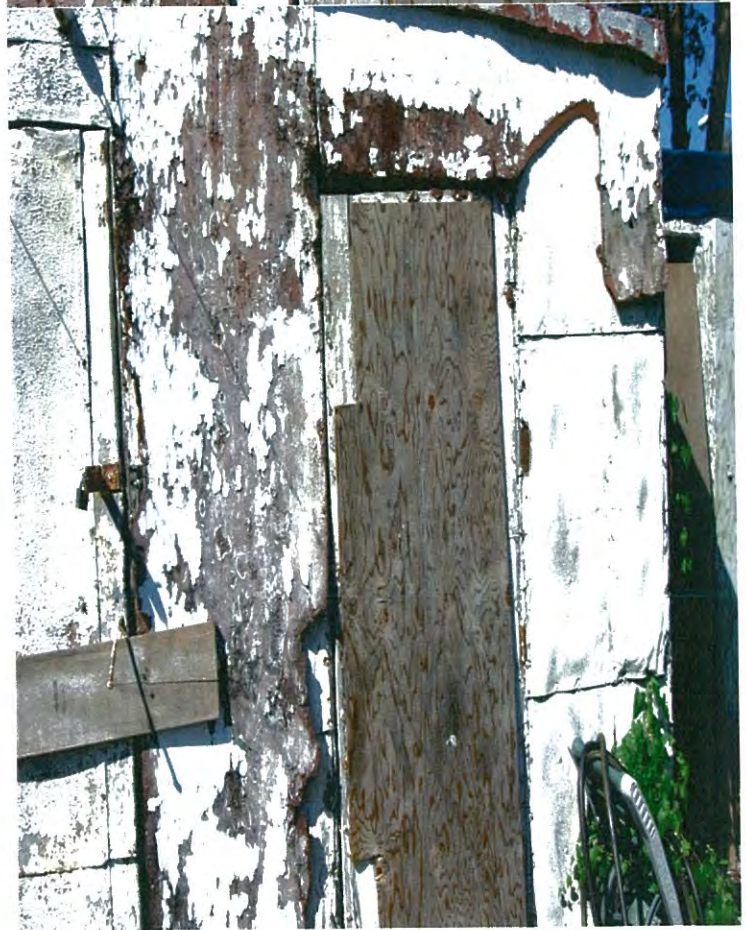
## 5. Garage

**Garage has several layers of board, tin and Plywood**

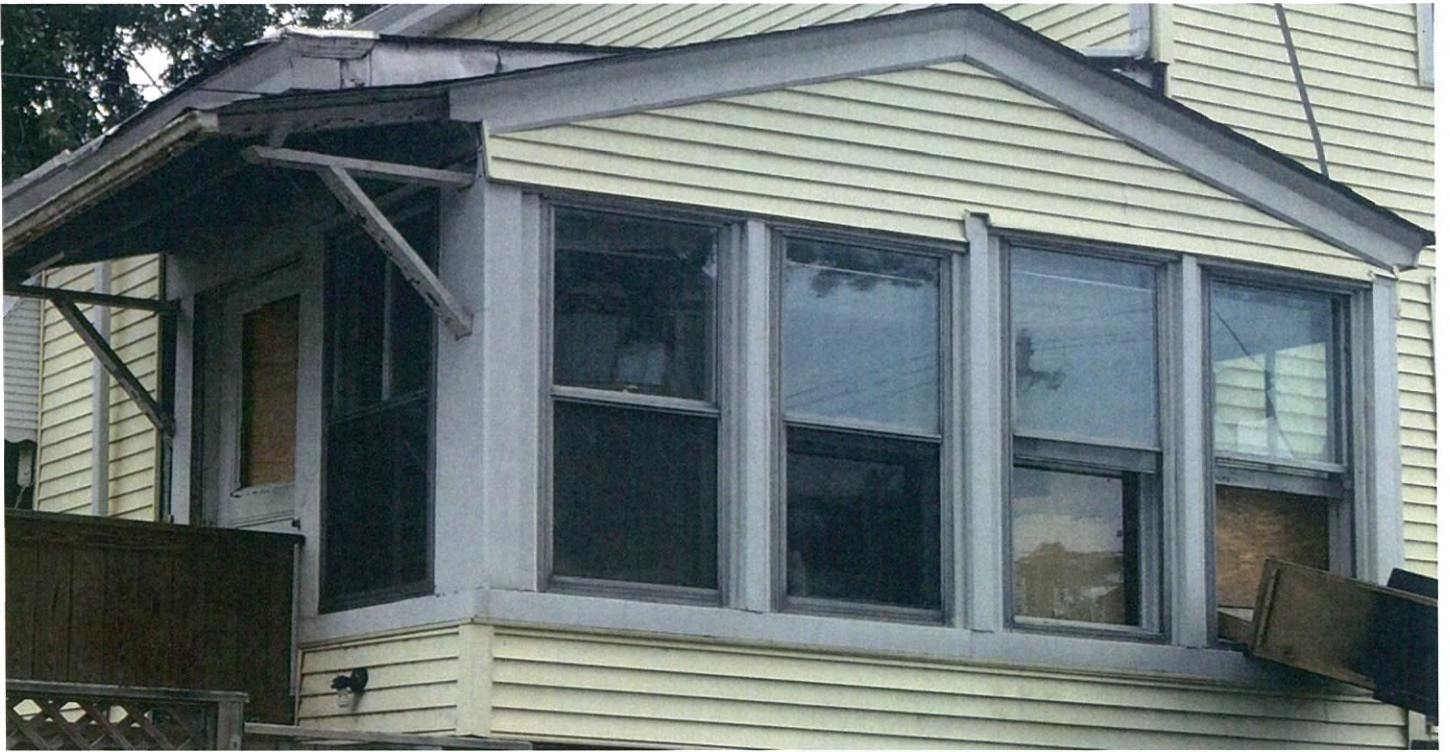
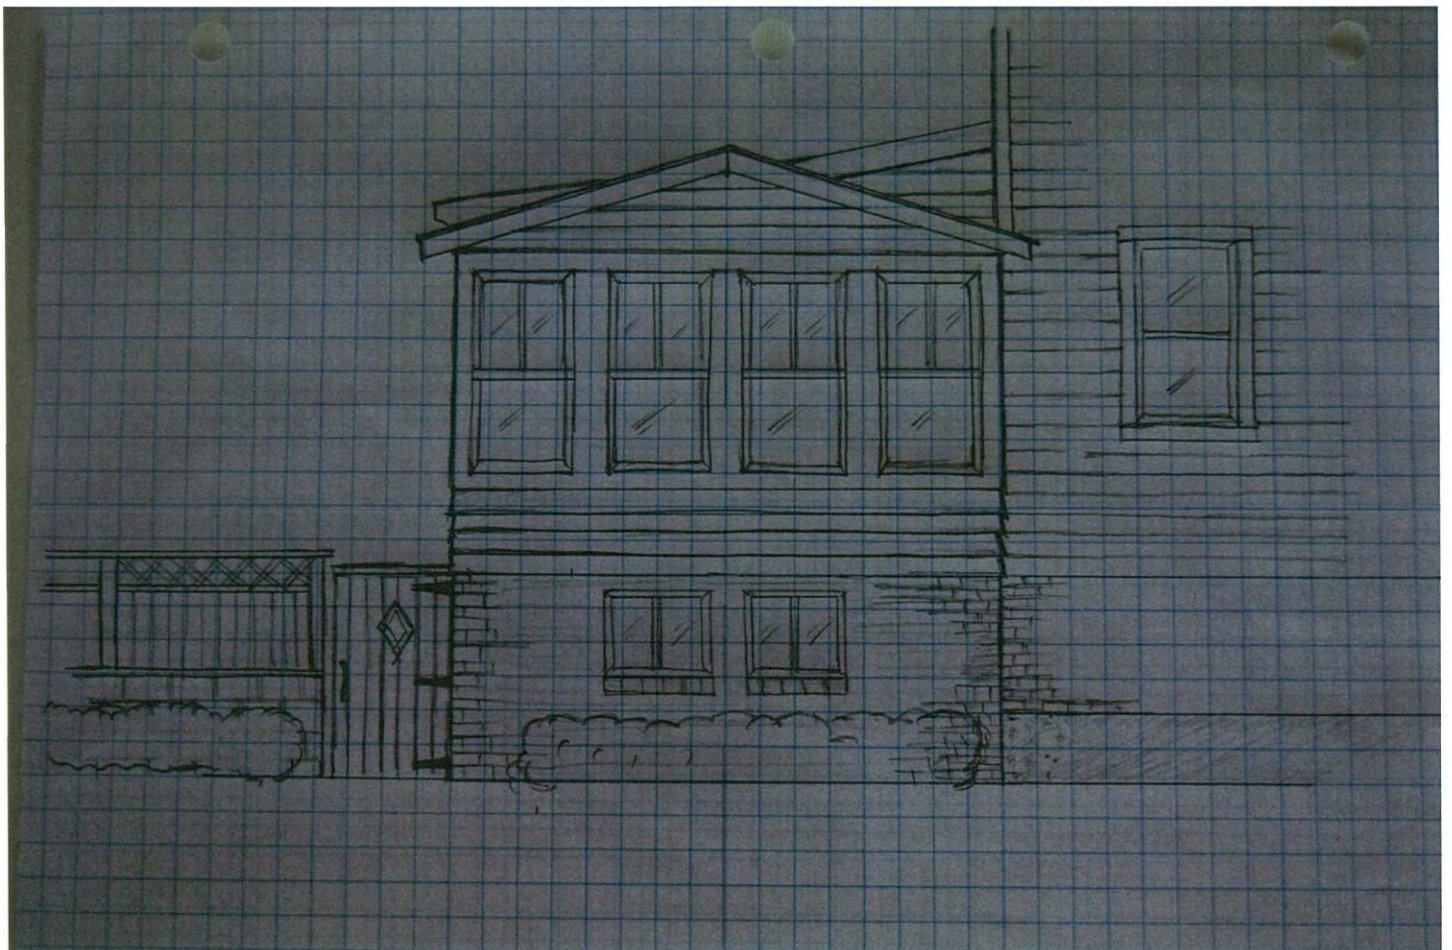
## 6. POARCH

**Enclosed Poarch Windows are two different sizes 32" X 65" and 32" X 70", we want to change the window size so they are all the same and 32" X 58". This will raise the interior bottom of the window where banquette seating for the dining room will be located.**
