Commission of Architectural Review SUBMISSION APPLICATION

LOCATION OF WORK: 215 W CLAY ST (aka 435 BROOK RD) DATE: 09.30.2016

Re: WINDOWS AT 215 W CLAY ST

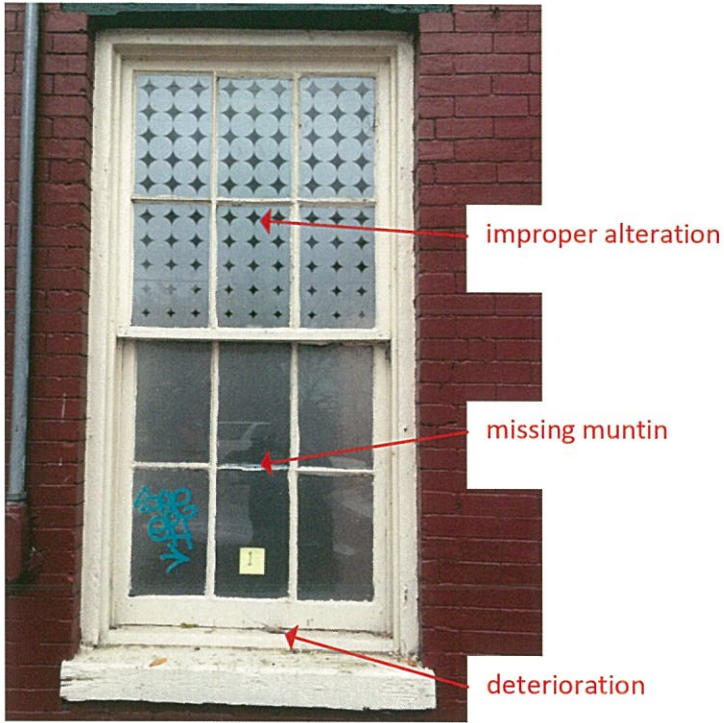
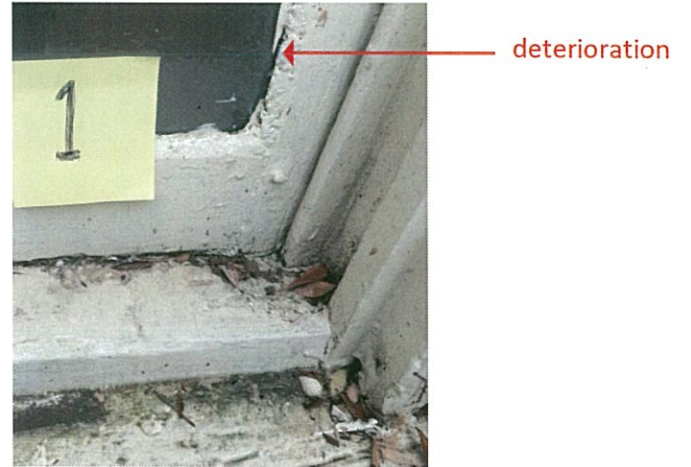
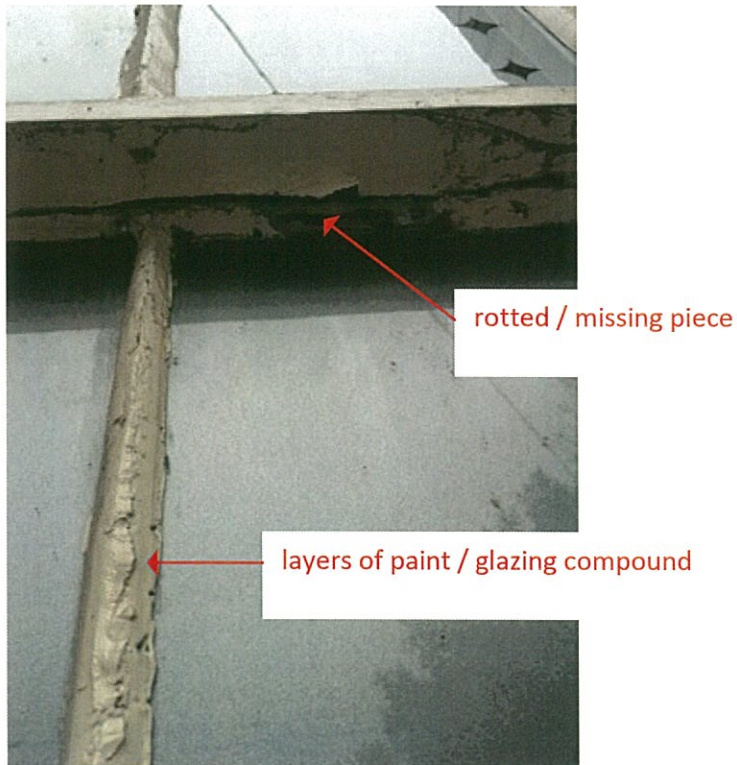
WINDOW 1

Window does not open, the wood sill is rotting, the wood frame is cracking and the joints are expanding

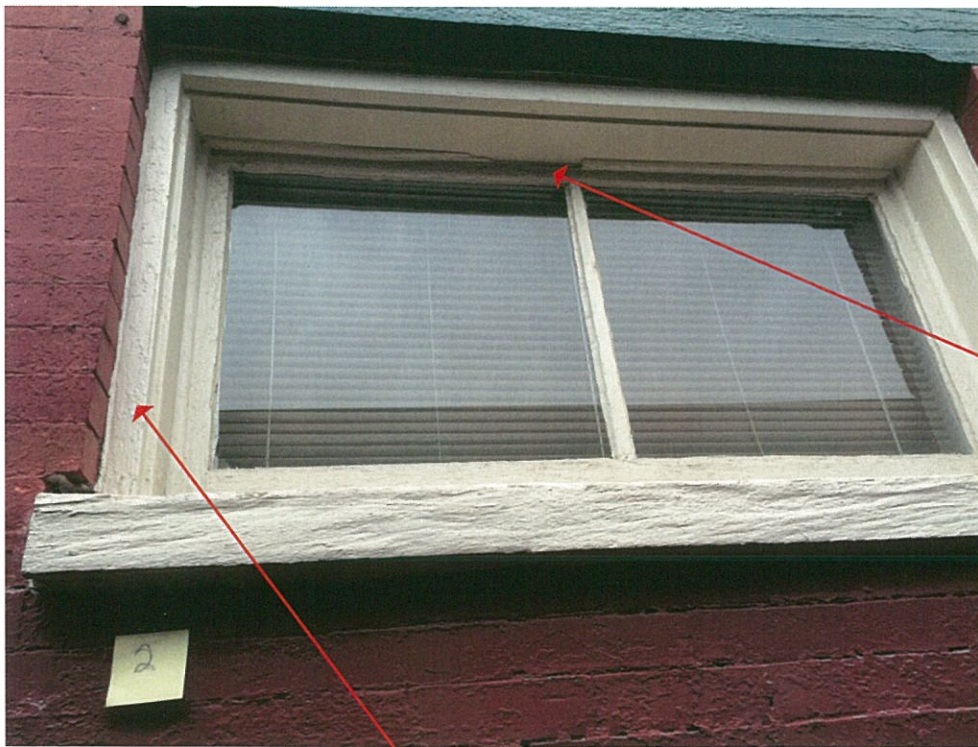
WINDOW 2

The wood sill is rotting and sits at an improper angle that collects water in the rain causing the window frame to rot, frame is held together by paint in some locations, water is getting in through cracks in the frame

rotted / missing piece

layers of paint

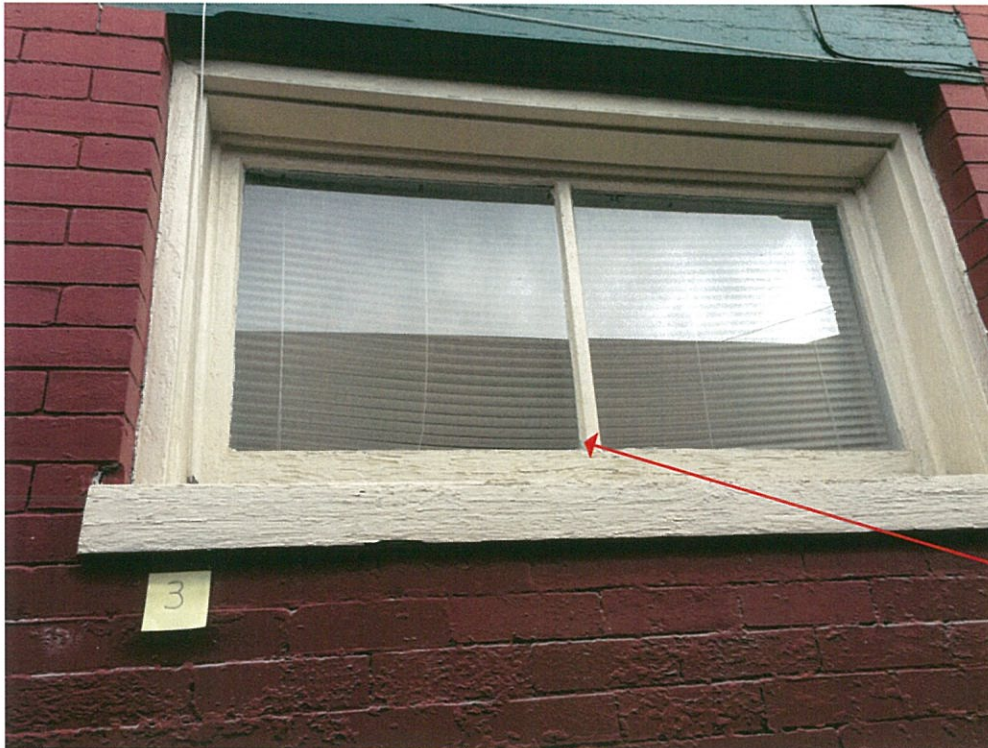
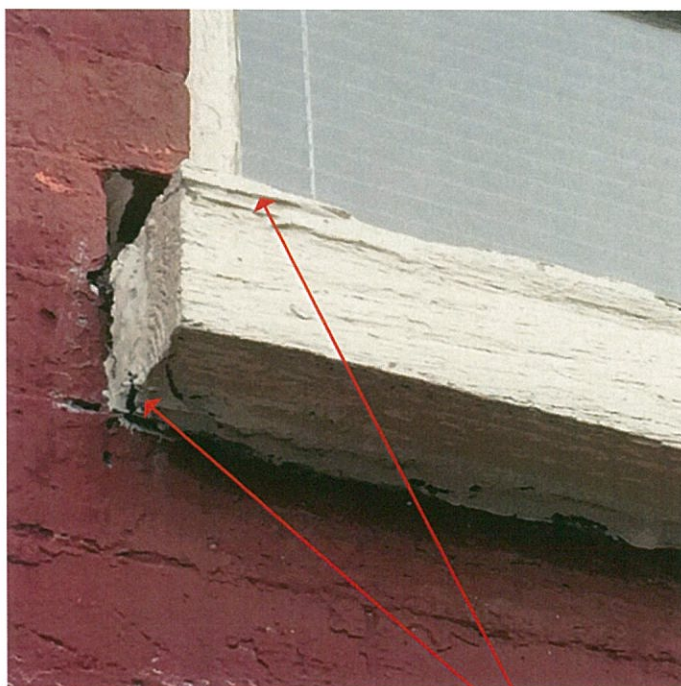
WINDOW 3

The wood sill is rotting and sits at an improper angle that collects water in the rain causing the window frame to rot, frame is held together by paint in some locations, water is getting in through cracks in the frame

deterioration

splitting

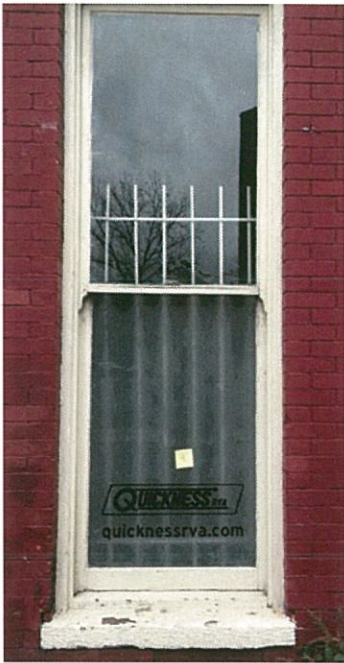
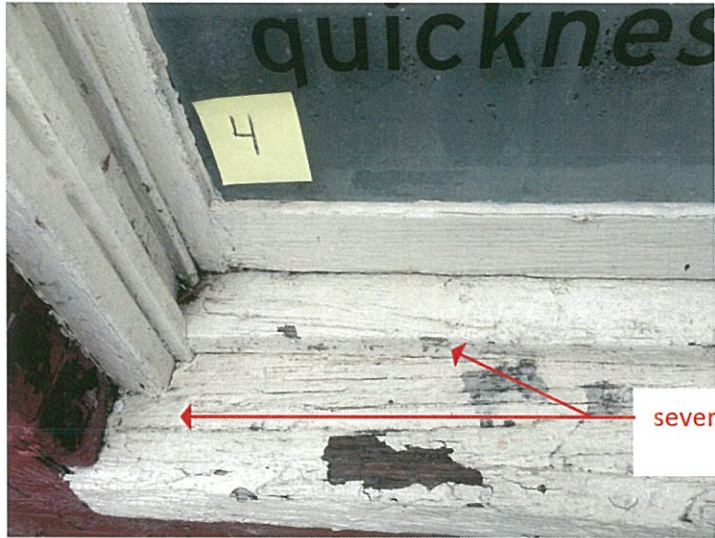
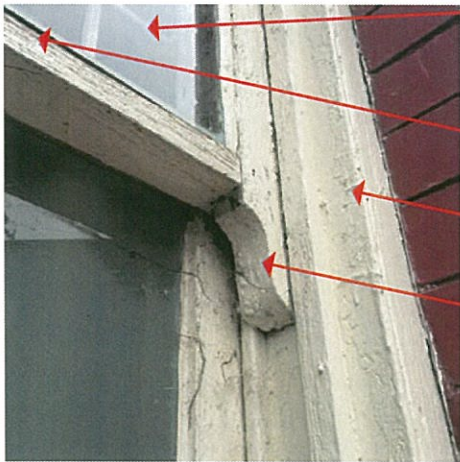
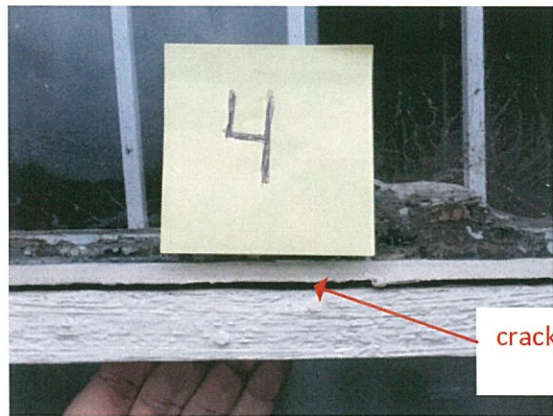
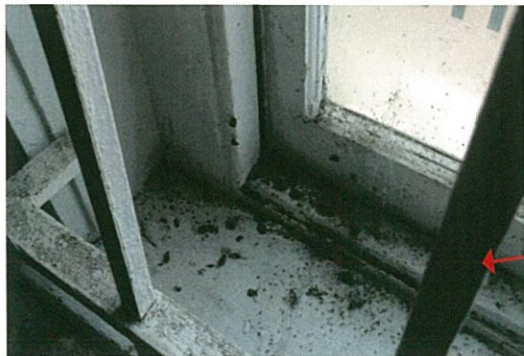
WINDOW 4

Window does not open, wood window frame is rotting at sill, frame joints are separating, a crack has opened up along the whole length of one sash

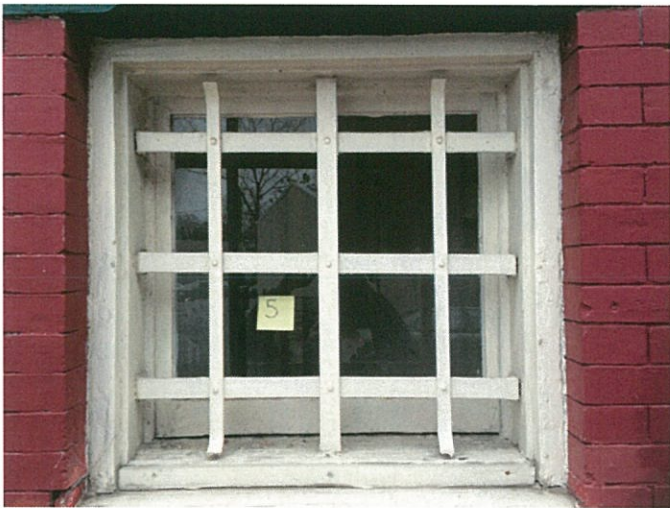
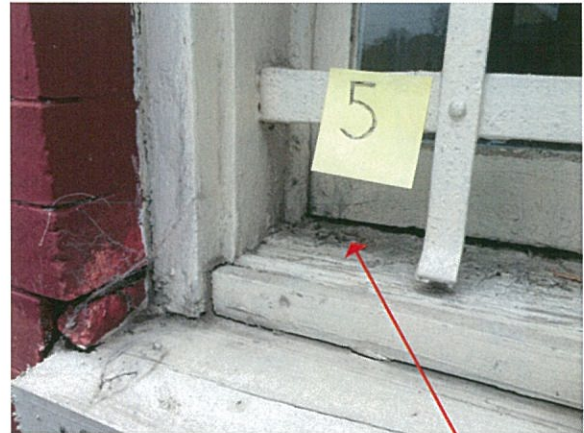
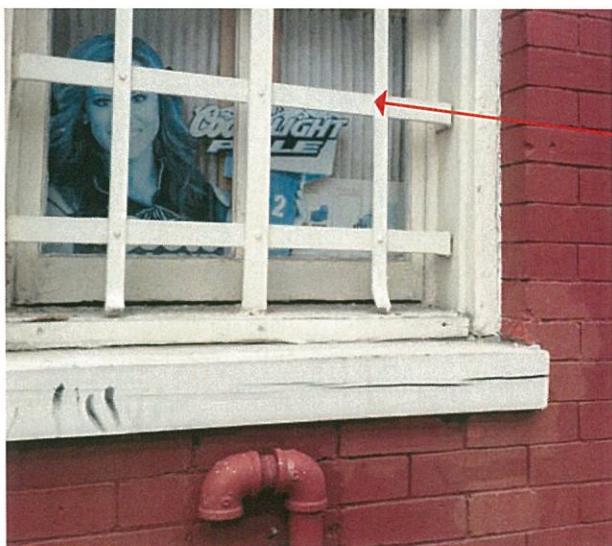
WINDOW 5

Window does not open, the joints are separating, there is rotting wood along the frame, water is getting into cracks and the window frame sill is rotting

deterioration

improper alteration

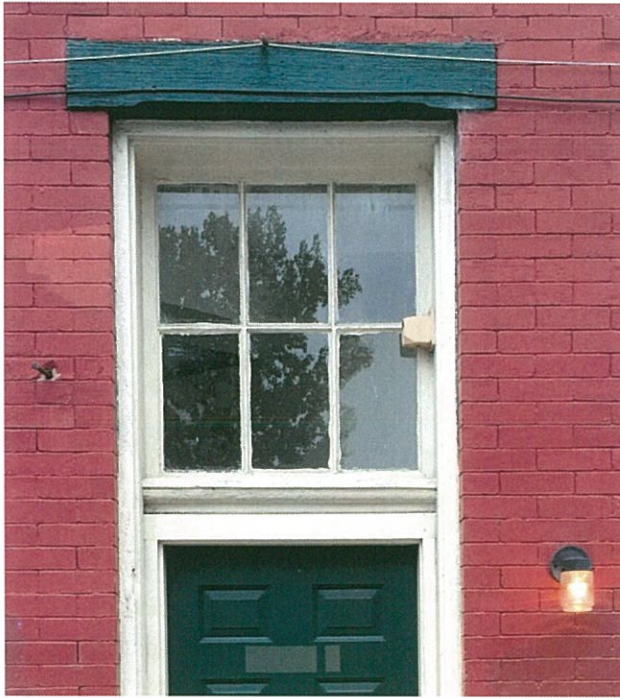
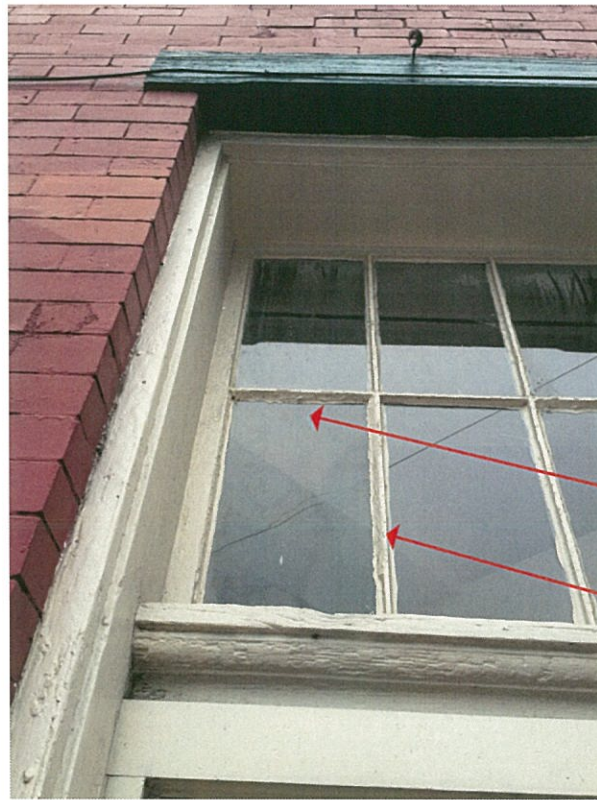
WINDOW 6

The wood frame and muntins are deteriorating, the joints are expanding

deterioration

layers of paint

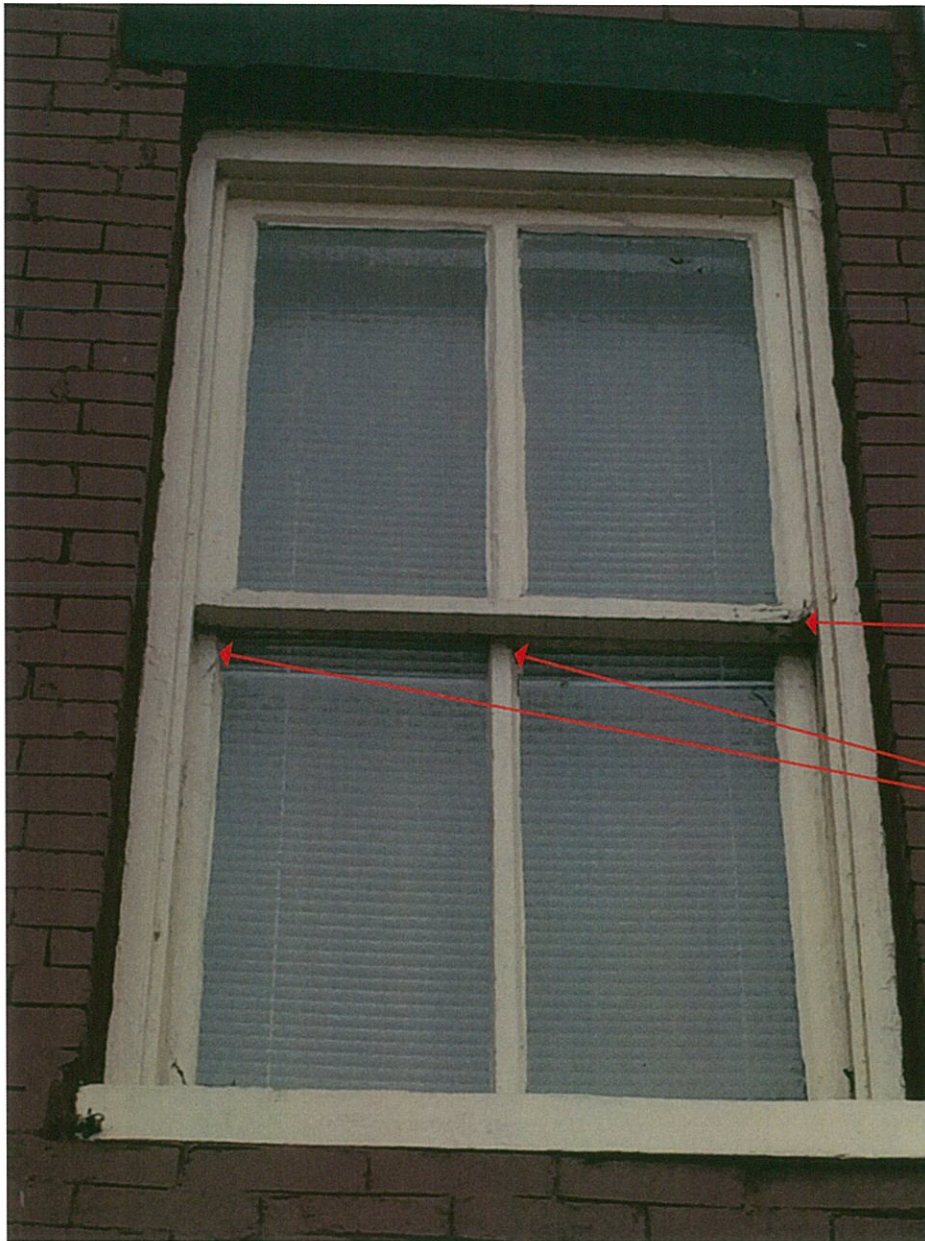
WINDOW 8

Window does not open, interior wood has cracked open along the length of the inner track

deterioration

missing /
rotting pieces

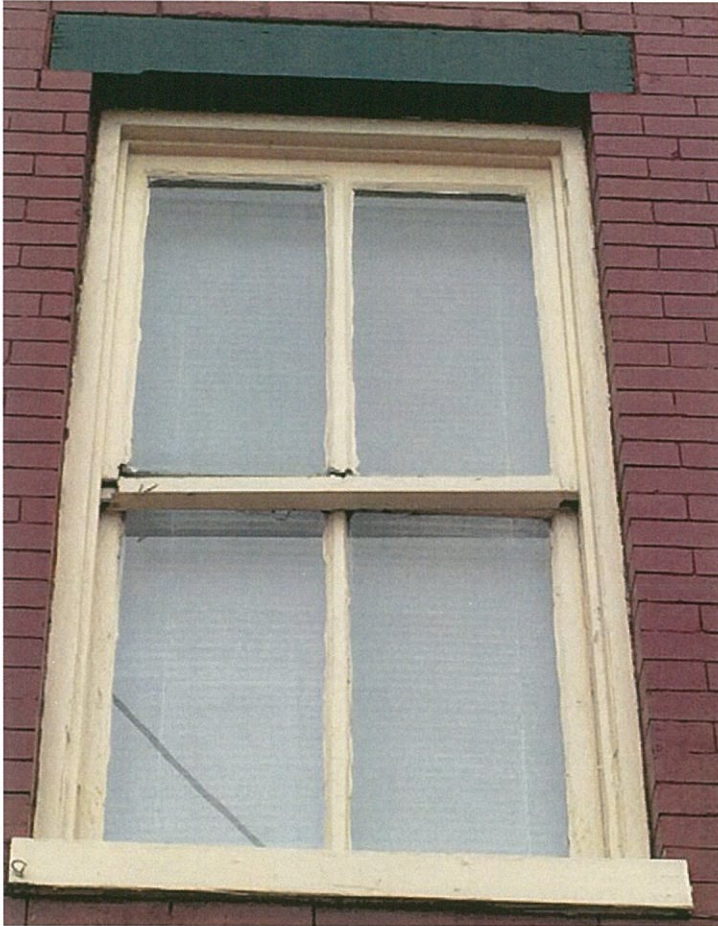
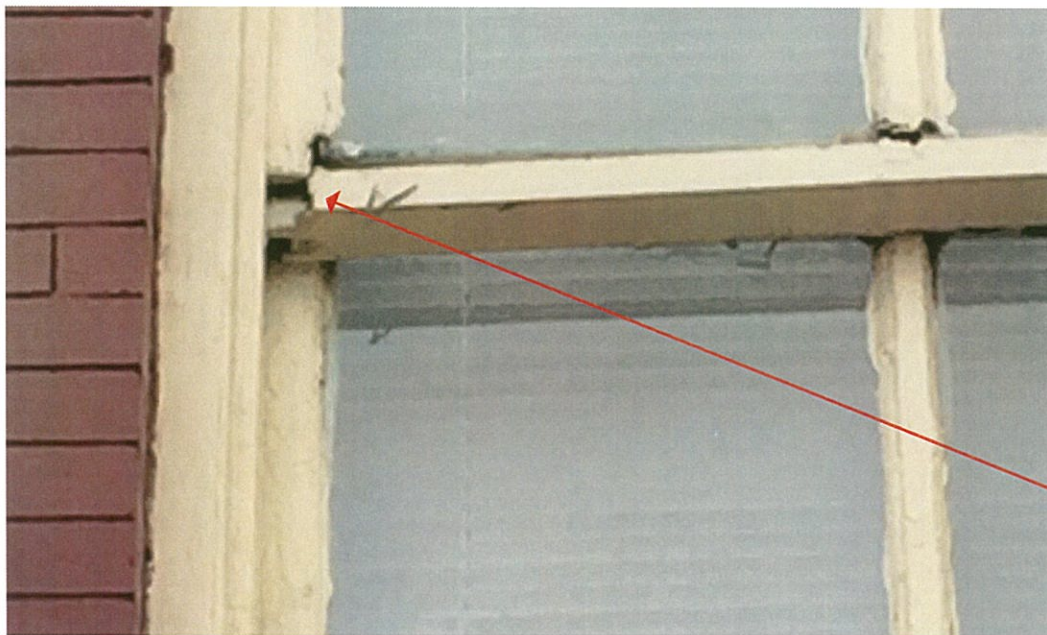
WINDOW 9

Opens only approximately 10 inches, window is out of square and joints separated, inner and outer tracks rotting

broken frame

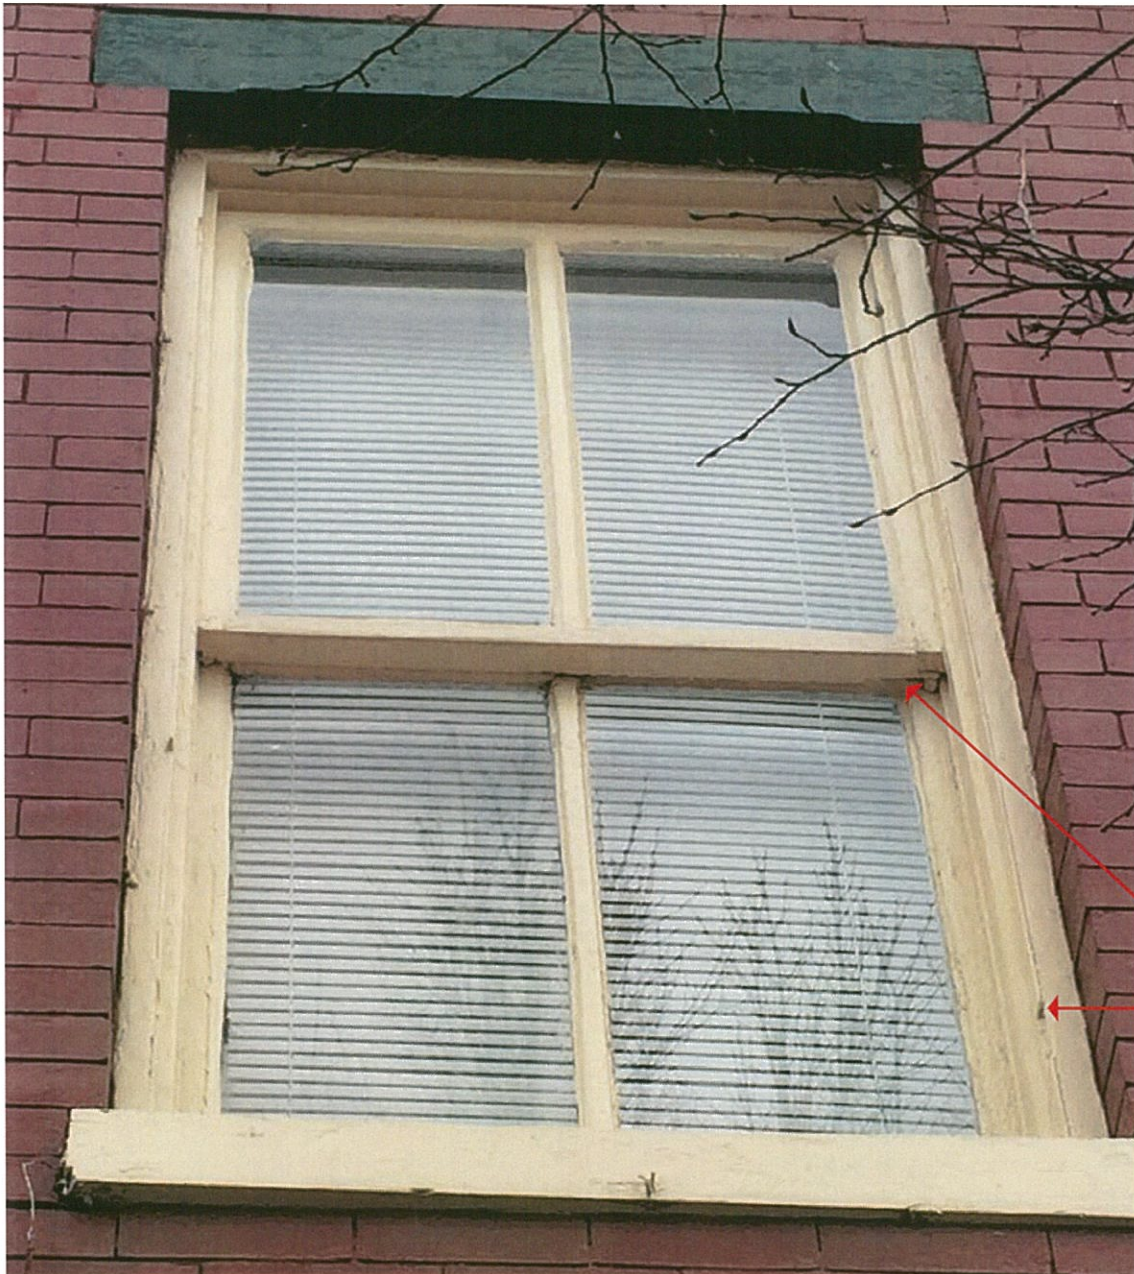
WINDOW 10

Opens only approximately 18, wood is cracking, wood pieces flake off with use

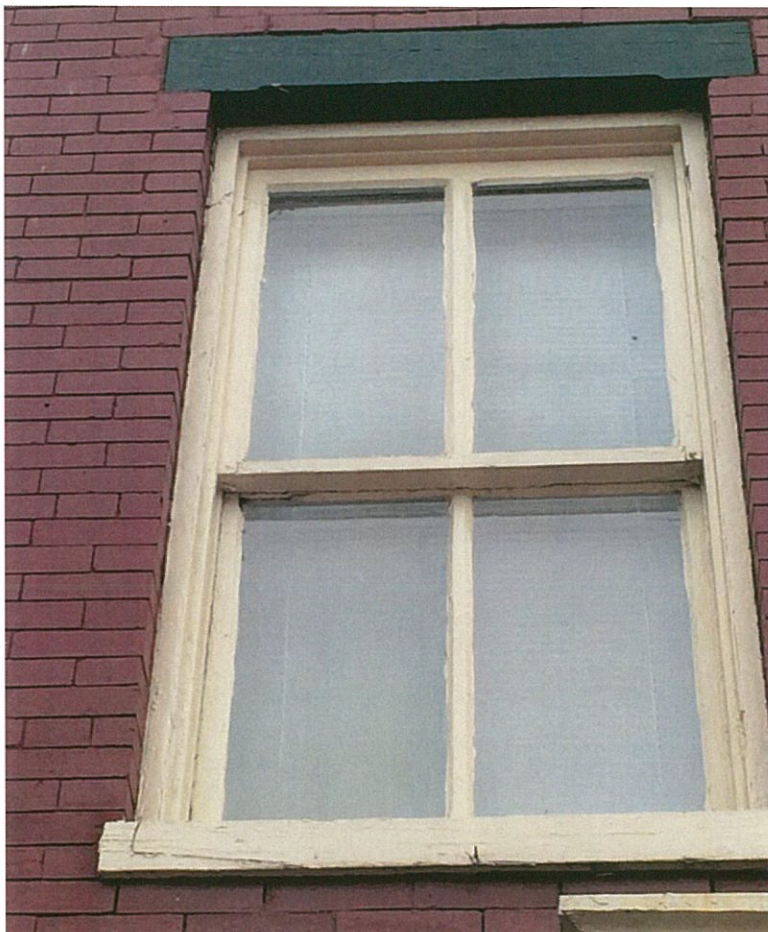
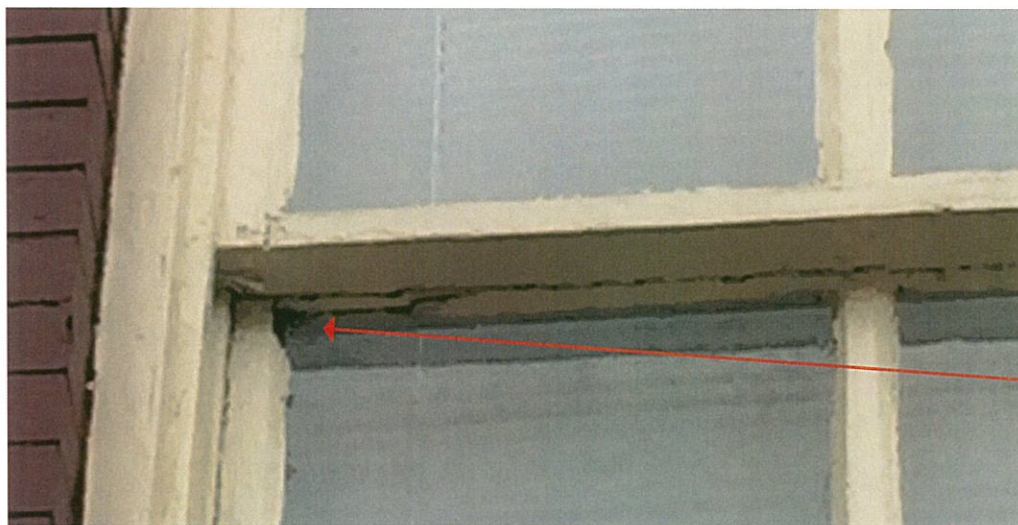
WINDOW 11

Opens only approximately 16", rails are rotting

missing pieces/deterioration

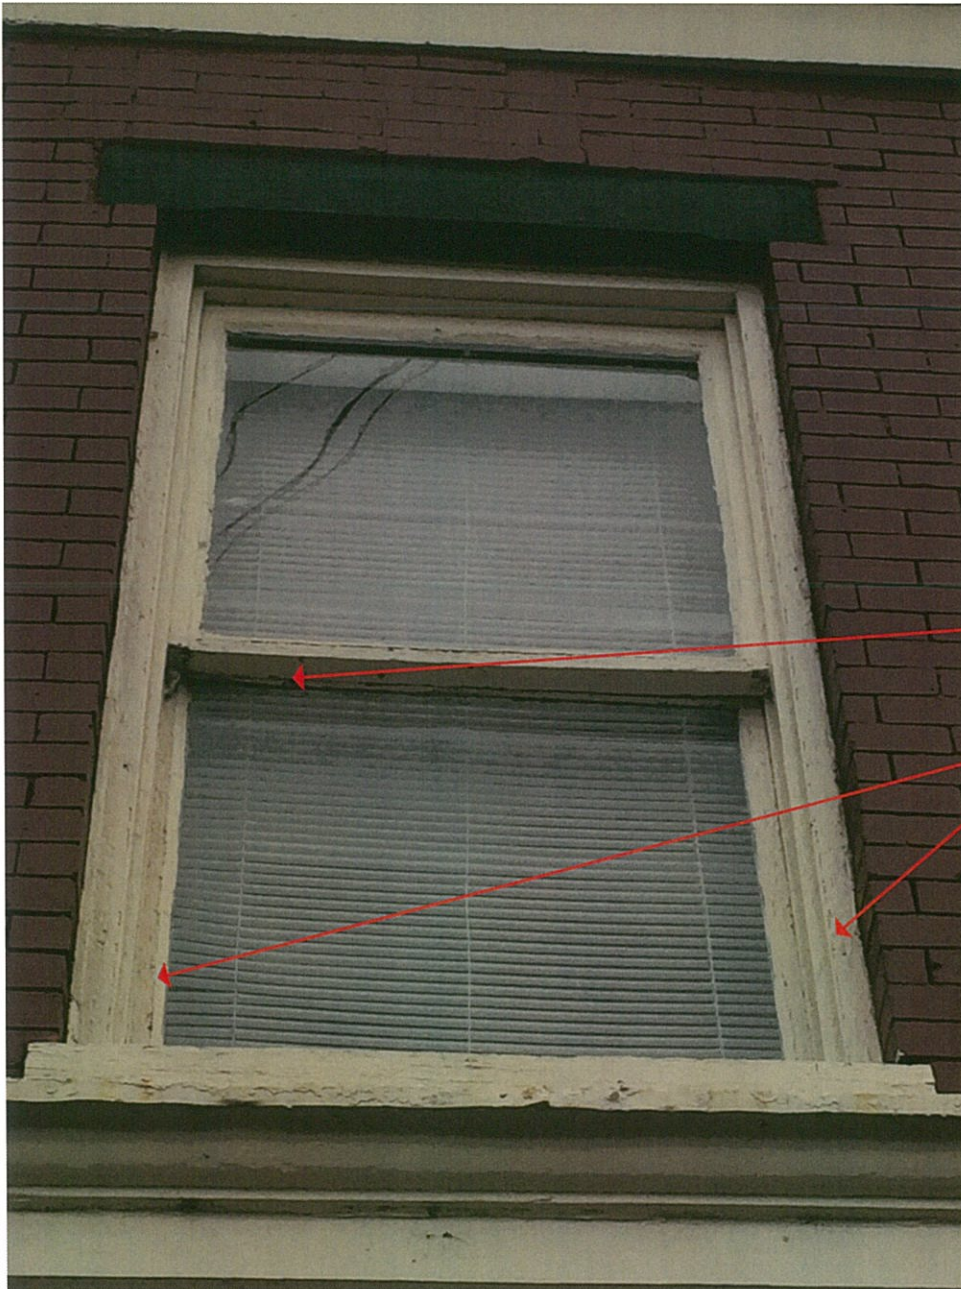
WINDOW 12

Opens only approximately 18", center rail and inner track rotting

missing pieces/deterioration

layers of paint

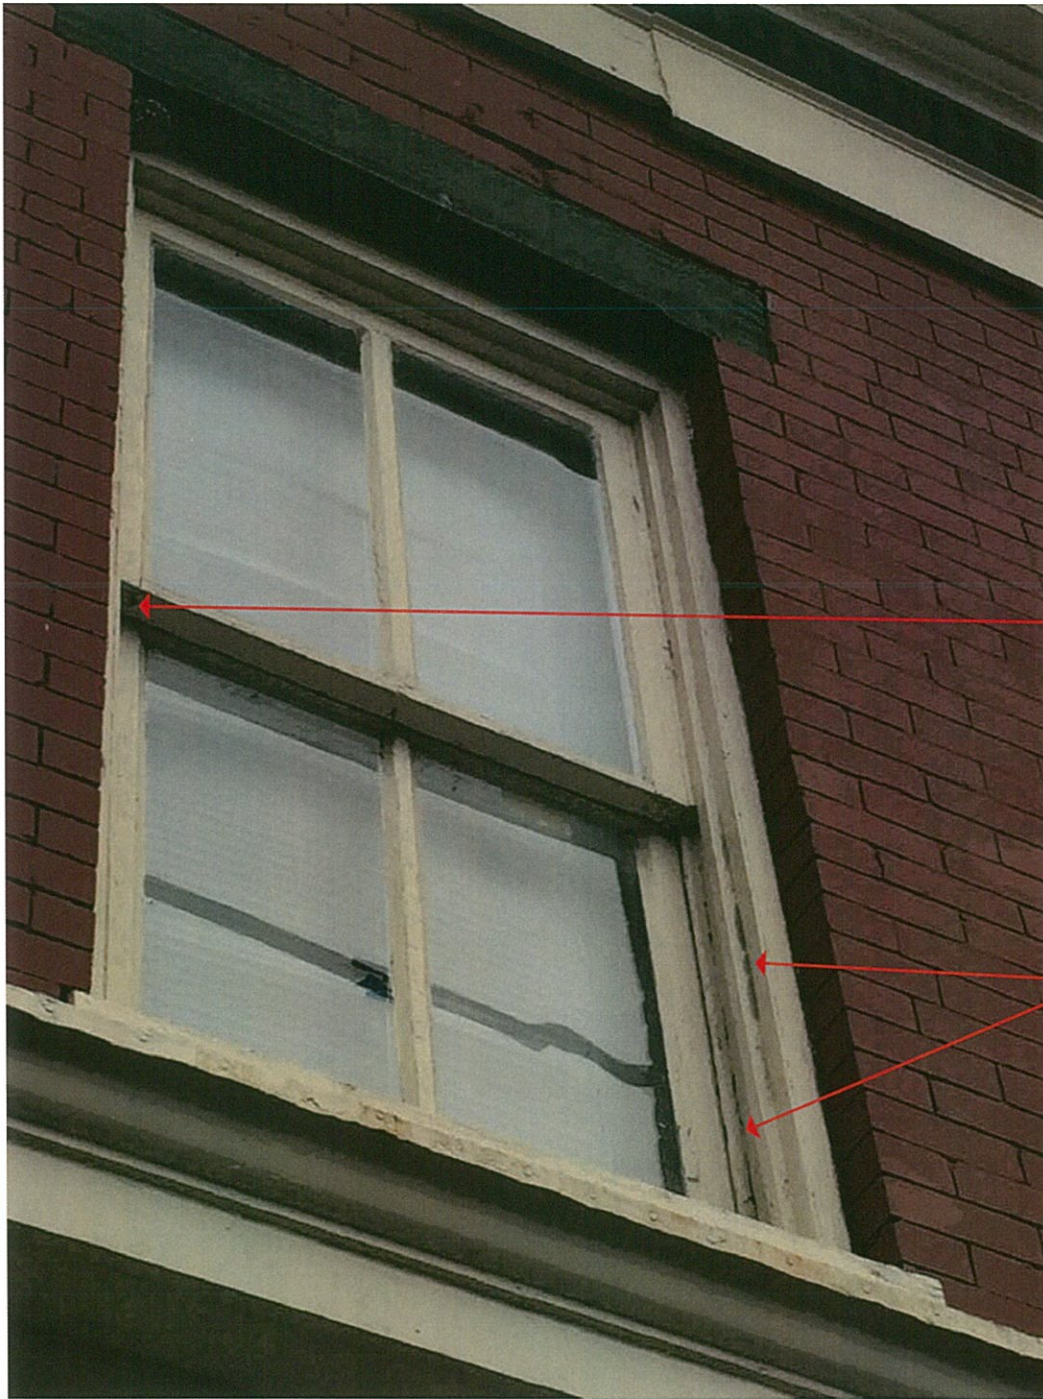
WINDOW 13

Opens only approximately 18", tracks are rotting and joints expanding, wood is soft to the touch

improper alteration
(screwed shut)

cracking/deterioration

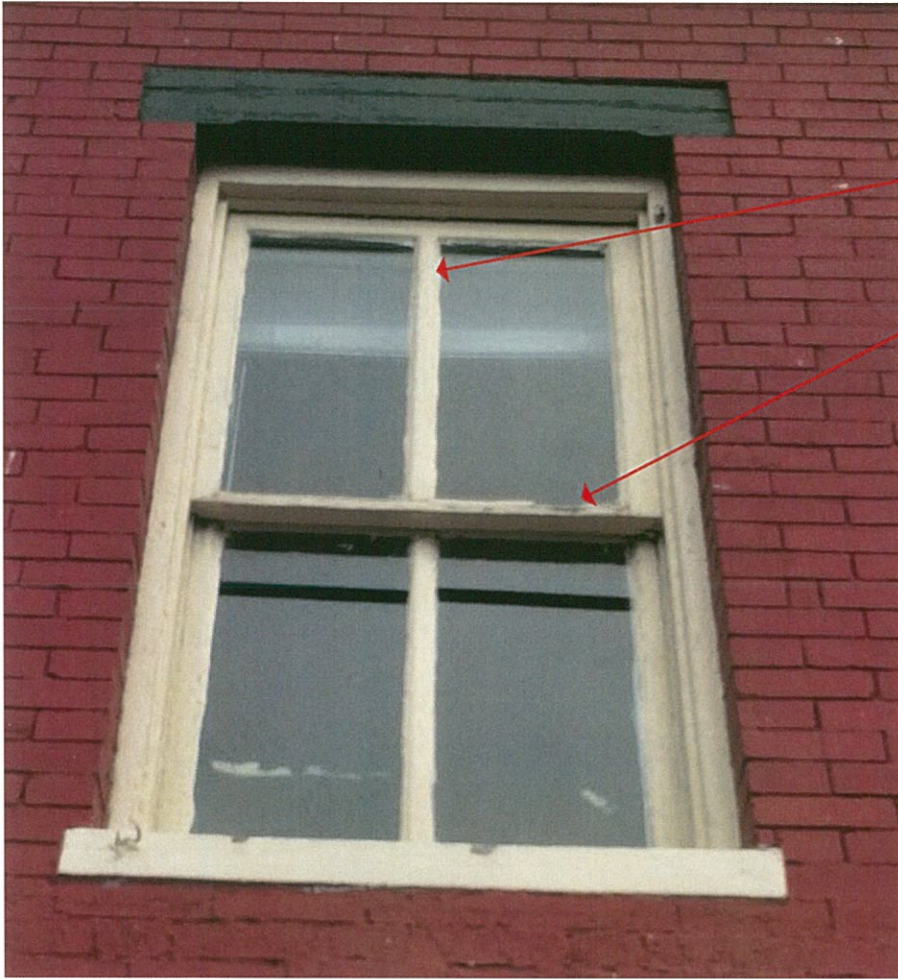
WINDOW 14

Opens only approximately 10", cracking wood along inner track, wood is soft to the touch

Layers of paint

Deteriorated/missing pieces

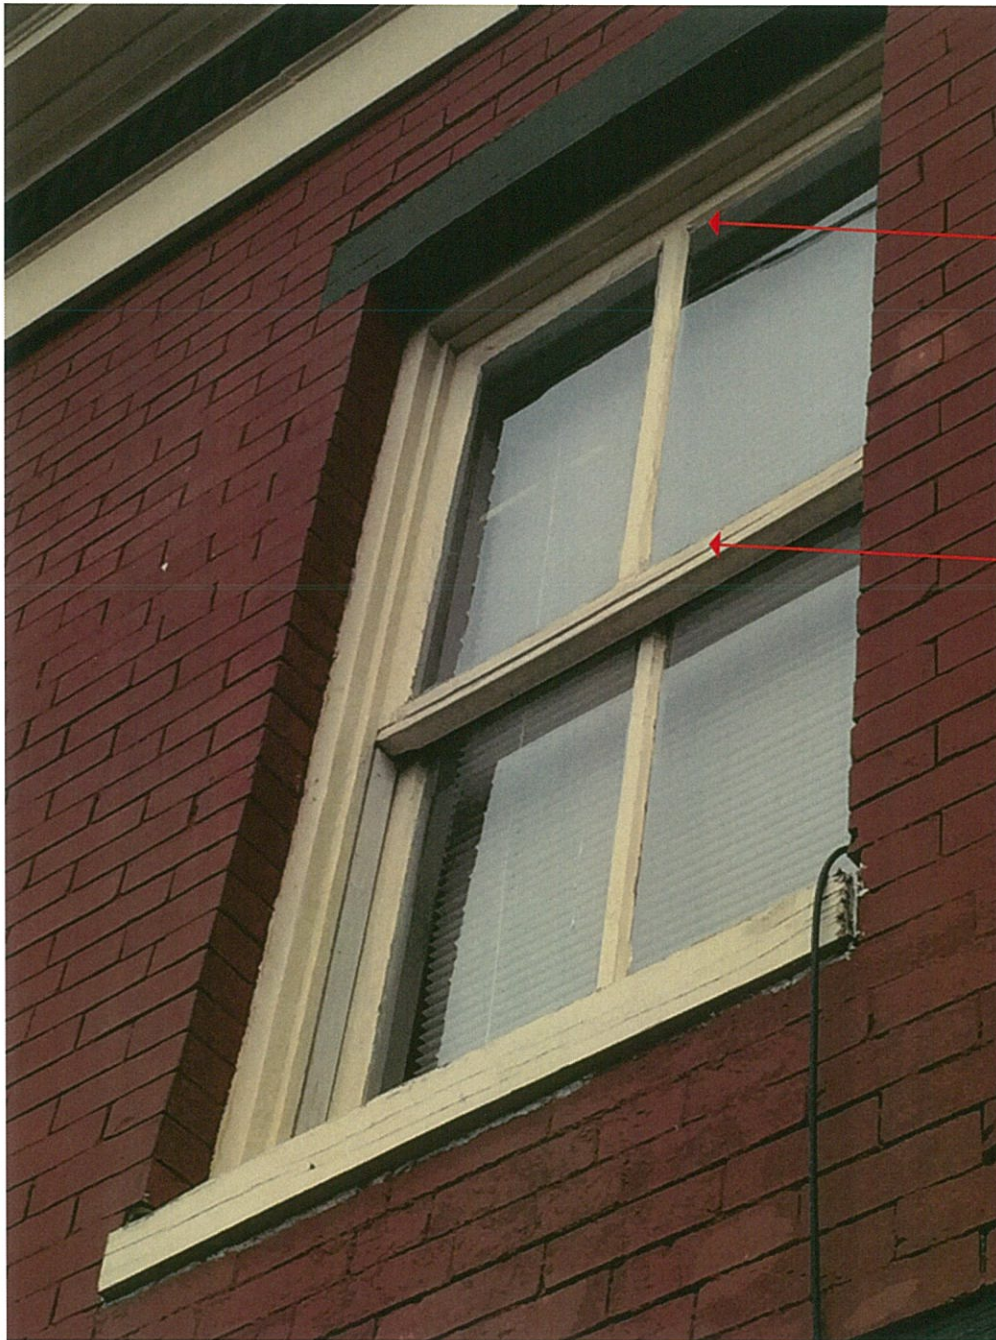
WINDOW 15

Opens only approximately 18", wood is rotting and joints cracking

rotting / missing pieces

splitting

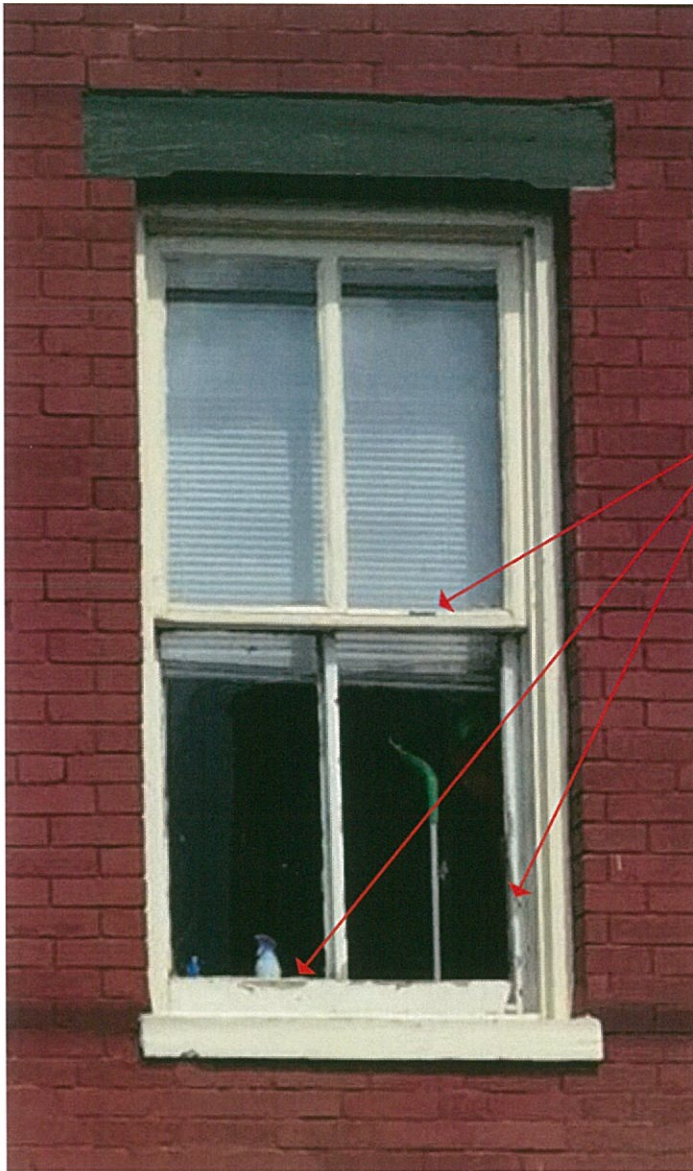
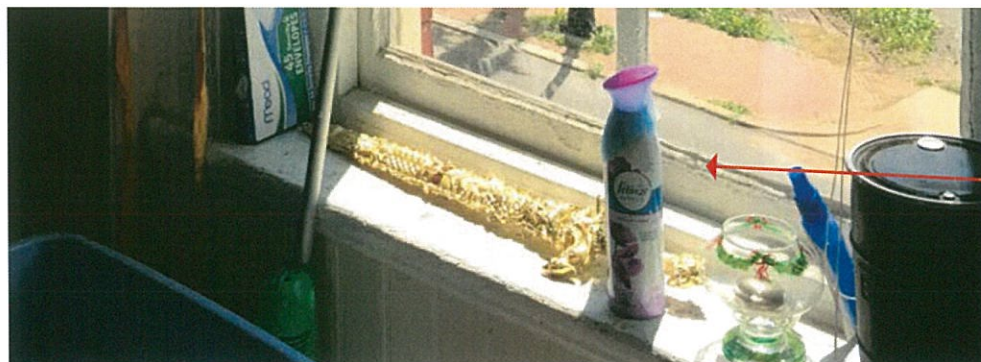
WINDOW 16

Opens only approximately 18", cracked wood is rotting along its full length

Deteriorated/missing pieces

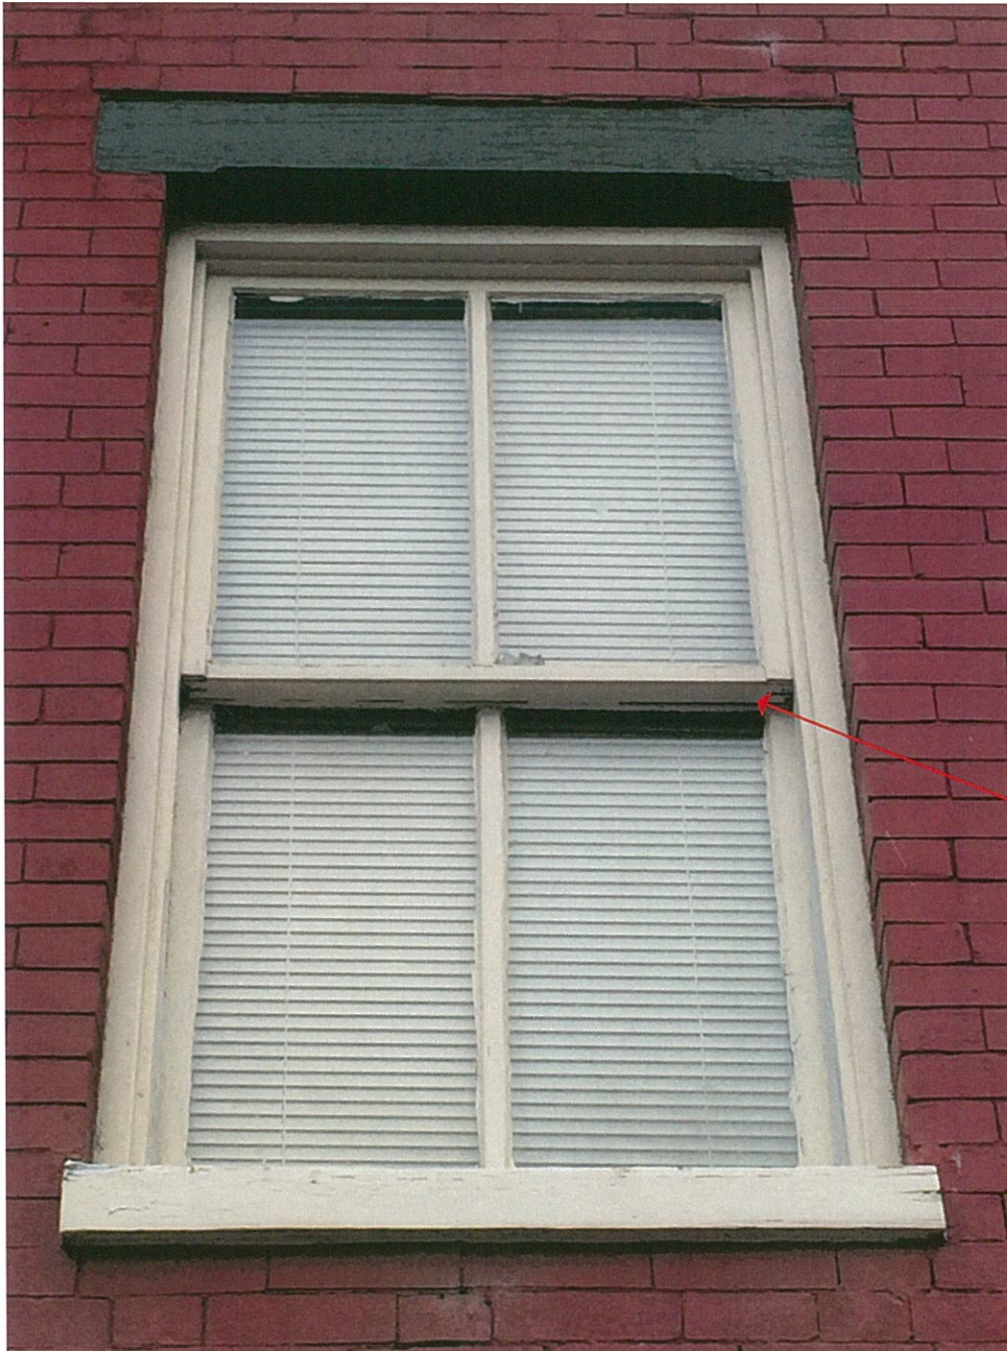
WINDOW 17

Window not accessible from the interior, window frame is separating at joints

splitting/deterioration,
joints separating

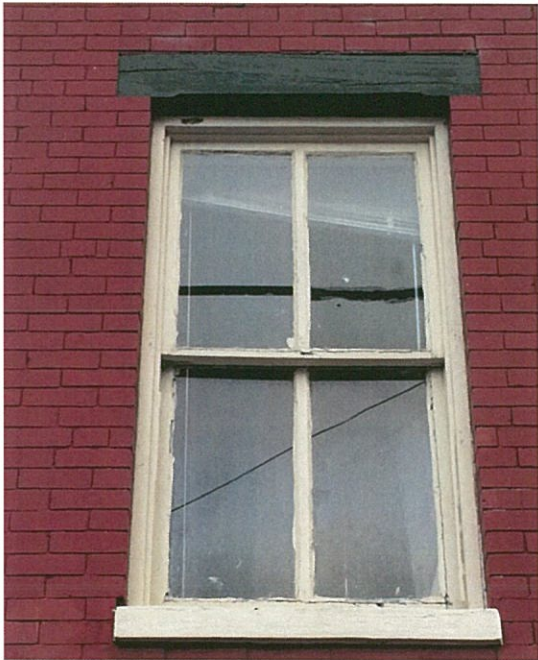
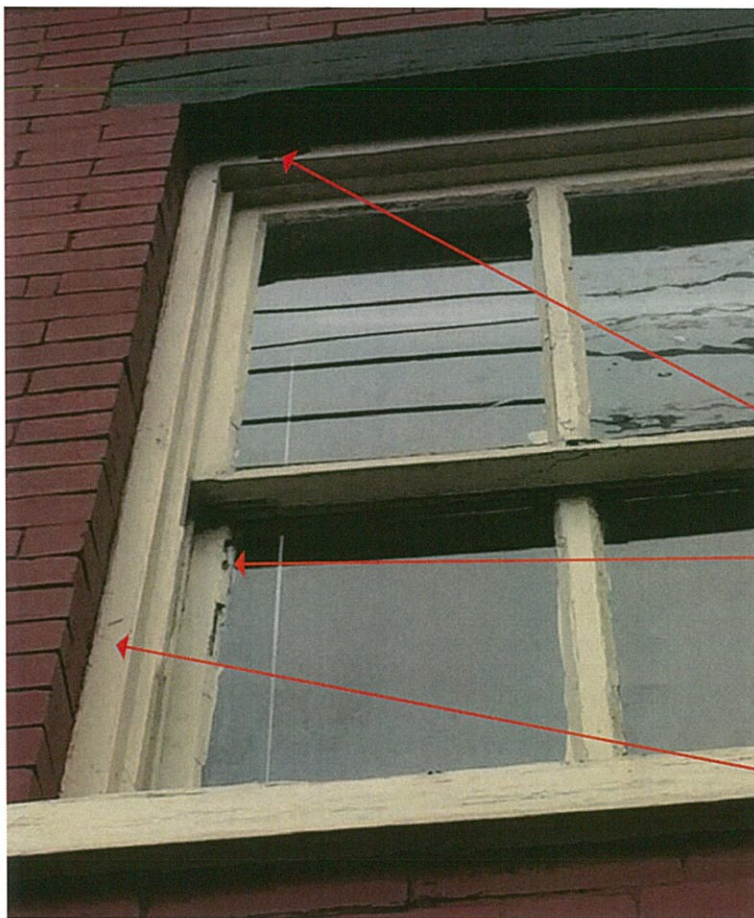
WINDOW 18

Window does not open due to joint expansion

missing pieces/deterioration

layers of paint
