**COMMISSION OF ARCHITECTURAL REVIEW  
STAFF REPORT  
February 24, 2015 Meeting**

10. **CAR No. 15-012** (Instant Construction) **402-404 N. 29<sup>th</sup> Street**  
**Church Hill North Old and Historic District**

**Project Description:** **Extensive exterior alterations**

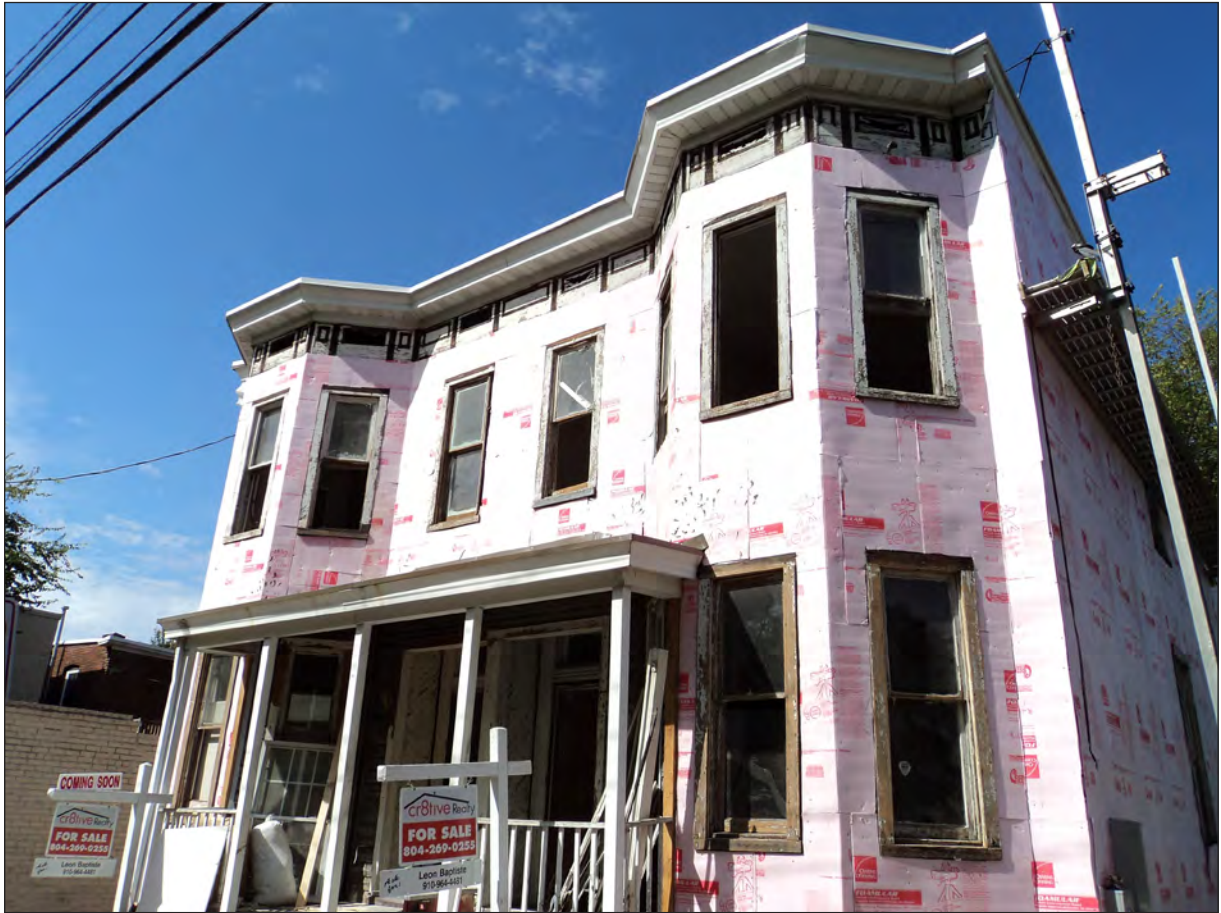
Photo taken 10/7/2014

Before the work took place, the original frieze was covered by vinyl siding. The applicant states that the frieze was uncovered and subsequently restored with replacement wood where needed. However, photographs of the structure while work was on-going show the ghosting of the original frieze which does not match that of the installed cornice.

Staff recommends that the applicant return to the Commission with an updated application which details the restoration of the original roof frieze as evidenced by the ghosting of the original feature, as well as restores the features of the porch, including the center railing between the two sides, to their original condition. In regards to the siding, an amenable outcome could be the salvaging of all original beaded siding to the front façade of the structure, reserving the side and rear elevations for the new, replacement siding.
