Property Address: 620 N Arthur Ashe Blvd

Historic District: Boulevard/Museum District

**Memorandum in Support of Application for Certificate of  
Appropriateness to Replace Windows and Storm Door at  
620 N Arthur Ashe Boulevard, Richmond, Virginia**

**Project Name:** 620 N Arthur Ashe Boulevard Window/Storm Door Replacement

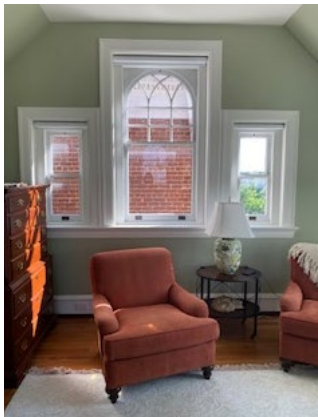
Window 1, 2, 3

The third-floor windows are of unknown age. They are single pane glass in wood construction. None of them are operational for varying reasons. Their rope and weight systems have deteriorated, some are swollen shut, one does not close completely, some have shrunk causing significant gaps and energy loss, several have cracked panes. Their design and materials no longer provide adequate protection for the structure from the outdoor elements such as rain, wind, and sun exposure and they do not provide a point of egress from the third floor due to operational failure. The failing windows contribute greatly to the energy loss on the third floor making it difficult to control the interior temperature. And finally, the failing windows offer little insulation from the street noise which has increased significantly over time as the City of Richmond has grown.

Window Information				General Condition				Window Assessment							Proposed treatment
Window #	Style	Width and Height	Material	Paint condition?	Square?	Operable?	Missing or broken panes?	Sill and Lintel	Jambs	Rails	Stiles	Muntins	Panes and Glazing Putty	Total Value	
Ex.	Double-hung 2/2	36" x 78"	Wood	Poor	Yes	No	Yes	2	1	2	1	1	3	10	Replace and reglaze broken panes, waterproof and repaint wood.
1	Double-Hung 1/1	16 x 40	wood	Poor	No	No	No	1	3	3	3	N/A	4	14	Replace
2	Gothic-Double-Hung 1 1/4	32 x 66	wood	Poor	No	No	Yes	1	3	3	3	1	4	15	Replace
3	Double-Hung 1/1	16 x 40	Wood	Poor	No	No	No	1	3	3	3	N/A	4	14	Replace
4	Gothic-Double-Hung 1 1/4	40 x 70	Wood	Poor	No	No	Yes	1	3	3	3	1	4	15	Replace
5	Gothic-Double-Hung 1 1/4	40 x 70	Wood	Poor	No	Yes	Yes	1	3	3	3	1	4	15	Replace

The Applicants would like to replace the third-floor windows and north facing storm door to restore the safety, security, and weather protection the house deserves. Replacing the windows and door are also essential to improving the energy efficiency and barrier from the ever-increasing street noise. The Applicants are extremely sensitive to the requirements of the historic district within which their structure resides and have proposed a replacement solution that meets the standards and guidelines of both the Secretary of the Department of Interior and the City of Richmond Historic Districts Guidelines.

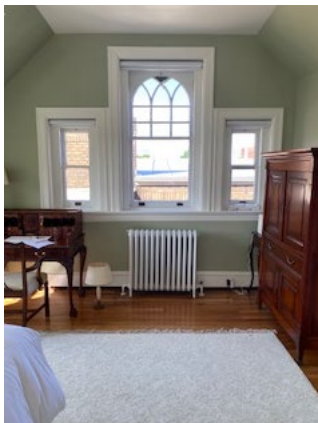
Window 6, 7, 8

Interior view of windows to be replaced

Window Information			General Condition				Window Assessment							Proposed treatment
Window #	Style	Width and Height	Material	Paint condition?	Square?	Operable?	Missing or broken panes?	Jambs	Rails	Stiles	Muntins	Panes and Glazing Putty	Total Value	
Ex.	Double-hung 2/2	36" x 78"	Wood	Poor	Yes	No	Yes	1	2	1	1	3	10	Replace and reglaze broken panes, waterproof and repaint wood.
6	Double-hung 1/1	16 x 40	Wood	Poor	No	No	No	3	3	3	N/A	4	14	Replace
7	Gothic Double-hung 1/1	32 x 66	Wood	Poor	No	No	Yes	3	3	3	1	4	15	Replace
8	Double-hung 1/1	16 x 40	Wood	Poor	No	No	No	3	3	3	N/A	4	14	Replace
9	Double-hung 1/1	22 x 44	Wood	Poor	No	No	No	3	3	3	N/A	4	14	Replace
10	Double-hung 1/1	31 x 45	Wood	Poor	No	No	No	3	3	3	1	4	15	Replace

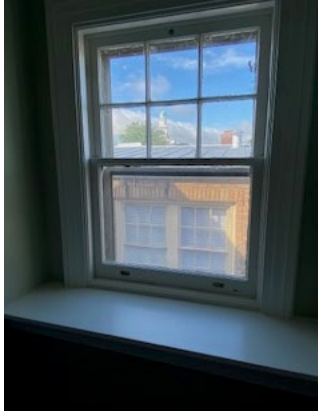
Window 11

Interior view of window to be replaced

11 Double-hung 31 x 45 wood Poor No No No 3 3 3 1 4 15 Replace

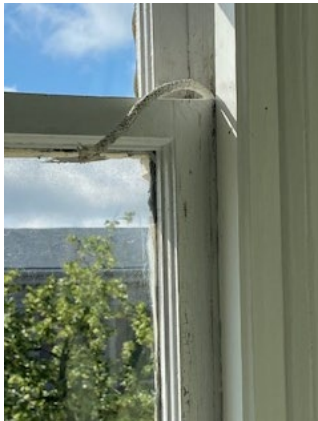
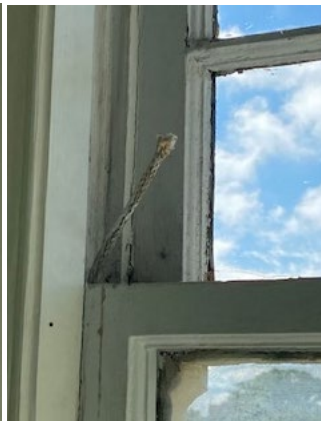
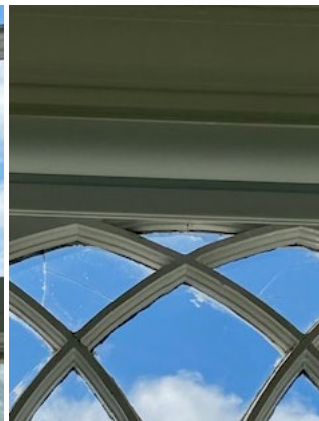
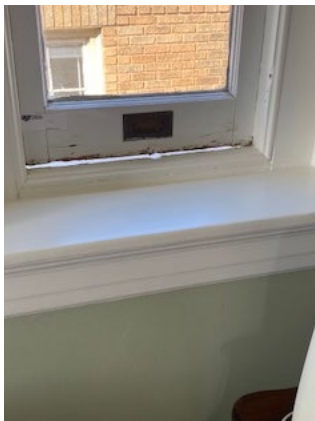
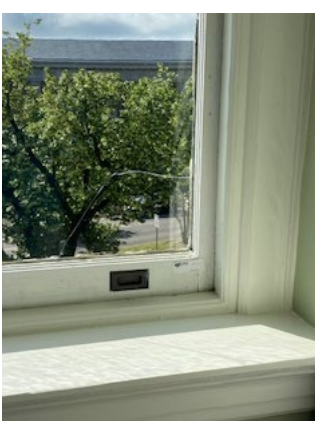
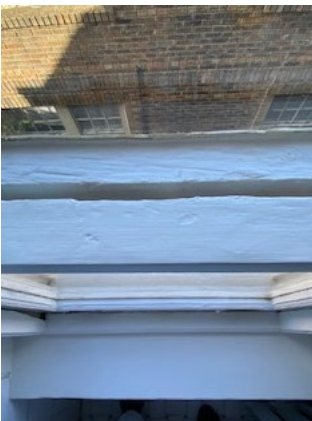
Details of window damage
