Staff Report
City of Richmond, Virginia

Commission of Architectural Review

8.COA-147332-2024	Final Review	Meeting Date: 5/28/2024
Applicant/Petitioner	Christopher Wingfield	
Project Description	Restore, repair, and replace elements on the façade in need of repair.	
Project Location		
Address: 2808 East Leigh Street		
Historic District: Church Hill North		
High-Level Details: The applicant proposes to make exterior alterations to a detached, two-story, Colonial Revival dwelling circa 1900. Exterior alterations will include replacement of wood siding and front porch elements with a new design.		
Staff Recommendation	Partial Approval	
Staff Contact	Alex Dandridge, (804) 646-6569, alex.dandridge@va.gov	
Previous Reviews	None.	
Conditions for Approval	<p><i>Staff Recommends approval of:</i></p> <ul style="list-style-type: none">• Replacement of the front windows in-kind to match the existing light configuration, dimension, and that the upper sashes feature ogee lugs like the existing.• Staff recommends that all existing window casing and sills be retained and repaired as necessary, and not be wrapped in another material.• The new windows must be within the existing framing and must be

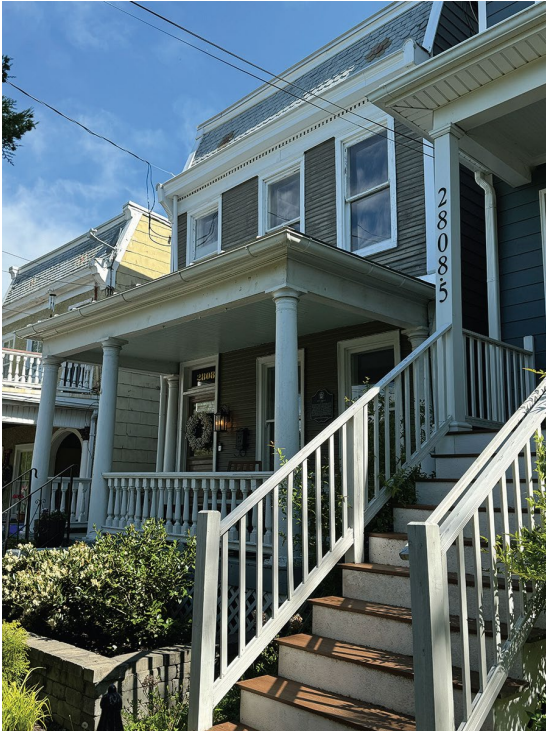
Figure 1. Front Façade with narrow siding.

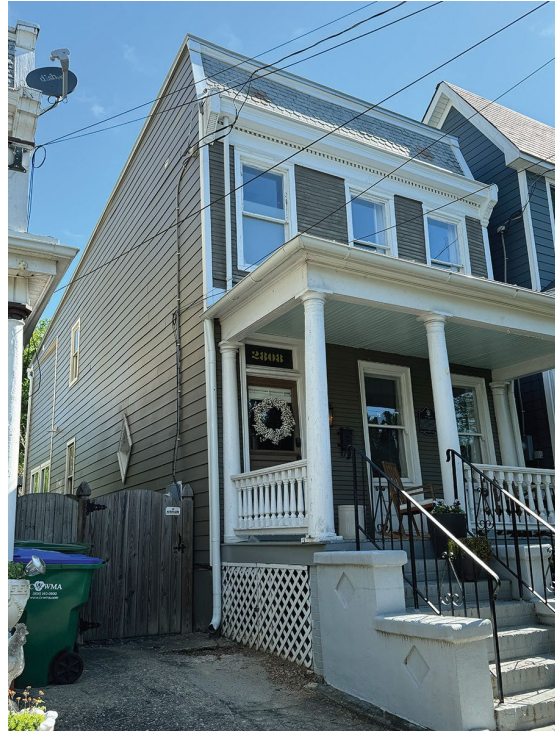
building in 2017. The building has been clad in novelty siding for many years which had led to the degradation of the wooden siding beneath.
--	--	--

Figure 2. Side façade with replacement siding.

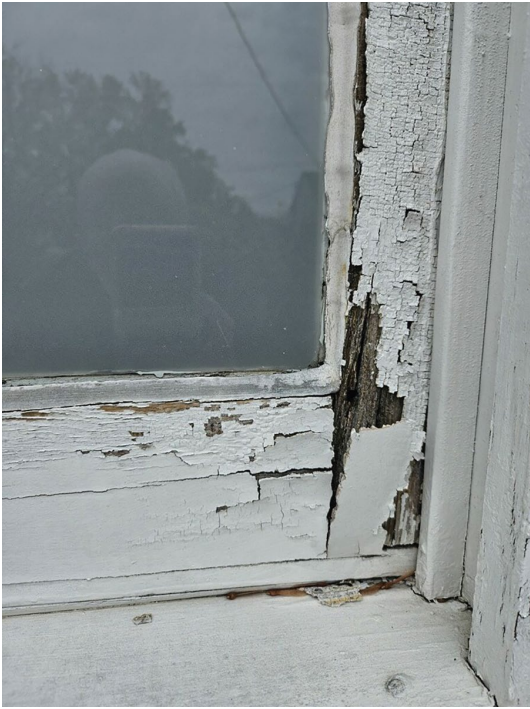
Guideline Reference	Reference Text	Analysis
<p>Building Elements, Windows, pg. 69</p>	<p><i>7. Windows should only be replaced when they are missing or beyond repair. Any reconstruction should be based on physical evidence or photo documentation.</i></p>	<p>The applicant proposes to replace the front windows which appear to be deteriorated beyond repair. Excessive wood rot is present on the windows.</p> <p>The general exterior rehabilitation of the house was approved by the Commission in 2017. The exterior rehabilitation included removing the faux brick, asphalt shingle siding, and restoring the front windows. The Commission did approve the replacement of many side elevation windows due to deterioration, minimal visibility, and traditional design of the replacement windows.</p> <p><u>Staff recommends that the front windows be replaced in-kind to match the existing light configuration, dimension, and that the upper sashes feature ogee lugs like the existing. The new windows must fit within the existing framing and must be wood or aluminum clad wood. Final window specifications sent to staff for administrative review and approval.</u></p> <p><u>Staff recommends that all existing window casing and sills be retained and repaired as necessary, and not be wrapped in another material.</u></p> <p>Staff was not able to locate historic photographs of the property.</p>

Figure 4. Window Deterioration

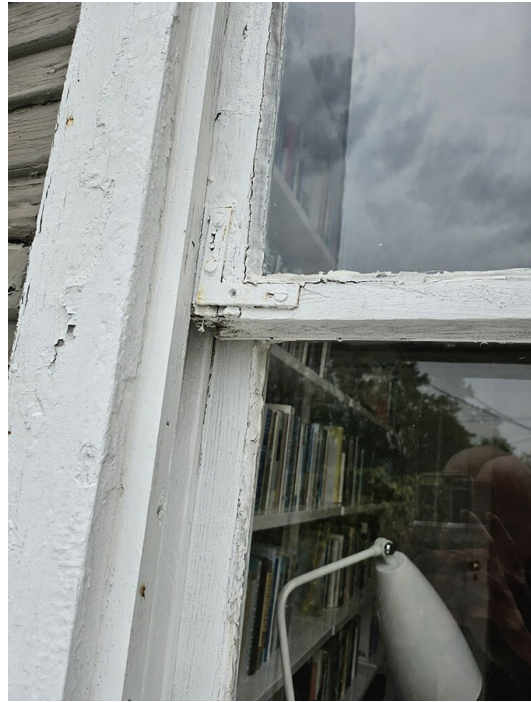
Figure 5. Window Deterioration

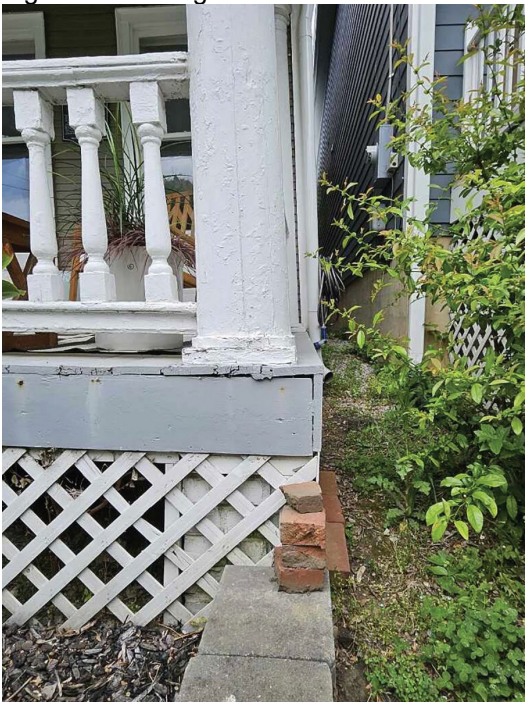
<p>Secretary of the Interior’s Standards for</p>	<p><i>Repair damaged elements instead of replacing them. Use materials that match the original in type, or use physically and</i></p>	<p>The applicant proposes to replace the existing front porch railing and balustrade. The existing balustrade features a wide, substantial banister</p>

Figure 5. Existing balustrade and columns.

<ul style="list-style-type: none"> • The wood siding on the façade be replaced with new wood “bb” siding. • decking boards be installed perpendicularly to the face of the building. <p><i>Staff recommends denial of:</i></p> <ul style="list-style-type: none"> • using a five – seven-inch reveal siding on the front façade. • Replacing the front banister and balustrade with a new design.
--	---

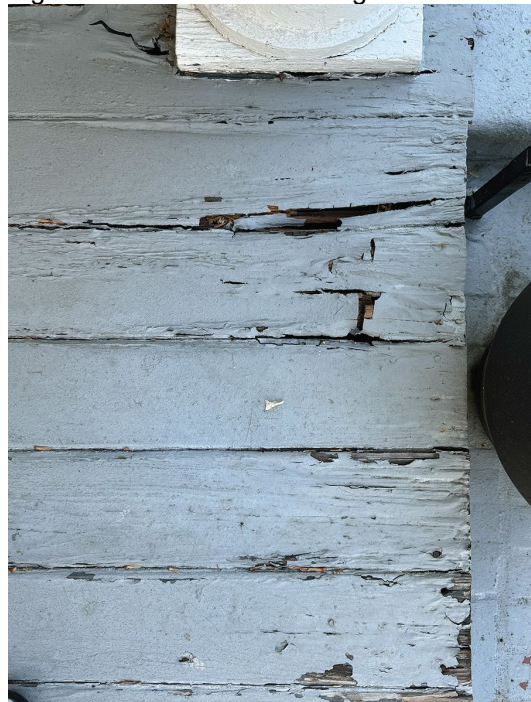
Figure 6. Deteriorated decking boards.
