# Commission of Architectural Review SUBMISSION APPLICATION

LOCATION OF WORK: 21 W Clay St. DATE: 9/23/14

Window Replacement - 13 of the 37 windows in the home. Please see attached explanation of we are adhering to Design Guidelines, and accompanying photos

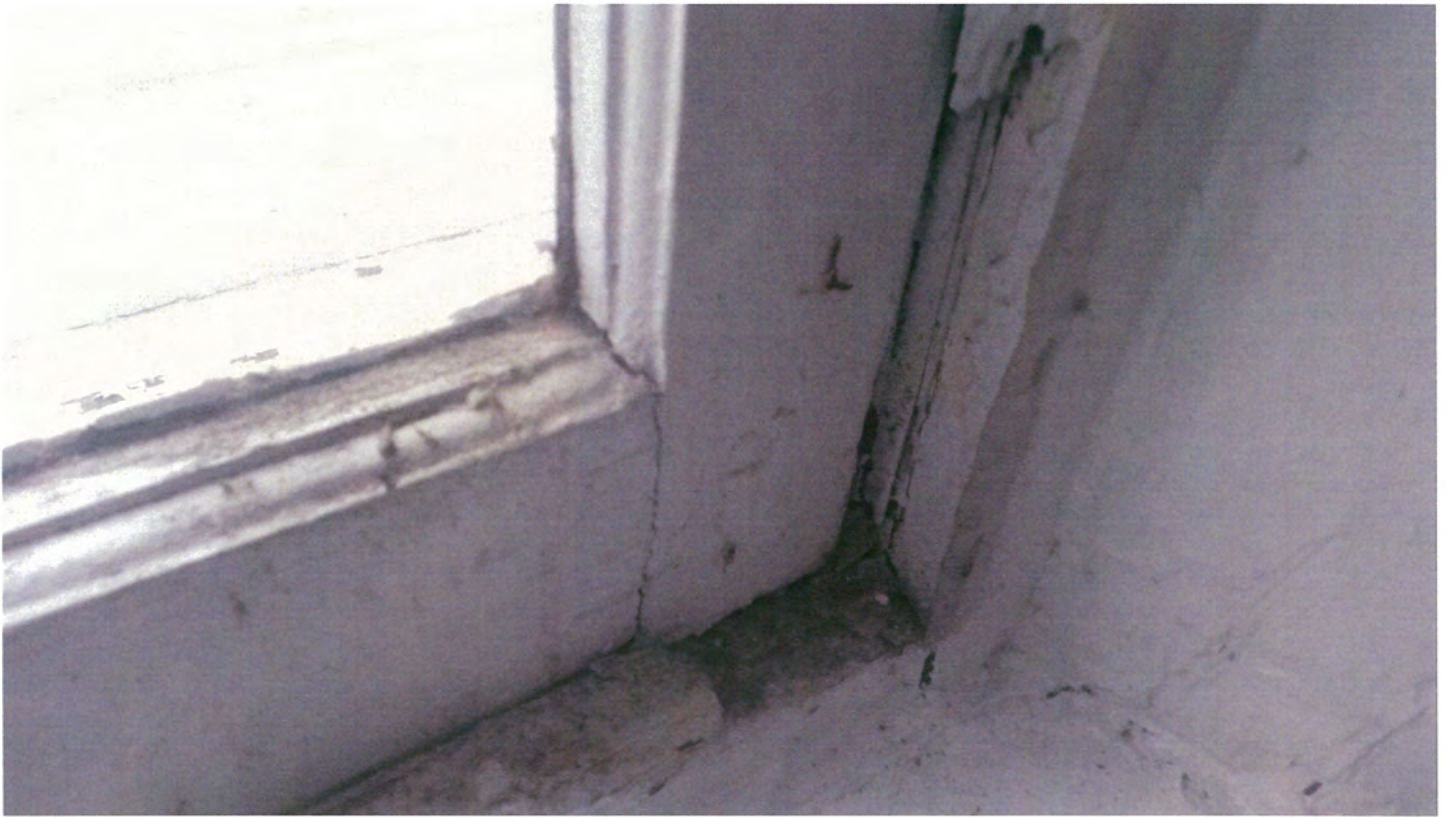
Clay St. Second Floor Window 1.

Rotted and Broken jams.

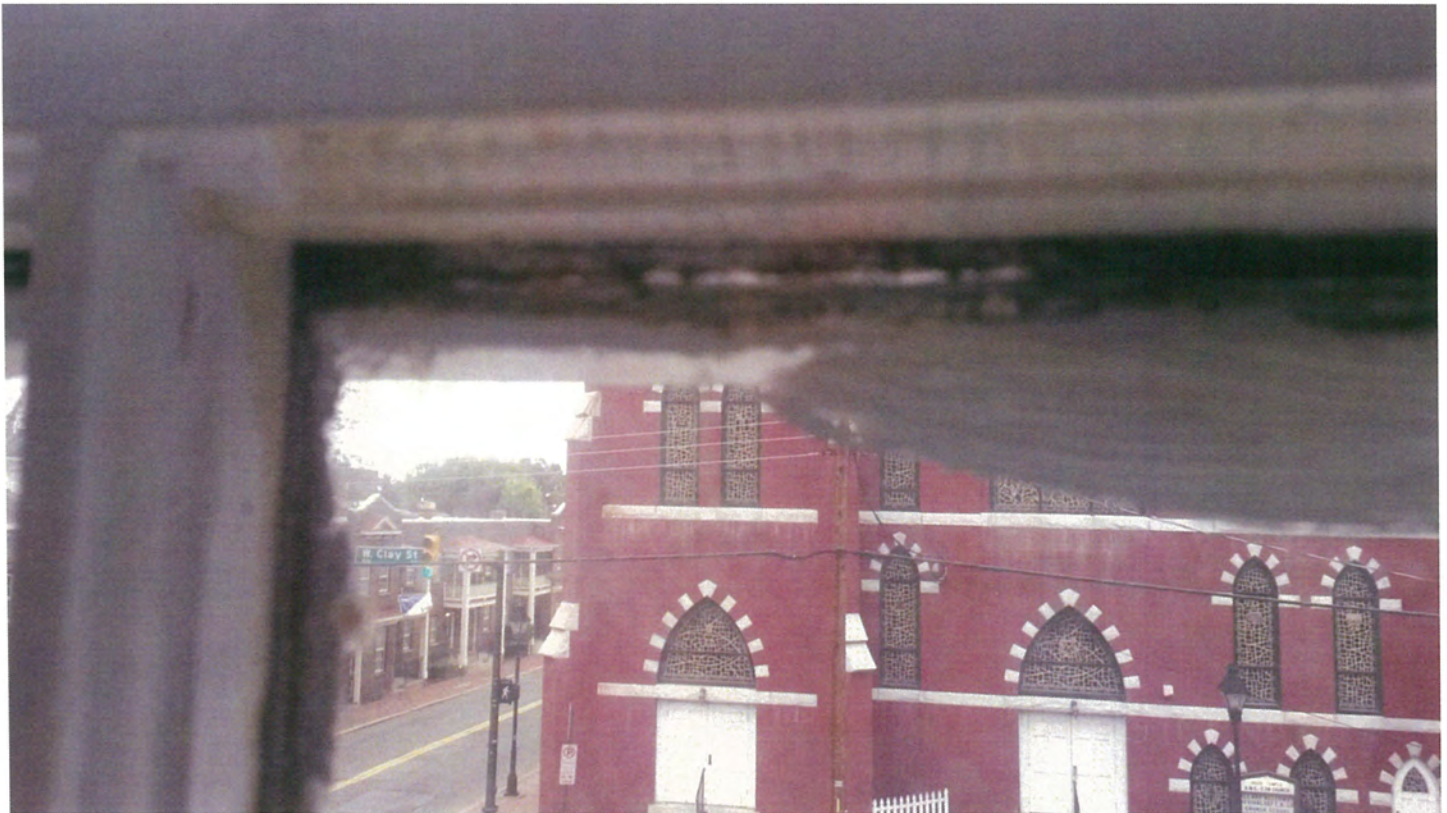
Window glazing broken and detached from muntin.

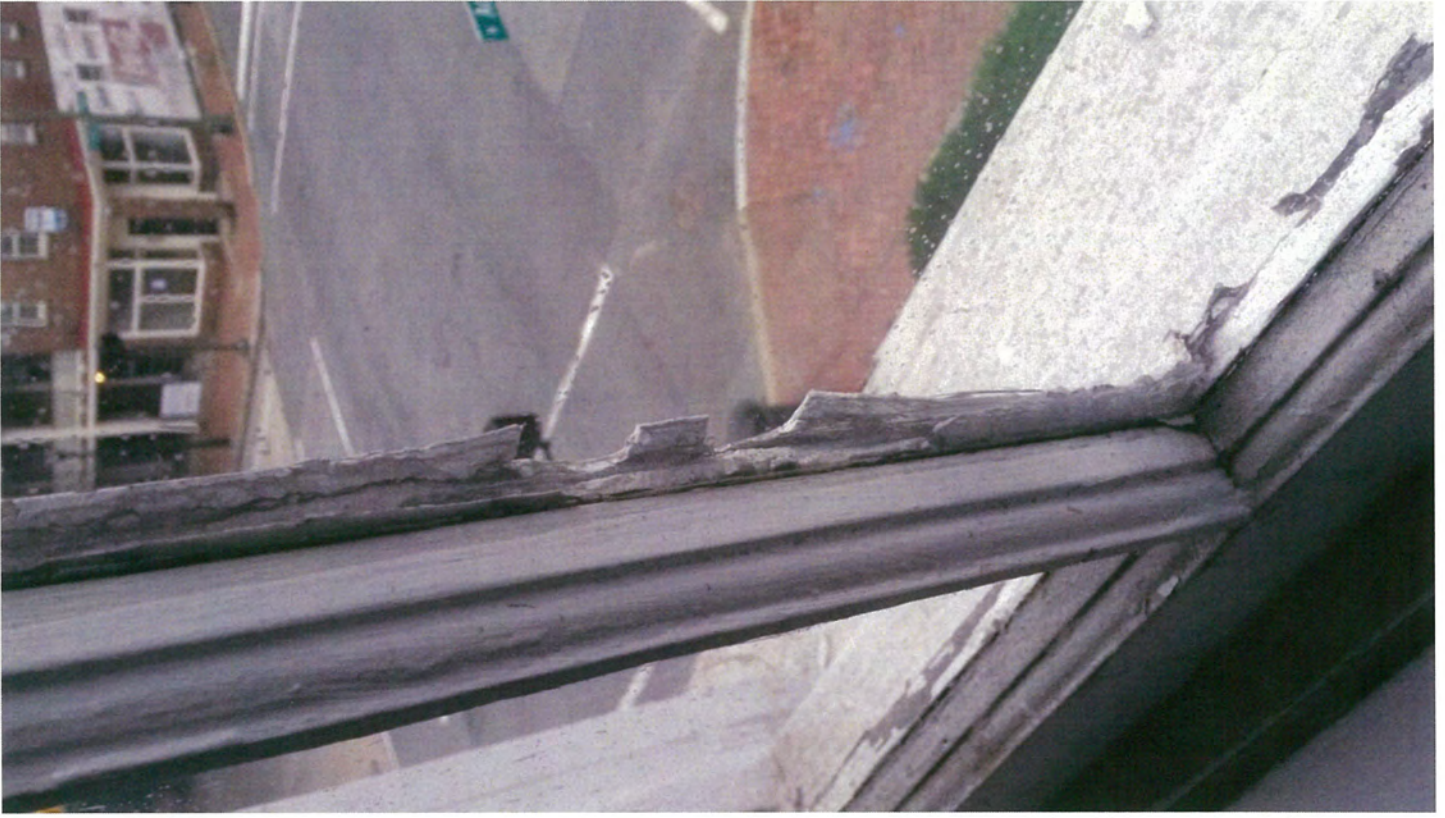
Clay St. Second Floor Window 2

Broken Muntin.

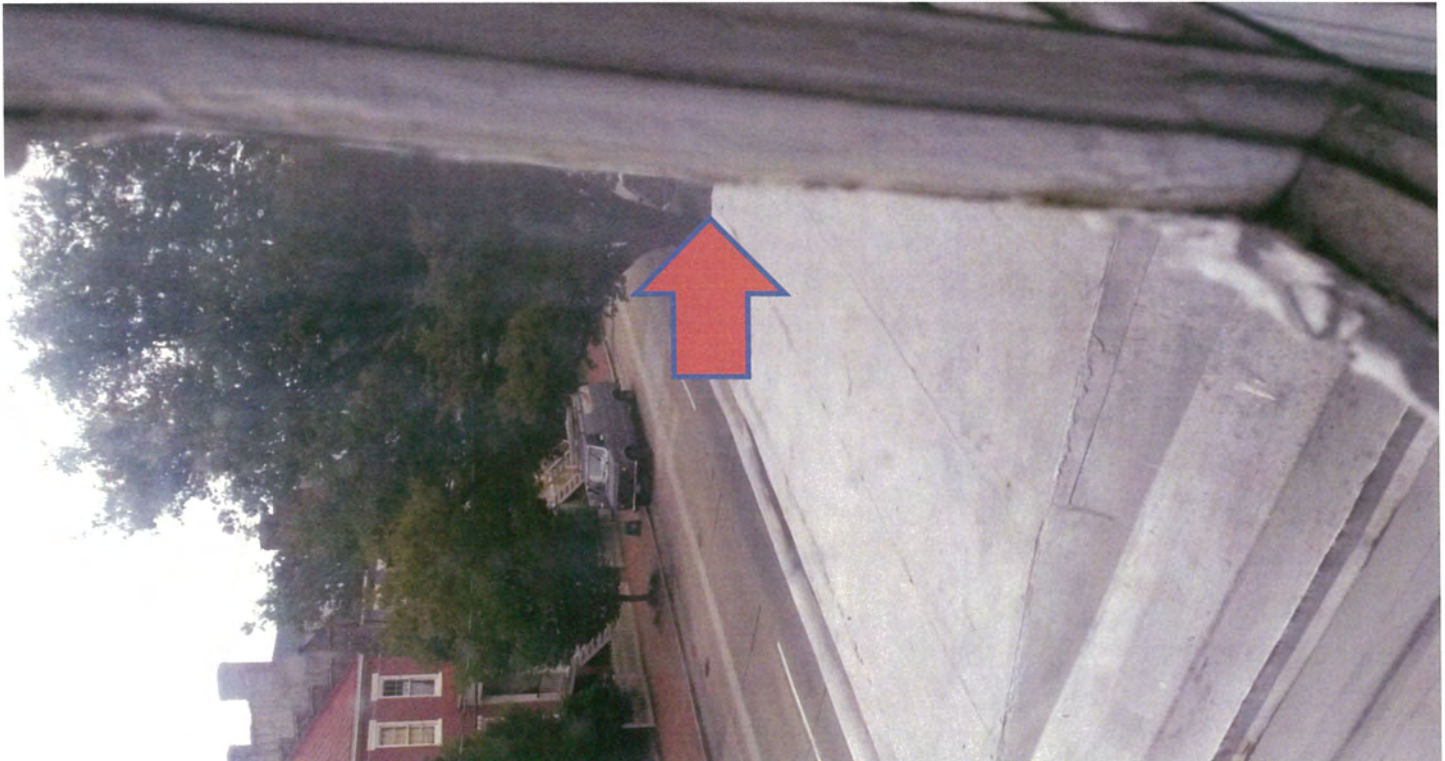
Exterior Muntin broken off due to rot

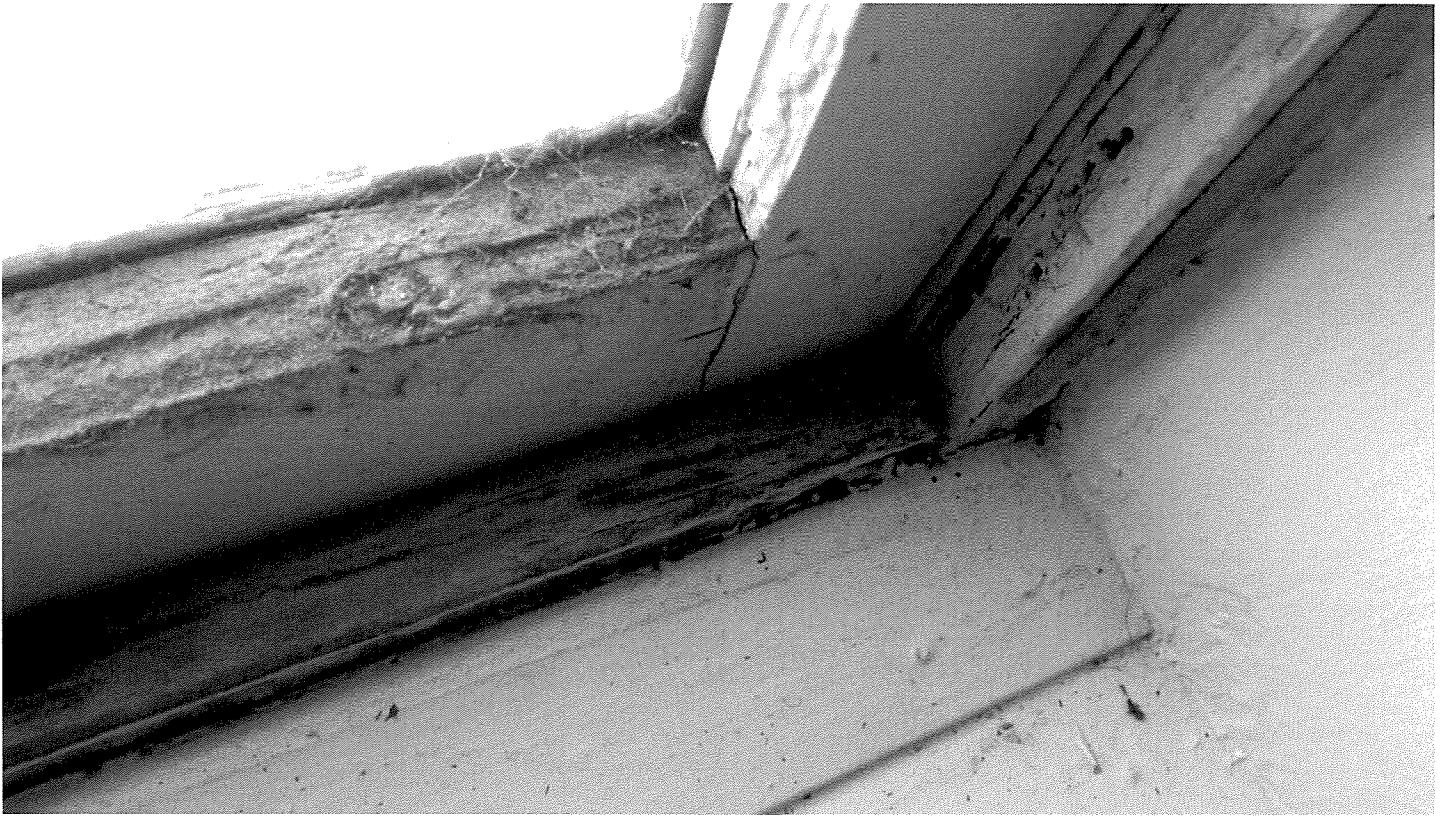
Interior dry rot.

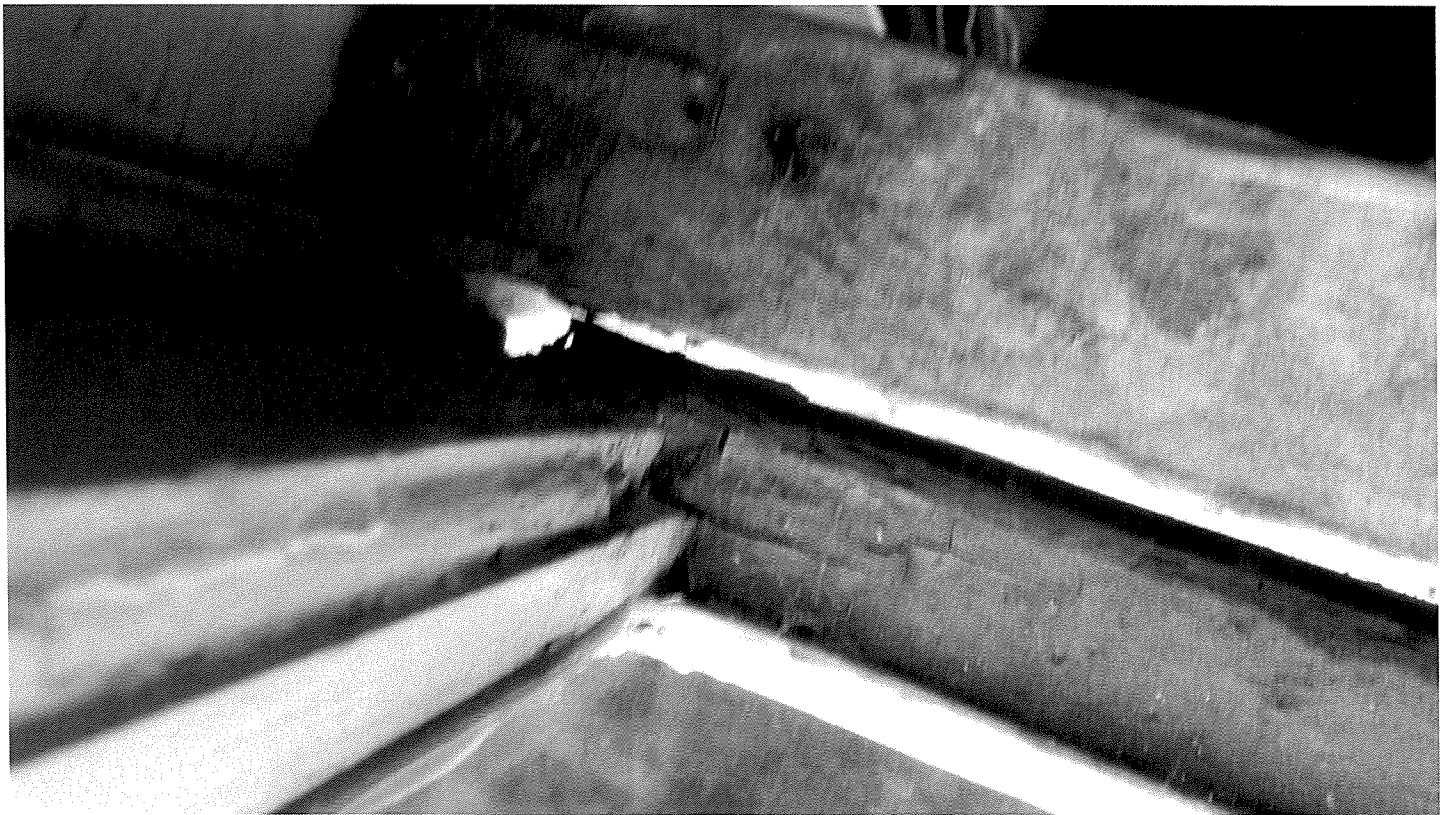
Exterior window sash rotted.

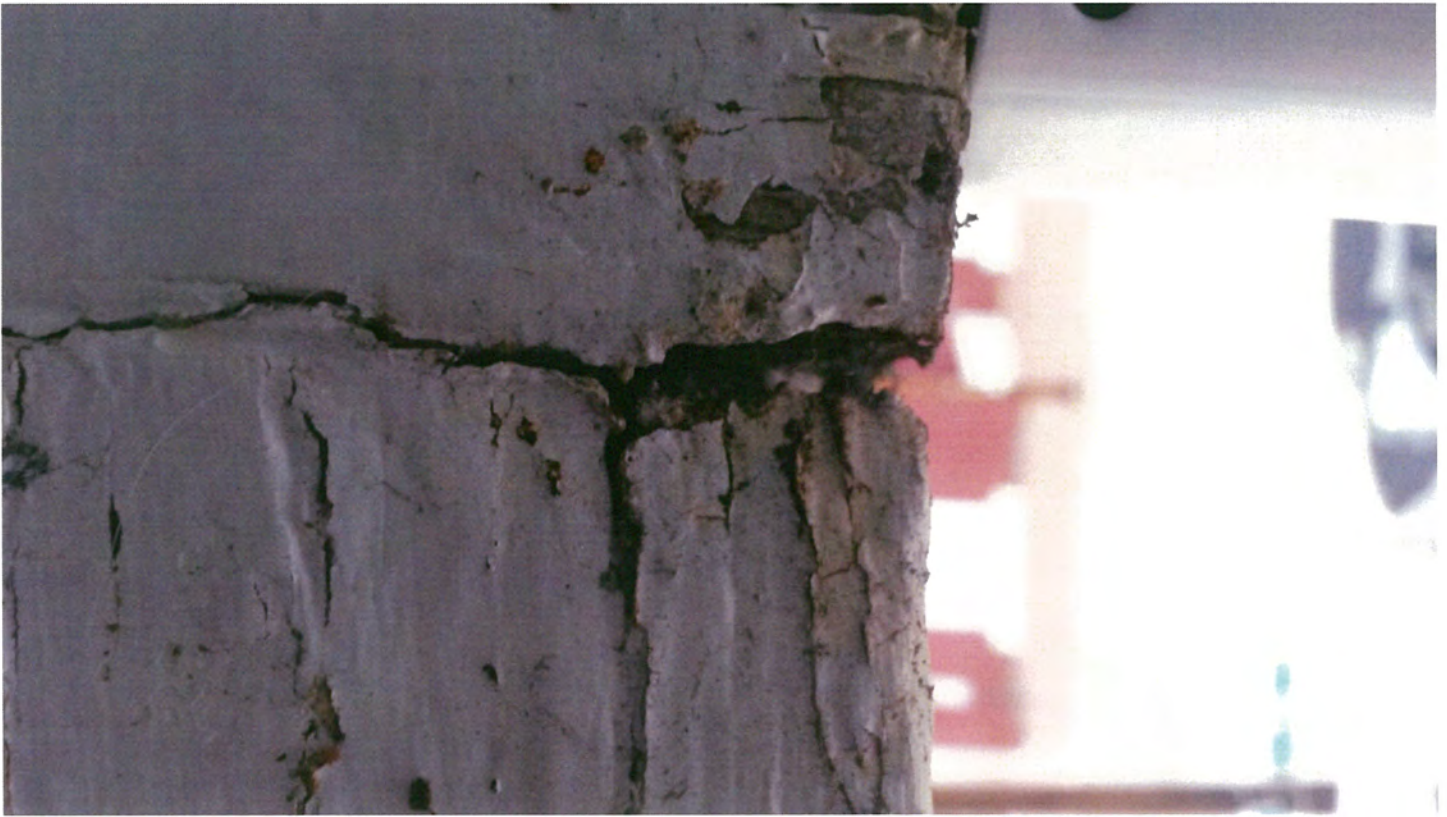
Clay St. Second Floor Window 3

Wood rot

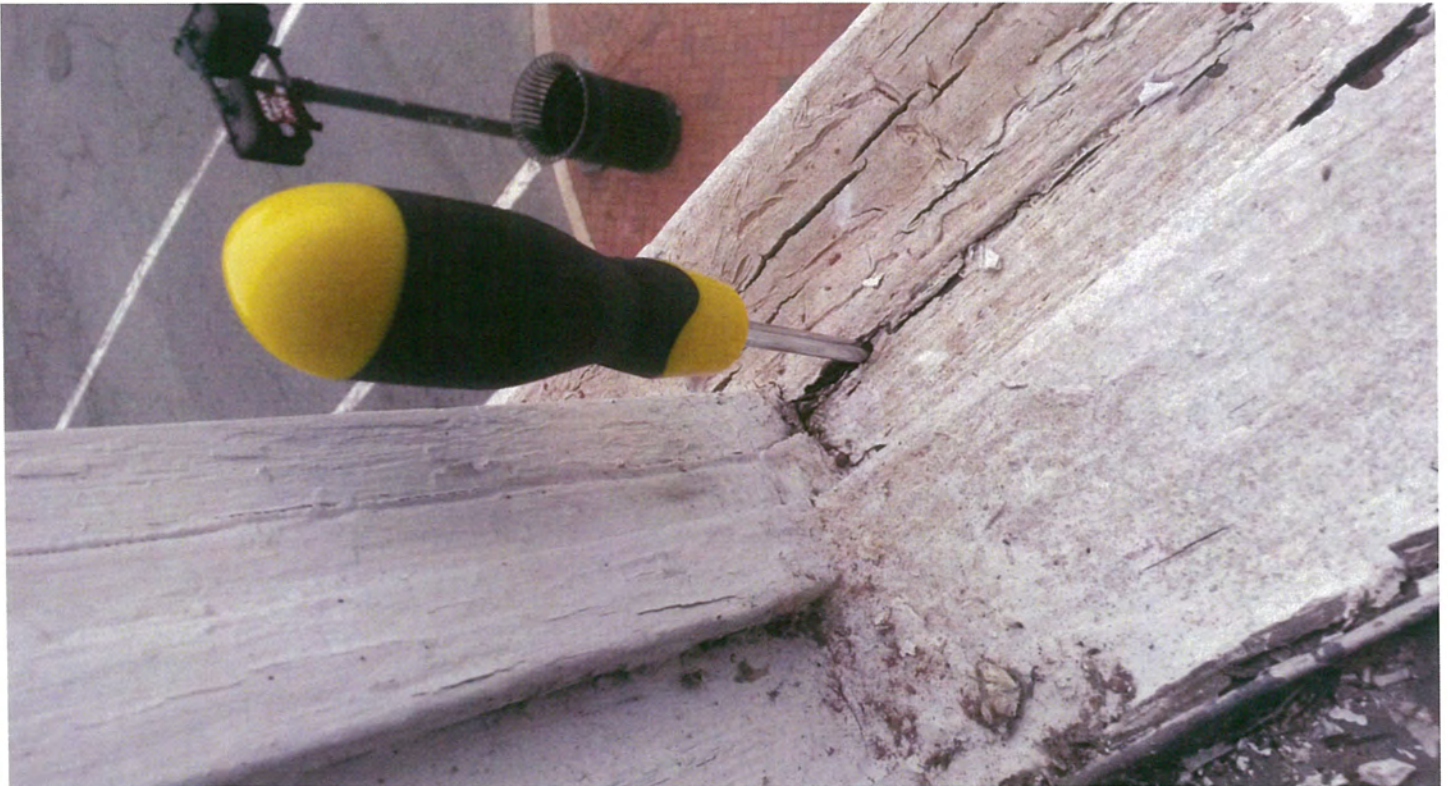
Sill wood rot.

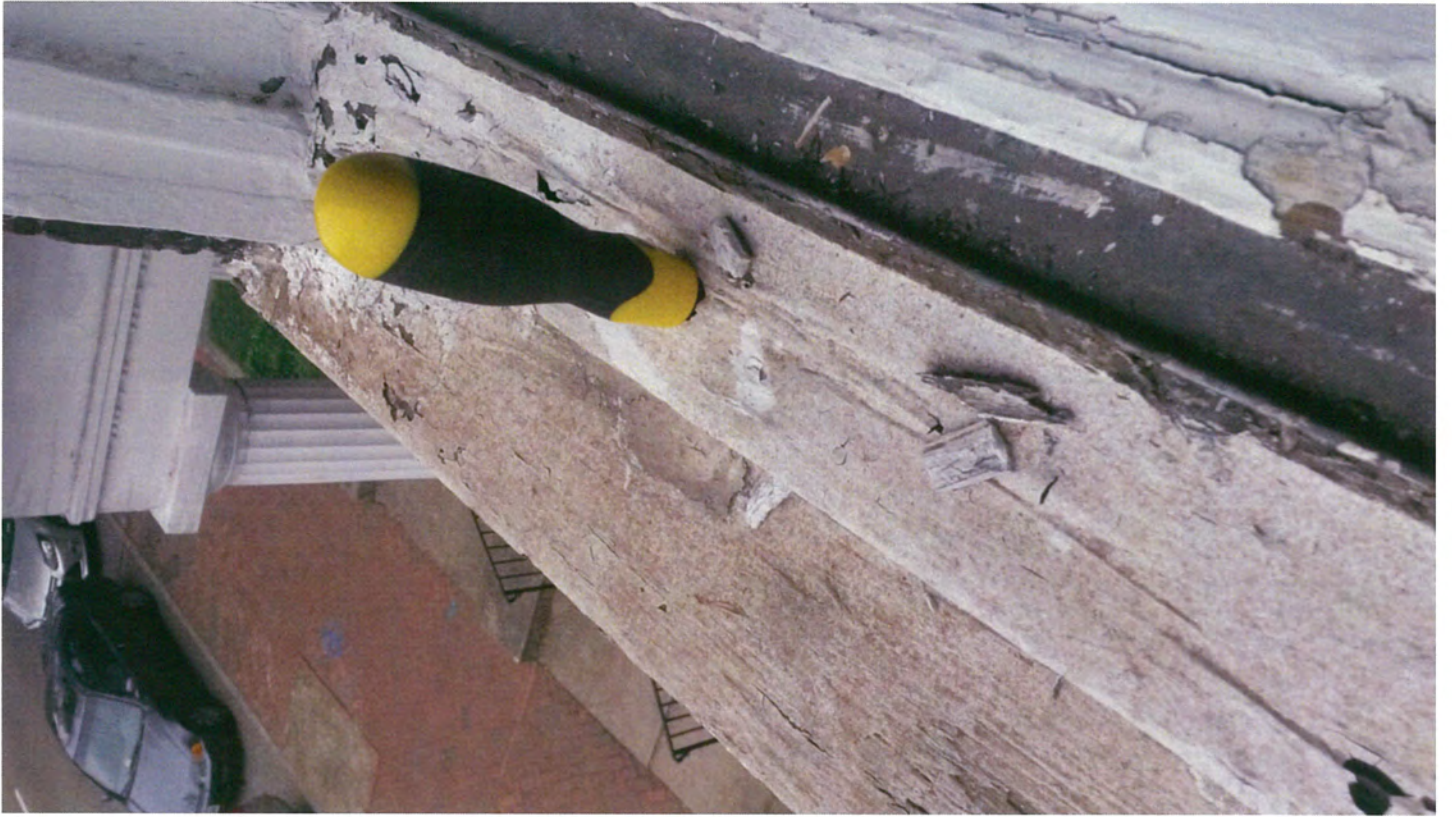
Weather-guard wood rot.

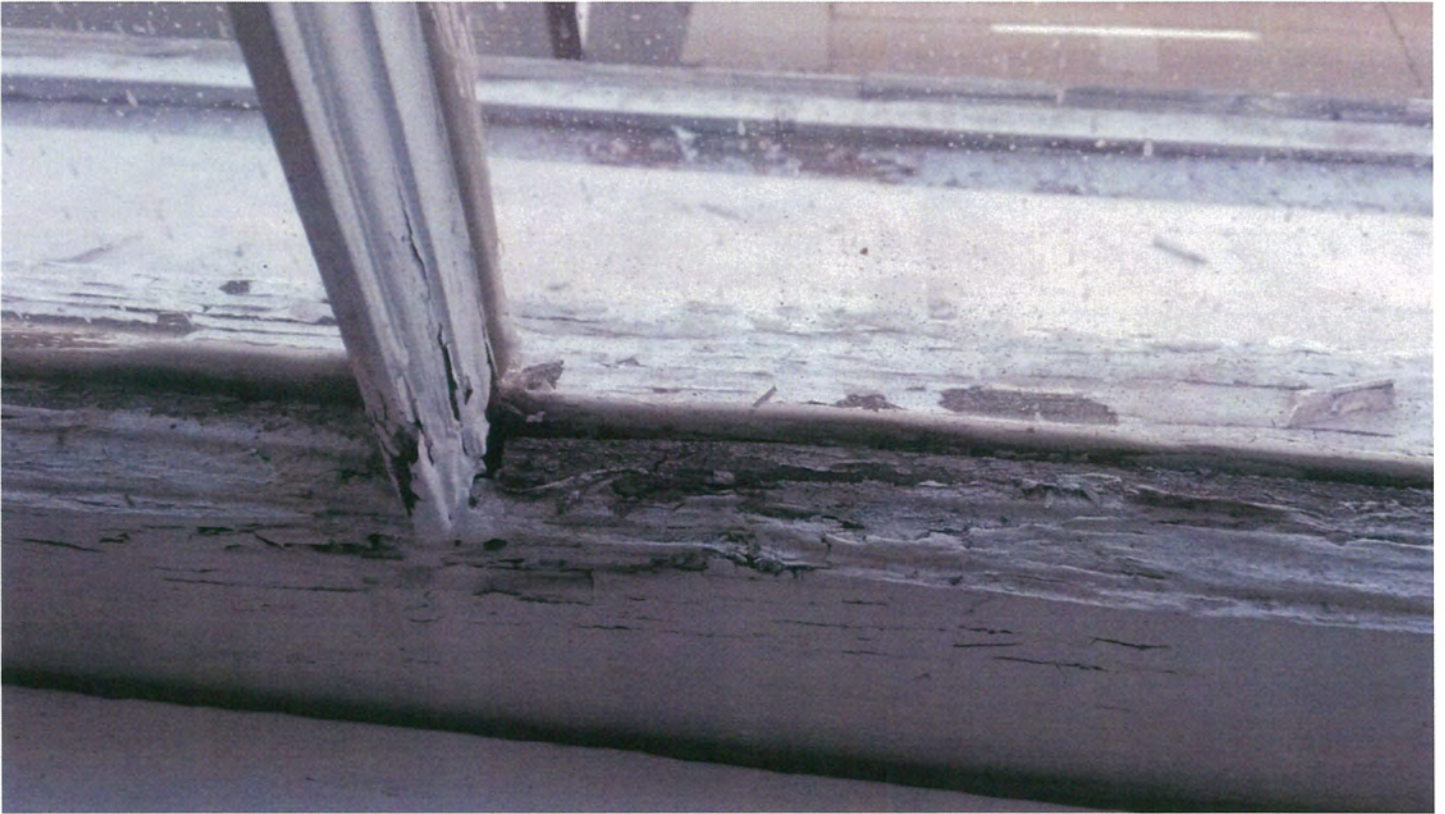
Clay Street Third Floor Window 1.

Dry rot and muntin no longer connects to sash.

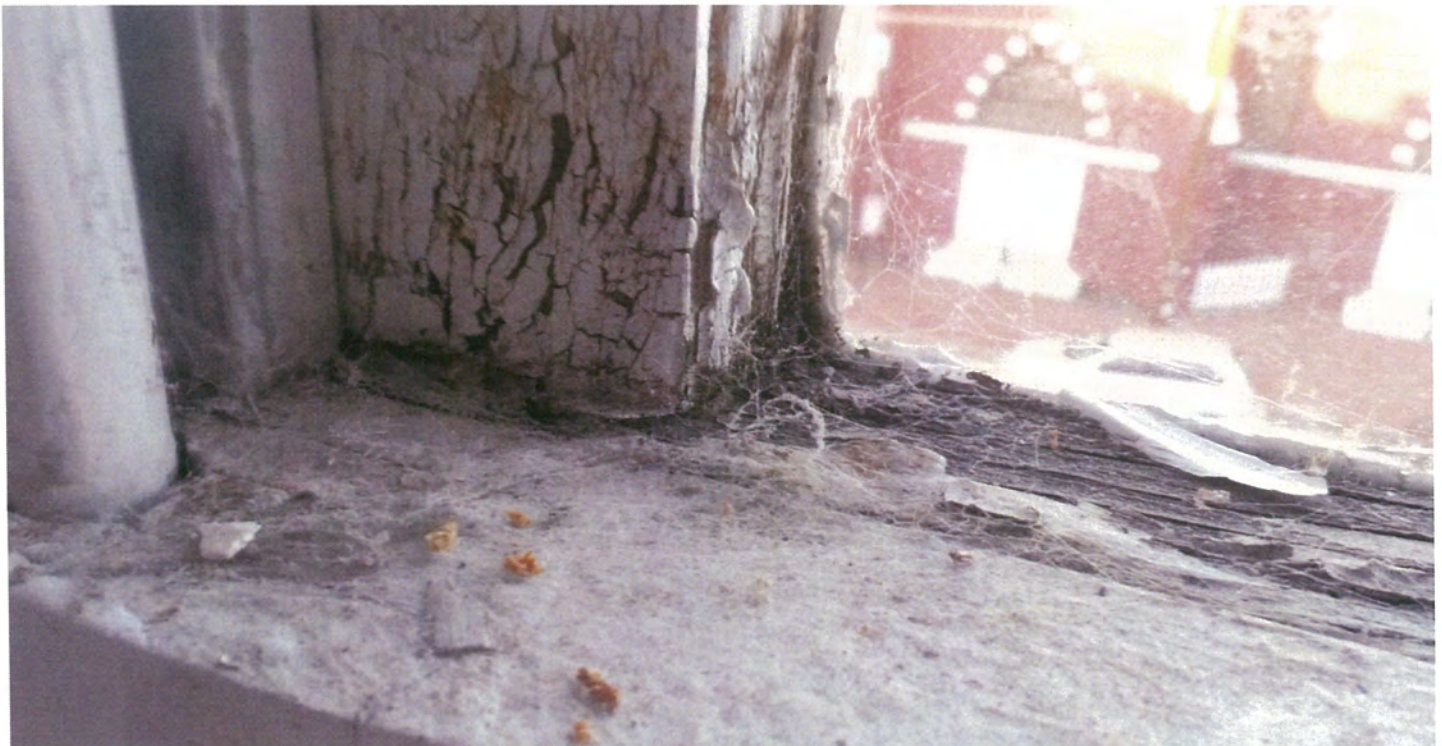
Clay Street Third Floor Window 2

Wood rot and what appears to be mold or fungus.

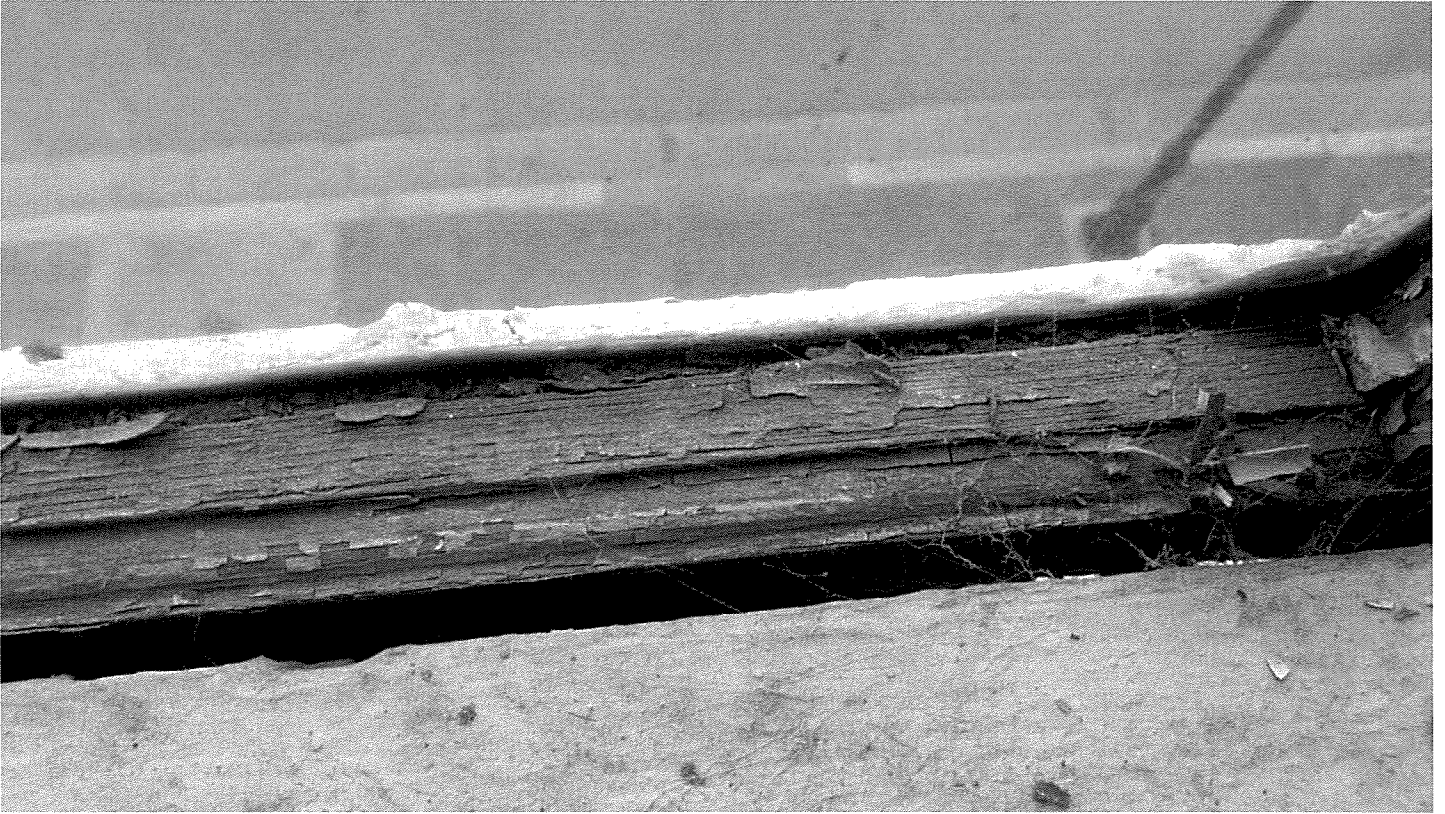
N. Adams St. Second Floor Window 1.

Wood in poor condition. Large gap between sashes.

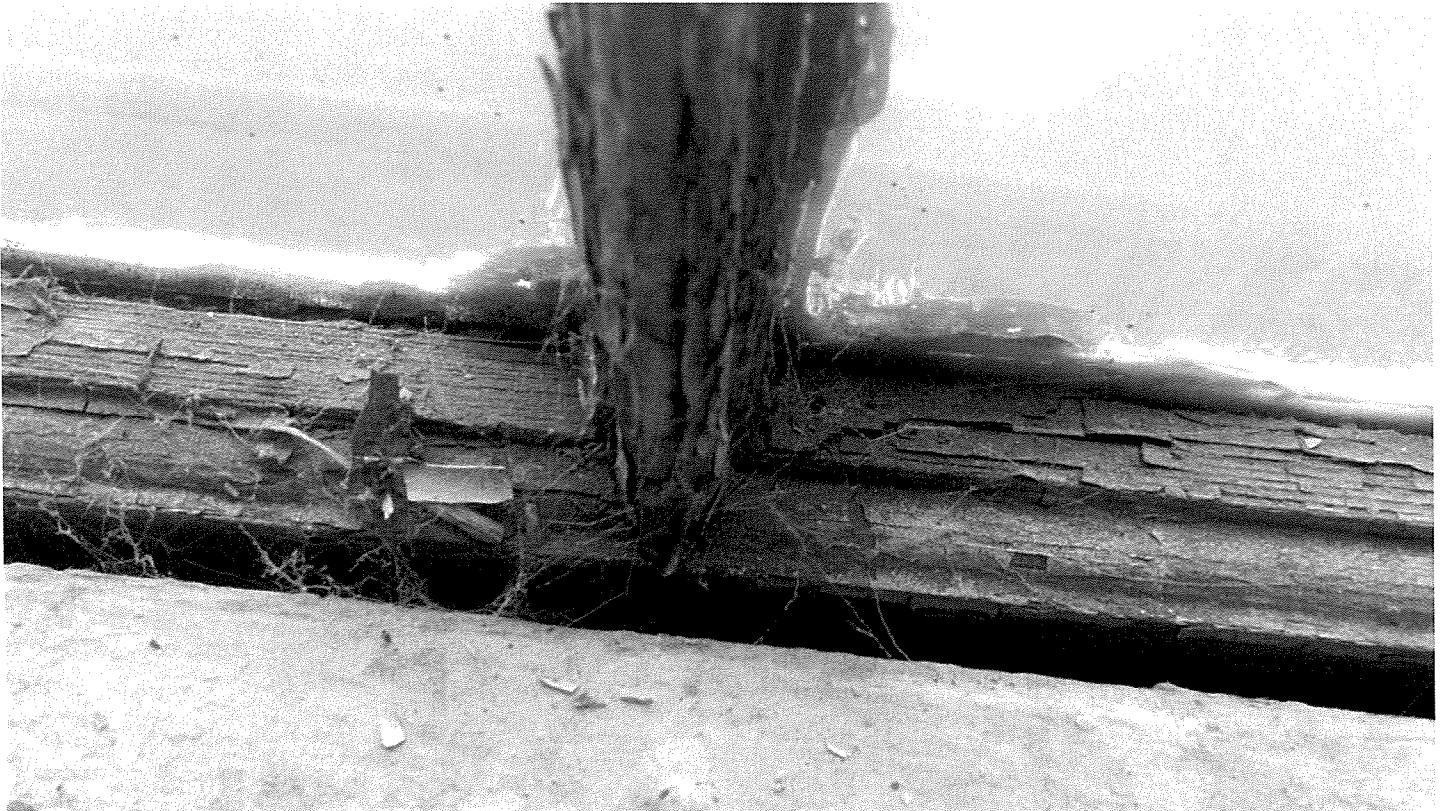
Wood in poor condition.

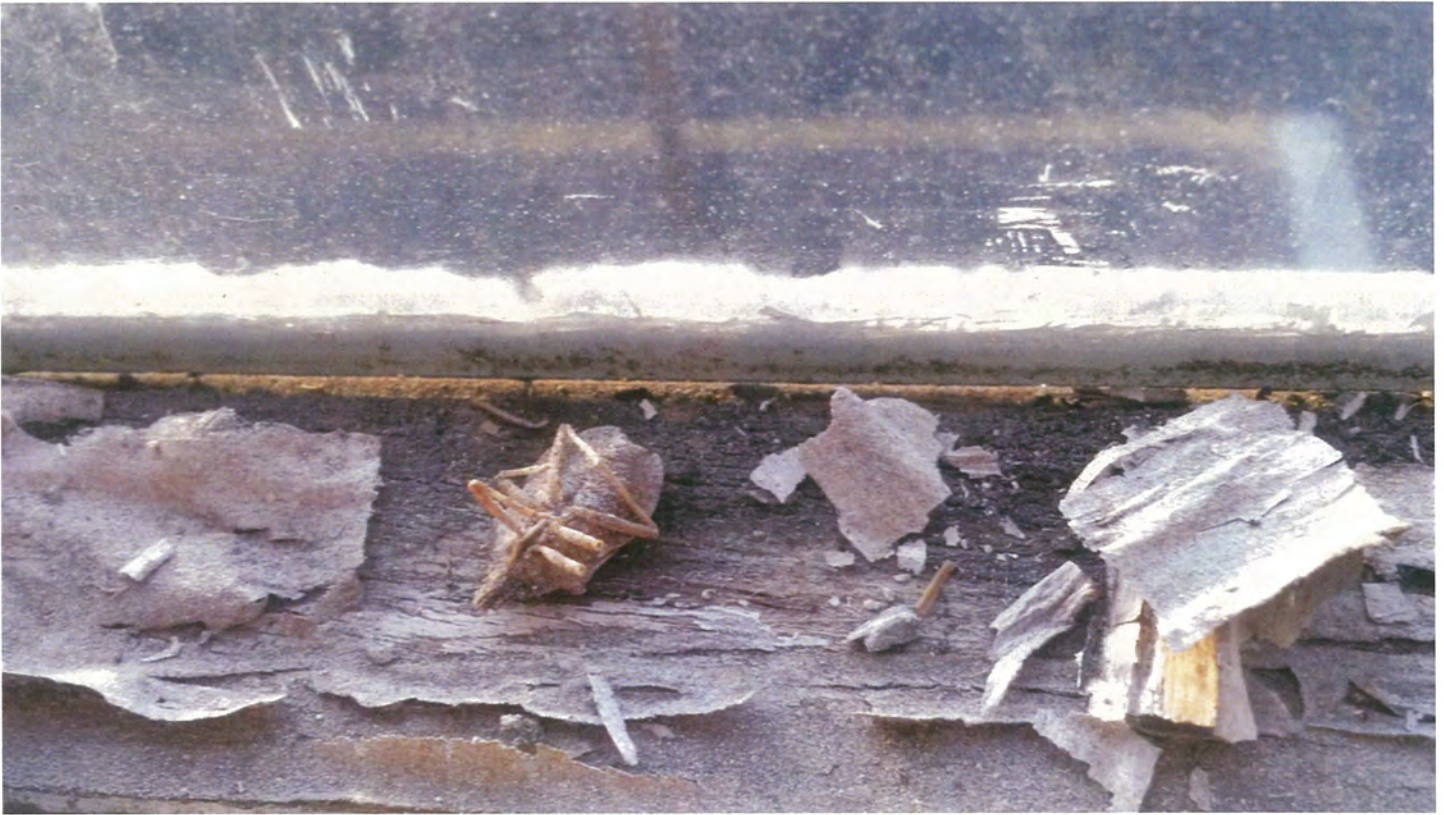
N. Adams Third Floor Window 1

Glazing no longer connects.

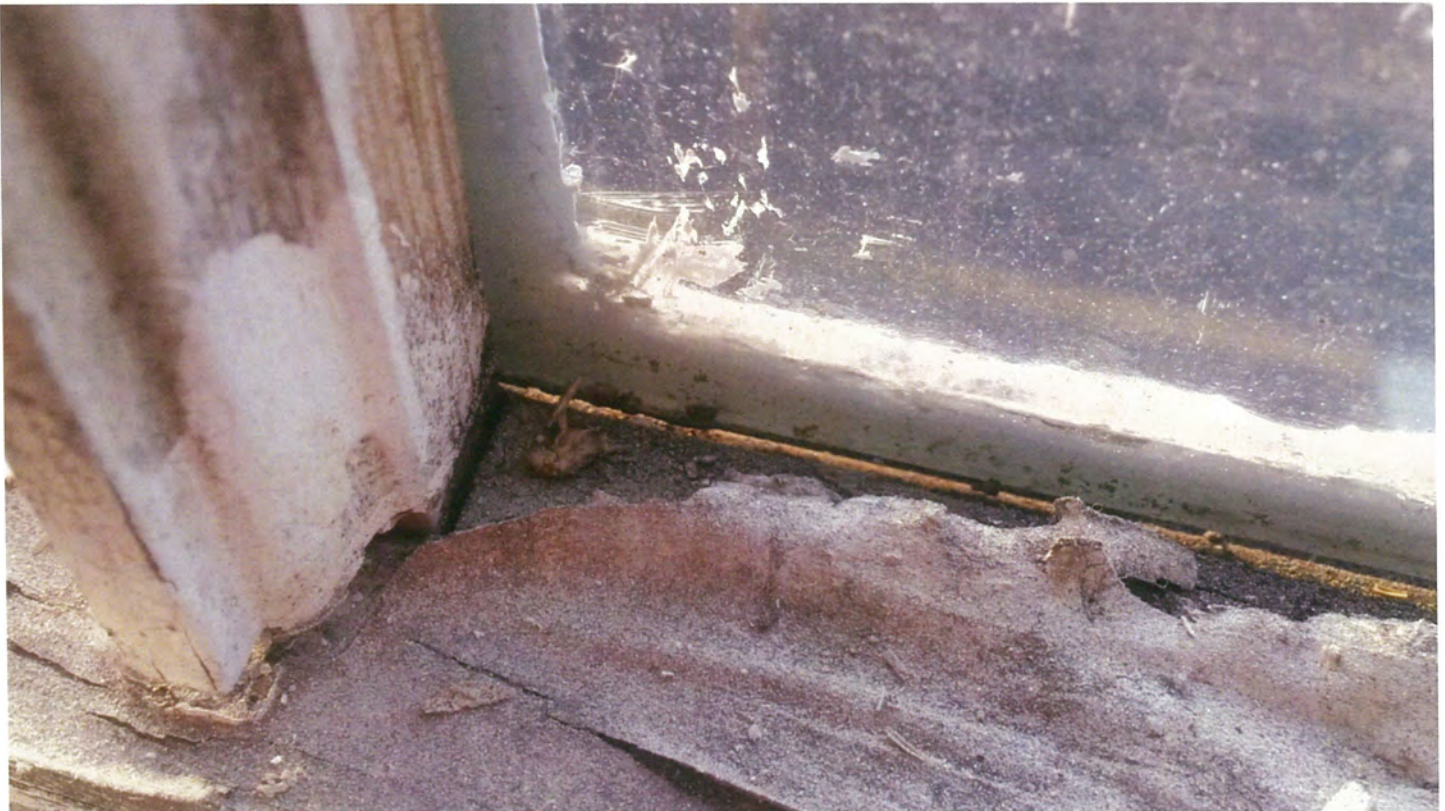
Muntin no longer connects to sash. Evidence of rot to sill.

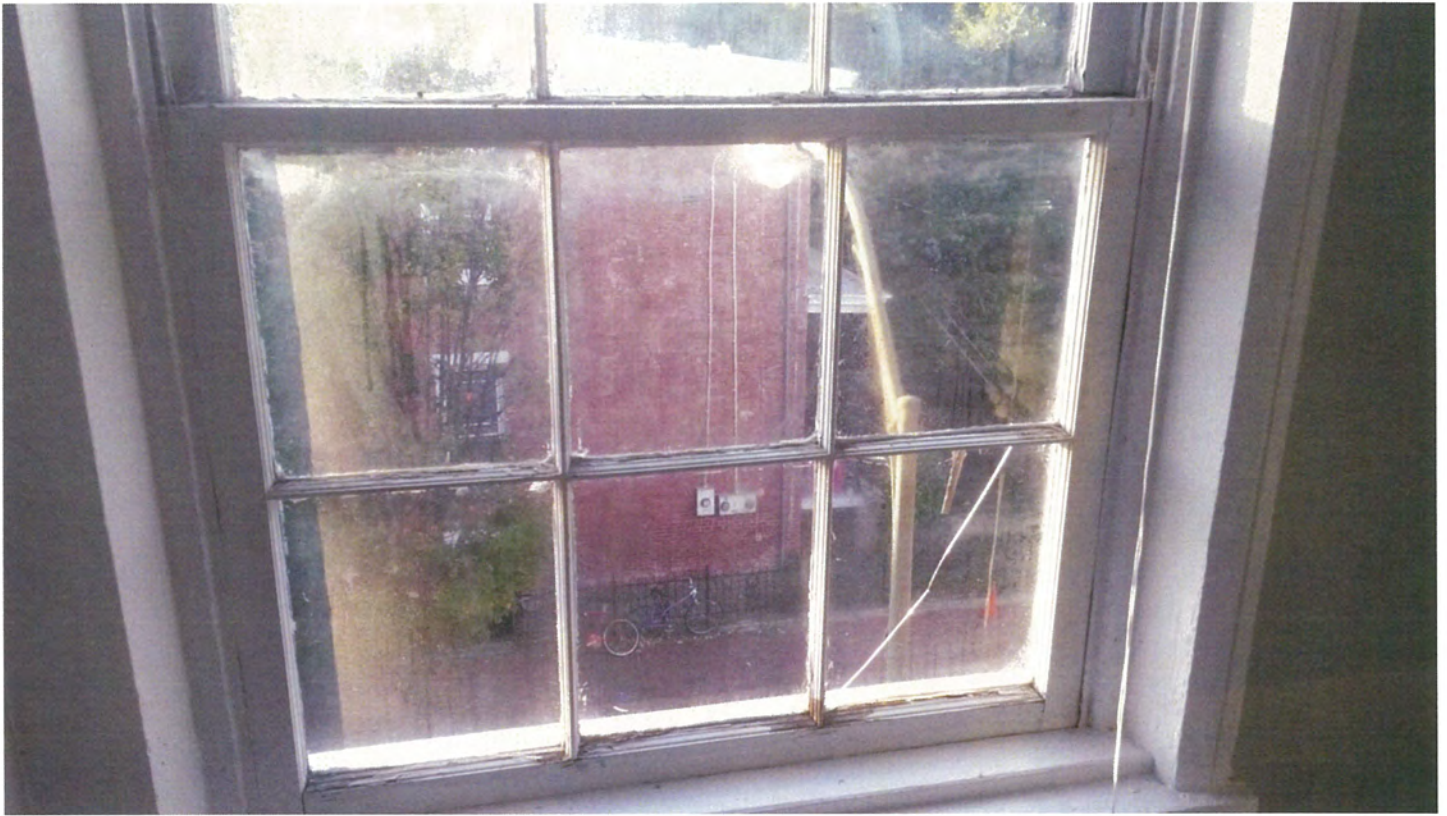
N. Adams Third Floor Window 2

Glazing cracked.

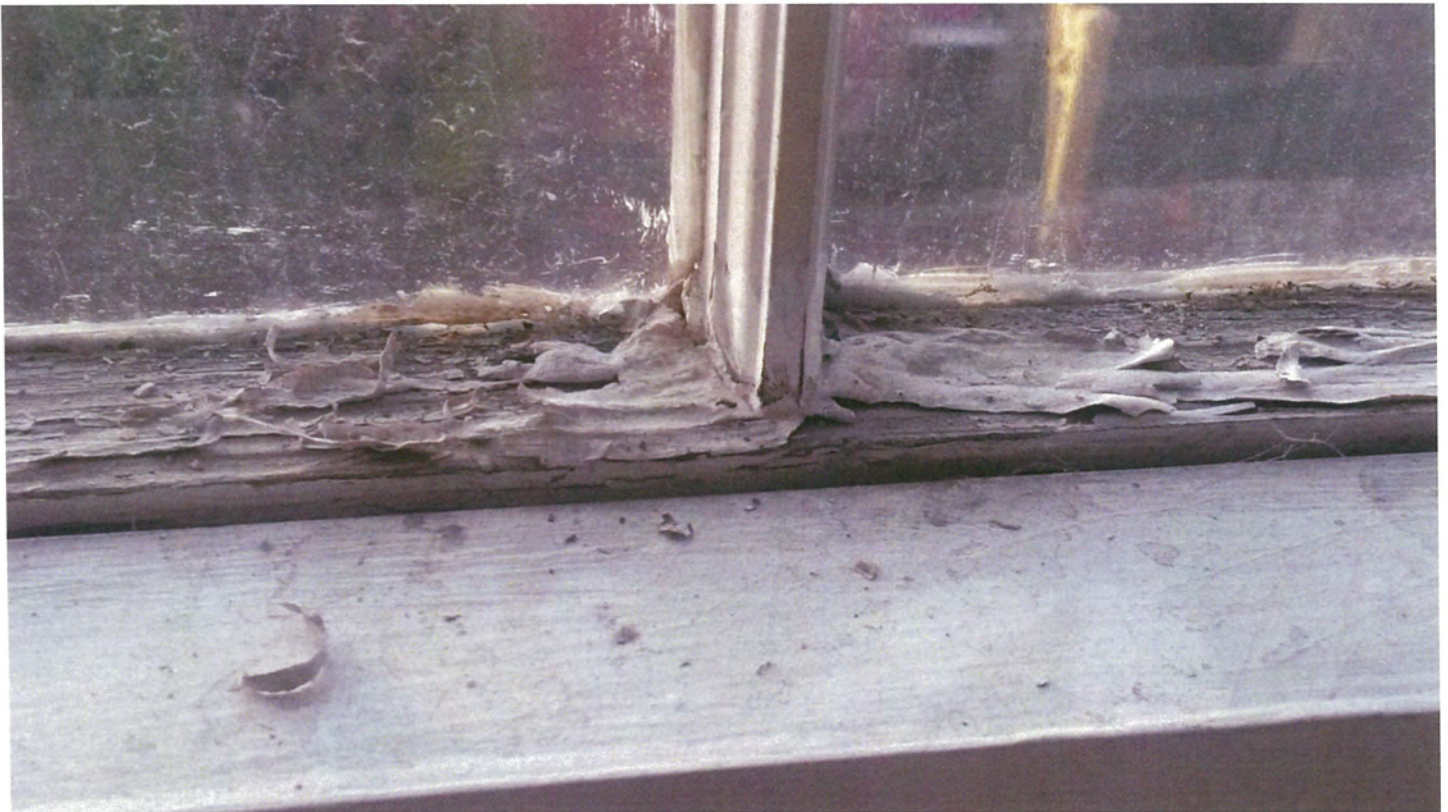
Peeling paint.

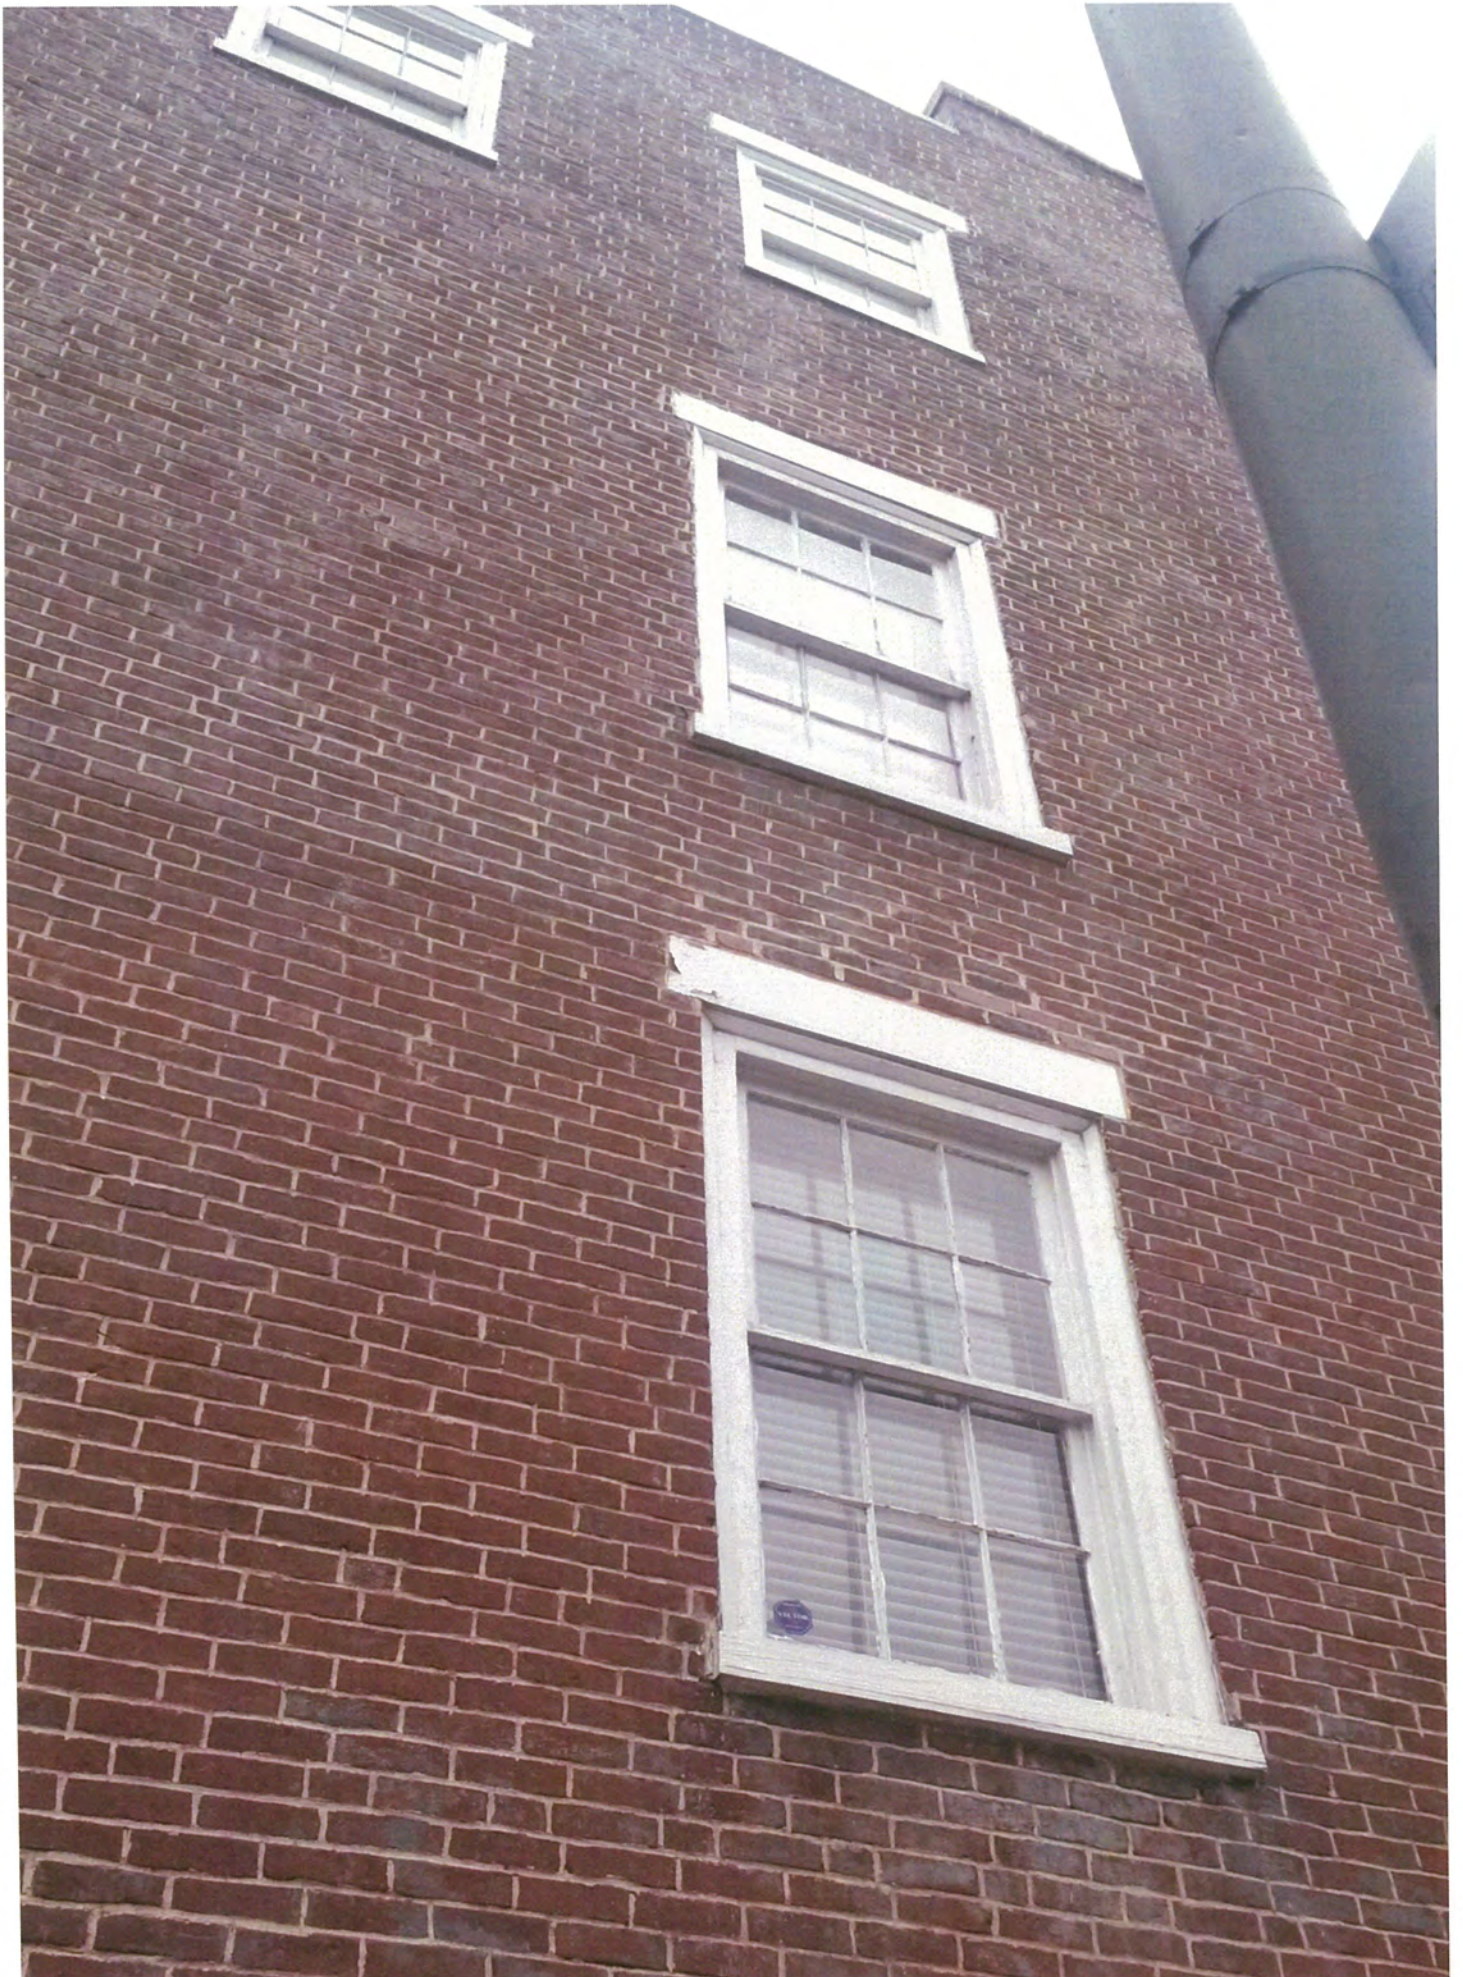
Picture 1: View from sidewalk closest to 21 W. Clay on N. Adams. Note that only the two windows at the top are slated for replacement. The observer must tilt their neck significantly to see the windows on the 3<sup>rd</sup> floor.
