# Commission of Architectural Review SUBMISSION APPLICATION

LOCATION OF WORK: 22 SOUTH BOULEVARD DATE: 4/23/14  
RICHMOND VA 23220

## Problem Identification

## Overview

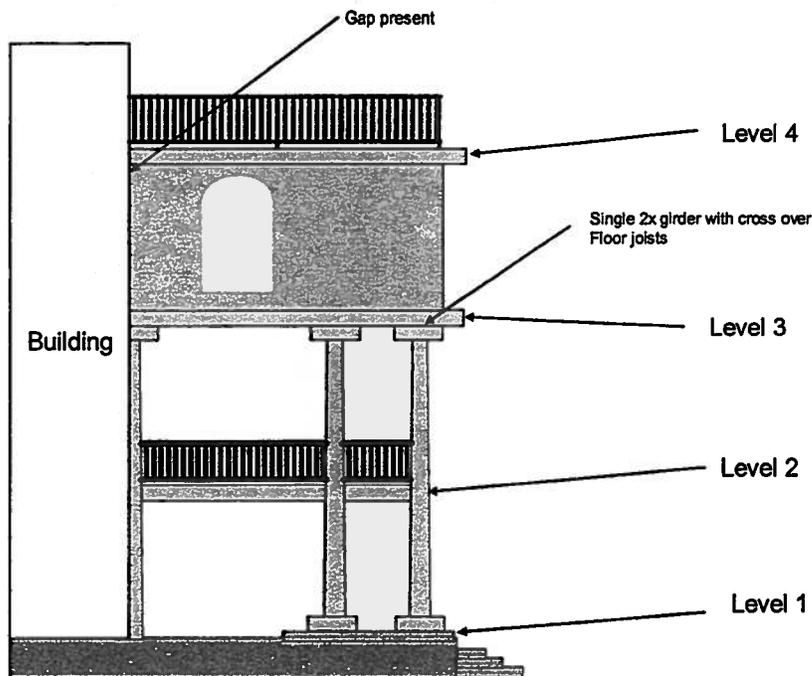
Level four at the building intersection has pulled away from the building structure. New wood scabbed to lengthen joists as well as installation of a new band was previously completed in an attempt to remedy the problem. New deck wood was apparently installed as an attempt to bridge the gap caused by the settling on the outside or street side of the balcony.

Level three has a number of problems that led to the movement of level four, as detailed below:

- Outer girder carrying the floor joist load from column to column is only a single 2-inch member with significant sag between support posts
- Compression of cross-sectional area of each floor joist is present at intersection with single 2-inch girder
- Load bearing center line is located on the outer 1/3 of the columns, not in the center
- Loose water damaged joists were noted
- Outer portion and side of deck above allows water to infiltrate to structure

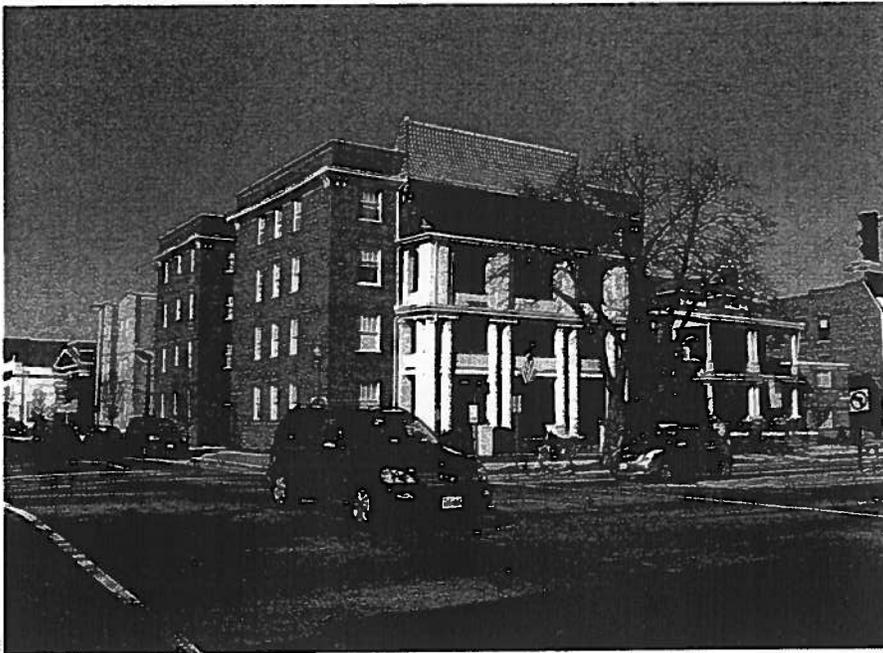
A four story multi-family dwelling located at 22 South Boulevard, Richmond, VA., is experiencing structural shifting/pullout on the top two levels of a four level front side balcony. Building was constructed ~80 years ago, wood-framed with brick facing on all sides. Balcony main entrance level consists of masonry and tile; levels two and three are wood decks and railings. Level four is primary weather covering for the balcony structure constructed of wood with mineral based roofing system and built-in gutter on all three sides. Levels two and three are supported on the street side by ~18 foot wooden tapered columns. Level four is supported by decorative wood framing, with stucco overcoat, from level three.

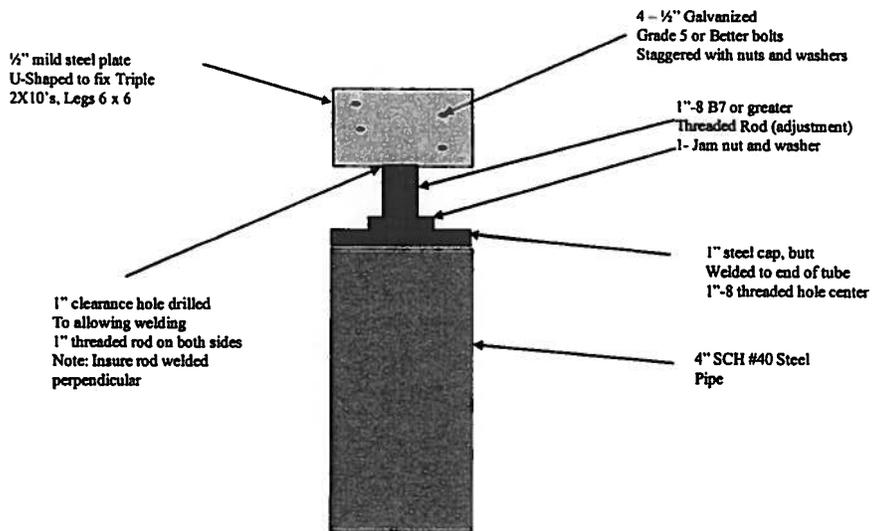
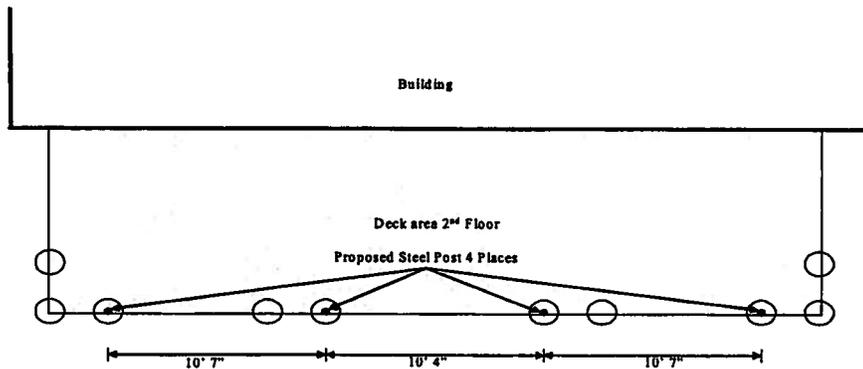
Initial inspection indicated overloading and settling of structural members, side opposite building wall or street side, on levels two and three. As a result, this overload/settlement results in the building side of structure to pull away from building ~ 6 inches at the very top of level four floor.

Both level three and four include floor joists that extend from building structure to street side of balcony. Wood appears to be structurally sound and only minor water damage noted.

- Note:
1. Steel Post 3" Sch #40 x ~17.5'
  2. Post Centered in Pillar
  3. Post to bear on 1/2" 12" x 12" plates at bottom of Pillar
  4. Plate to pipe mount can be field fabricated (I.e. Short coupling) to aid installation

2. Once support posts are in place, install triple 2 x 10 field constructed girder across all four support posts, cantilevering them past post 2 and 7, to support outside load.
