**Commission of Architectural Review**

3. COA-134294-2023	<b>Final Review</b>	Meeting Date: 8/22/2023
Applicant/Petitioner	Amy Xia and Olivia Murphy (JP Exteriors)	
Project Description	Remove existing deteriorating wooden columns and replace them with fiberglass columns.	
Project Location

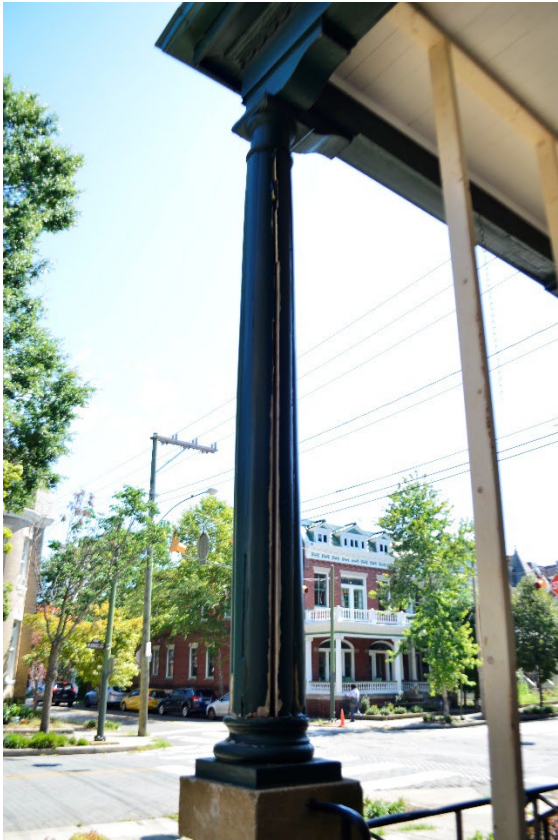
Figure 3. Photograph showing deterioration on the far west column.

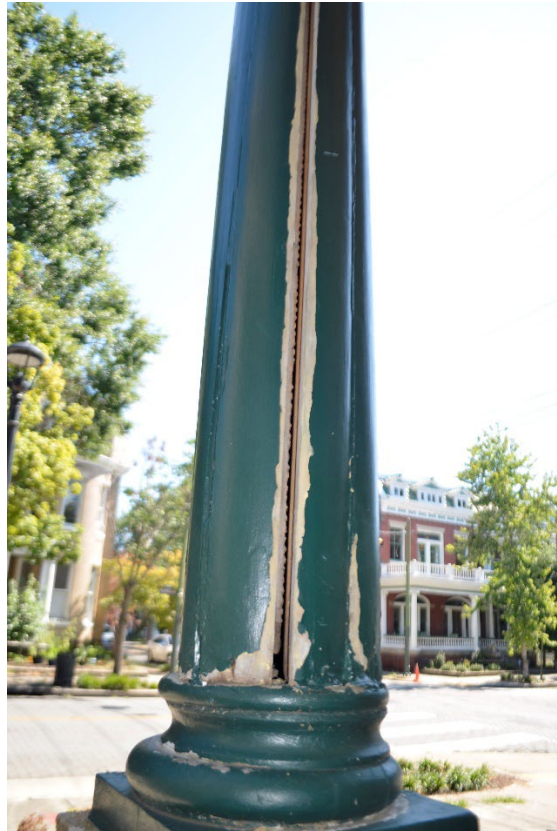
Figure 4. Close-up view of the deterioration on the far west column.

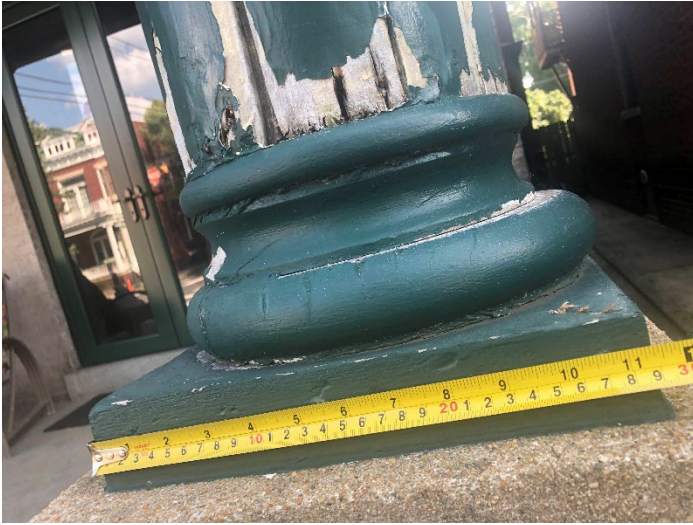
Figure 5. Close-up photograph of deterioration on the base of the far west column.

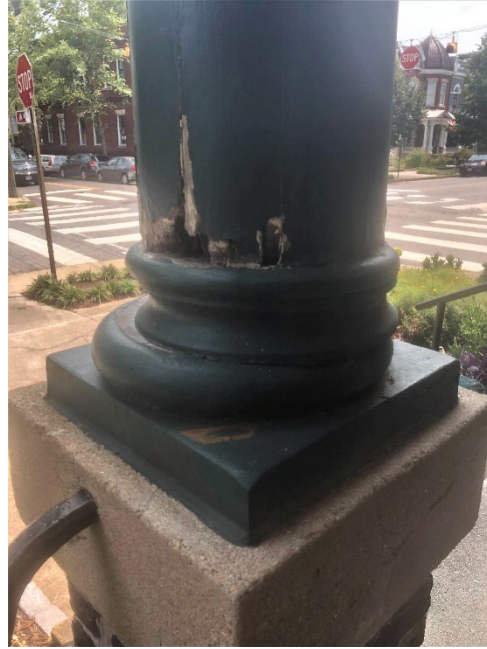
Figure 6. View of deterioration on the second column from the west.

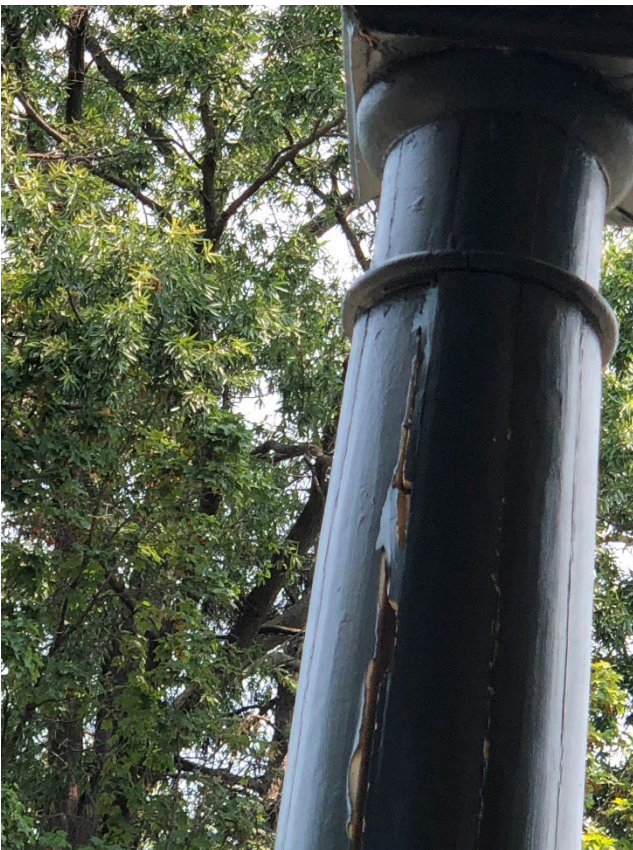
Figure 7. View of deterioration on the far west column.

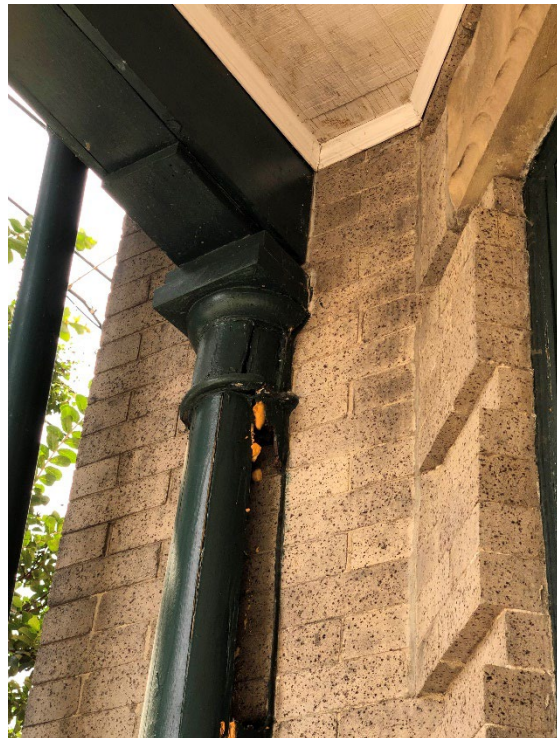
Figure 8. View of deterioration of the top of the east engaged column.

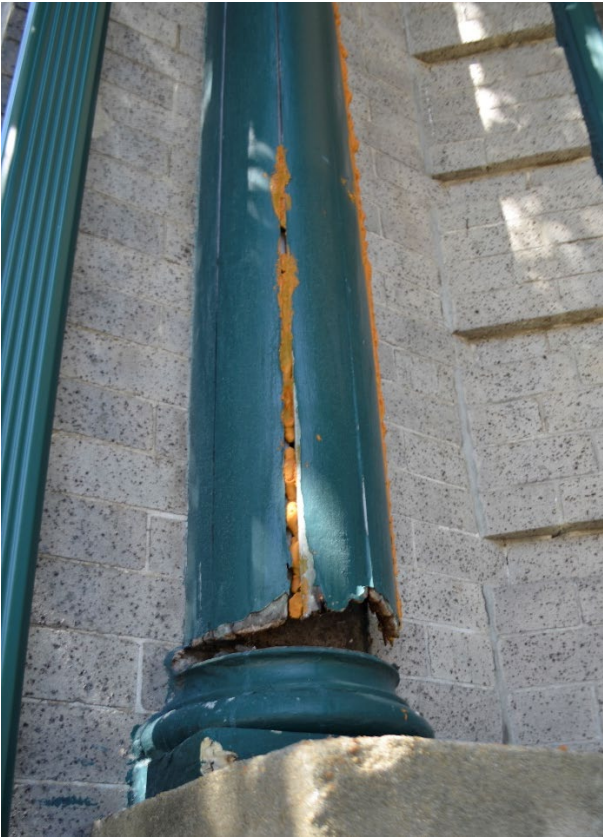
Figure 9. Photograph showing the deterioration of the east engaged column.

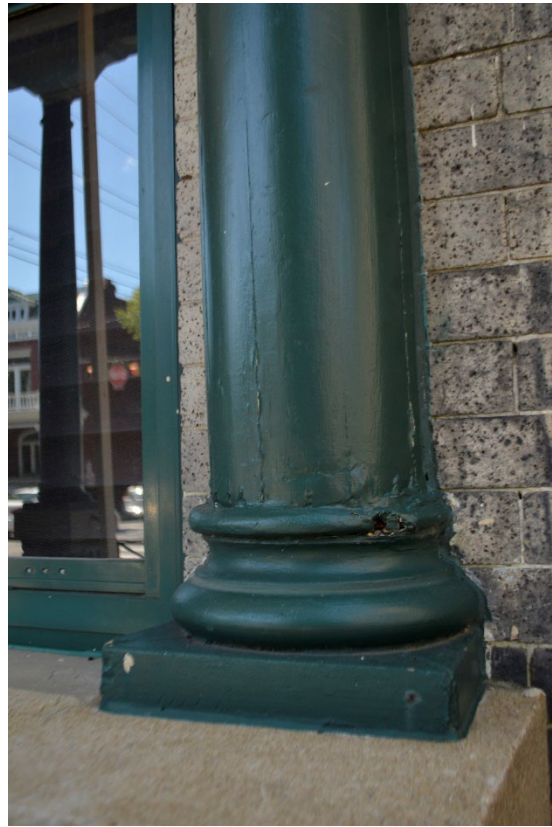
Figure 10. Photograph showing deterioration on the west engaged column.

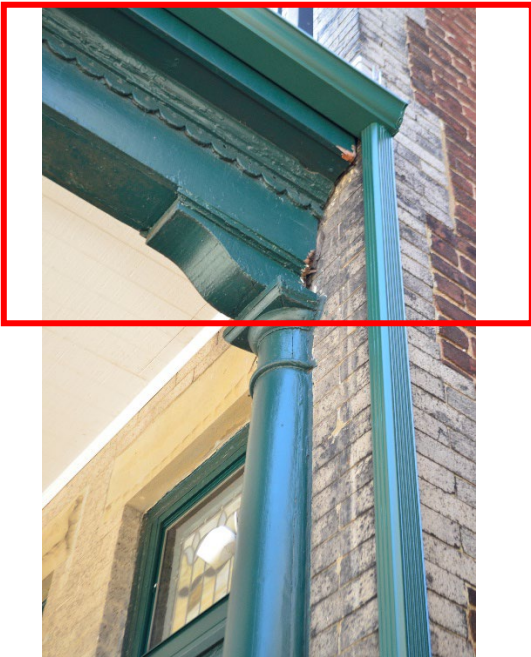
Figure 11. Photograph of deterioration behind the architrave. All elements of the entablature, highlighted by the red box, need to be retained and replaced.
