Commission of Architectural Review

3. COA-134294-2023	Final Review	Meeting Date: 8/22/2023
Applicant/Petitioner	Amy Xia and Olivia Murphy (JP Exteriors)	
Project Description	Remove existing deteriorating wooden columns and replace them with fiberglass columns.	
Project Location

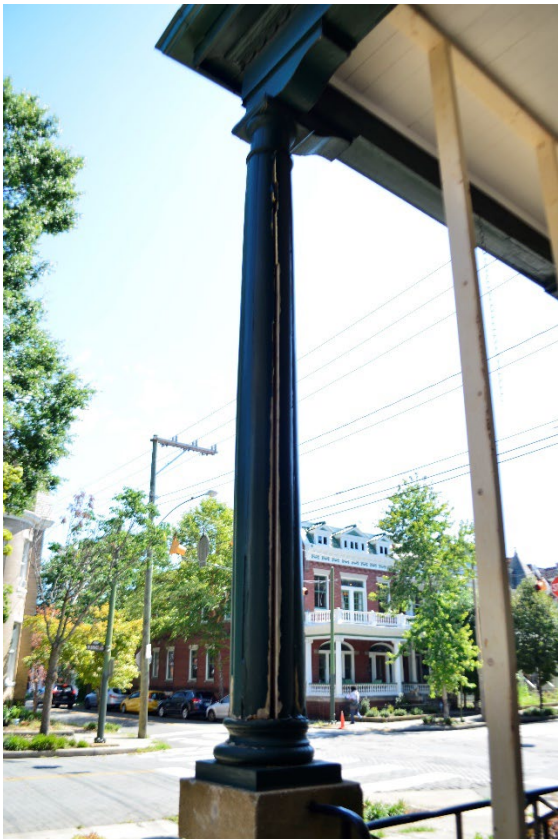
Figure 3. Photograph showing deterioration on the far west column.

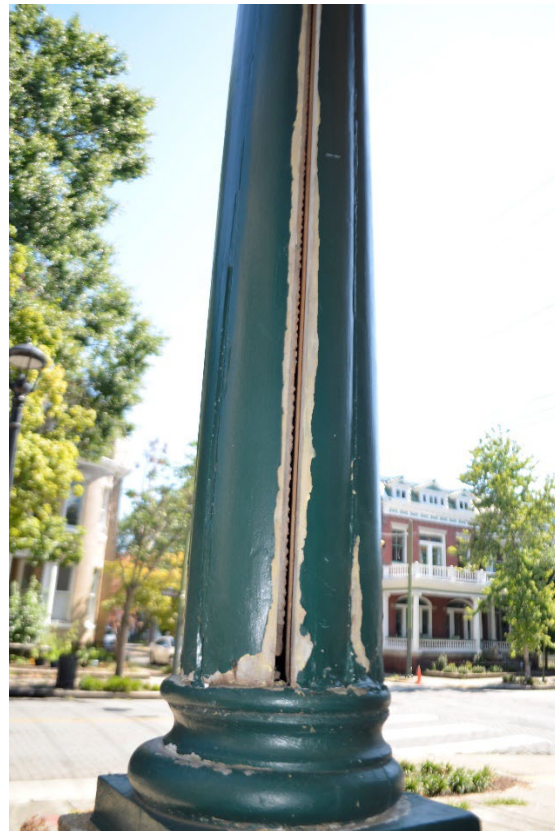
Figure 4. Close-up view of the deterioration on the far west column.

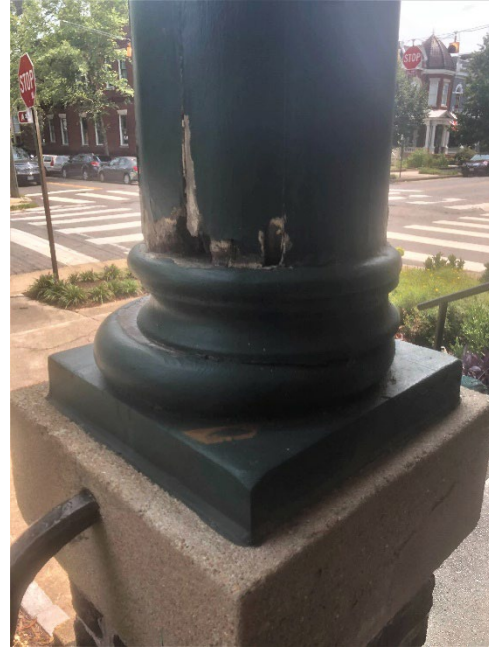
Figure 6. View of deterioration on the second column from the west.

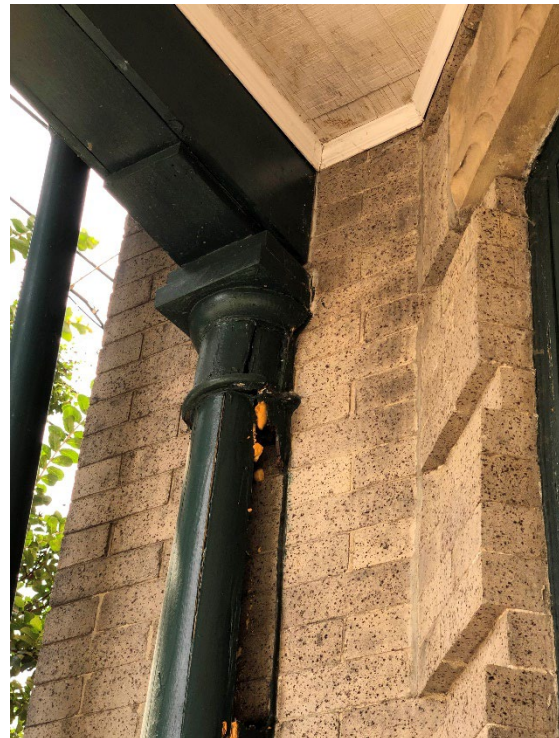
Figure 8. View of deterioration of the top of the east engaged column.

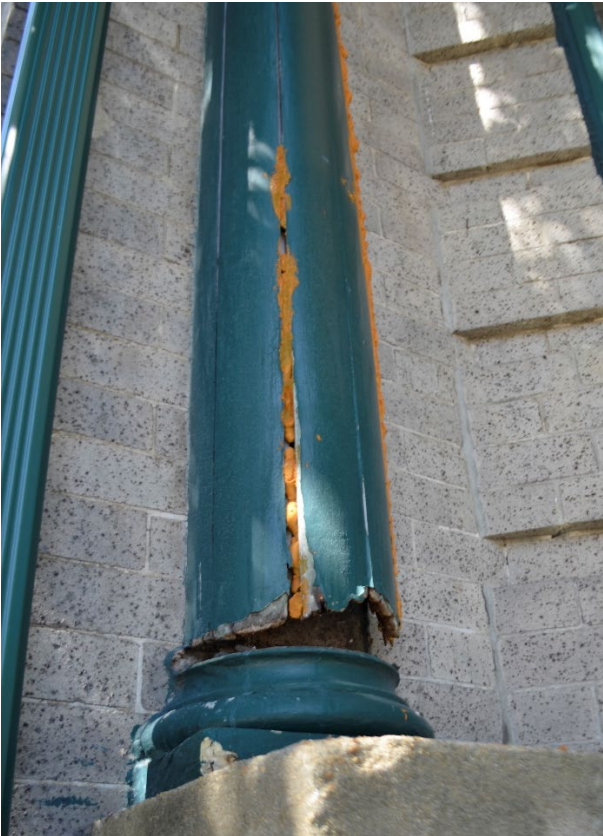
Figure 9. Photograph showing the deterioration of the east engaged column.

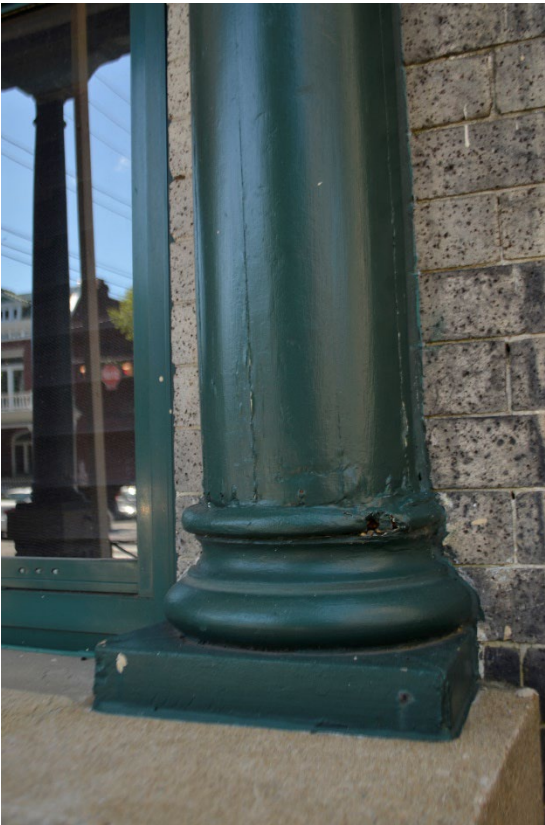
Figure 10. Photograph showing deterioration on the west engaged column.

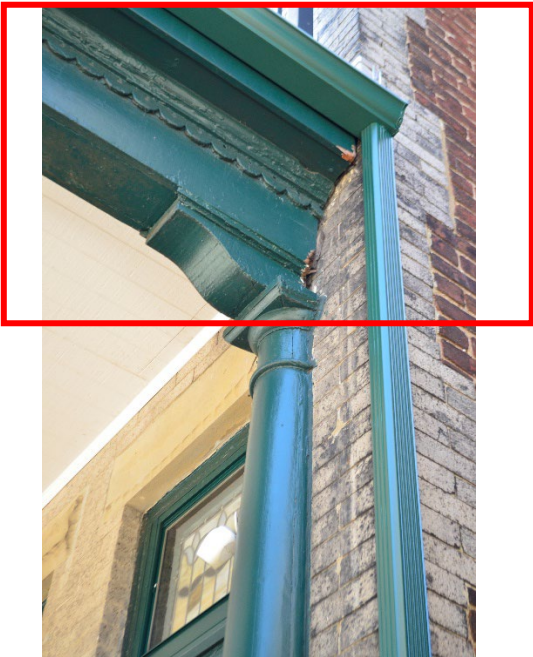
Figure 11. Photograph of deterioration behind the architrave. All elements of the entablature, highlighted by the red box, need to be retained and replaced.
