**COMMISSION OF ARCHITECTURAL REVIEW
STAFF REPORT
August 28, 2018 Meeting**

9. **COA-039802-2018** (L. Lefferts)

**2708-2712 East Broad Street
St. Johns Old and Historic District**

Project Description: Install exterior gutters along the porch cornice and downspouts on the outer bays.

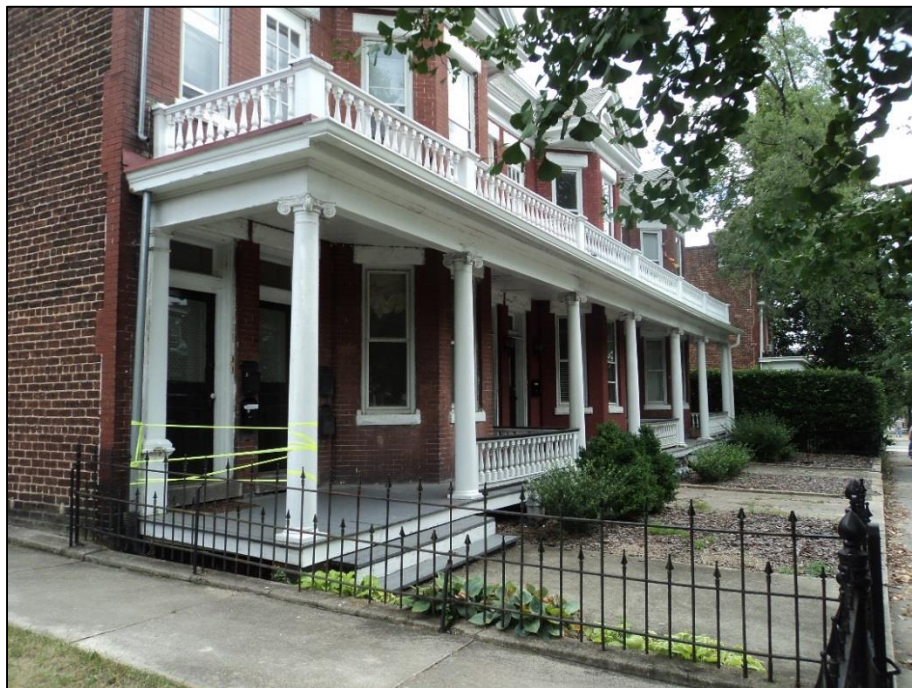
The new gutters appear to be vinyl with plastic downspouts and are installed directly below the porch roof cornice line. The gutters project past the cornice line at either end of the porch roof. At the outer bay of 2712 East Broad a downspout was installed on the front of the outermost column.

2708 - 2712 East Broad, New Gutters.

The *Guidelines* note that repair (pg. 91, #3) including membrane lining (pg. 66# 8) should be undertaken as part of preventative maintenance. Based on the profile of the porch roof, Staff believes that box gutters might be present on the porch roof. The *Guidelines* recommend that leaky box gutters should be lined with membrane roof (pg 66, #8). Staff recommends that if box gutters are present, they should be repaired, including lining with a membrane, and the newly installed exterior gutters be removed.

The *Guidelines* also state that suspended gutters should be attached at the eaves with spikes or straps and that the straps should be fastened under roofing materials not on the roof surface (pg. 66, #9). Staff recommends that if box gutters are not present that the current gutters be replaced with a less visually intrusive model, such as a half round, and that the downspout and gutter on the column of the outer bay of 2712 East Broad Street be moved to a less visible location.

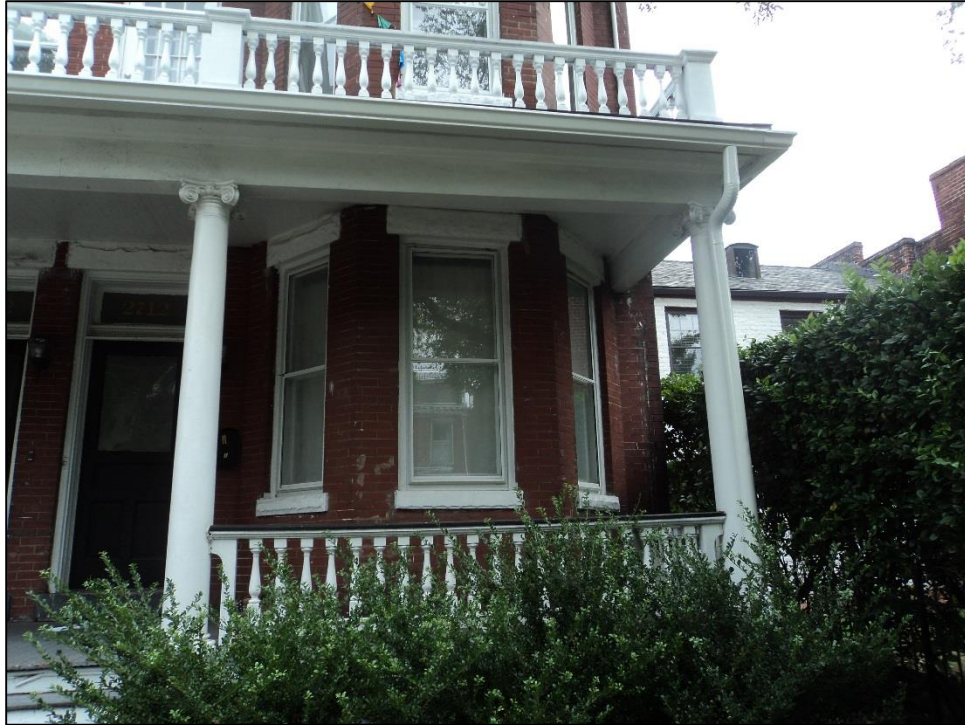
2712 East Broad Street, New Downspout.
