# AFTER-ACTION ASSESSMENT REPORT

FEBRUARY 2025

City of Richmond  
900 E Broad Street  
Richmond, VA 23219

HNTB Corporation  
2900 S Quincy Street  
Suite 600  
Arlington, VA 22206

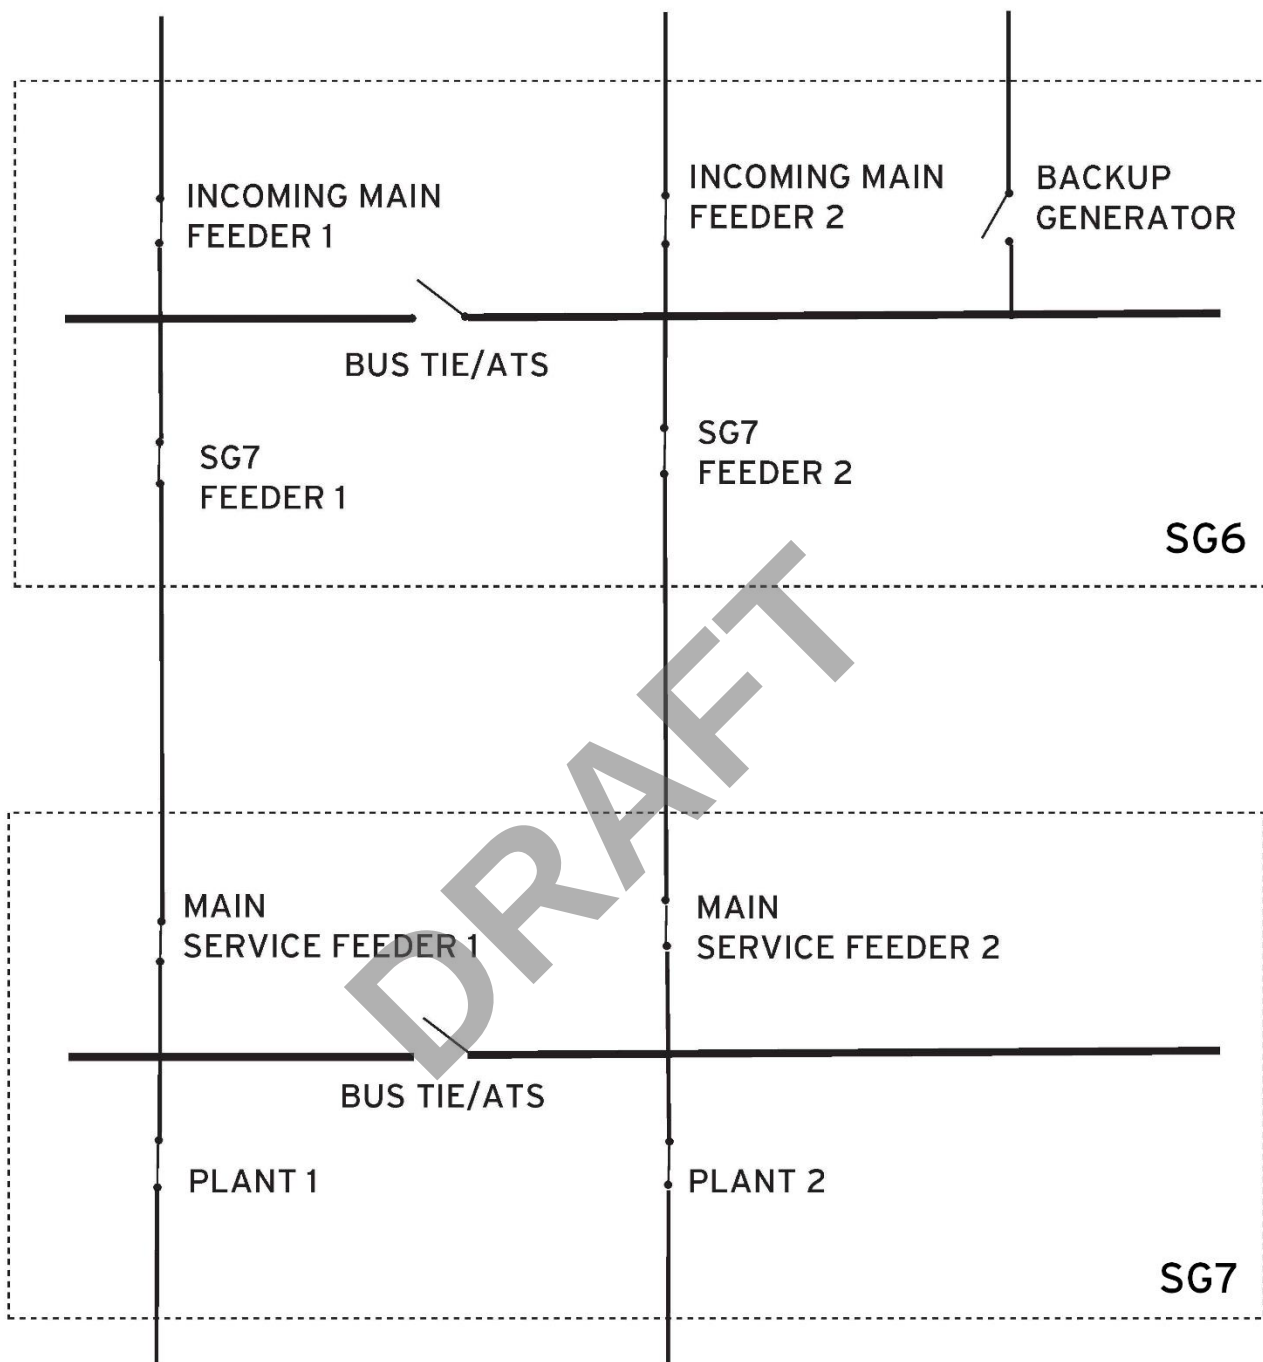
**Figure 3. Switchgear SG 6 and SG 7 Summer Mode**

Switchgear SG 6 and SG 7 are operated in one of two modes of operation: Summer Mode or Winter Mode. An illustration of Summer Mode in Switchgear SG 6 and SG 7 is shown in **Figure 3** and an illustration of Winter Mode in Switchgear SG 6 and SG 7 is shown in **Figure 4**. Summer Mode mitigates the risk of a complete WTP power outage when one (1) of the Main Feeders loses power. The Agastat Relay closes the bus tie switch between sides of the switchgear. Summer Mode also allows the Bus Tie/ATS in SG 7 to function as a spare for the Bus Tie/ATS in SG 6. If the Bus Tie/ATS in SG 6 fails to close on loss of a feed, then the Bus Tie/ATS in SG 7 would close and maintain power to the entire WTP. Winter Mode is utilized to take advantage of less expensive power from Main Feeder 1 but requires the Bus Tie/ATS in SG 6 to operate to restore power to the WTP when Main Feeder 1 loses power. When operating in Winter Mode, the Bus Tie/ATS in SG 6 becomes a singular critical component with no redundancy.

- Operate the WTP in Summer Mode all the time or at least during storm events that have risks of power outages (DPU has indicated that this has been implemented as the normal operating mode moving forward).

Furthermore, this mode of operation allows the Bus Tie/ATS of SG 7 to be operated as a redundant system for the Bus Tie/ATS in SG 6. (Note: Some modification may need to be made to the switchgear(s) to allow for redundant operation. Operation manuals for SG 6 and SG 7 were not available to verify if any modification would be required.) Having a redundant switchgear Bus Tie/ATS substantially mitigates the risk of a primary power failure.

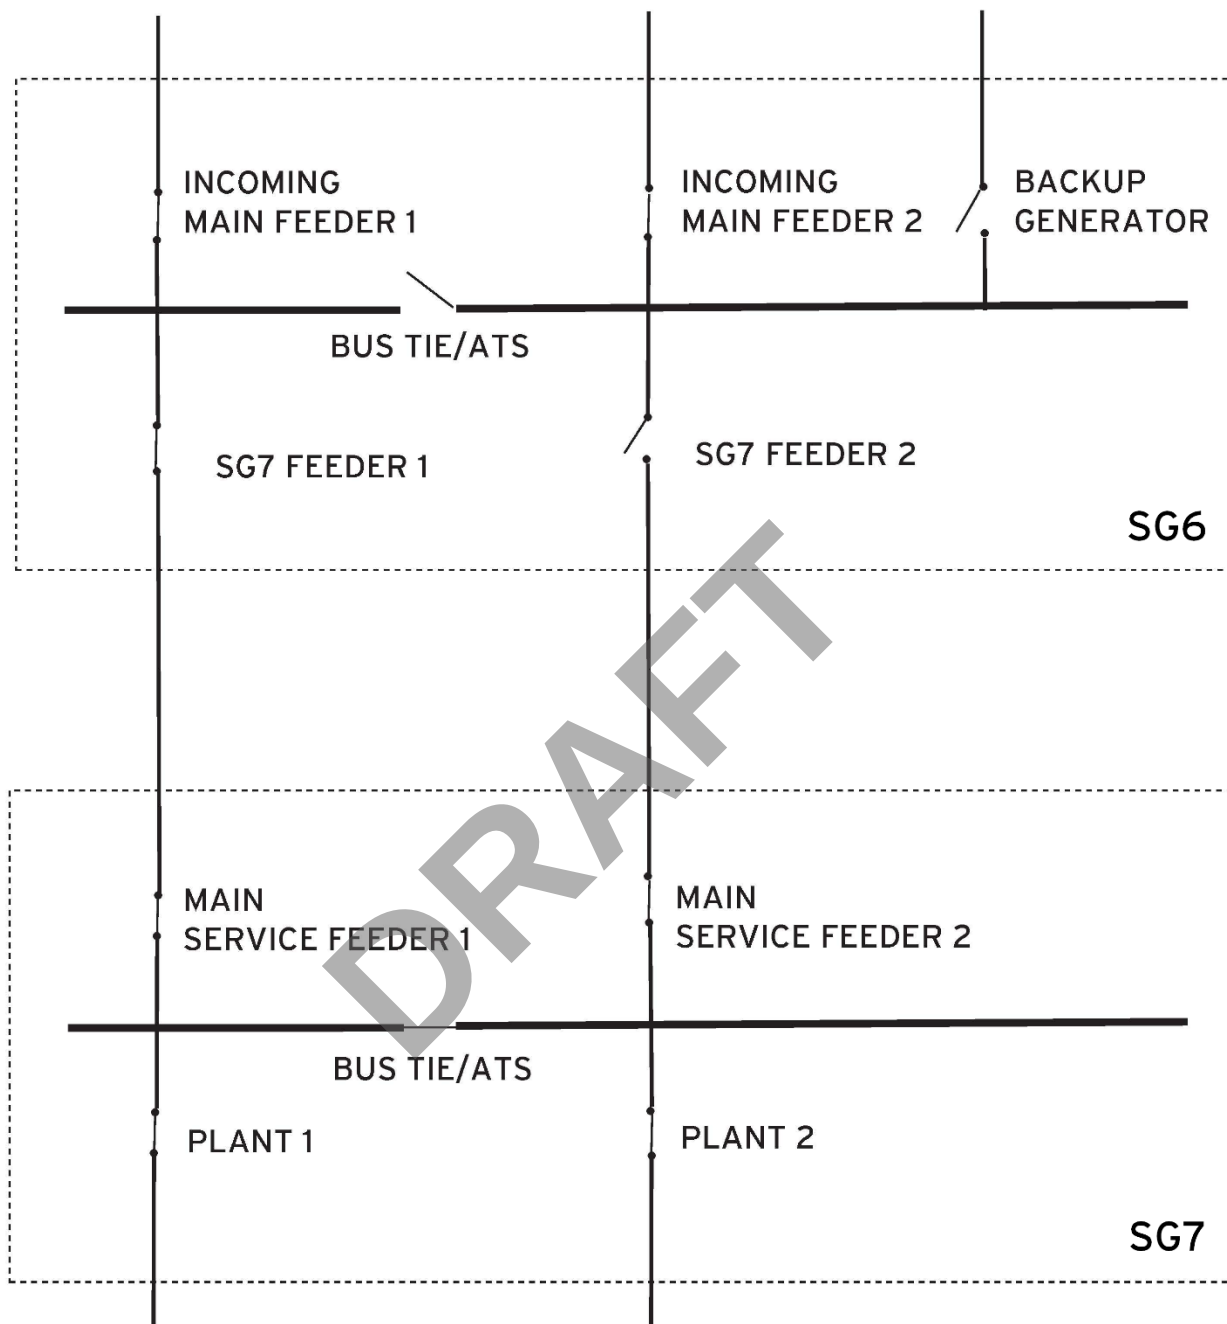
**Figure 4.** Switchgear SG 6 and SG 7 Winter Mode

The WTP was in Winter Mode operation of the switchgear system, and this put the WTP at risk because the SG 6 Bus Tie/ATS becomes a singular critical component. Given the risk, an SG 6 Bus Tie/ATS failure plan should have been attached to the SG 6 Bus Tie/ATS Cabinet and electrical staff trained on its content. If an electrical staff member had been on site during the power failure, then completing a manual transfer as detailed in a failure plan may have prevented the basement water from reaching the critical electrical systems. Once the electrician did arrive on site, they spent time assessing the situation and restoring power via a manual transfer, but it is unclear if they were trained to complete the transfer because the manual transfer was not completed until the electrical supervisor arrived on site.

as the root cause. The WTP was operating in Winter Mode, so the Bus Tie/ATS in SG 6 was a singular critical component. The failure of the Bus Tie/ATS in SG 6 to automatically transfer from Main Feeder 1 to Main Feeder 2 because a coil in the Bus Tie/ATS failed was determined to be the root cause of the event. If this Bus Tie/ATS worked as intended, the WTP power supply would have been switched over to Main Feeder 2, which still had power at the time of the failure. While this failure was determined to be the root cause, operating in Winter Mode put the WTP at greater risk. Had the WTP been operating in Summer Mode, at minimum Plant 2 still would have had power or the Bus Tie/ATS in SG 7 would have worked as intended and the WTP power supply would have switch over to Main Feeder 2. In addition, the above concerns regarding the basement flooding and dewatering, power systems, control systems, staffing, training, operating procedures, asset management, maintenance, and communication all contributed to the escalation of the event at the WTP on January 6. These factors revealed several concerns and opportunities for improvement regarding operation of the WTP to mitigate the risk of a similar event occurring again.
