# City of Richmond After-Action Assessment Report

April 7, 2025

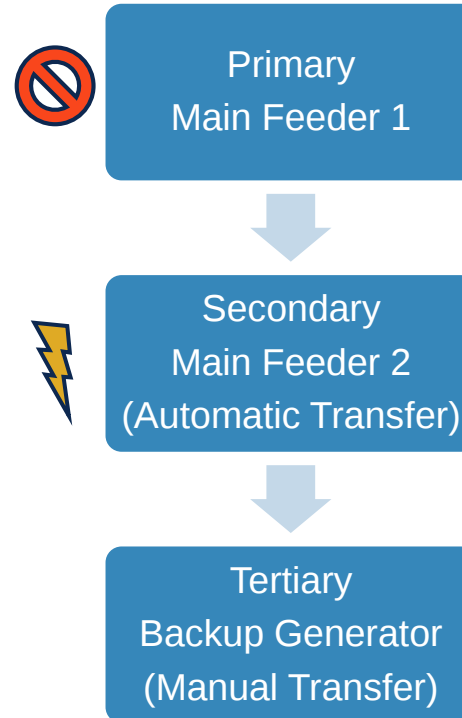
## Winter Mode of Operation

- Winter Mode puts the WTP at greater risk. Bus tie in SG 6 becomes singular critical component.
- Close coil in SG 6 bus tie cabinet failed (root cause of event).
- UPS did not close filter effluent valves.
- Existing UPS units were undersized and had additional loads placed on them.

- Code requires WTP facilities have two (2) power sources, a primary and a backup.
- Richmond WTP has two (2) feeds from Dominion Energy that serve as primary and backup.
- Backup generators are a tertiary and manual power supply source.
  - Intended to be used when both power feeds are out.
  - Main Feeder 2 still had power, so first step was to transfer power to that that feed.

- Operate the WTP in Summer Mode at all times.
- Develop a bus tie failure plan, ensure all electrical staff are properly trained on the plan, and clearly display the plan on each bus tie cabinet.
- Provide a filter effluent valve UPS with a parallel duplicate backup UPS in each plant; sizing and operation to meet requirements of Chapter 7 of the VA Electrical Code for legally required systems.
- Provide automatic transfer system for the existing backup generator system.
