I hope this email finds you well. I have spent quite a bit of time trying to master the window survey and put the rest of the pieces together so that we can move forward with the exterior renovations for 504 N. 29th St.

# Window Survey

504 N 29<sup>th</sup> St.

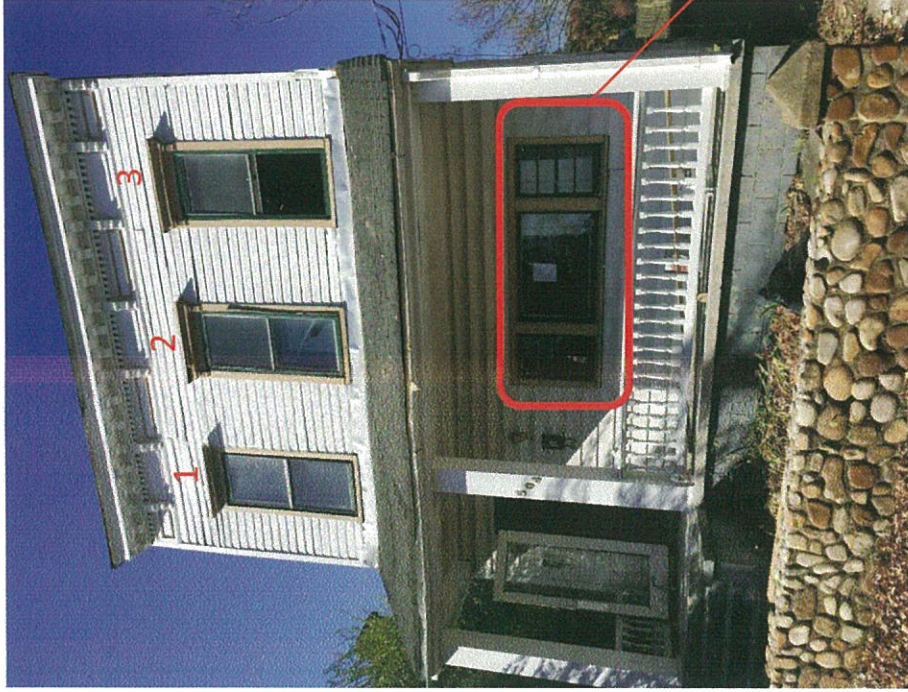
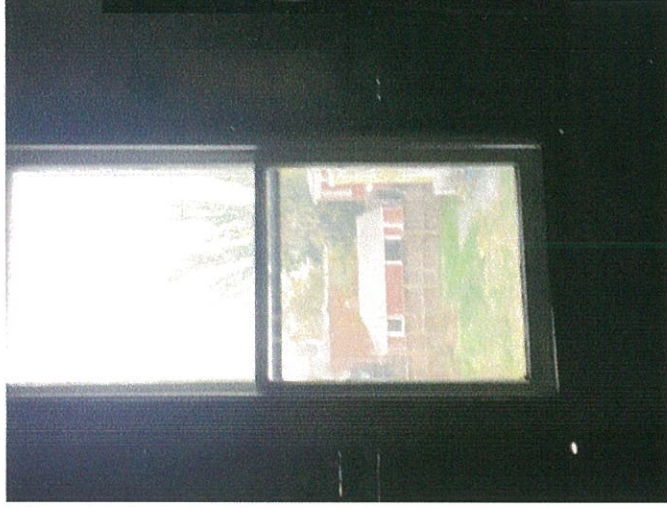
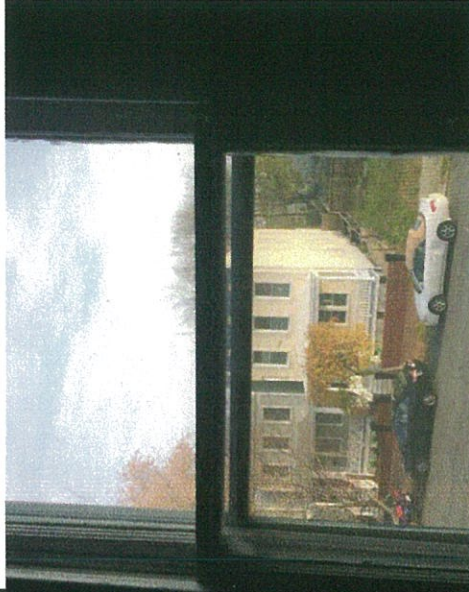
1 – this window has many gaps that allow daylight and air in, the window does not close, there are no locks

These windows are not original and will be replaced with 2 separate 1 over 1 panel windows, already approved.

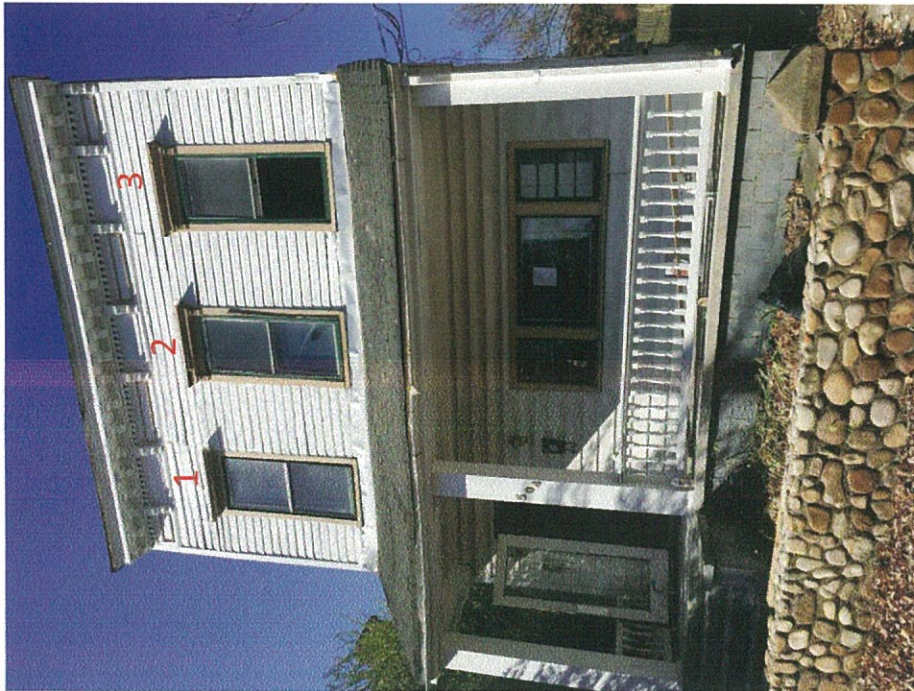
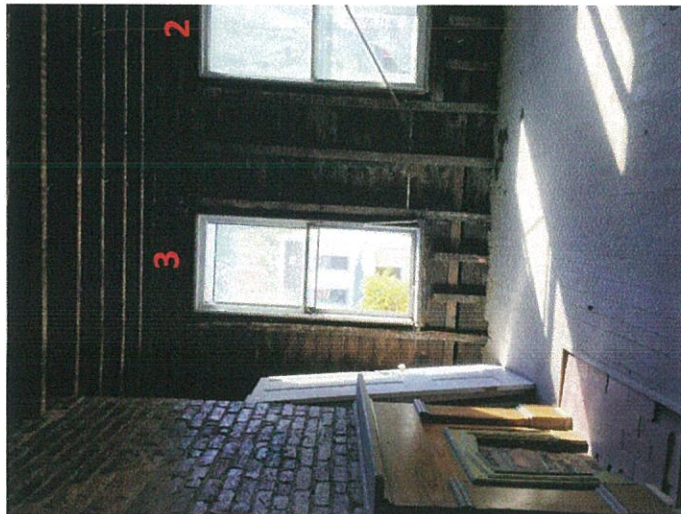
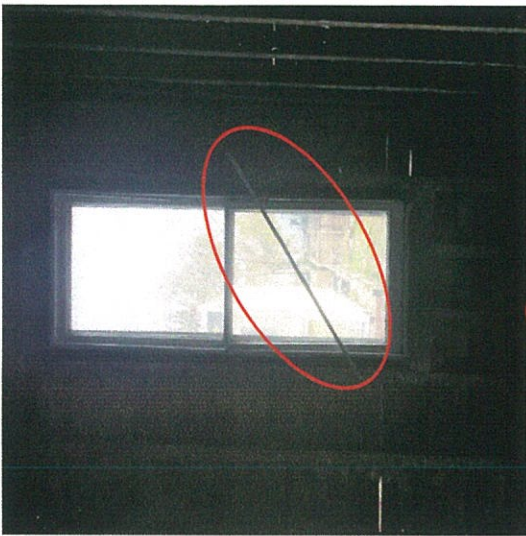
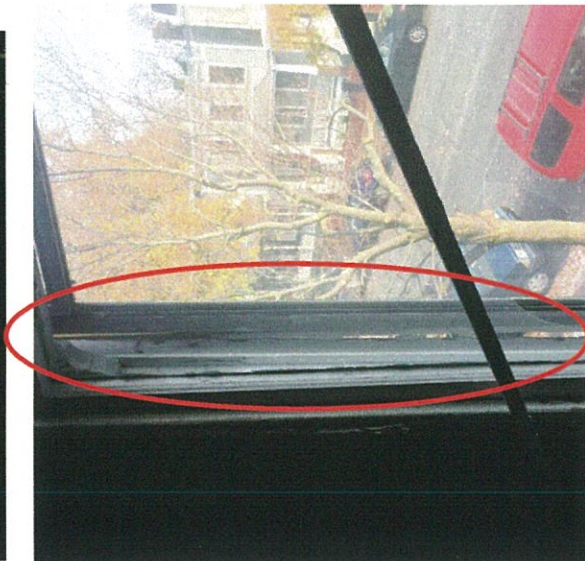
2 – this window is currently being held in place by the piece of wood shown in the picture due to the damage of this window. There are many gaps allowing outside air in.

-I have attached the window survey. Due to the extensive damage to the mix of original and non-original windows, we are requesting to replace all windows with wood, 1 over 1, replacement windows.

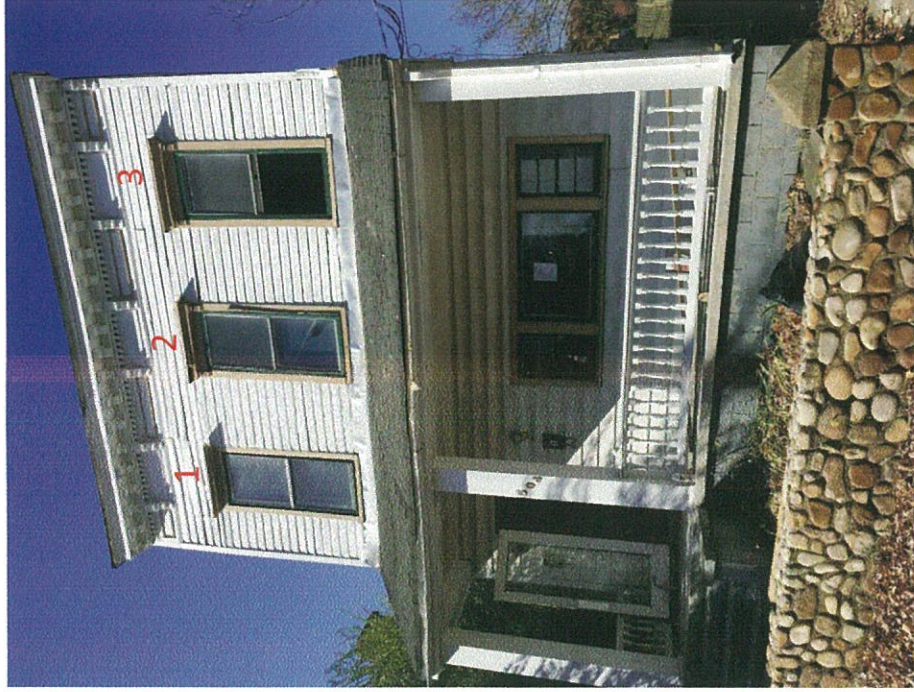
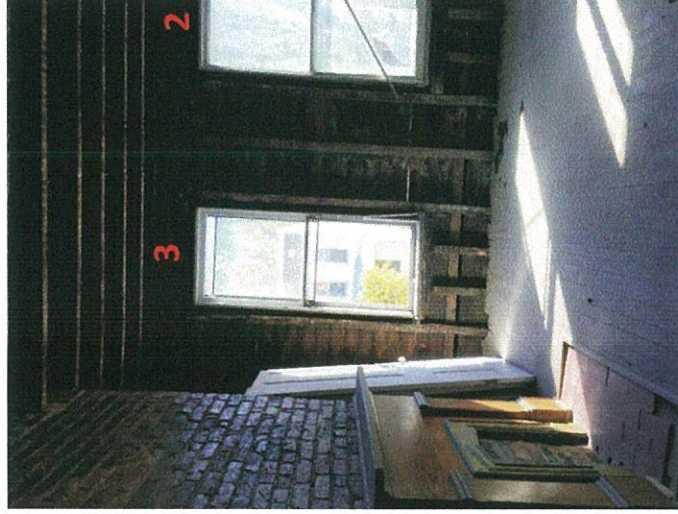
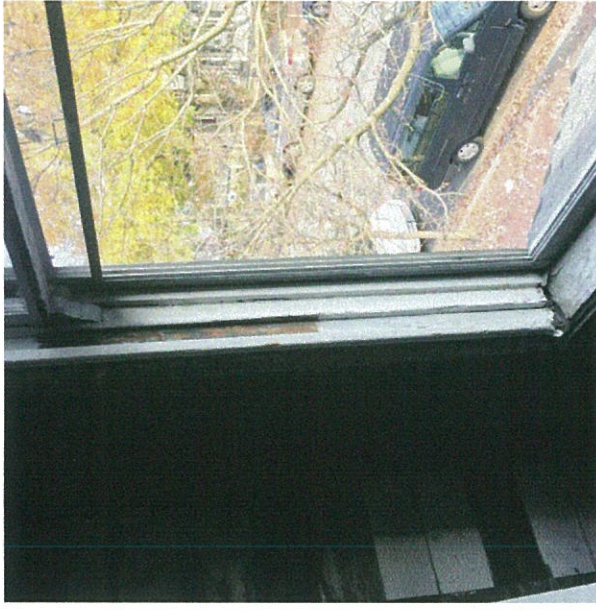
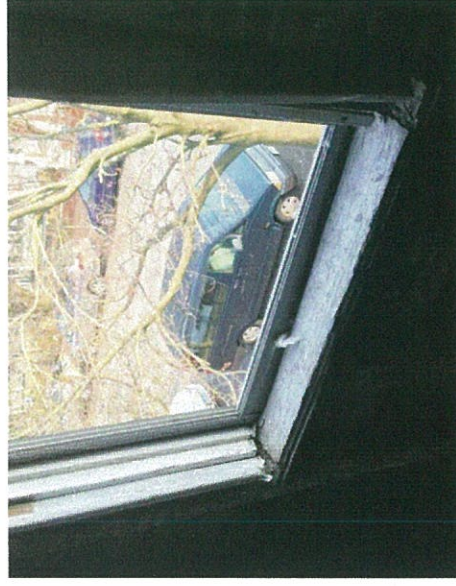
3 – this window is missing the lower pane; the wood has rotted, the screens are off track/wrong size

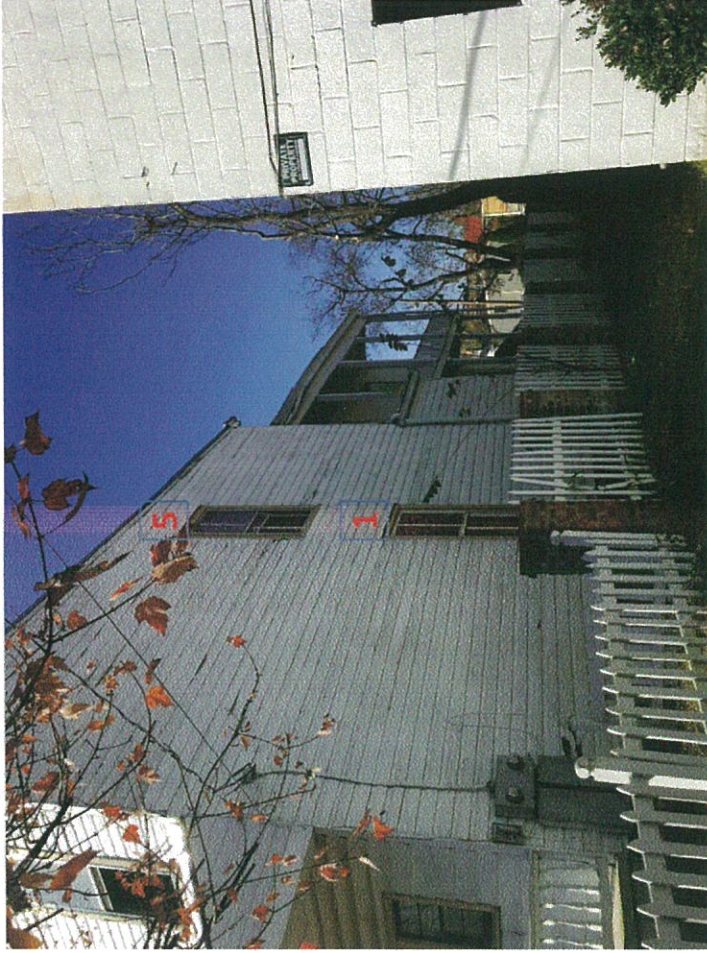
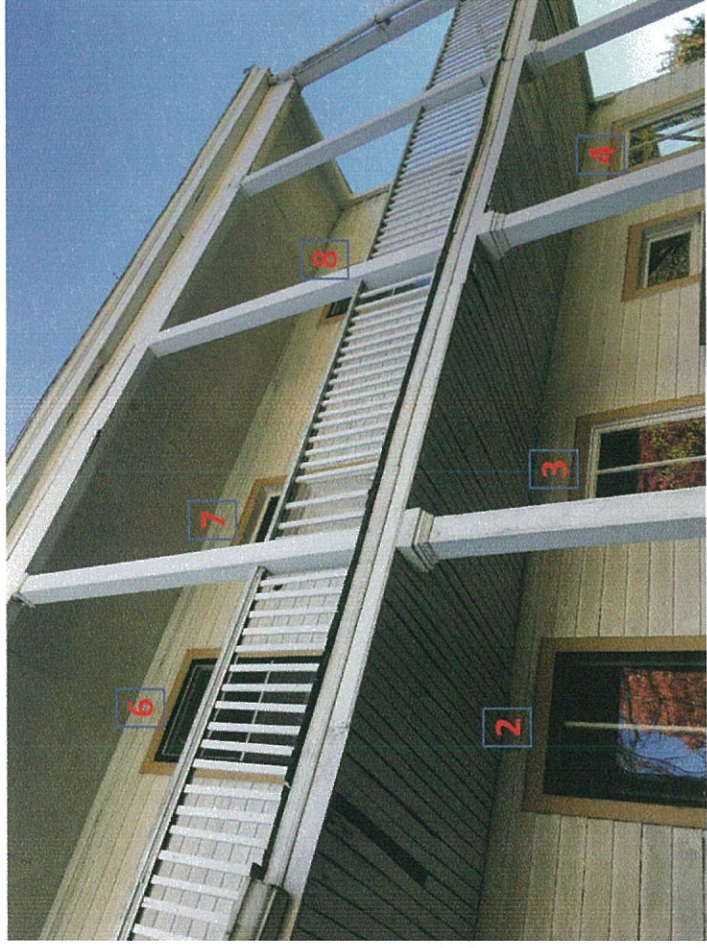
Notice that lower level windows on this side of the home are 2 over 2 panel design which are not original.  
Please reference window #s on this page for next pages

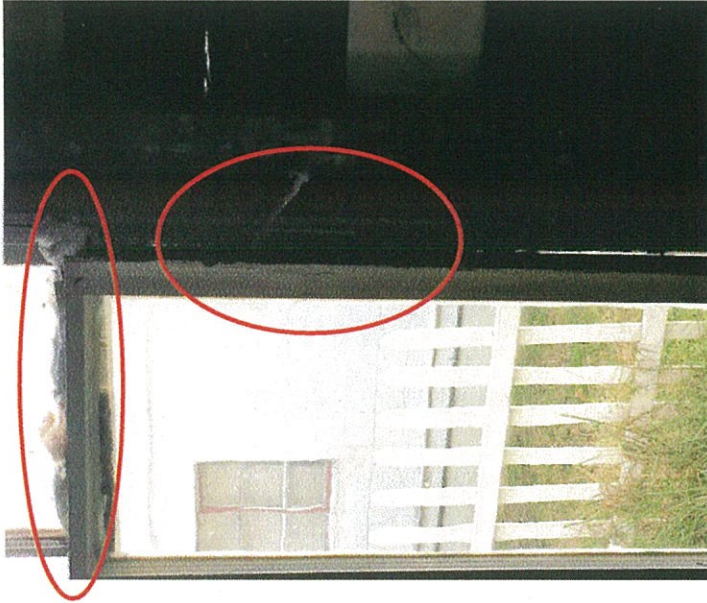
Windows 2-3 are not original (2 over 2 design); the windows are inoperable as evidenced in these pictures by cotton and foam insulation and nailing the windows in place and closed; the weight systems are also missing or inoperable due to missing weights

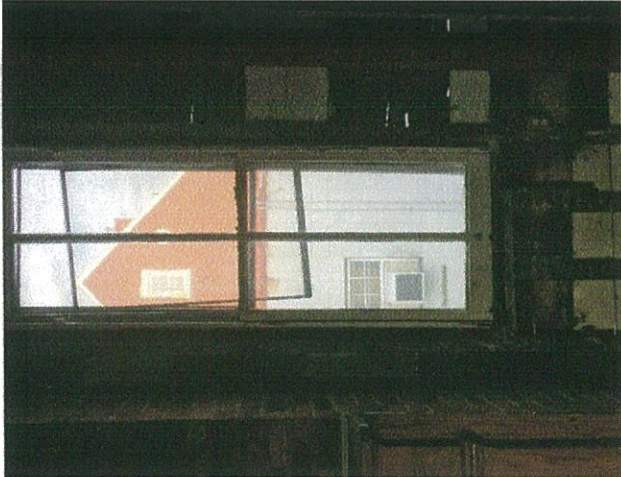
Windows 5 & 7-3 are not original (2 over 2 design); the windows are inoperable with several gaps, #7 has been modified to include a mirror as the base panel, #6 is nailed shut, #8 doesn't close, weights system no longer exists on 5,6,8

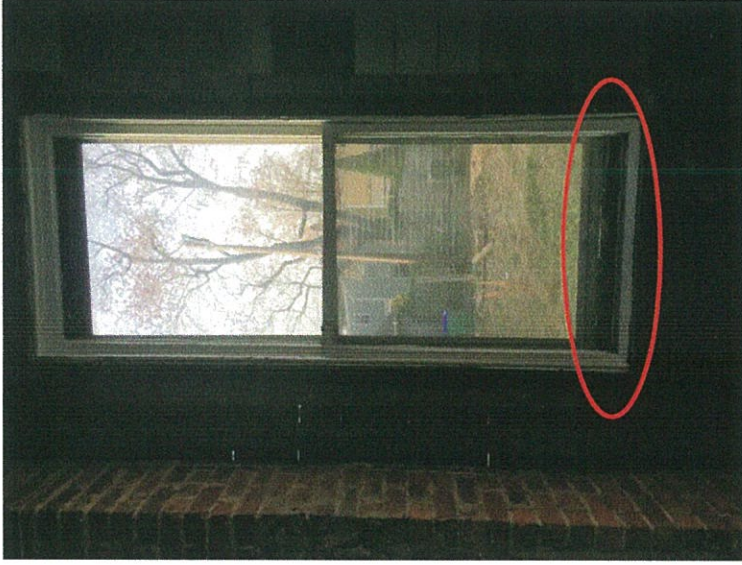
Rear window 1 has severe rot at the bottom pane and has been nailed shut with no latch in place, window 2 no longer has a weight system

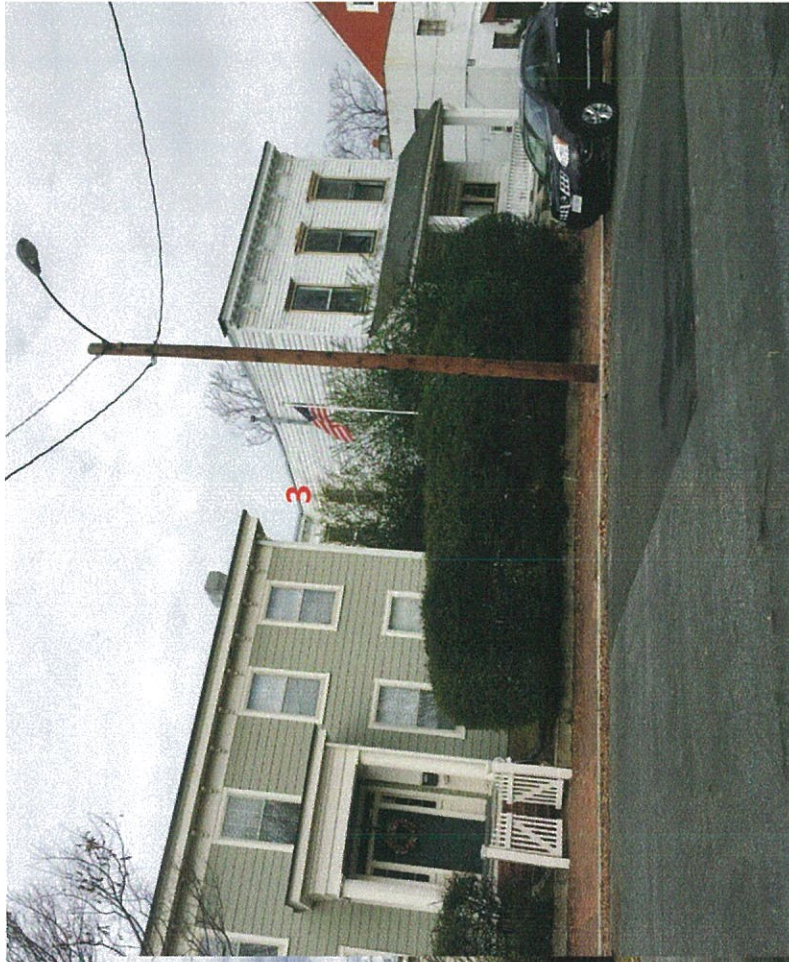
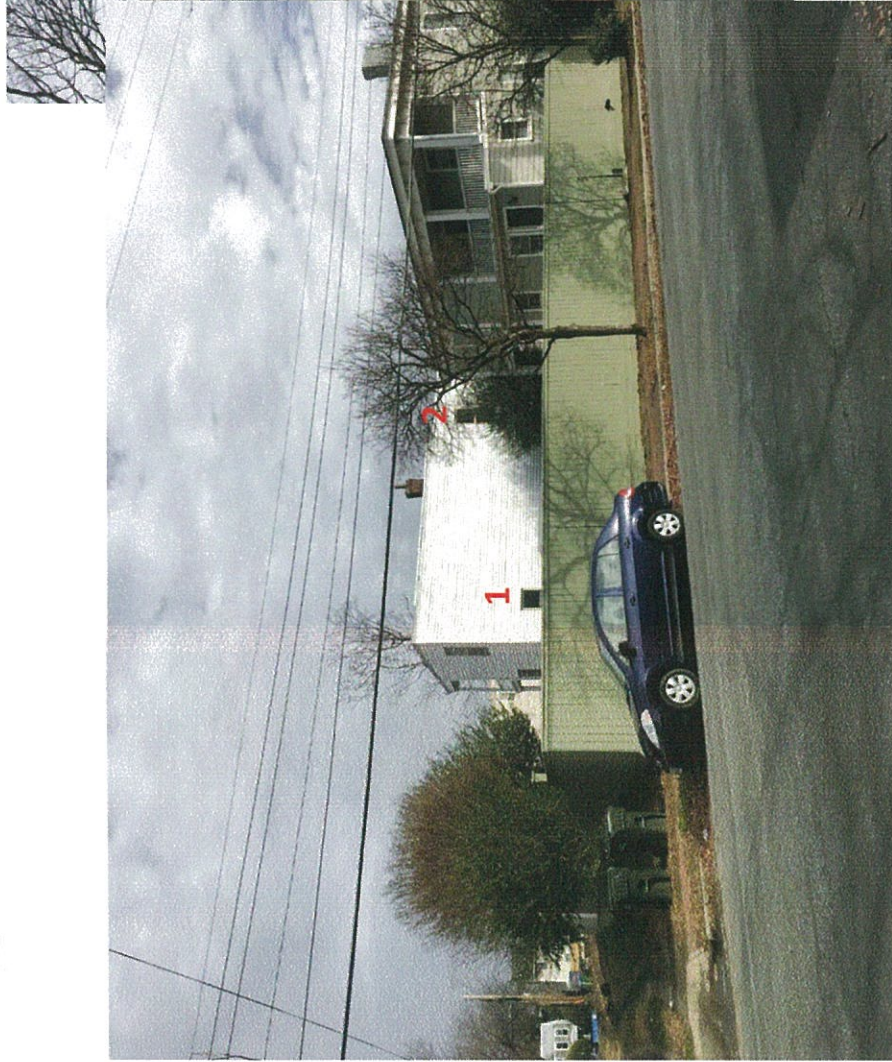
**Left side** — The view of this side of the home is obstructed by the neighboring home. This side must also be protected with a fire wall due to it being on the property line of the neighboring home.

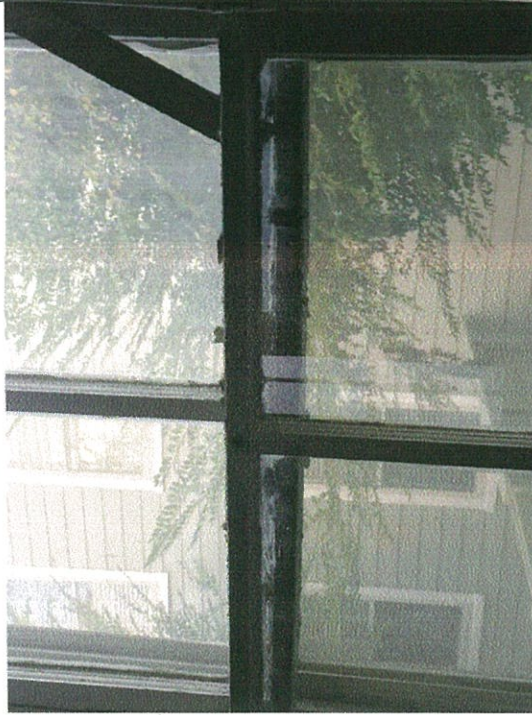
#1 window is inoperable and is being held together by a nailed piece of wood

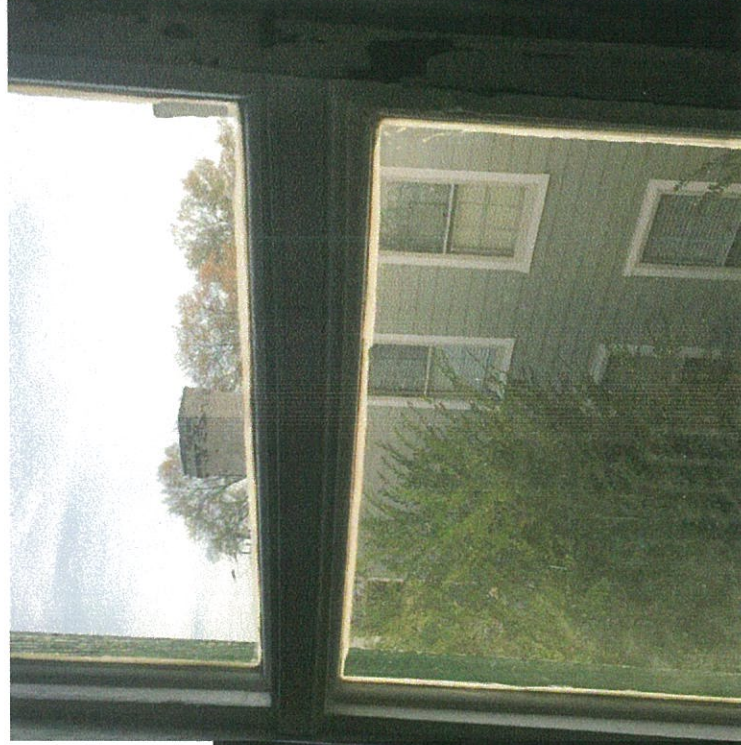
#2 window does not open

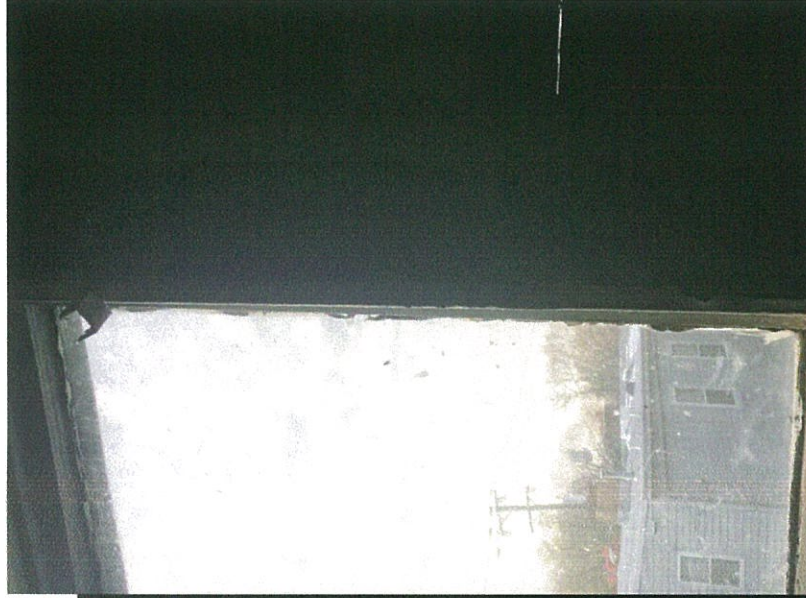
#3 window does not open and has rotted
