# Commission of Architectural Review

8. COA-164459-2025	Final Review	Meeting Date: 5/27/2025
Applicant/Petitioner	Austin Farrell	
Project Description	Result of a violation: Replace original, deteriorated roofing with a new material.	
Project Location		
Address: 510 West 20 <sup>th</sup> Street		
Historic District: Springhill		
High-Level Details: <p>The applicant requests retroactive approval to replace an original hand-seamed metal roof with asphalt shingles, and a front porch roof with a standing-seam metal roof.</p> <p>The existing building is a frame, Colonial Revival, American Foursquare with a hipped roof, full-width front porch, and bb-siding ca. 1925.</p> <p>This work was completed without first obtaining a Certificate of Appropriateness and a building permit.</p>		
Staff Recommendation	Denial	
Staff Contact	Alex Dandridge, alex.dandridge@rva.gov, (804) 646-6569	
Previous Reviews	<p>This application was scheduled for review by the Commission at the April 2025 meeting; however, was withdrawn due to an administrative error.</p> <p>A Notice of Violation and a Stop Work Order was posted to the property in March 2025 after the work had already been completed.</p>

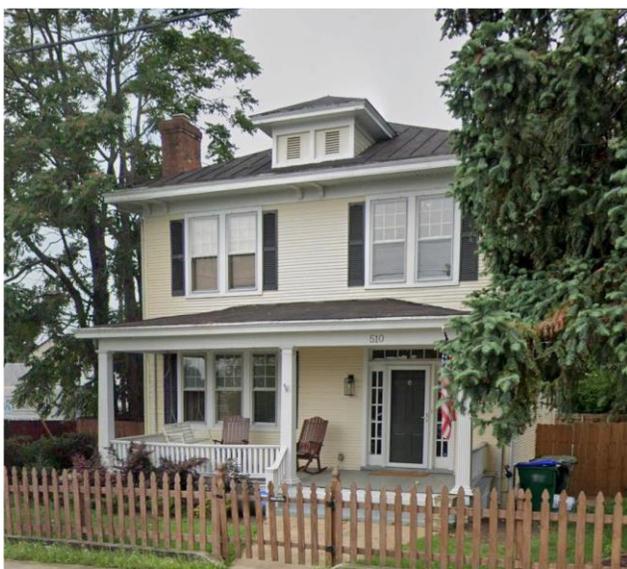
Guideline Reference	Reference Text	Analysis
Standards for Rehabilitation, Residential	<i>Retain original metal features such as cast iron porches and steps, metal cornices, roofs, roof cresting, window sash,</i>	The building originally featured a hand-seamed metal main roof, and a porch roof that was likely a terne coated

Figure 1. Previous condition of 510 W. 20th Street.

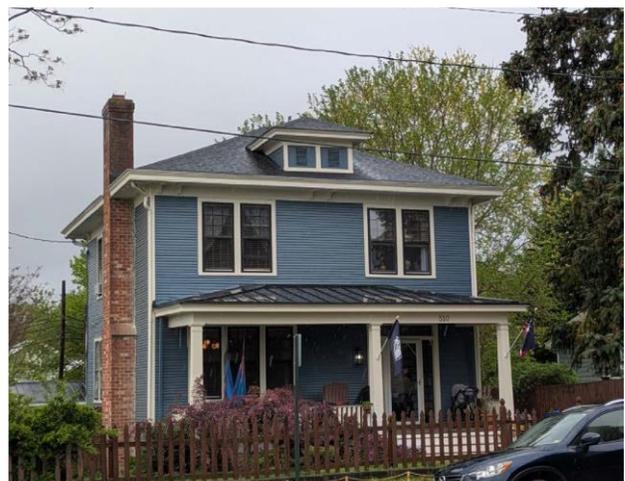
Construction, #3, pg. 59	<i>entablatures, columns, capitals, window hoods and hardware and the color and finish of all original materials.</i>	metal, but most recently appears to have been a rolled, or membrane roofing.  Both roofs have been replaced. The main roof now features asphalt shingles, and the front porch roof, standing-seam metal.
Building Elements, Roofs, Roof Replacement/  Reconstruction, #3 pg. 6	<i>Substitute materials may be used if the same kind of material is not technically feasible because the material is no longer being made. Substitute materials should match the original style and form as much as possible.</i>	Asphalt shingles are not an appropriate substitute material for hand-seamed metal roofing as standing seam metal roofing is still produced today and asphalt shingles do not accurately portray the visual qualities of a standing-seam metal roof.  <u>Staff finds that the replacement of the original metal roof with asphalt shingles is not in-keeping with the guidelines and recommends denial of this alteration for the reasons stated above.</u>

Figure 2. Existing condition of 510 West 20th Street.

Staff Recommendations	Staff recommends denial of the proposed/installed roofing materials as the guidelines suggest that the roofs should be replaced with materials that match the original.

Building Elements, Roofs, Roof Repair, #'s 5 & 6 pg. 66	<i>5. The historic front and rear porches of many historic Richmond houses - particularly in the Jackson Ward and St. John's Church Old and Historic Districts- have shallow pitched metal roofs with flat seams (also called flat-lock seams). Flat seam metal roofs have a more homogenous appearance than the more typical standing seam metal roofs found on steeper slopes of the main roof.</i>	At appears that the front porch roof was replaced with a standing-seam metal roof. While the exact material of the original front porch roof is unknown, it appears that it had a flat/homogeneous appearance. The new metal roof that was installed creates shadow lines and a profile that was not previously present, and perhaps never present, on the front porch.  <u>Staff recommends denial of the replacement of the front porch roof with standing-seam metal.</u>  The roofs should be replaced with materials that match the original in design and material.

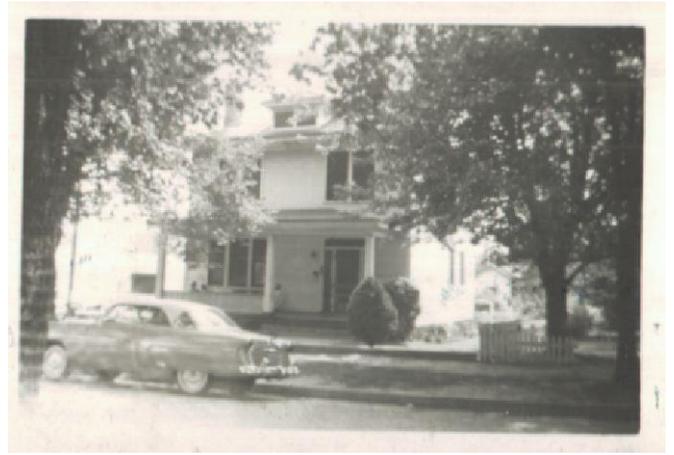
Figure 4. 510 W. 20th Street, 1950s

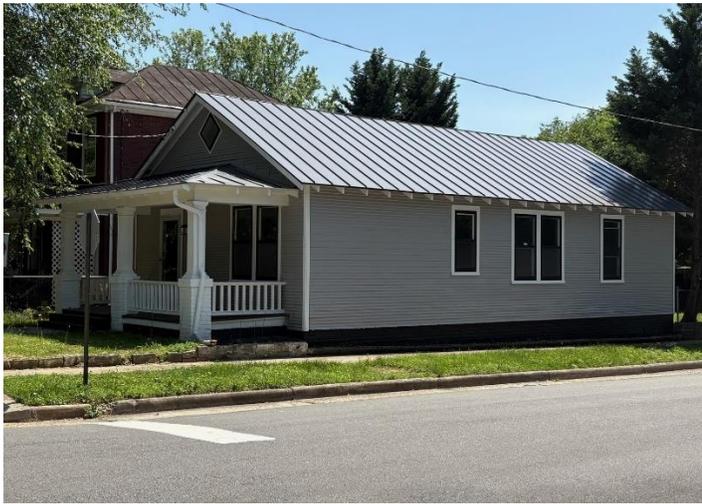
Figure 5. Recently replaced metal roof in district.

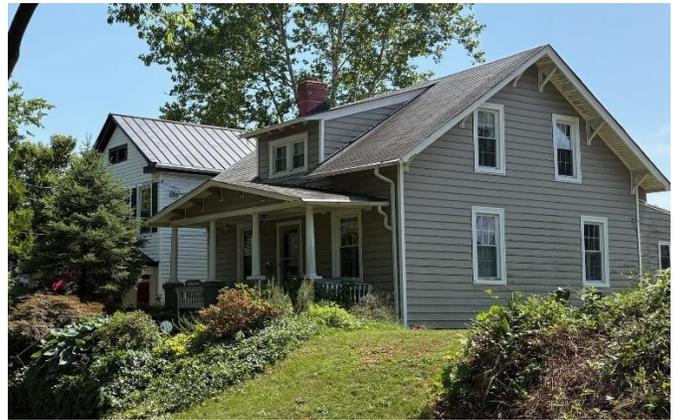
Figure 6. Recently replaced metal roof, and an existing asphalt shingle roof installed pre district designation.
