Commission for Architectural Review

Application for Certificate of Appropriateness

Address: 529 Mosby Street
Union Hill
Historic District: _____

Conceptual review to determine the status of the existing dwelling at 529 Mosby Street.

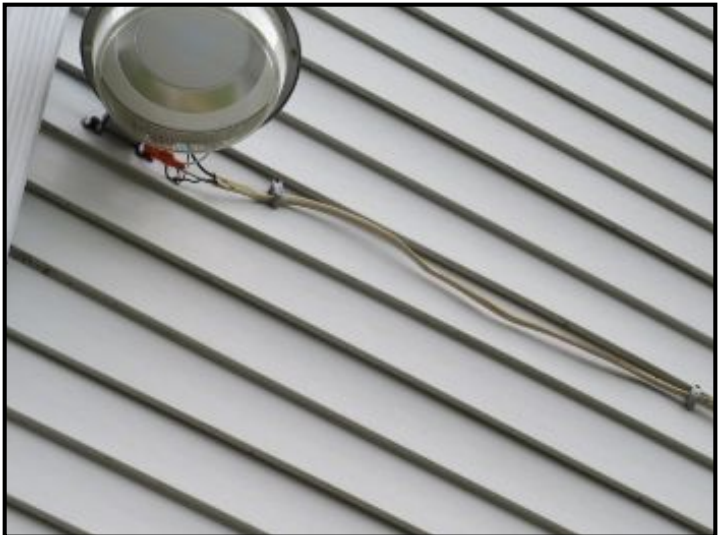
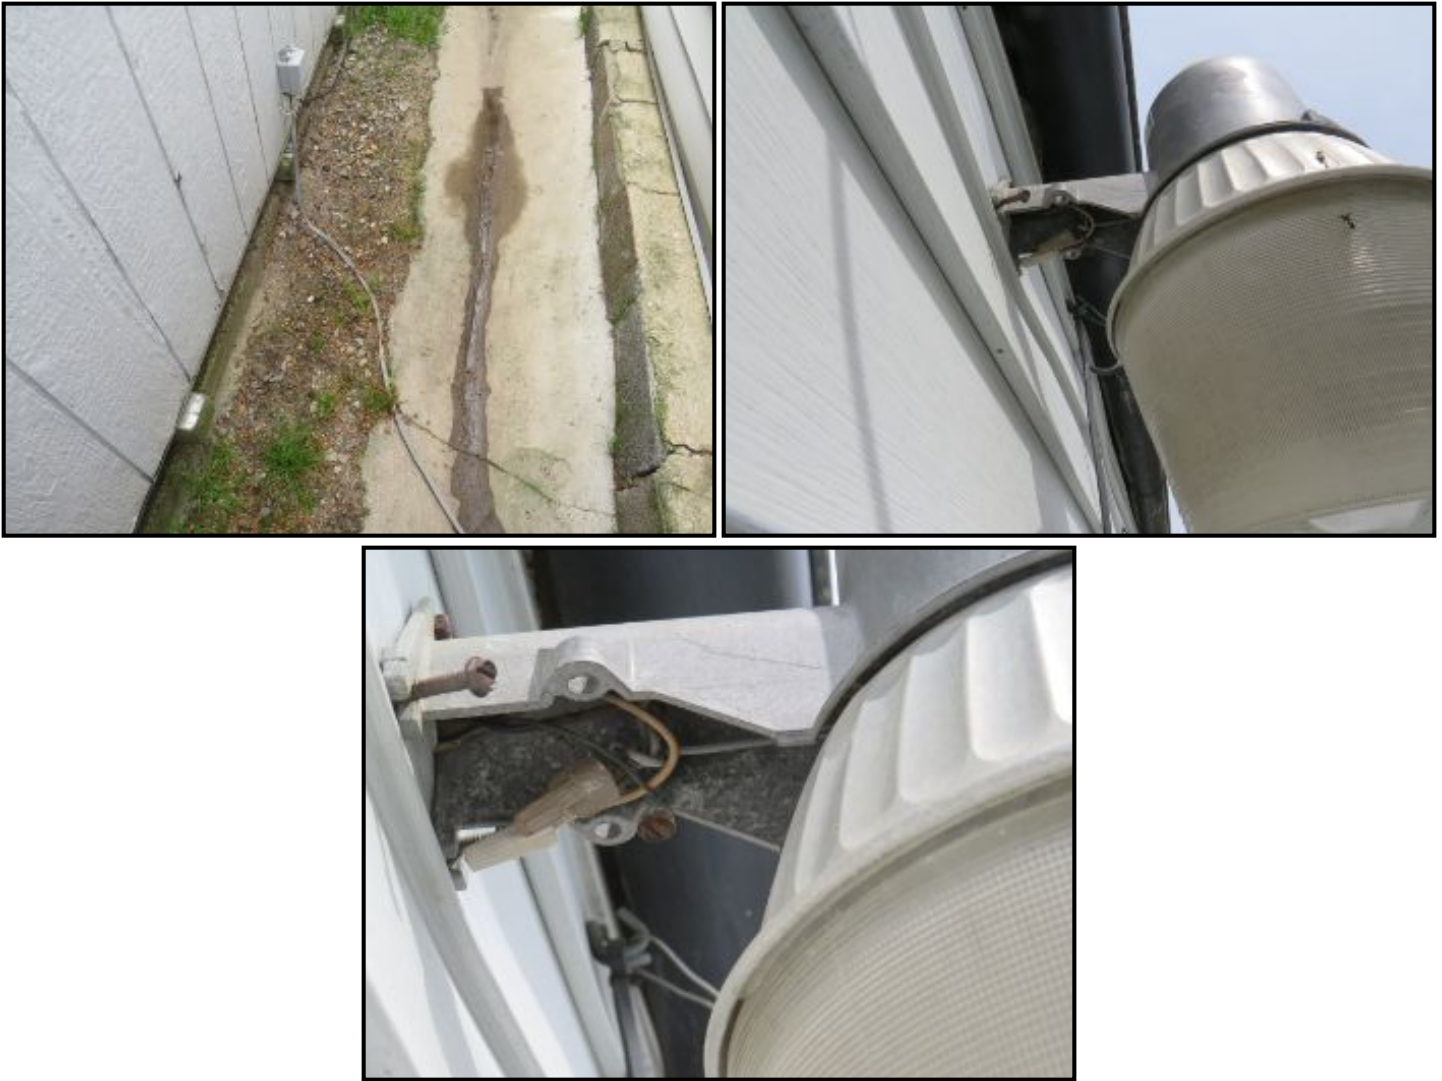
- Interior grade Romex should be replaced with exterior-rated Romex and enclosed in conduit.
- Connections made outside of a Junction Box, which is a potential shock or electrocution hazard.

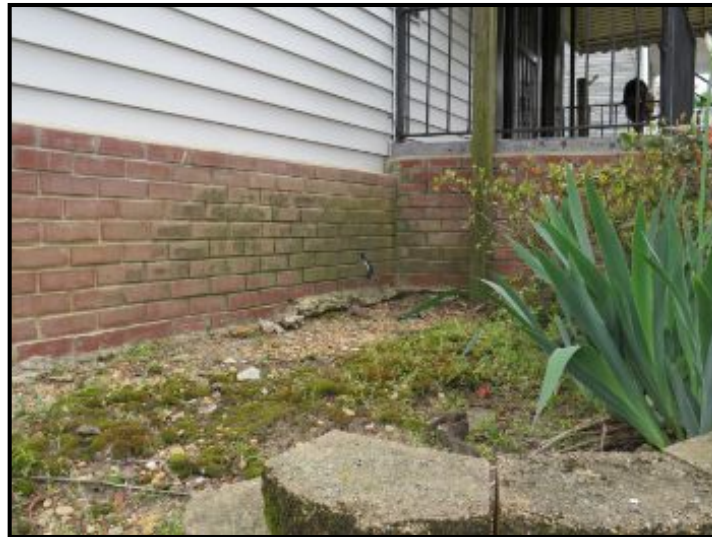
- Lot grading and drainage have a significant impact on the building, simply because of the direct and indirect damage that moisture can have on the foundation. It is very important, therefore, that surface runoff water be adequately diverted away from the home. Lot grading should slope away and fall a minimum of one (1) inch every foot for a distance of six (6) feet around the perimeter of the building.
- There are some low spots along the foundation. Recommend adding additional backfill to create the proper slope away from the house to allow for effective drainage.

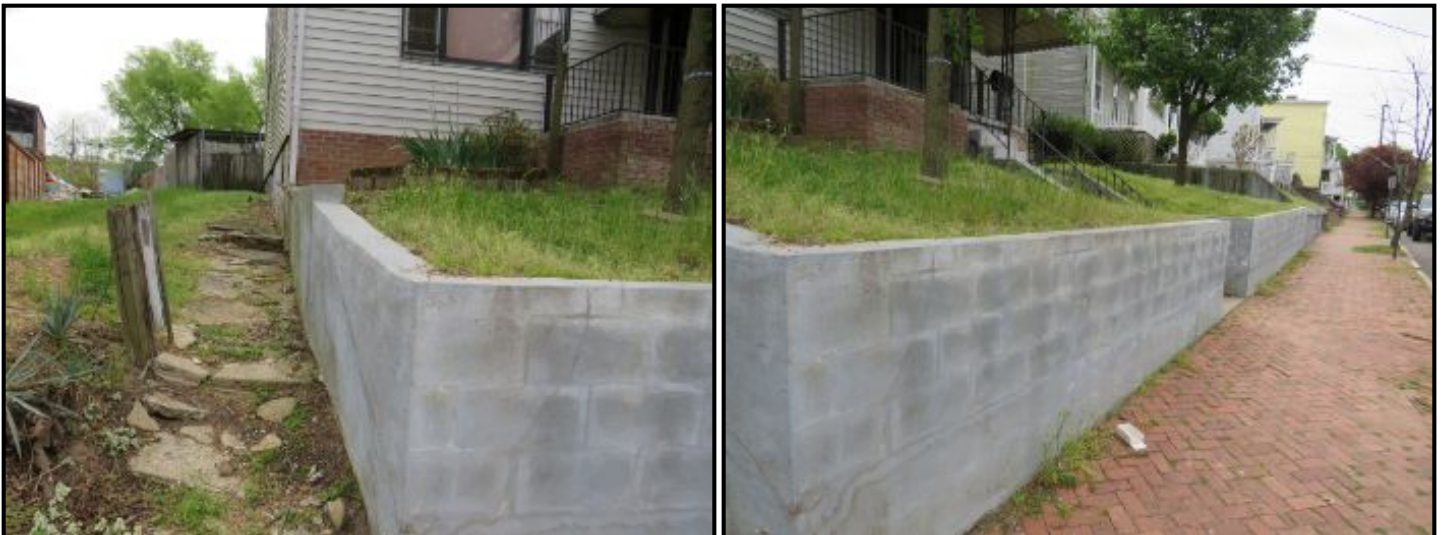
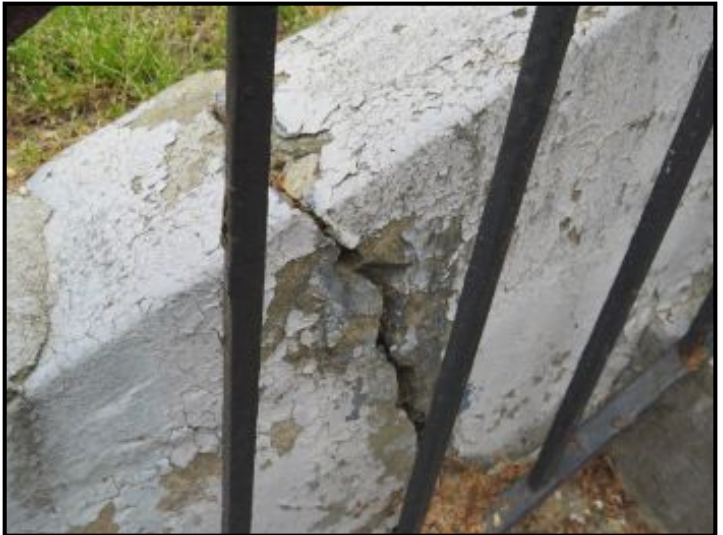
- **One or more retaining walls higher than 3 feet exists on this property and no guardrail is installed above. This is a safety hazard. Recommend having a qualified contractor install adequate guardrails above retaining walls higher than 3 feet where necessary and as per standard building practices (gaps no wider than 4", min. 36" high, vertical balusters so rail can't be used as a ladder, etc.)**
- **The retaining wall is leaning and there are large cracks noted. This is a potential safety hazard. Recommend repair by a licensed contractor.**

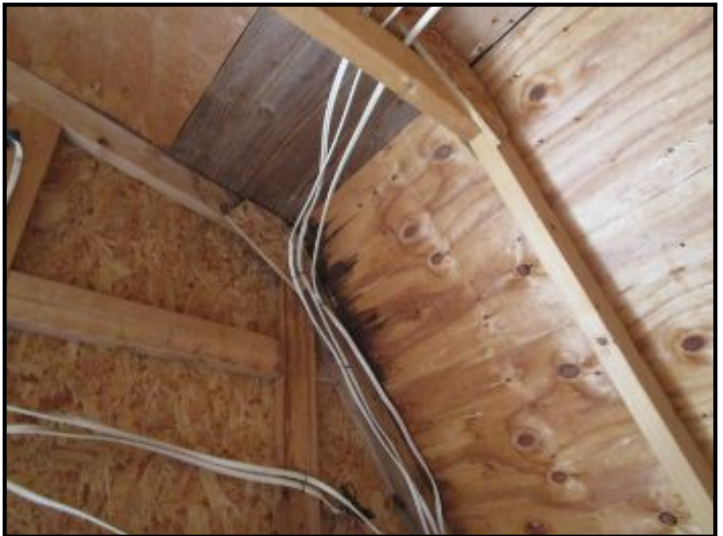
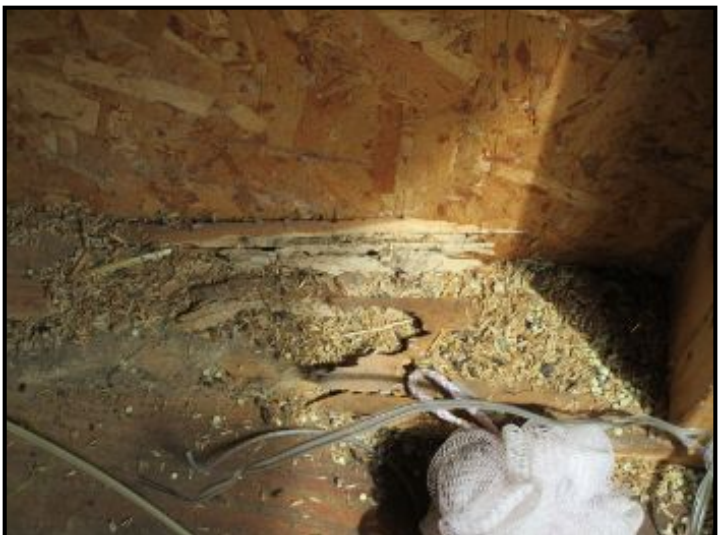
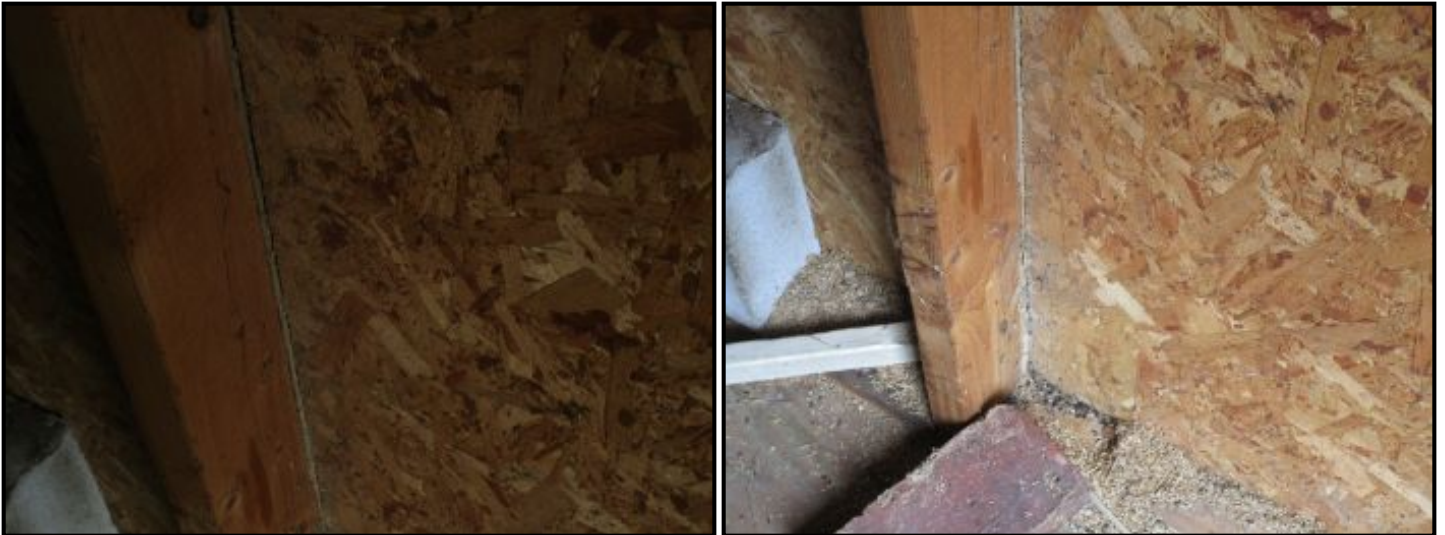
10. Shed

- The shed is in serviceable condition. There is moisture intrusion noted. Makeshift electrical and evidence of wood destroying insects. Sheds are typically sold as is.

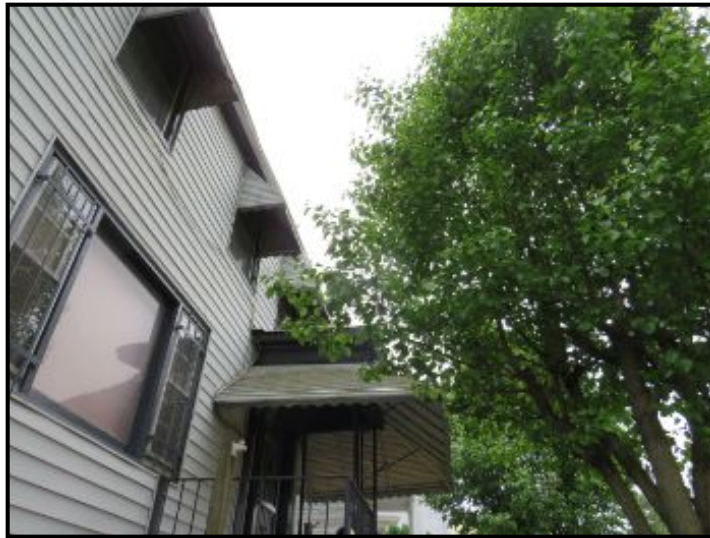
- Prune or remove any plants that are in contact or proximity to home to eliminate pathways of wood destroying insects.
- Tree limbs within 10 feet of roof should be trimmed away to provide air and sunlight to roof, while minimizing debris & dampness.
- Trim trees that are in contact or proximity to home. Branches can abrade roofing or siding. Recommend trimming tree limbs back to 10" away from the roof.

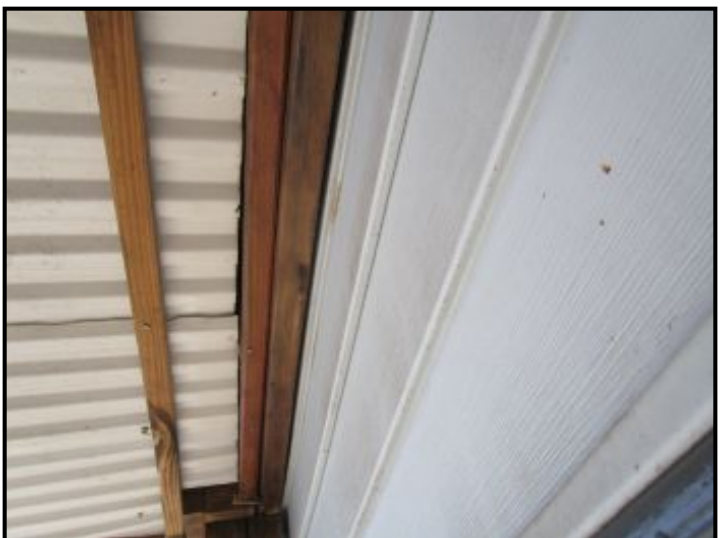
1. Deck

• Decks higher than 6 feet above grade that do not have diagonal decking should have diagonal bracing across the bottoms of the joists to keep the decking square. A deck that is not held square could permit the outer posts to lean to the right or left and parallel to the ledger board, and thus twist the ledger away from the home. Recommend repair by a licensed contractor.

• One or more deck ledger boards are nailed to the structure rather than being attached by adequate fasteners. This poses a significant safety hazard since the ledger board(s) may separate from the structure, causing the deck(s) to collapse. Recommend having a qualified contractor install lag screws or bolts as per standard building practices to securely attach the ledger board(s) to the structure. For more information on installing deck ledger boards visit:
http://www.hometime.com/Howto/projects/decks/deck_4.htm

• Recommend cleaning deck and treating with a waterproof sealant claiming to waterproof, block ultraviolet light, and stop mildew. [u]Consumer Reports[/u] recommends these products:

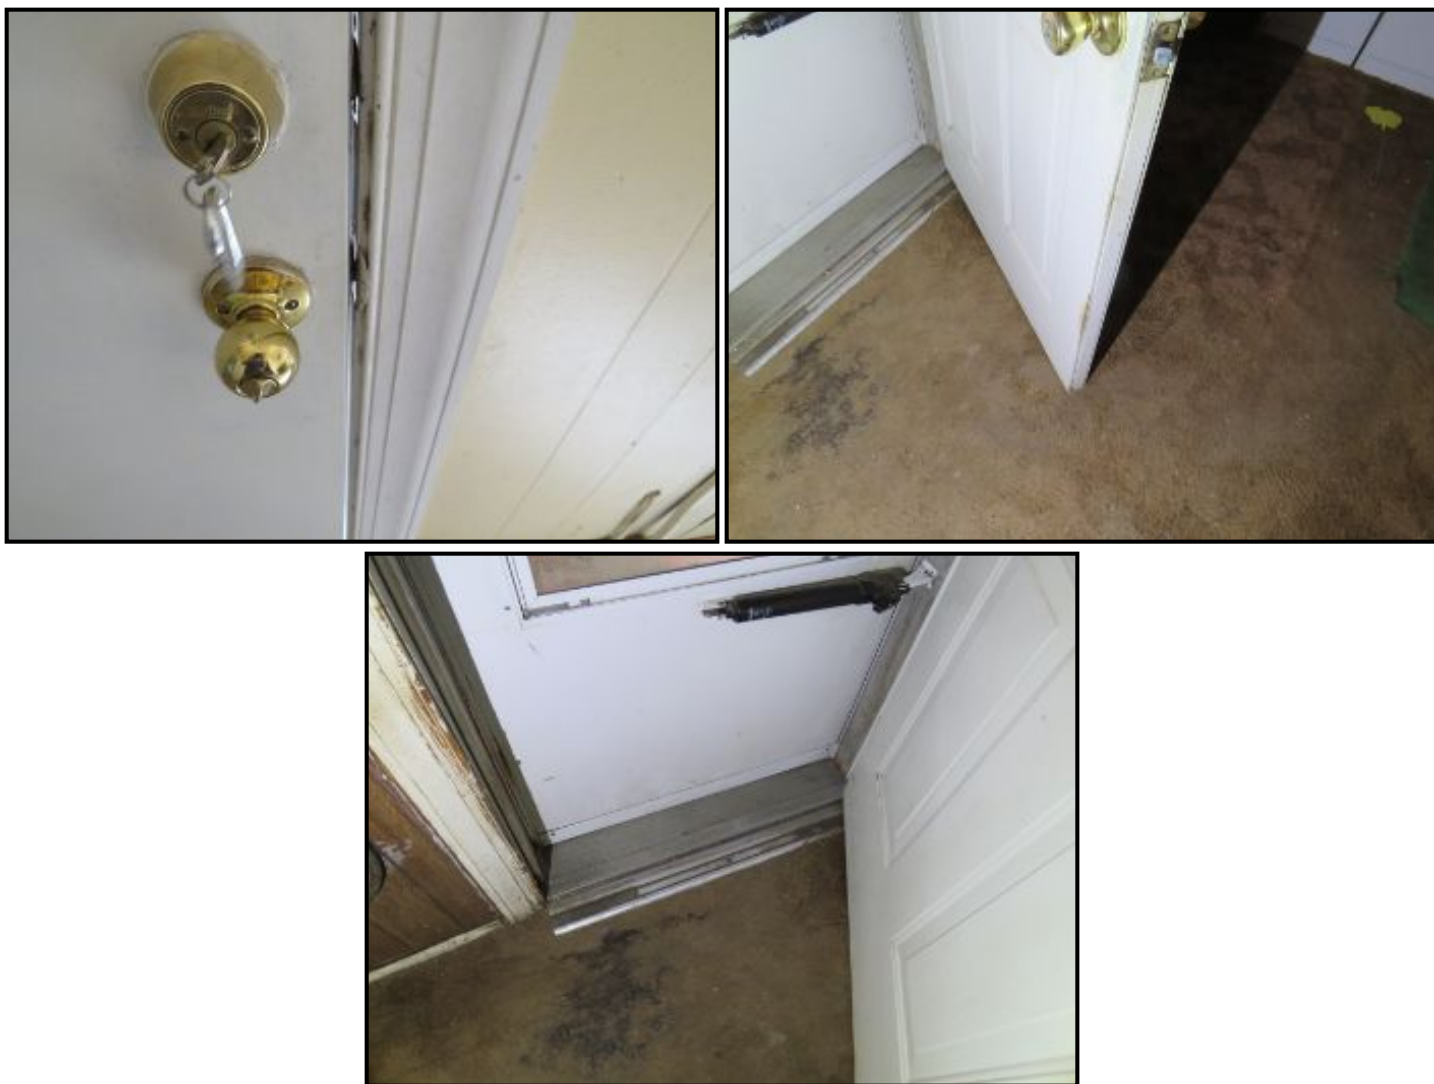
2. Doors

- **Emergency Egress Concern.** Exterior door(s) have a double-sided keyed dead bolt lock set. This type of lock requires a key to unlock the door from the inside and can present an obstacle to anyone trying to evacuate the home in the event of a fire.
- **The exterior doors thresholds are damaged/deteriorated. Recommend repair by a licensed contractor.**
- **The rear door knob does not latch easily.**

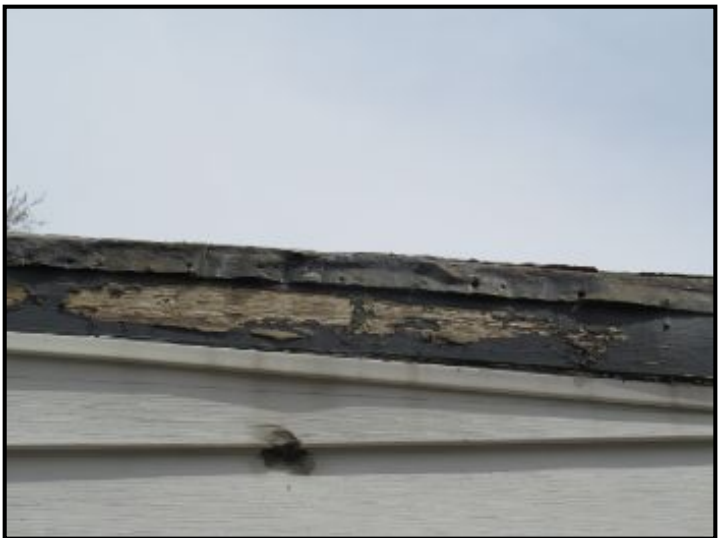
- Suggest sealing/caulking as part of routine maintenance to prevent deterioration.
- Approximately 3/4 of the homes built before 1978 (about 64 million homes) contain some lead-based paint. For more information, refer to the following EPA Fact Sheet:
<http://www.hud.gov/offices/lead/library/enforcement/fs-discl.pdf>
- There is paint/caulking deterioration at the window trim. Recommend repair by licensed painting contractor.
- There is paint deterioration at the soffit and eaves trim. Recommend repair by a licensed painting contractor.

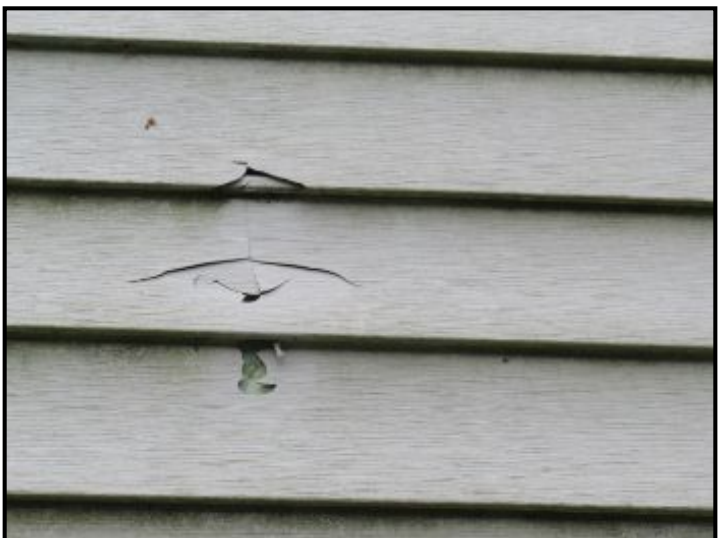
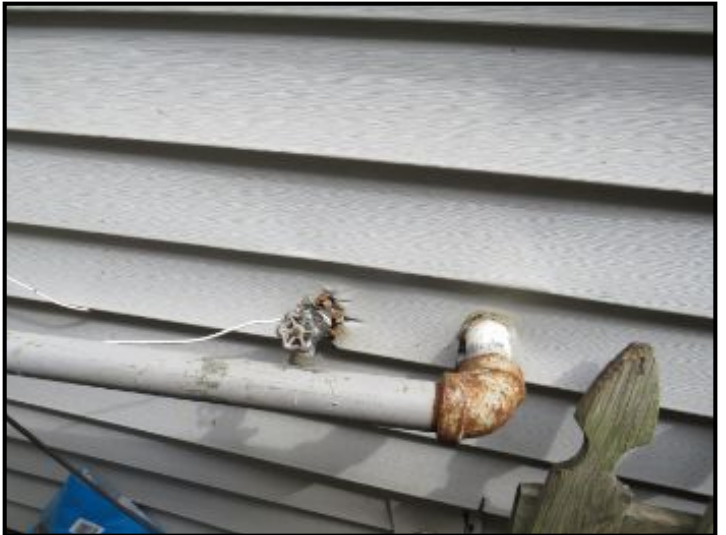
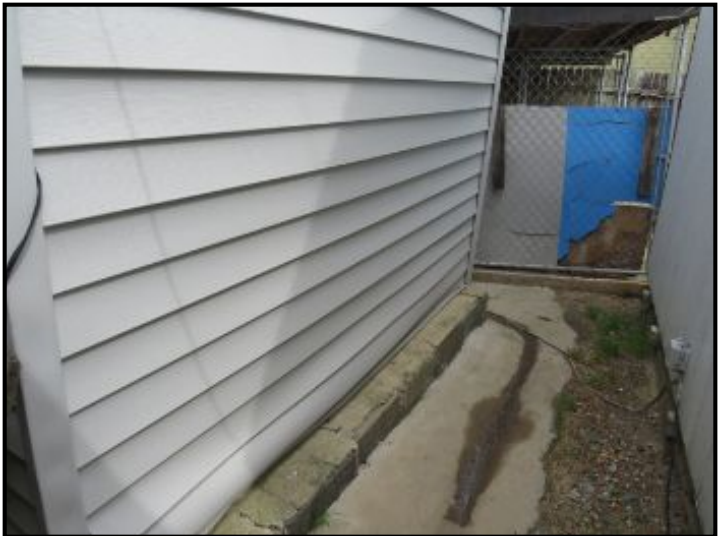
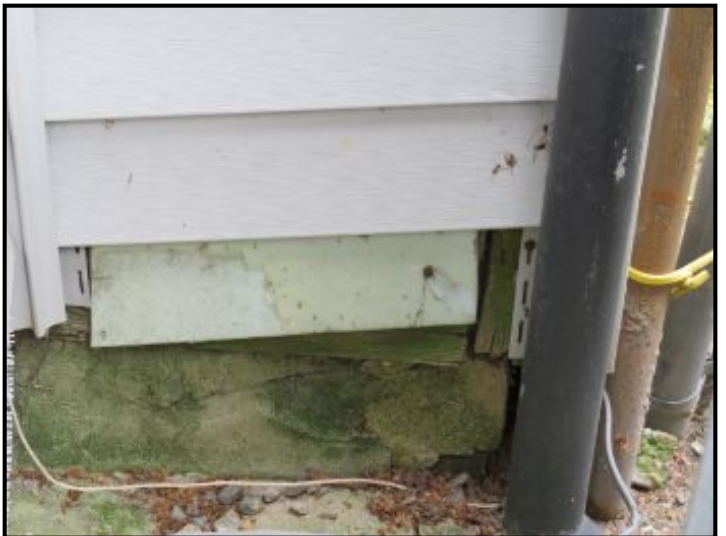
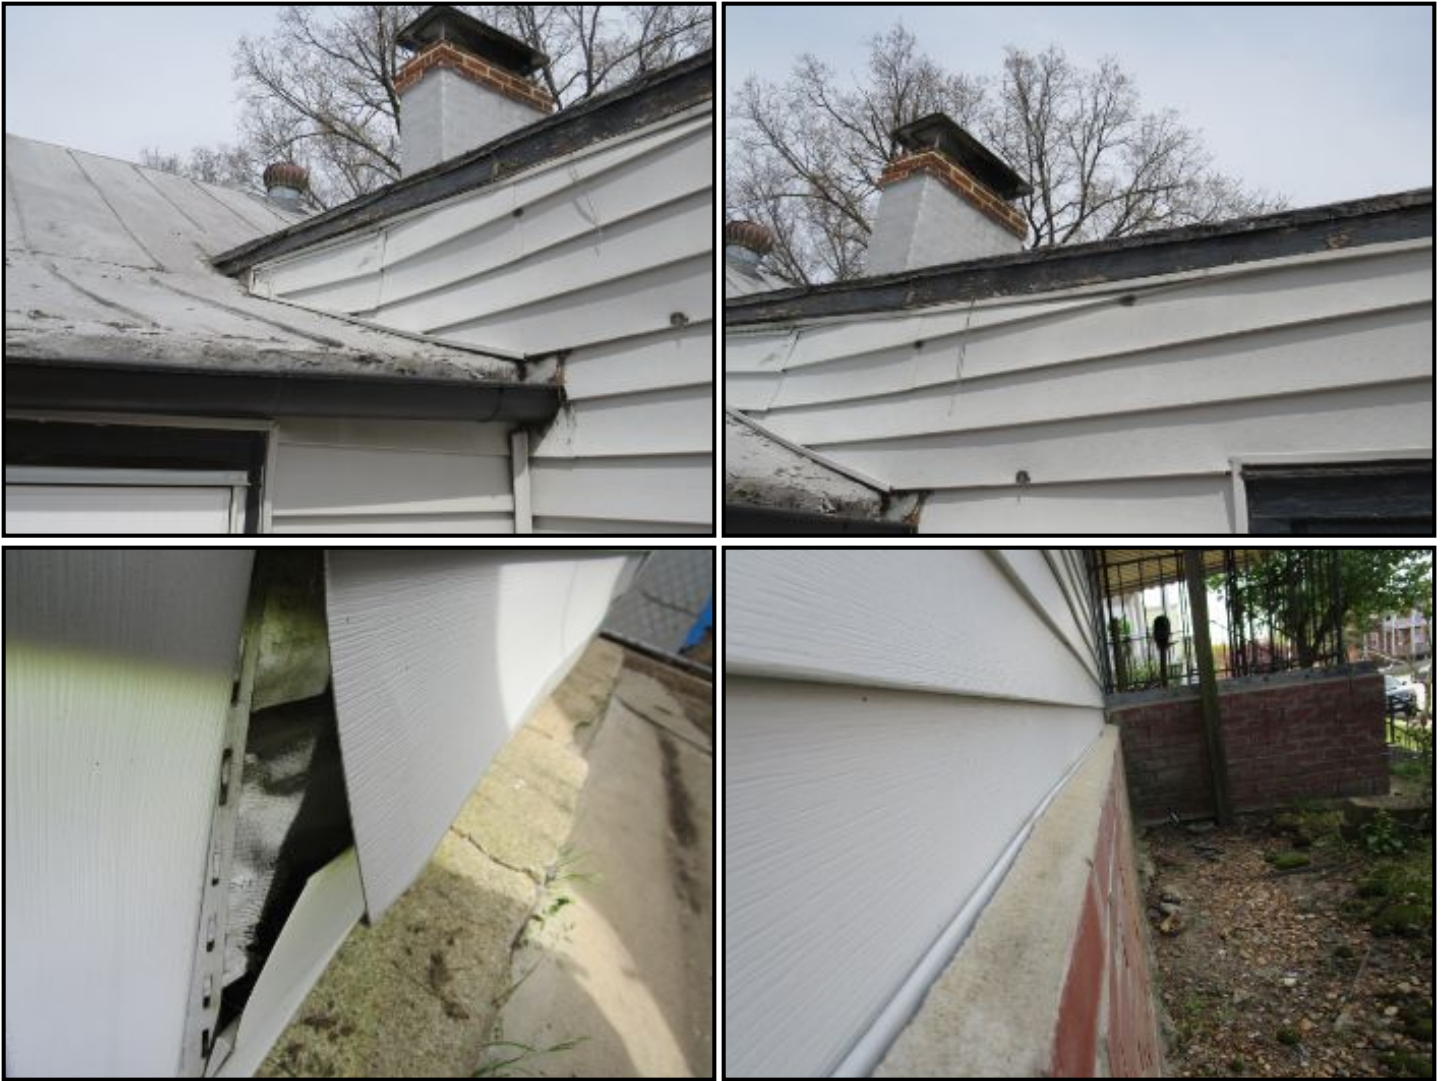
6. Siding Condition

- Caulk and seal all gaps, cracks and openings.
- Maintain all exterior finishes, caulking, and other sealants at any dissimilar material abutments and all penetrations to the walls and roof. This inexpensive task aids in the prevention of moisture intrusion and saves on costly repairs.
- **Significant siding damage or deterioration noted. Recommend repair by a licensed contractor.**
- **There is an area at the back of the home that appears that the walls have settled and are deteriorated. Recommend repair by a licensed contractor.**

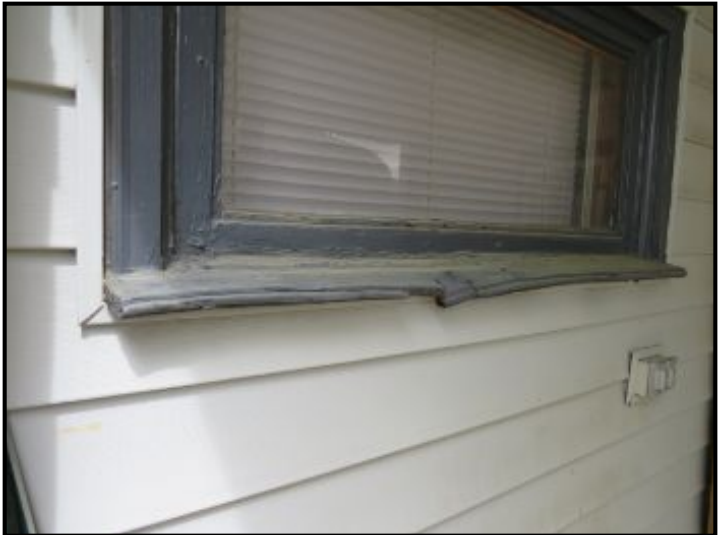
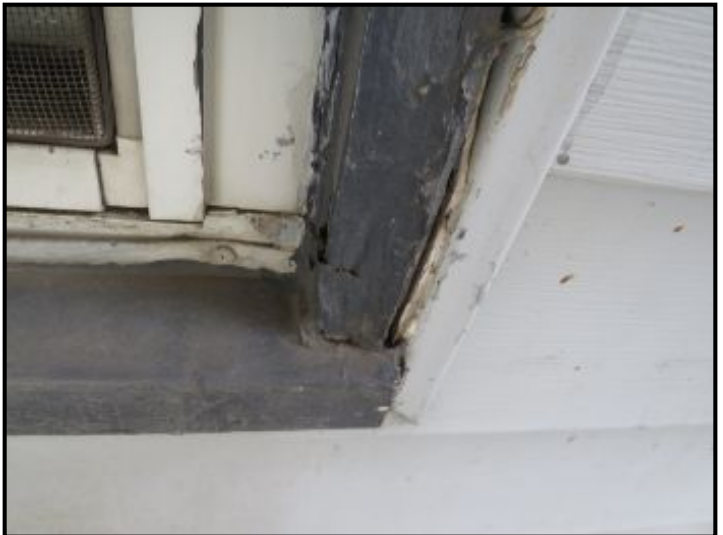
- There is wood trim deterioration at the windows. Recommend repair by a licensed contractor.
- There is wood trim deterioration at the soffit, eaves and trim. Recommend repair by a licensed contractor.

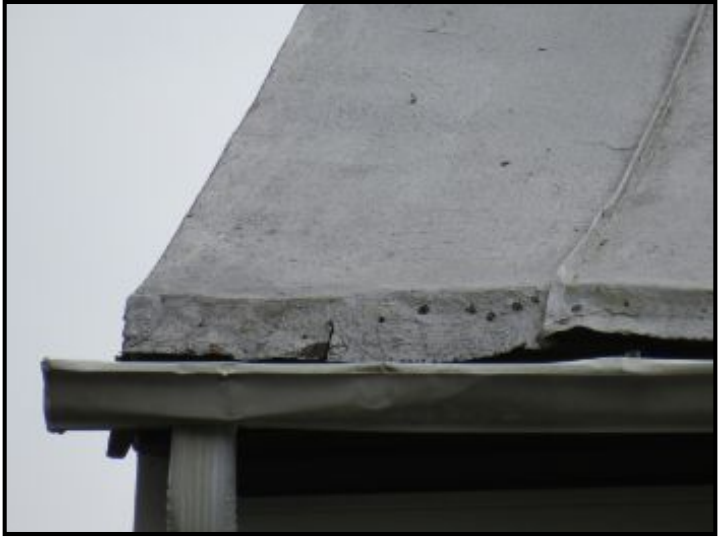
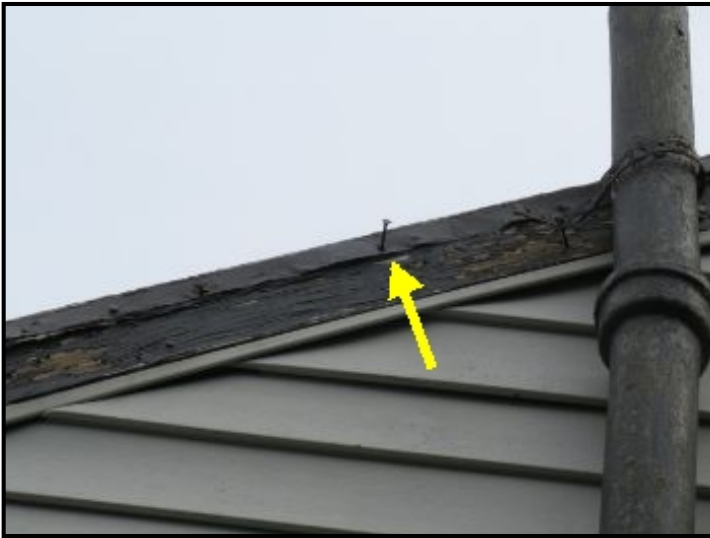
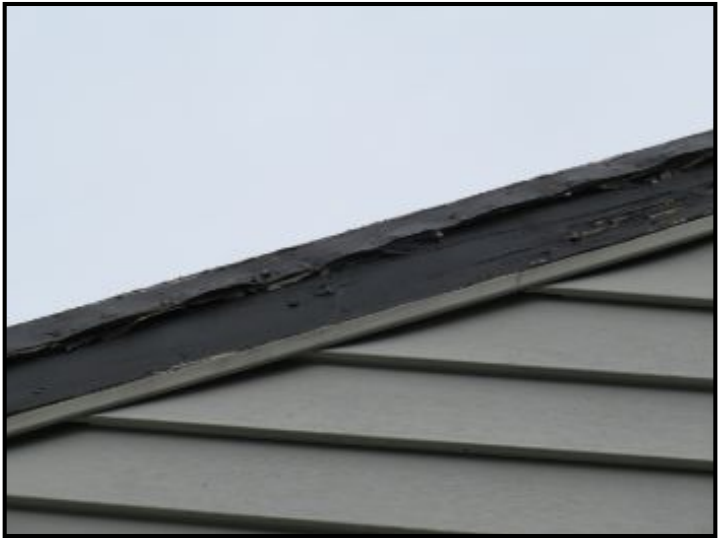
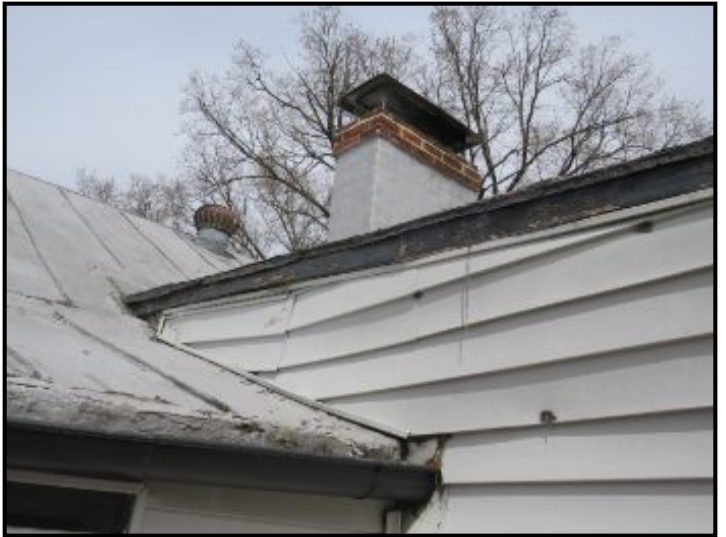
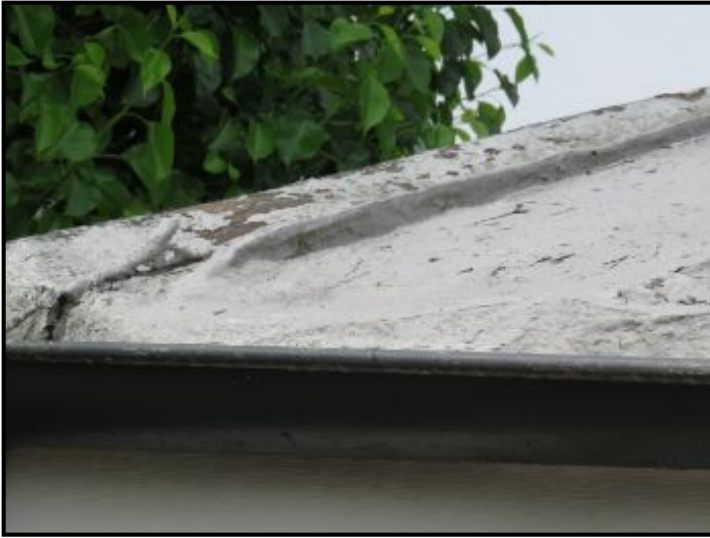
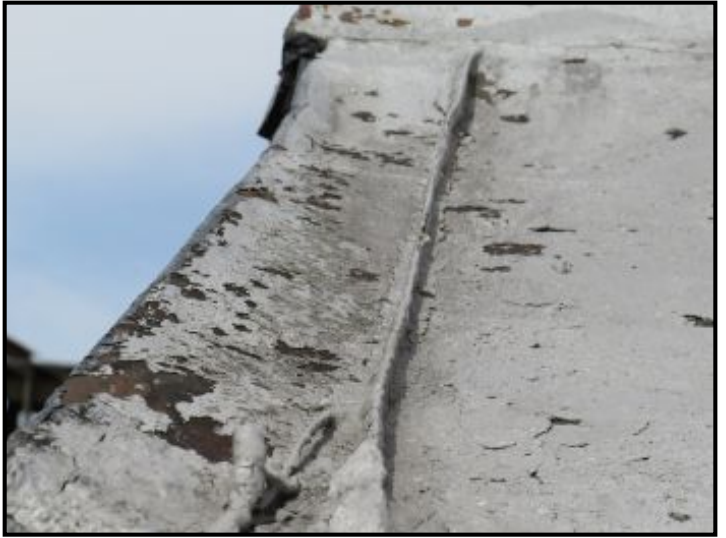
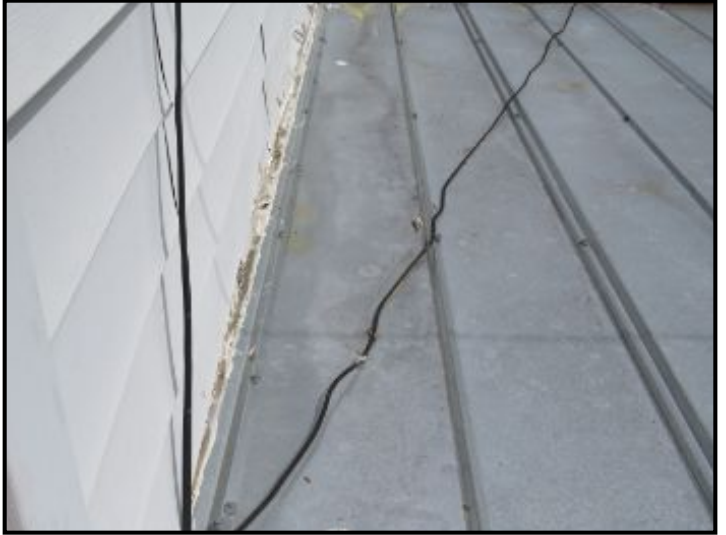
2. Roof Condition

- Note that experts recommend that any roof over 10 years old receive a roof certification by a local roofing specialist.
- **The roof is at the end of its useful life. There is splitting, rust and edges that are lifting. There is deteriorated paint and sealants. Recommend replacement/repair by a licensed roofing contractor.**

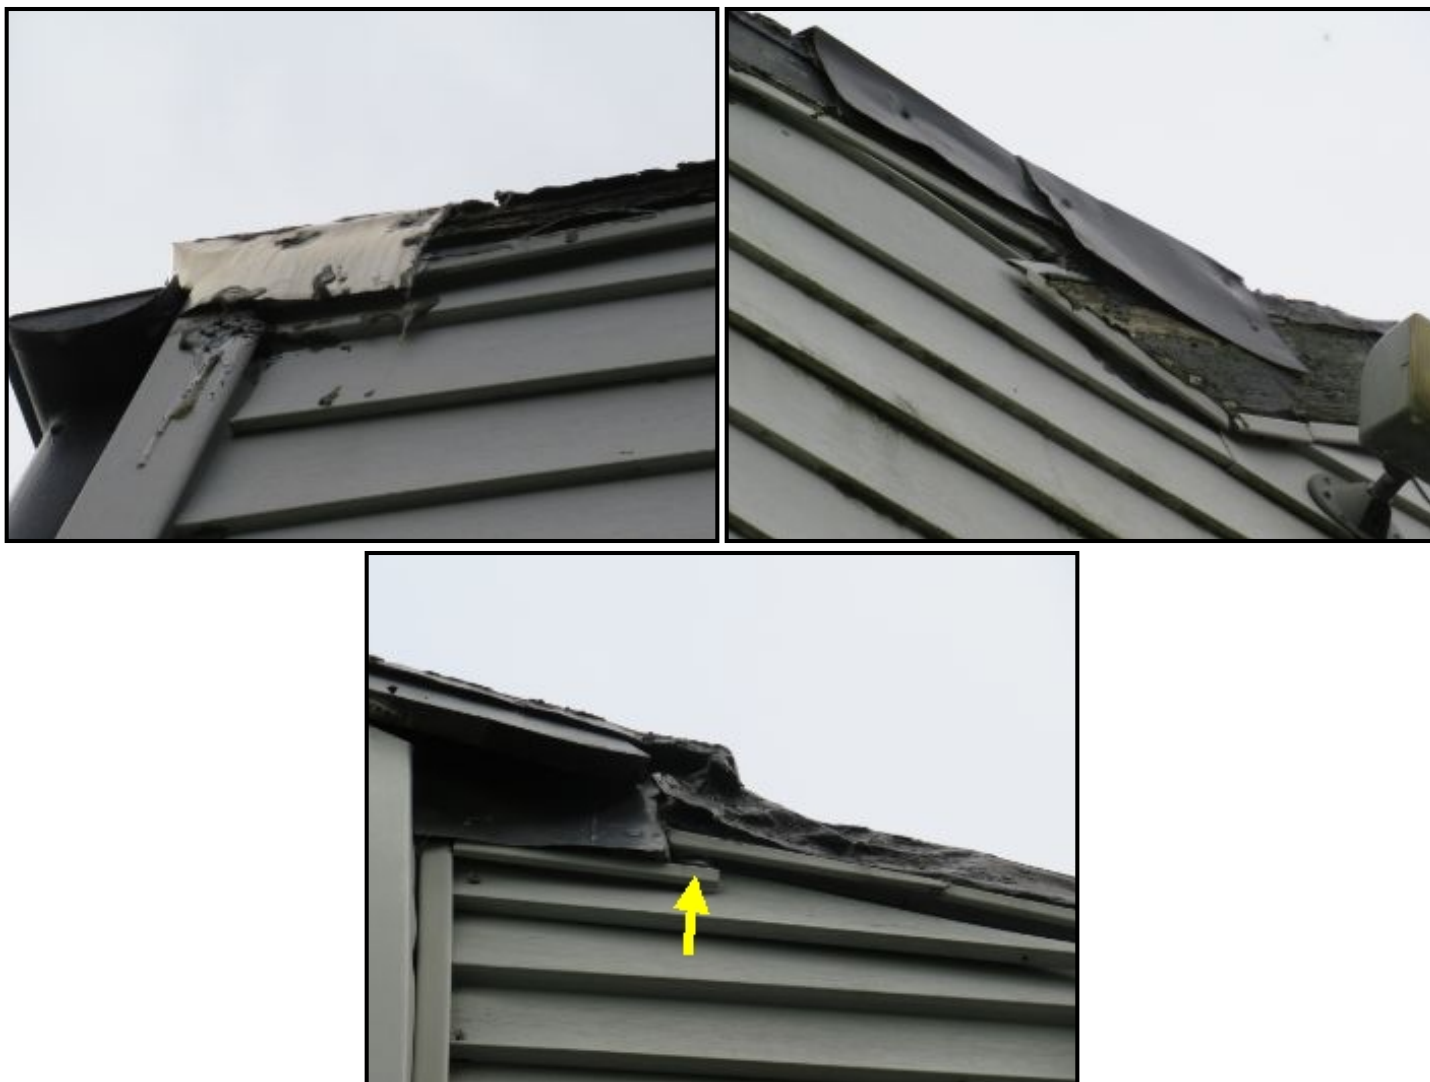
3. Flashing

- They are damaged and deteriorated flashing is noted at the roof section. There is exposed and deteriorated roof sheathing seen at the sides. Recommend repair by a licensed roofing contractor.

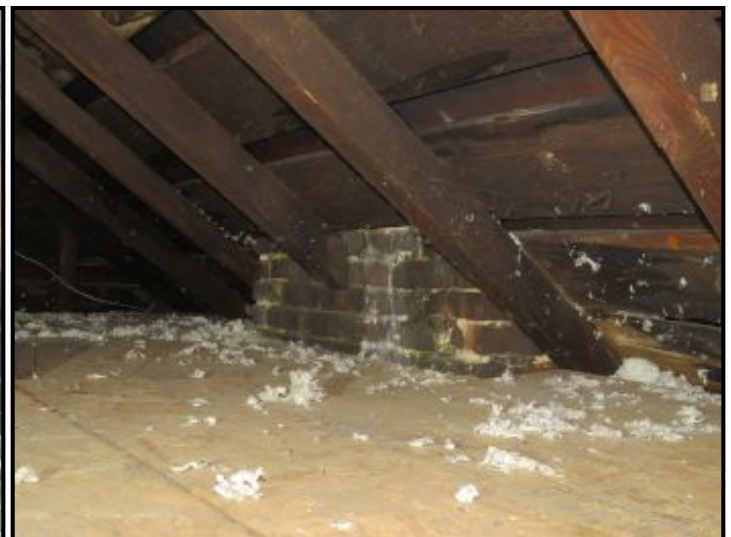
4. Moisture Intrusion

- There is evidence of past moisture intrusion in the attic. The areas were dry at the time of the inspection.

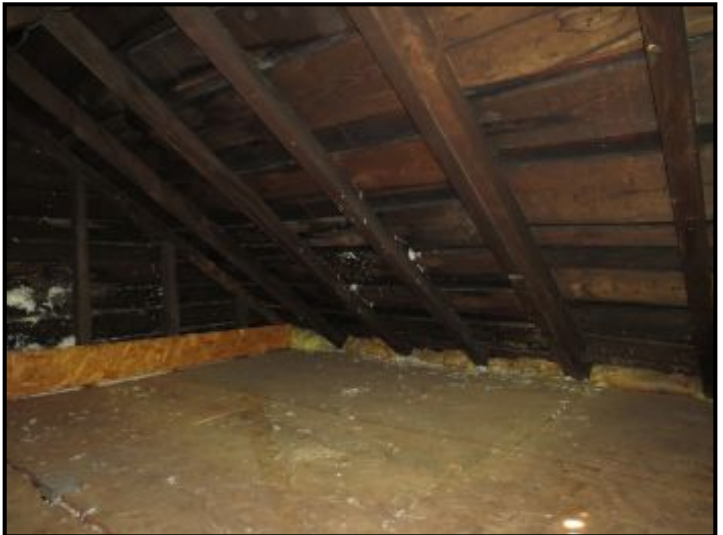
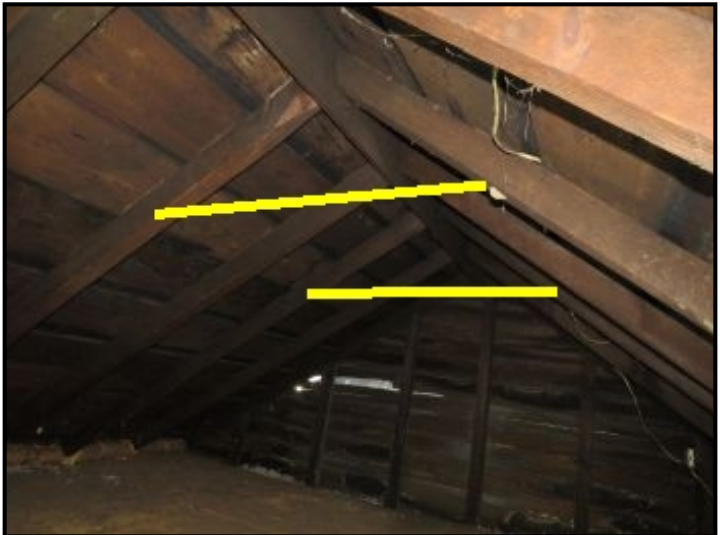
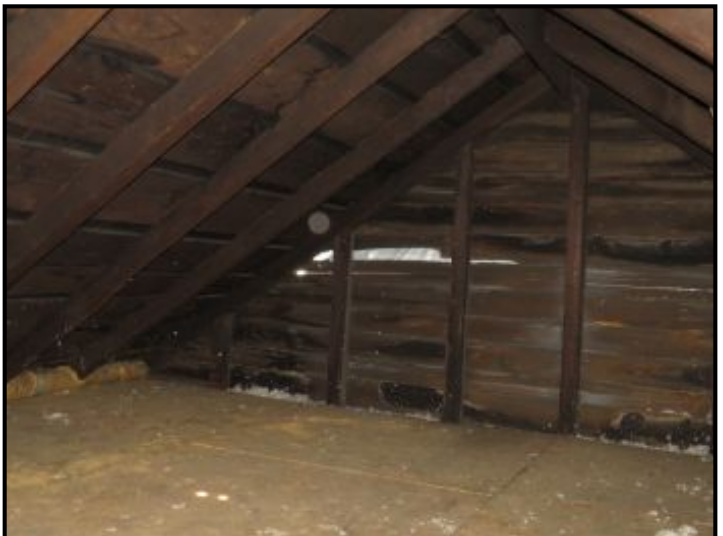
5. Structure

- **Framing is poorly braced. Recommend adding collar ties.**

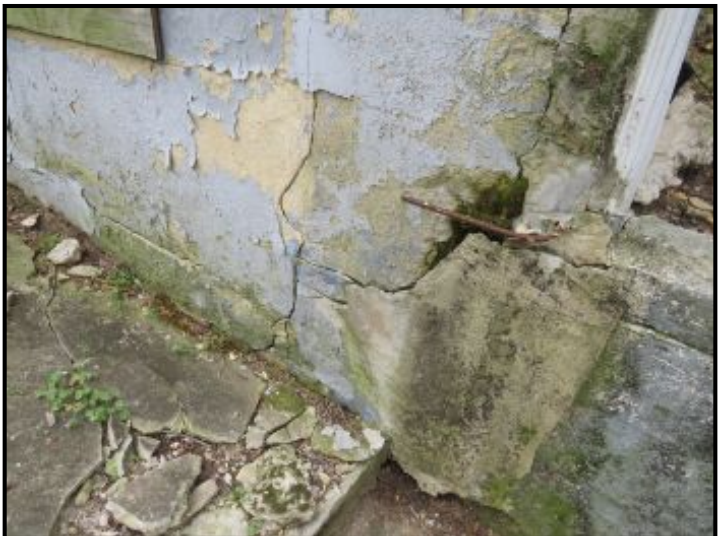
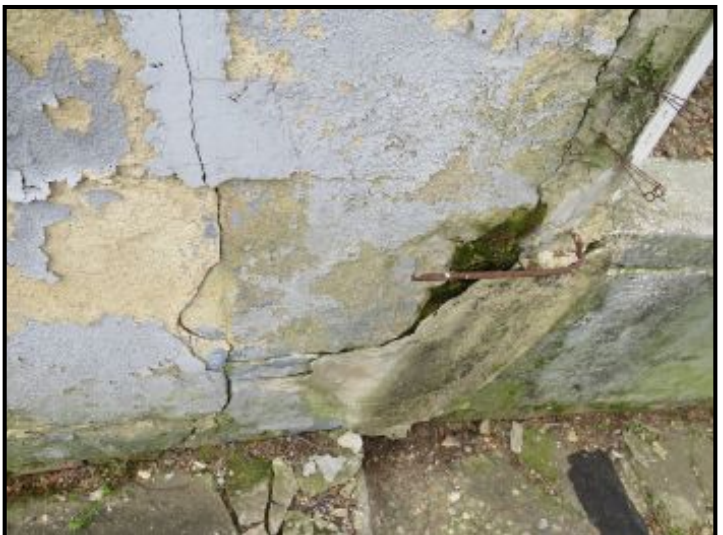
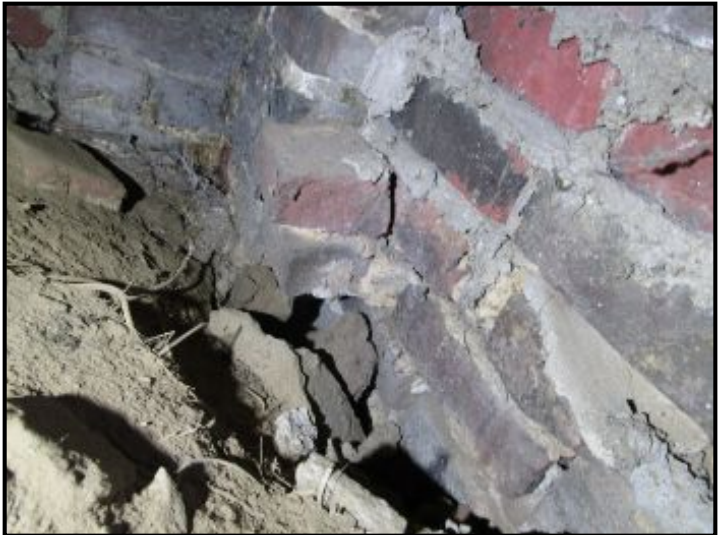
1. Foundation Walls

- There are holes in the foundation large enough for rodent intrusion. Recommend filling or closing any holes with mortar or grout.
- Pressure bulge in wall indicates excessive forces are being applied to the exterior side. It also appears that the front exterior downspout is dumping water into the foundation and there is washout at the front corner piers. Recommend repair by a licensed structural contractor.

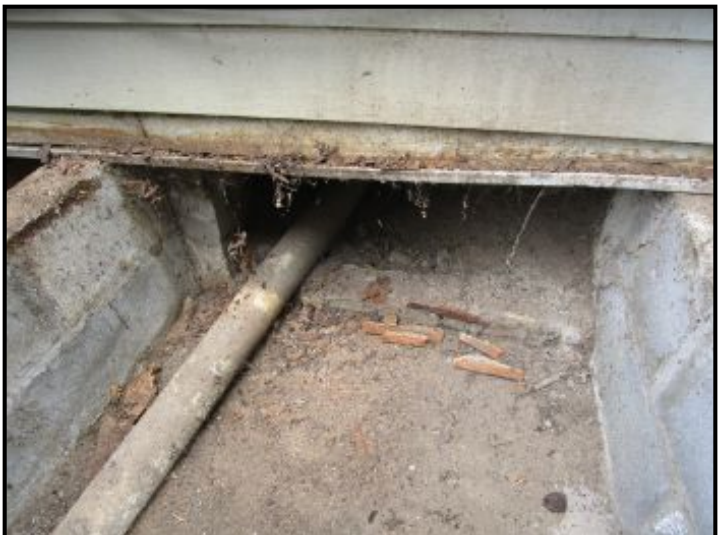
- **The crawlspace door is in poor condition and there is limited access to some areas. Recommend repair or replace by a licensed contractor.**

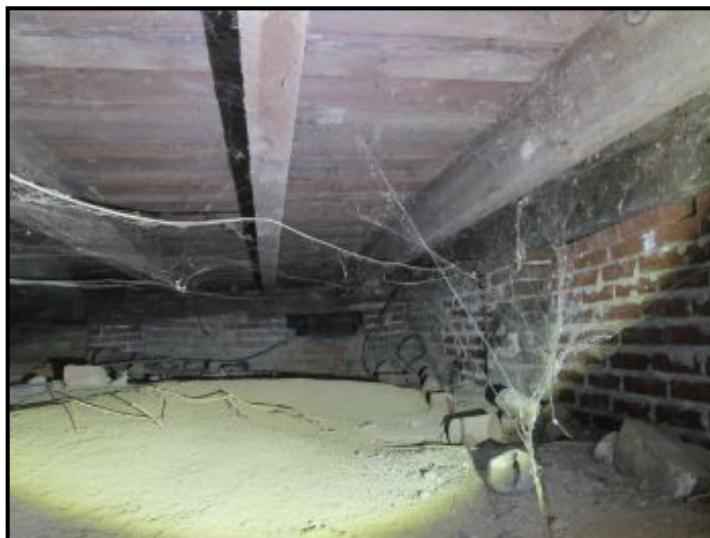
- No insulation under floor in crawl space. Recommend installing R19 or better (6" thick fiberglass batt) insulation below floor for energy efficiency.

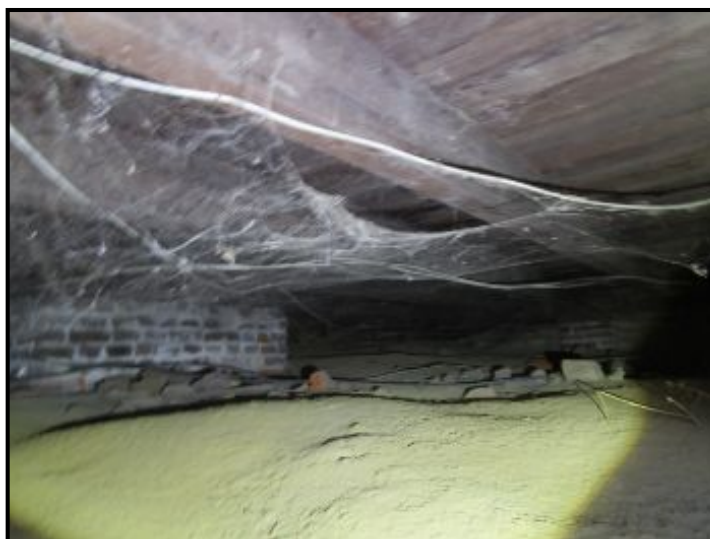
4. Moisture Barrier

- Moisture barrier missing. Recommend installing 6 mil plastic moisture barrier.

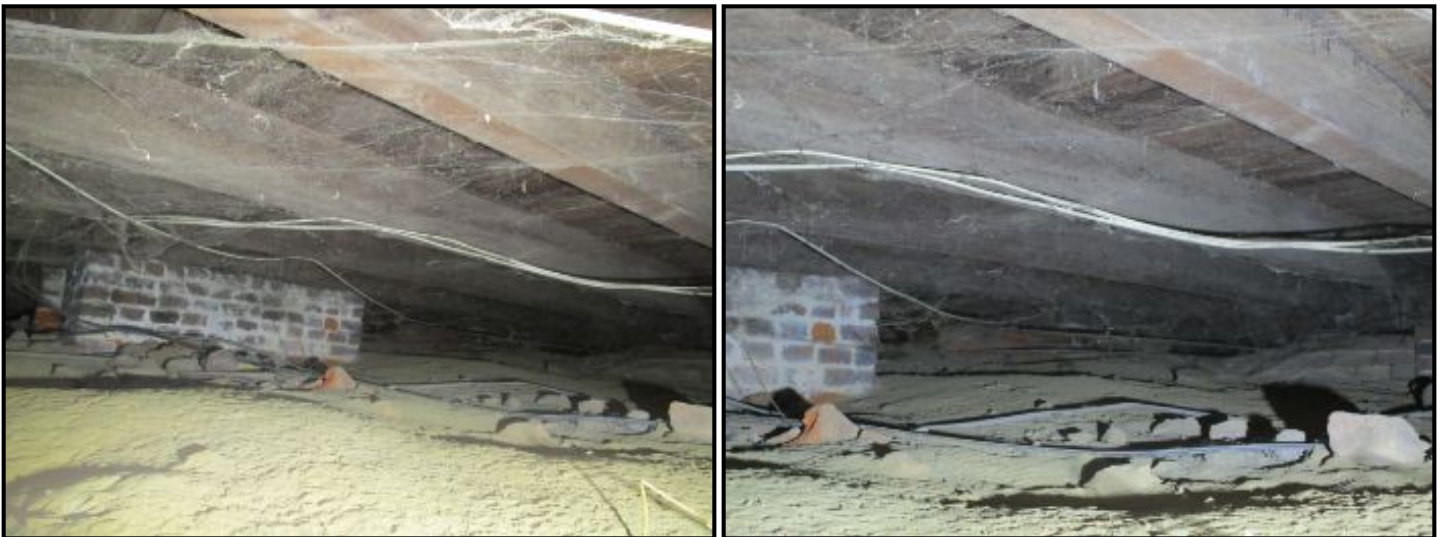
- There is a mold like substance found on the structural members in the crawlspace. This is a common condition as moist air enters the cooler crawlspace, moisture will condense on the crawlspace surfaces. Mold is a known allergen.
