Commission for Architectural Review

Application for Certificate of Appropriateness

Address: 529 Mosby Street
Union Hill
Historic District: _____

Conceptual review to determine the status of the existing dwelling at 529 Mosby Street.

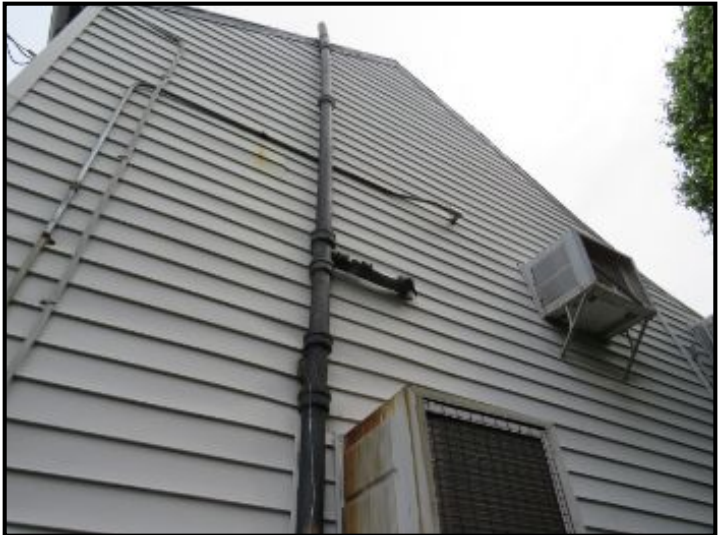
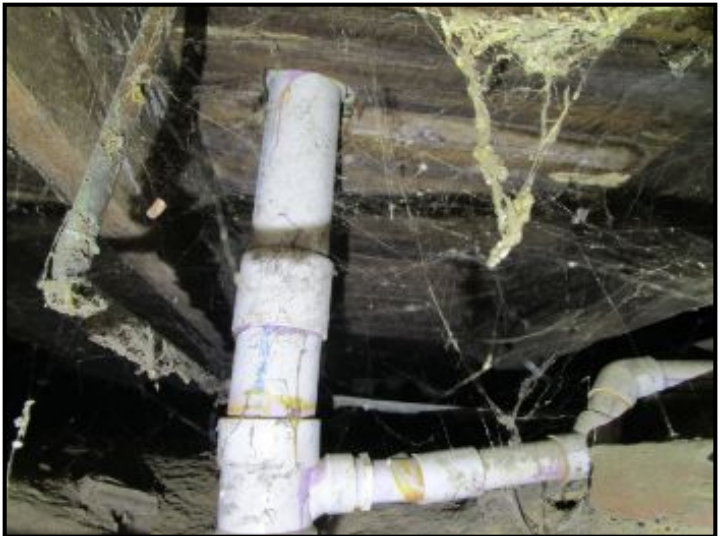
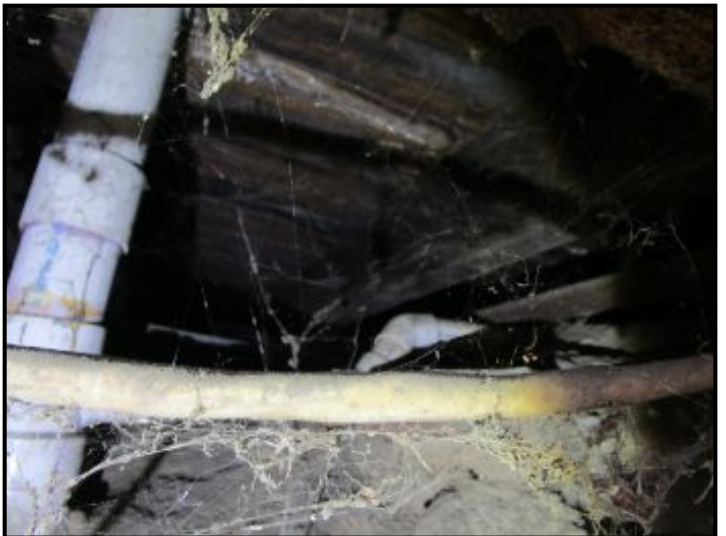
7. Plumbing Materials

- **ABS**
- Cast Iron
- Copper
- **PVC**
- Cast iron and galvanized drain lines have a life expectancy of 50 to 70 years. Recommend budgeting for replacement in the future.
- Most of the plumbing lines expose on the exterior of the home for the drain system. The water was off to the structure and could not be tested. There does not appear to be proper support at these drain lines and some areas need additional insulation to protect them. Recommend repair by a licensed plumbing contractor.

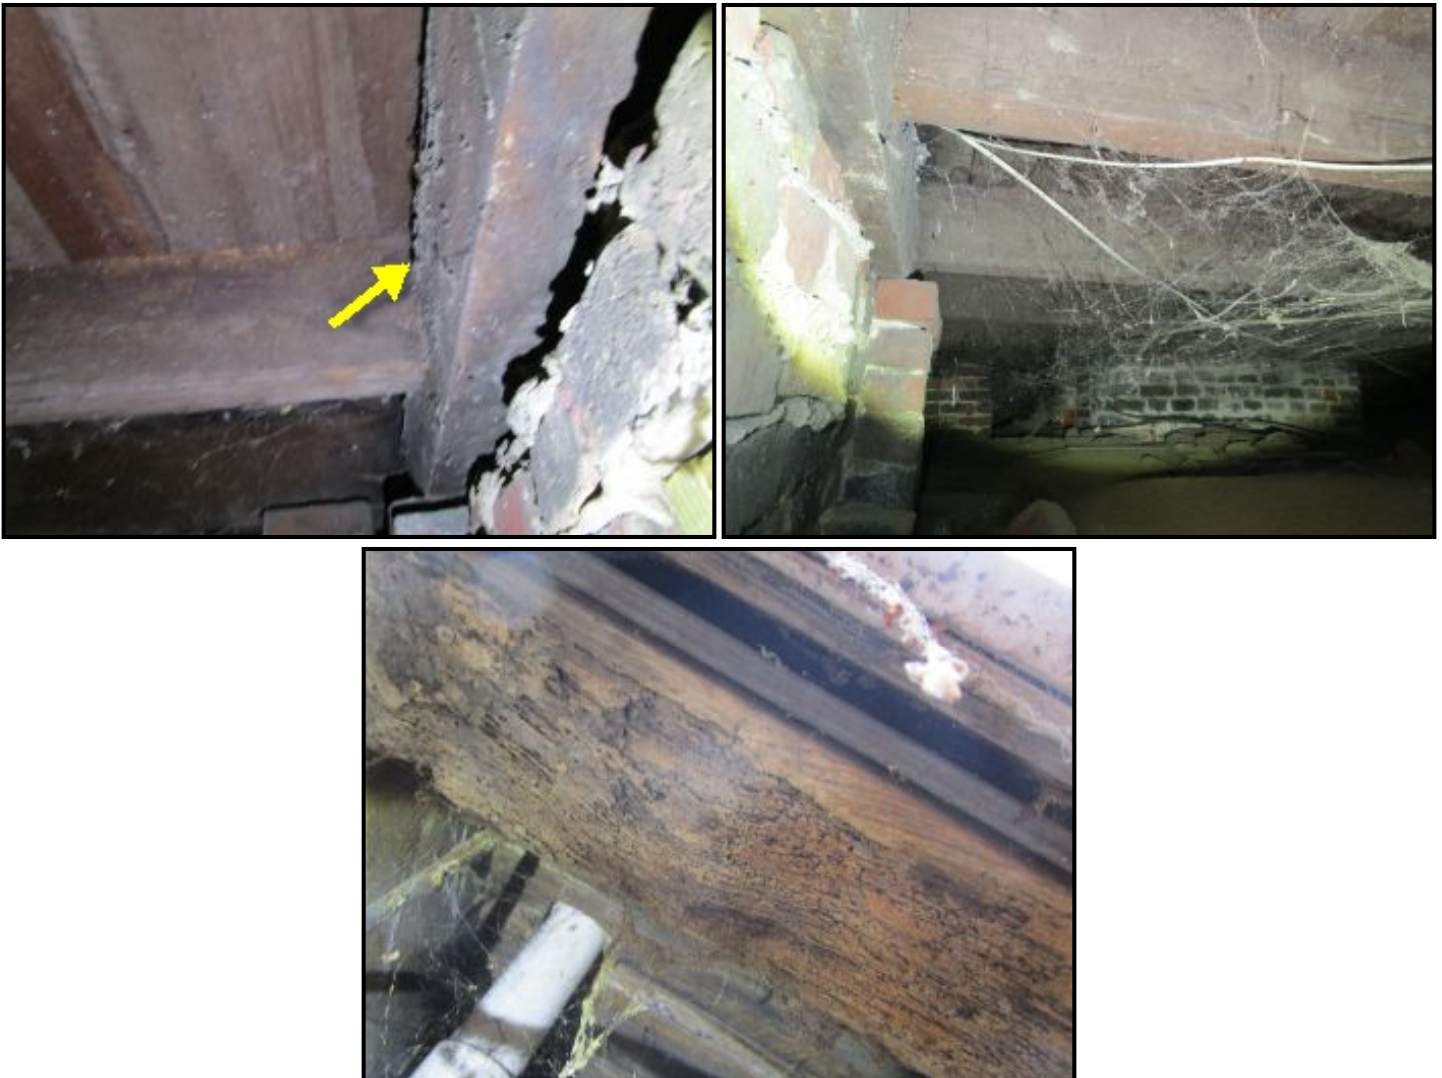
8. Framing

- **Improper cutting/or notching of floor joist noted. Recommend review and repair by a qualified contractor to provide proper support to load bearing floor system.**

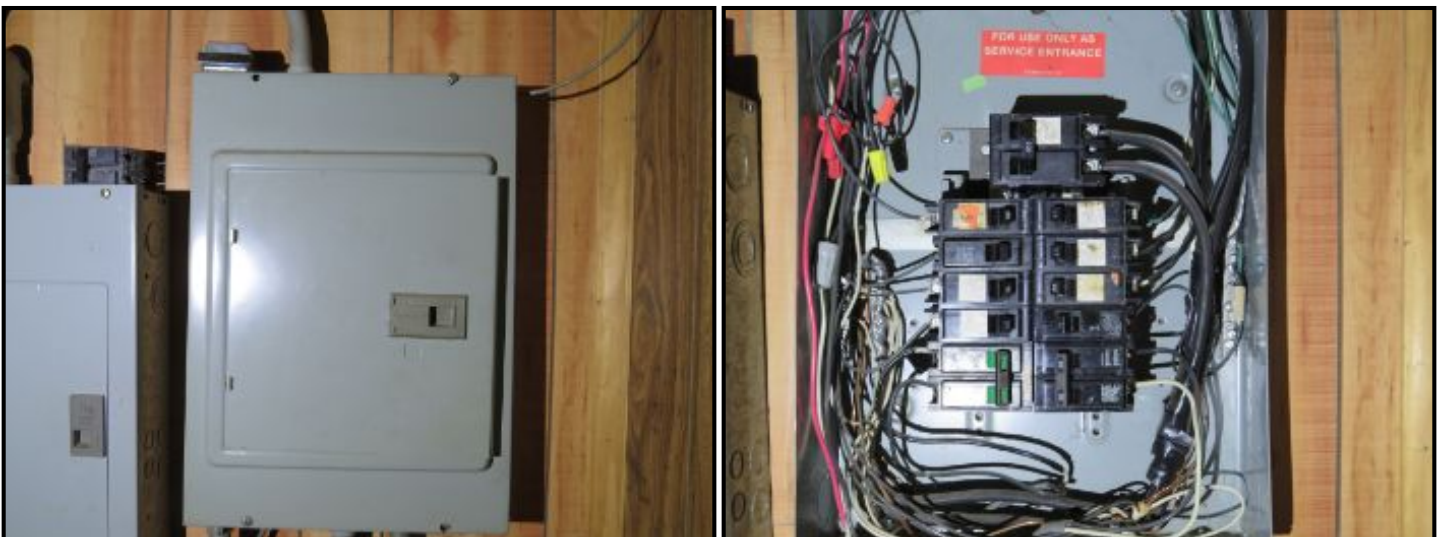
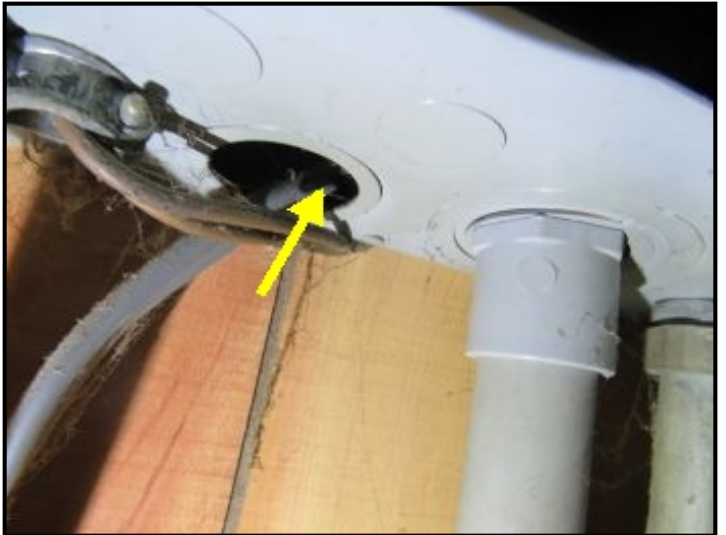
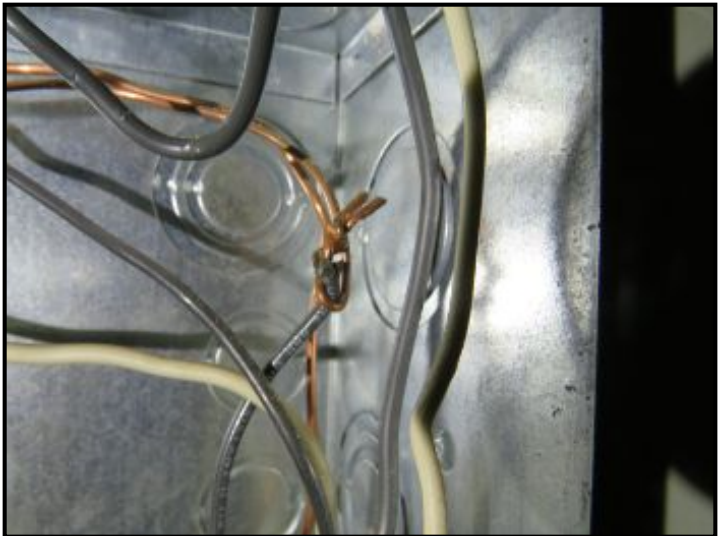
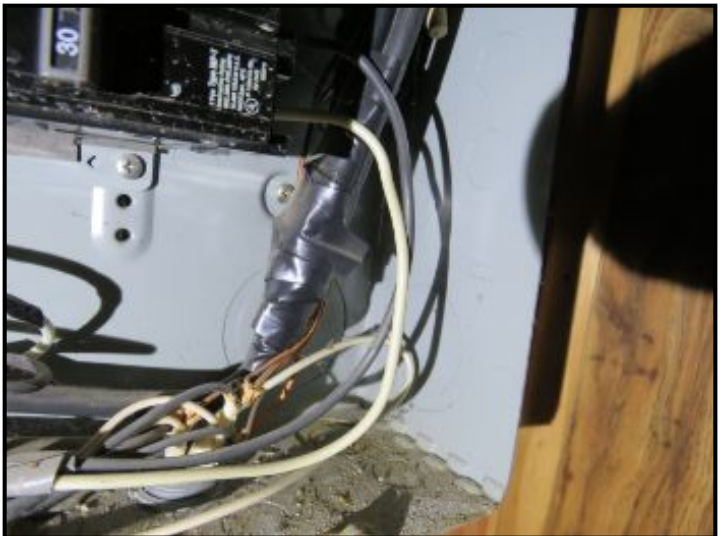
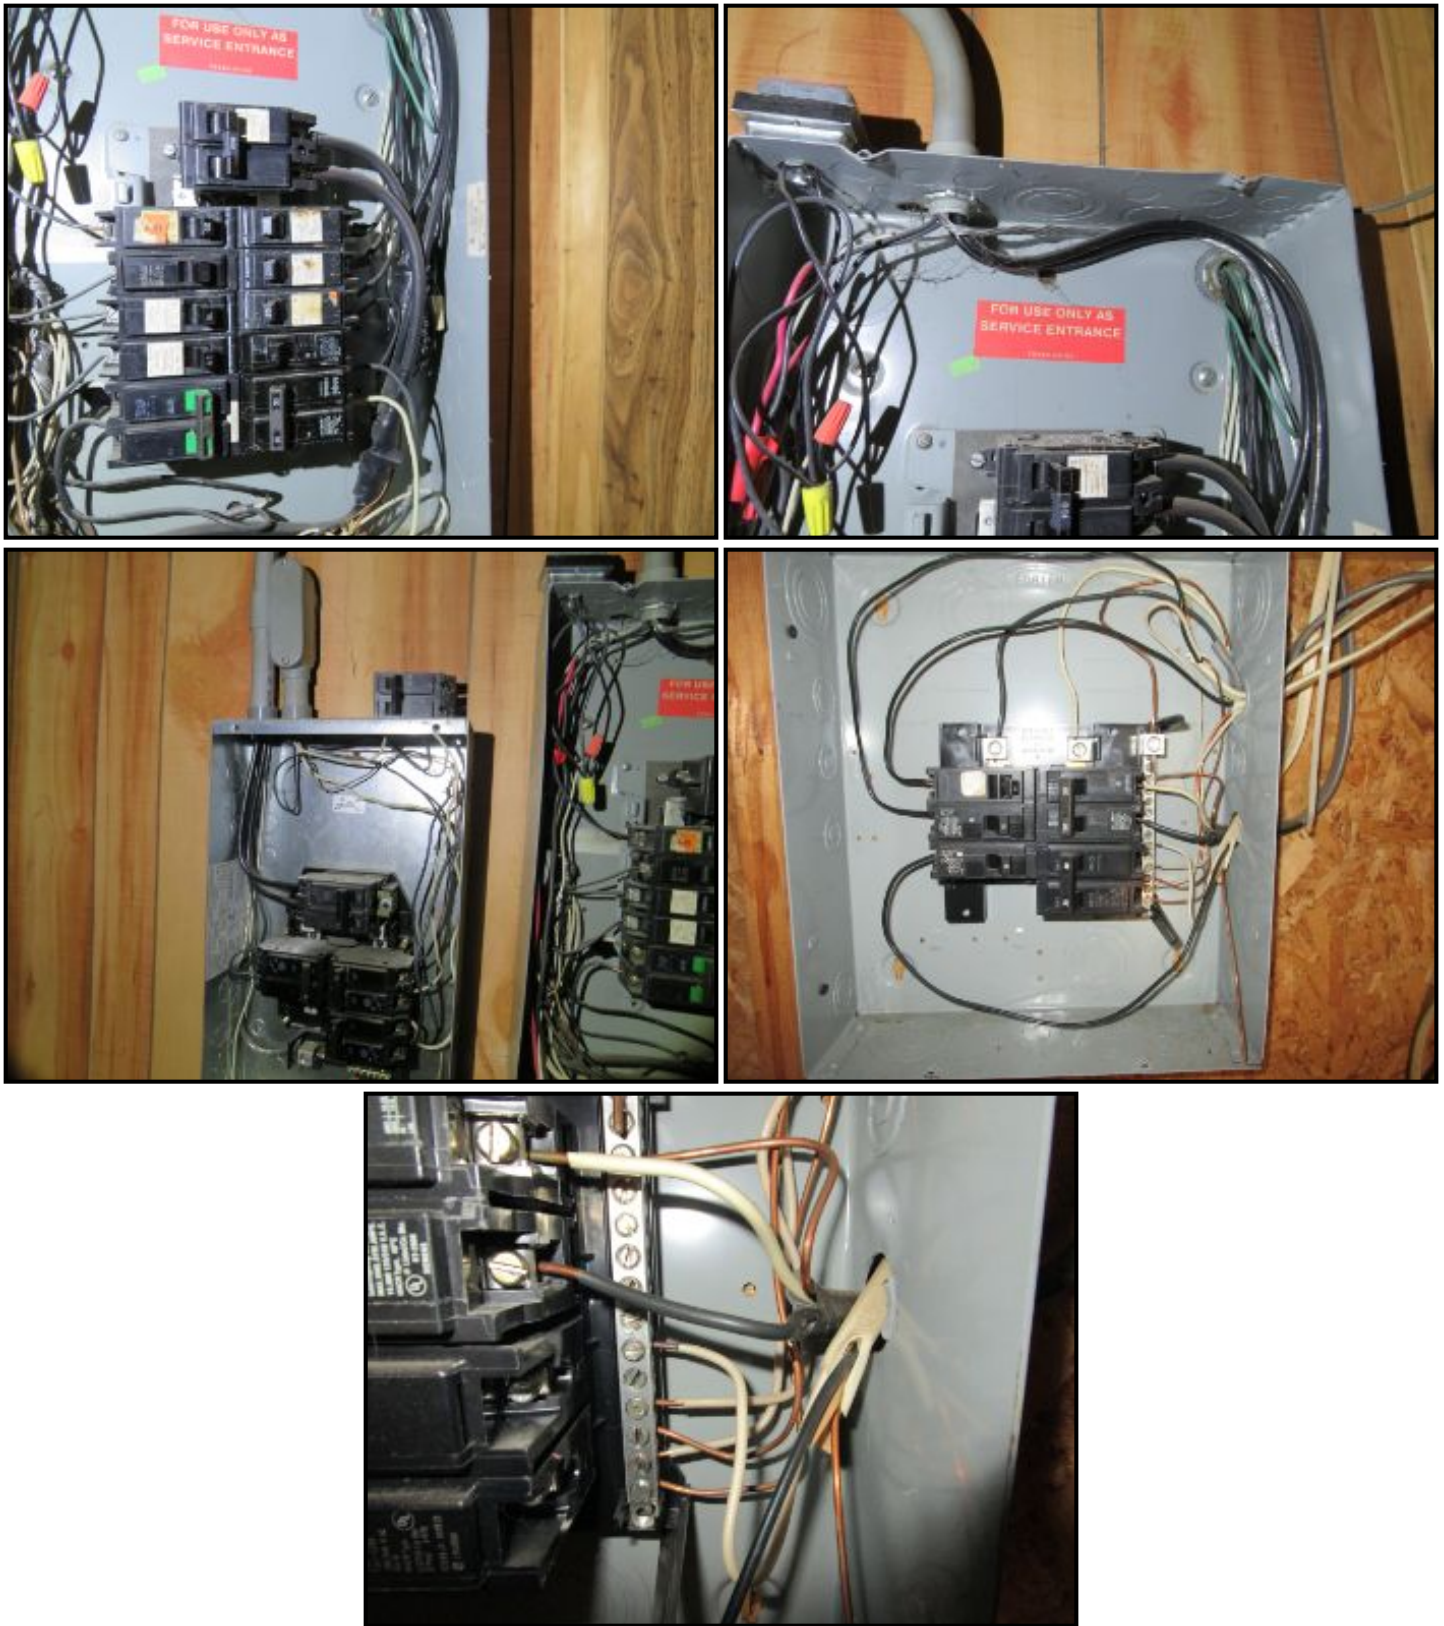
- **Exposed wire ends in panel box. Have evaluated by a licensed electrician.**

- **There are some questionable splices inside the electrical panel. It appears that the main 100 amp wire is split for two separate boxes. Recommend evaluation by a licensed electrician.**

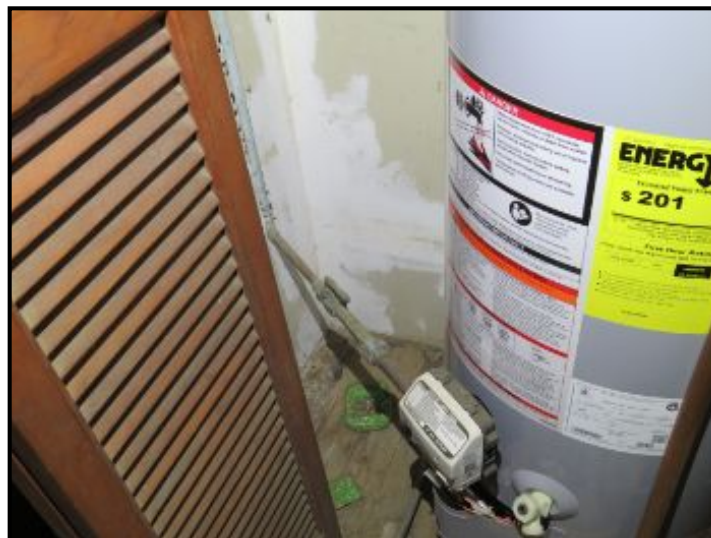
- There is no drip leg noted at the gas supply line. Current standards recommend drip legs to be installed in a manner that meets or exceeds fuel piping requirements for appliances and devices. The drip leg requirements are the same for both natural gas and propane. A drip leg can be installed anywhere at the low point in the piping system, if there is moisture in the gas this will allow for the removal of the condensation.

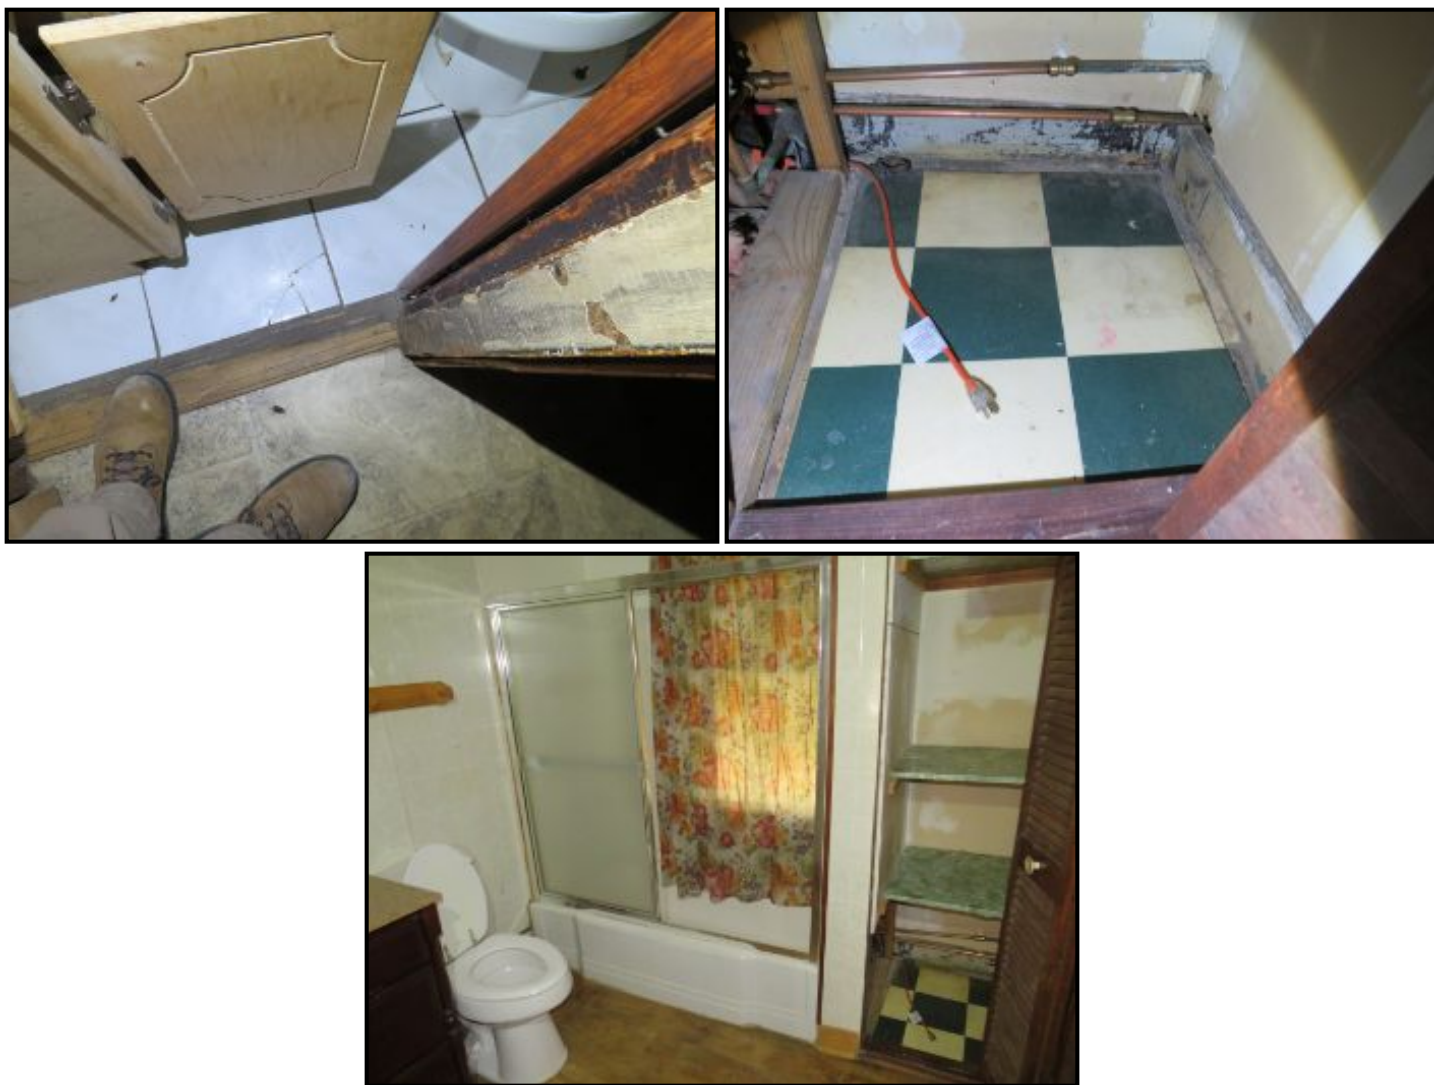
- Common cracks noted.
- Some of the floors in this building are a vintage 9" x 9" size; be advised that these tiles may be the type that had an adhesive containing asbestos. Asbestos is a health risk when it is made friable - in other words, when its fibres and dust can be breathed in by the lungs. To be safe, please refrain from removal and damaging these tiles until it is certain they are not asbestos containing material.

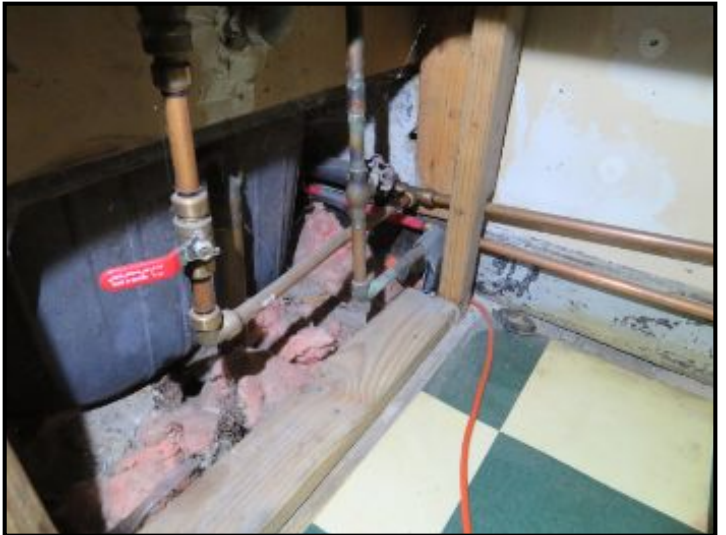
6. Plumbing

• **Improper "S" trap noted.** This trap configuration may cause the trap to siphon dry, allowing sewer gas and odor to enter the dwelling. This situation may be rectified by the installation of an anti siphon device (cheater vent). Suggest repair by a qualified professional. In the alternative, run a little bit of water into the sink to reseal the trap if odor is detected.

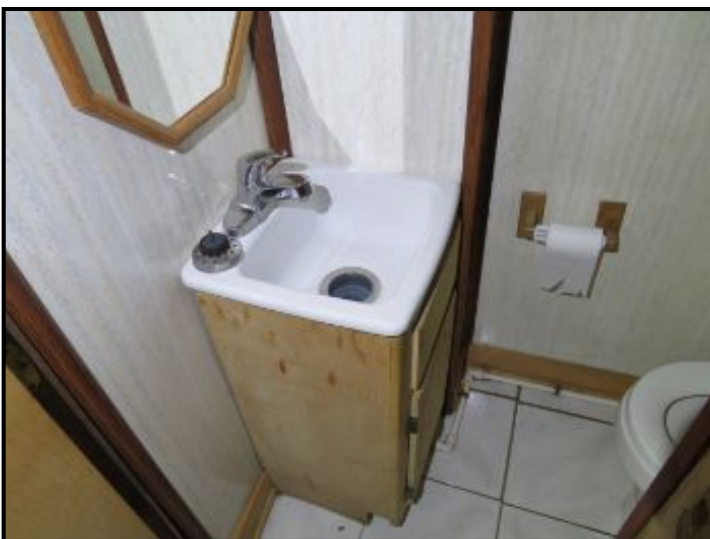
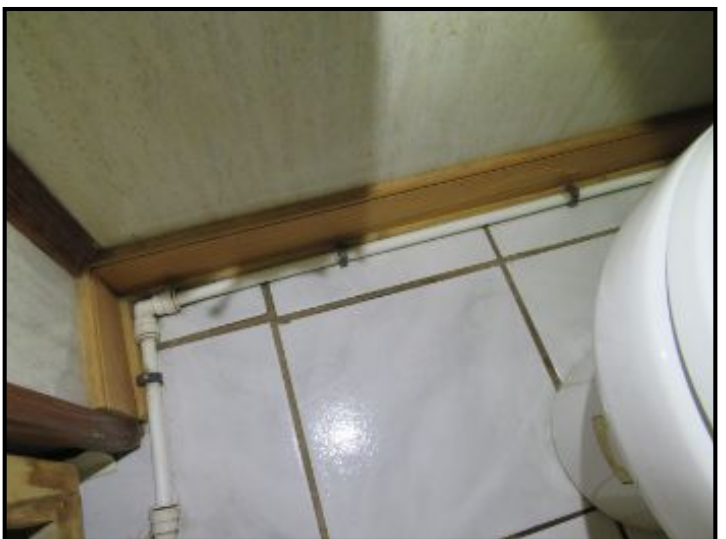
- Note that without water the sink(s) and dishwasher could not be evaluated.
- **The sink stopper linkage is damaged or disconnected and does not function properly. Recommend repair by a licensed plumbing contractor.**
- **There is PVC supply lines laying on the floor in the bathroom area. Recommend repair by a licensed plumbing contractor.**

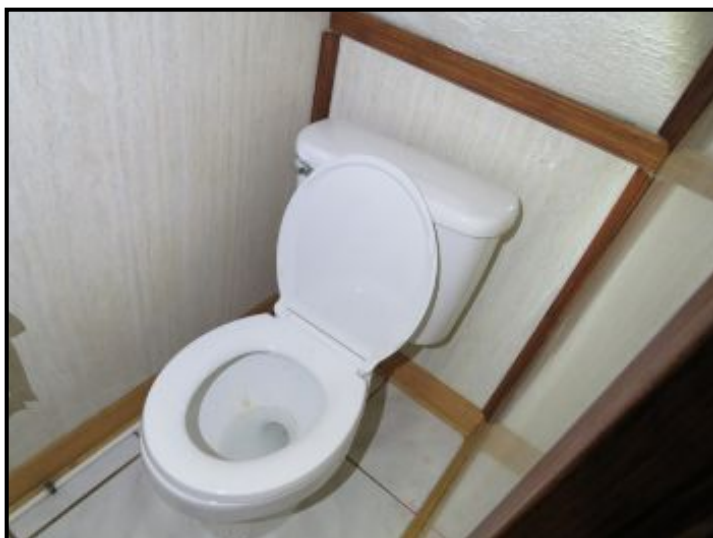
10. Toilets

- The toilet is loose at the floor. Recommend repair by a licensed plumbing contractor.
- The floor is sunk down at the back of the toilet. Recommend repair by a licensed contractor.

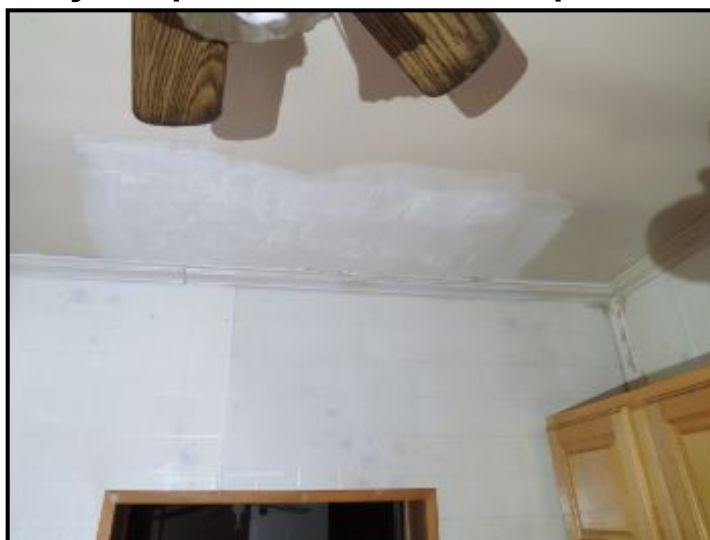
• **There are cosmetic drywall/plaster cracks and imperfections noted.**

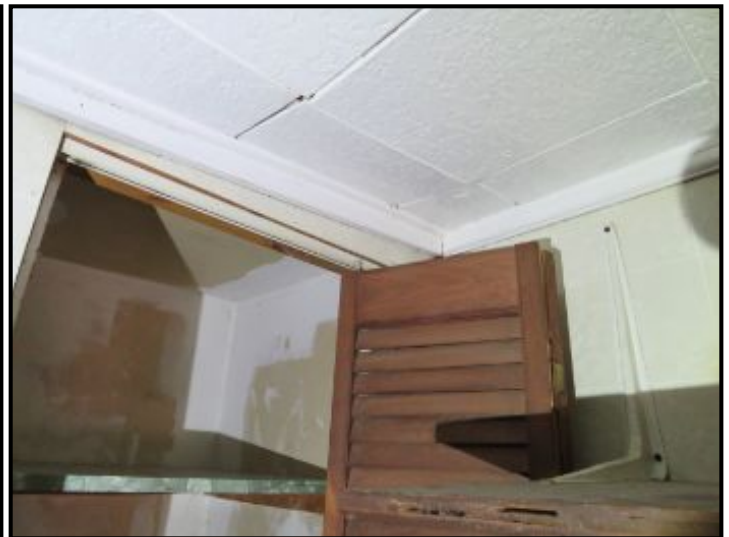
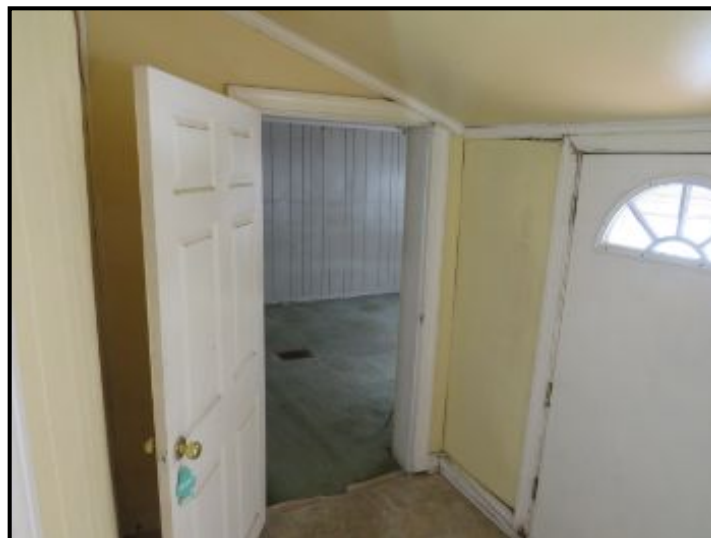
4. Doors

- Some doors do not latch properly or stick in the frame when closed. Recommend repair by a licensed contractor. 200.00 - 300.00
- Some doors drag the floor when opening. Recommend repair by a licensed contractor.
- Some bi-fold doors are out of the track. Recommend repair by a licensed contractor.
- Bedroom door is missing doorknob & hardware.

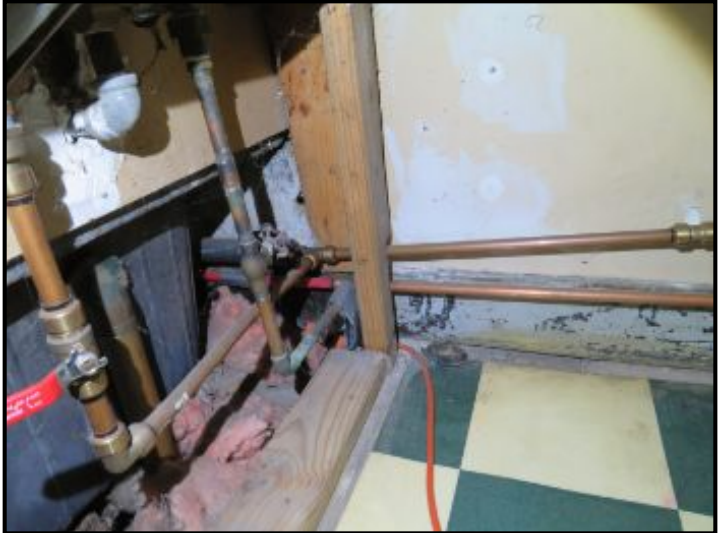
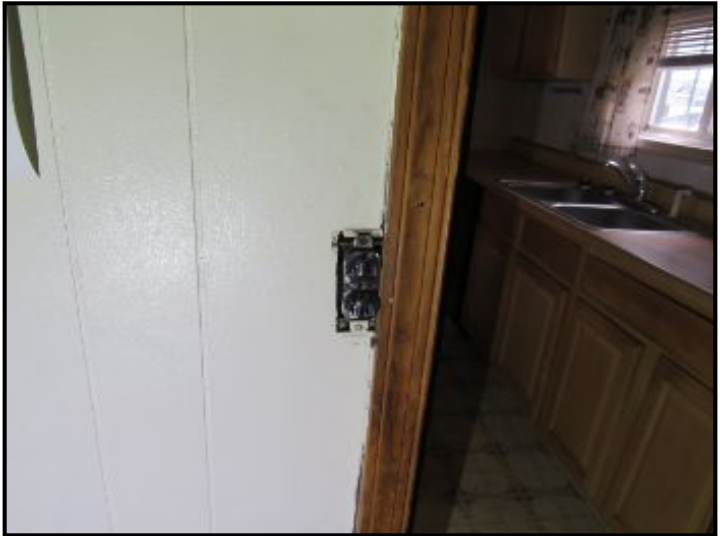
5. Electrical

- **Cover plate(s) are missing from one or more electric receptacle boxes. They are intended to contain fire and prevent electric shock from exposed wires. This is a safety hazard and poses a risk of both fire and shock. Recommend installing cover plates over receptacle boxes where missing.**
- **Electrical connections made out side of a covered junction box. This is a safety fire hazard. Recommend repair by a licensed Electrical contractor.**

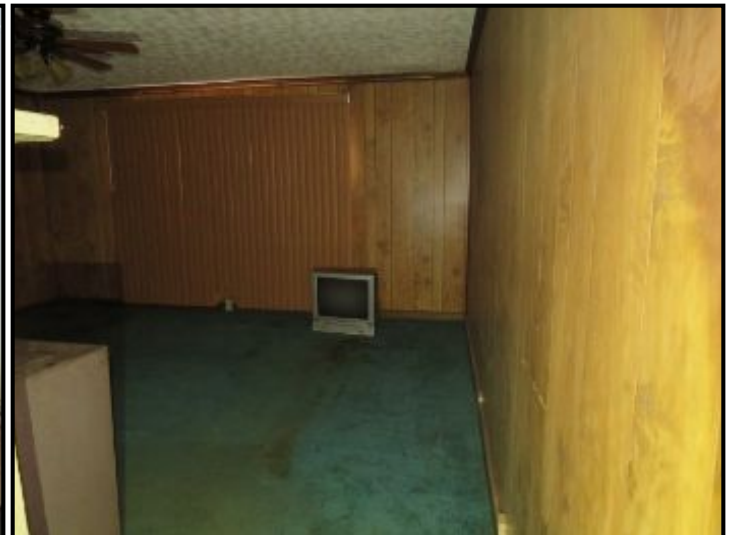
6. Floor Condition

- Some stained or faded carpets noted.
- The hardwood flooring is scuffed and stained in some areas..
- Walking on some sections of the floor results in squeaking or creaking noises. This is usually the result of substandard construction practices where the subfloor decking isn't adequately fastened (insufficient glue) to the framing below. In most cases, this is an annoyance only rather than a structural problem. Various solutions such as [[url="http://www.oberry-enterprises.com"](http://www.oberry-enterprises.com)]Squeeeeeek No More and Counter Snap fasteners[/url] exist to correct this. Repairs to eliminate the squeaks or creaks may be more or less difficult depending on there being finished hardwood floors, carpeting over the subfloor, and/or clear access to the underside of the subfloor. Recommend having a qualified contractor evaluate and repair as necessary.

- Some of the floors in this building are a vintage 9" x 9" size; be advised that these tiles may be the type that had an adhesive containing asbestos. Asbestos is a health risk when it is made friable - in other words, when its fibres and dust can be breathed in by the lungs. To be safe, please refrain from removal and damaging these tiles until it is certain they are not asbestos containing material.

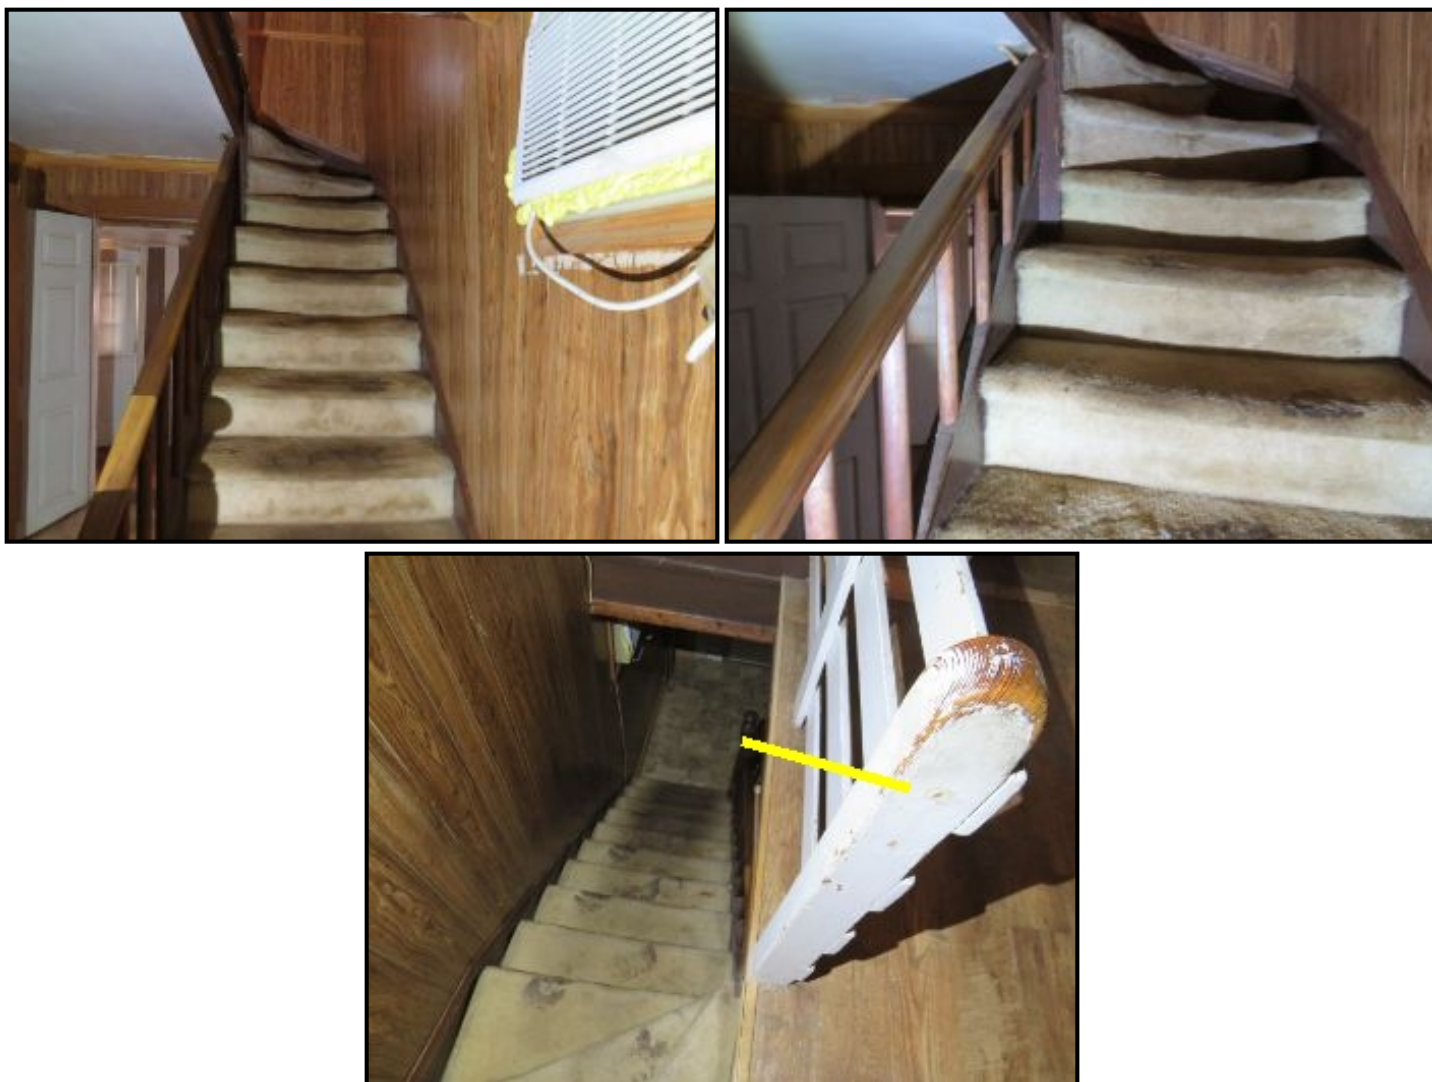
- The stair wells in the home can be considered narrow by current standards
- Hand rails are missing at the interior stairs. This is a safety hazard. Recommend repair by a licensed contractor.
- Lighting is NOT INSTALLED.

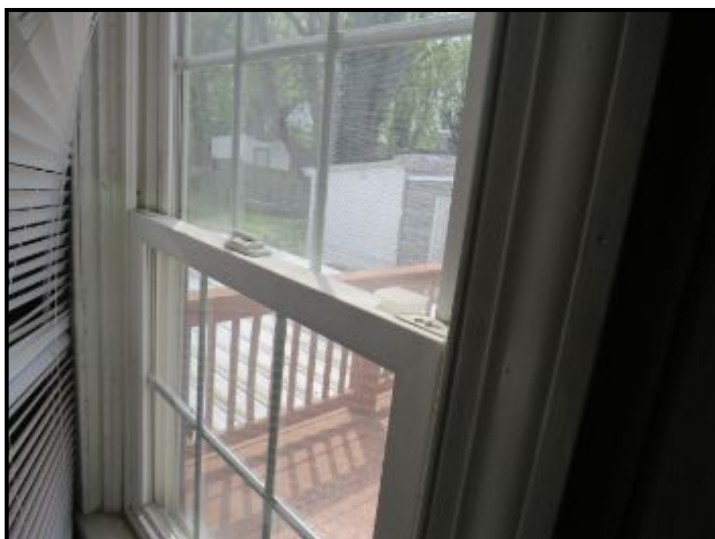
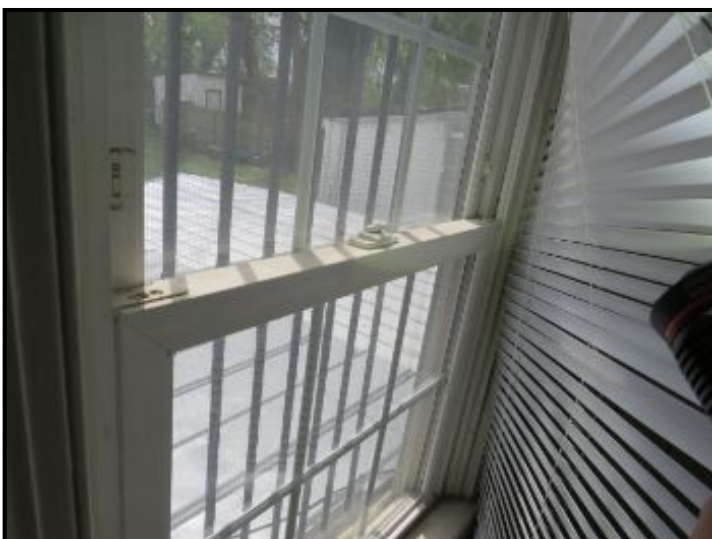
13. Window Condition

- **One or more windows did not lock/latch properly, recommend repairs for enhanced security/safety to occupants.**

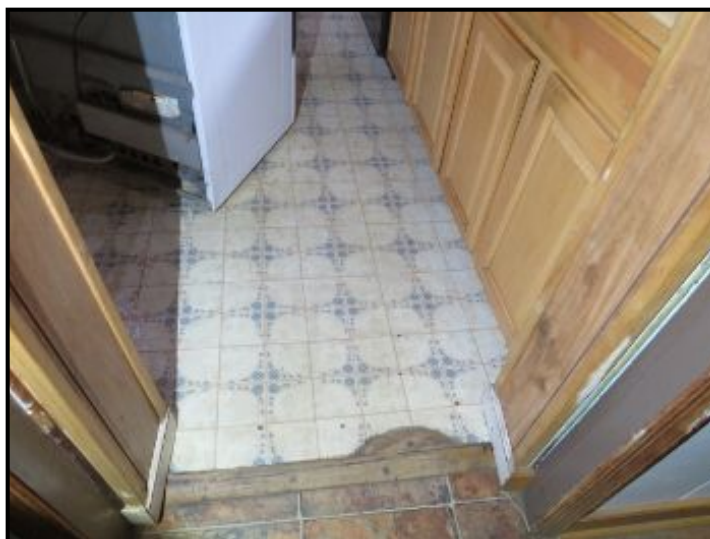
- Cosmetic kitchen floor damaged noted.

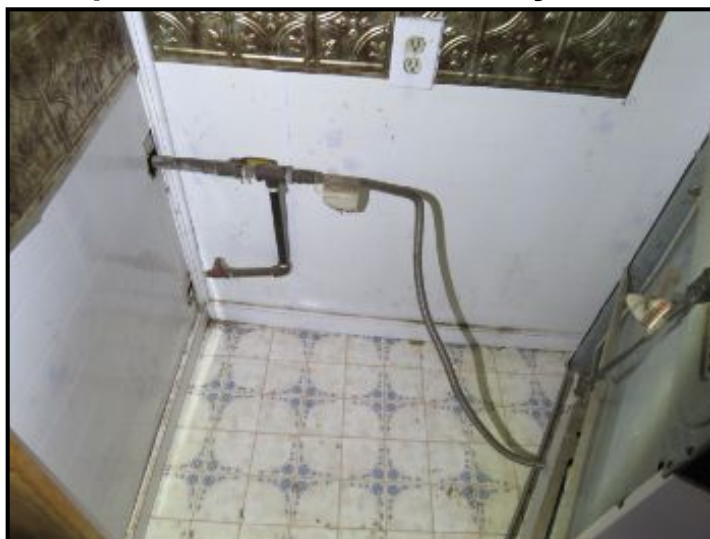
7. Oven & Range

- **Oven: gas burners**
- **Anti-tip bracket is missing from range installation. See label inside oven door. All free-standing, slide-in ranges include an anti-tip device and is essential in the safe operation of the range. It provides protection when excess force or weight is applied to an open oven door. Carried by home building centers.**

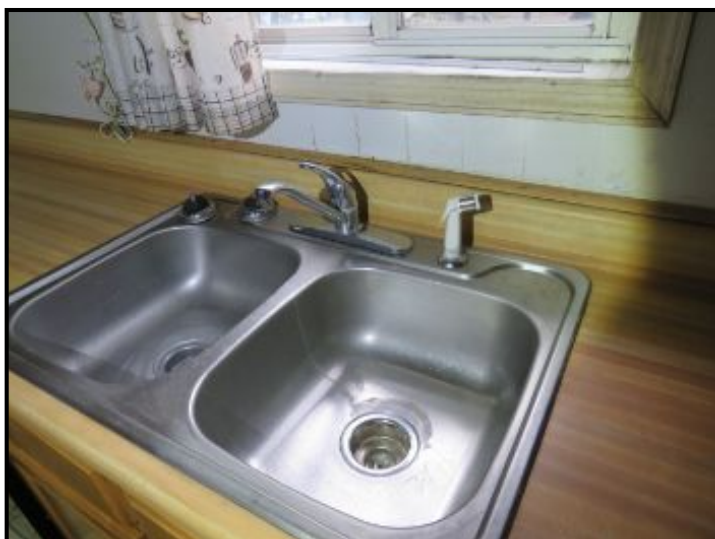
- **The sink could not be tested. The water is not turned on at the meter.**
