Commission of Architectural Review SUBMISSION APPLICATION

LOCATION OF WORK: 2220 E. Marshall St DATE: 11/18/15

Property Inspection Report

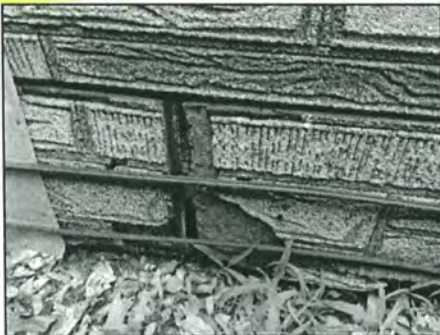
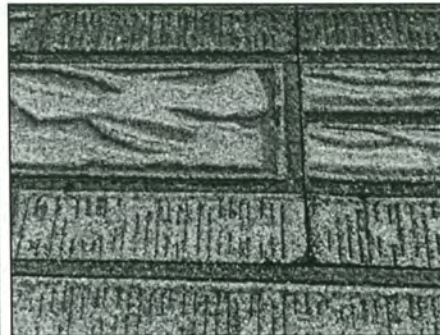
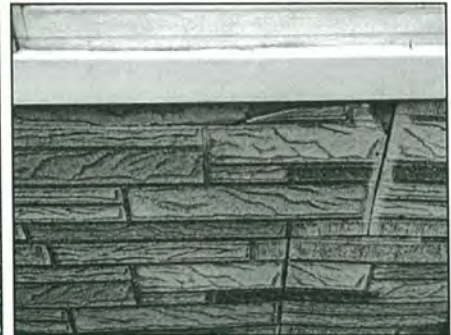
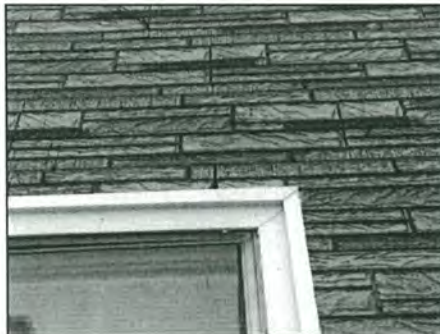
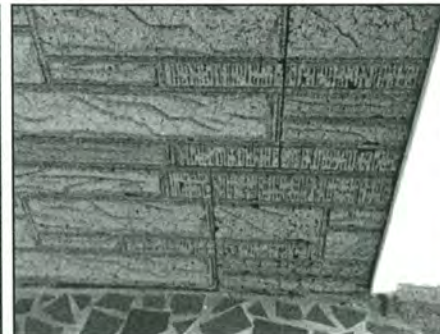
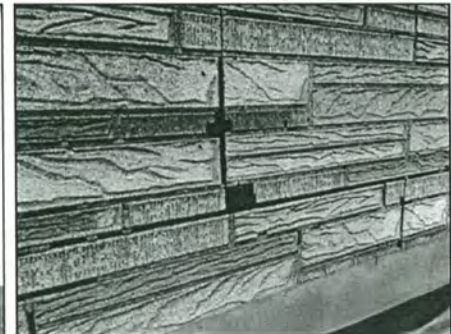
1.1. The asphalt siding has reached the end of its useful life. Many instances of damage, cracking, and deteriorating were observed. I recommend discussing options and costs for replacement with a qualified contractor. (\$8000-\$13000+)

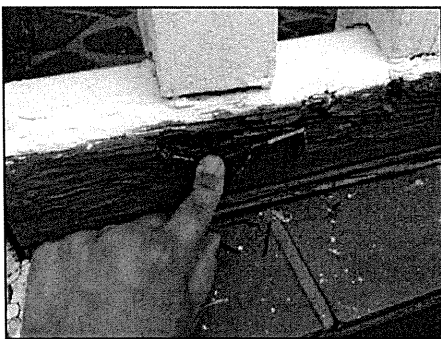
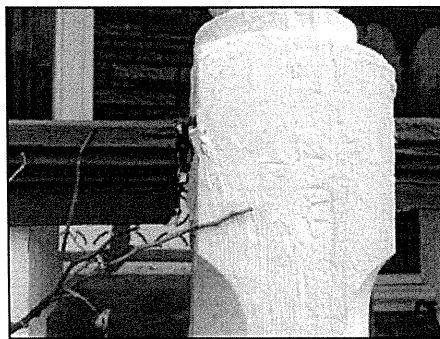
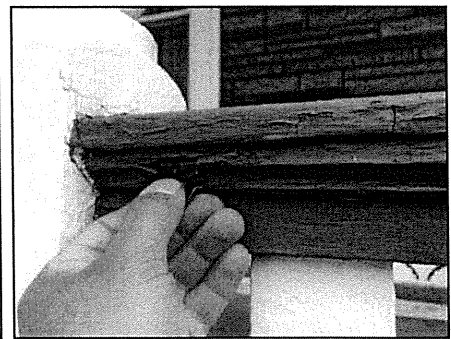
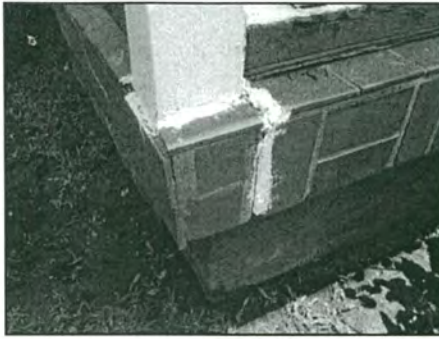
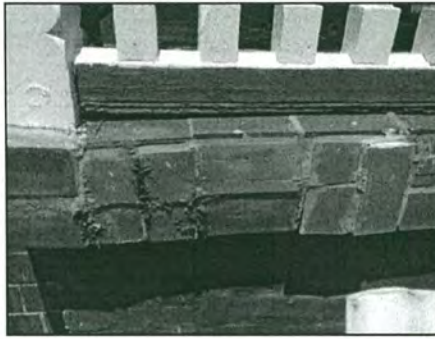
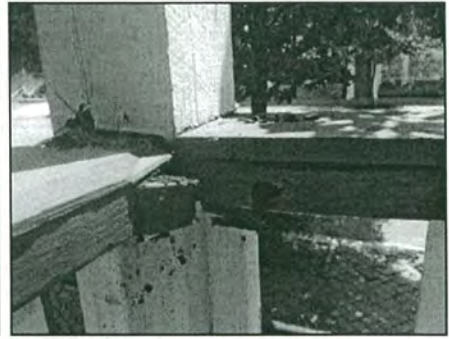
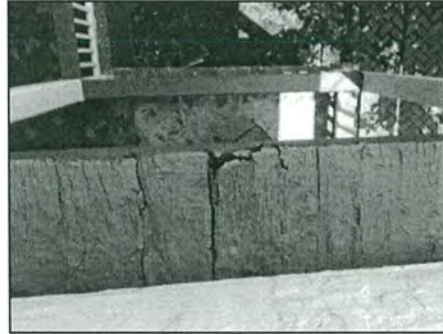
There were many instances of rot observed at the second floor porch including decking boards, wood trim, the main posts, and in the eaves above the main posts. I recommend repair by a qualified contractor. (\$500-\$800+)

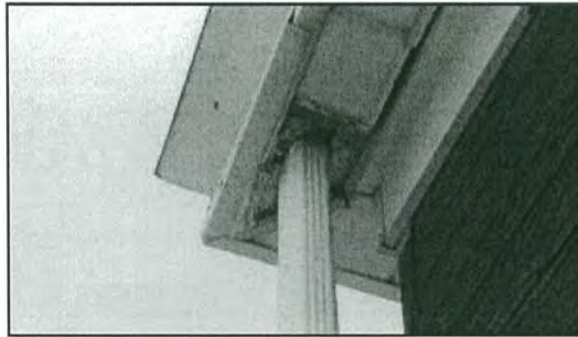
6.1. There was an instance of rot observed in the eaves at the front of the house. I recommend having a qualified contractor repair as needed. (\$150-\$250+)

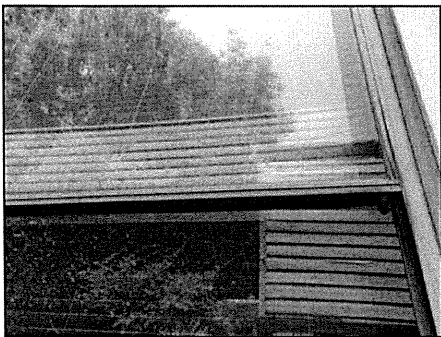
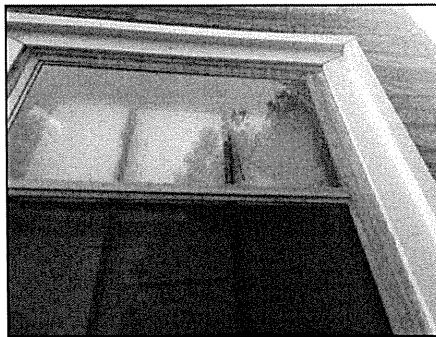
The rear exterior window had a crack in the pane. This was not observed from the interior due to the addition of the downstairs shower. I recommend repair by a qualified glazier or contractor.

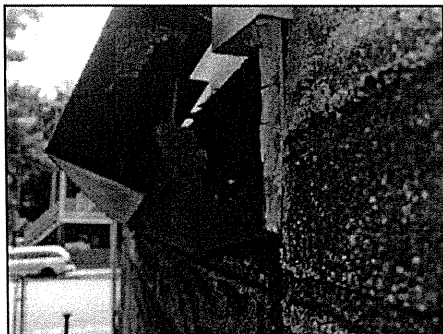
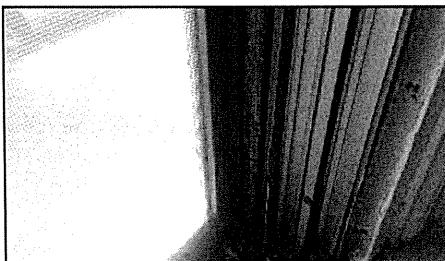
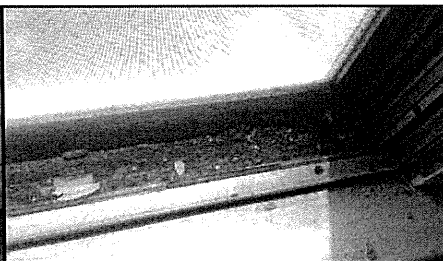
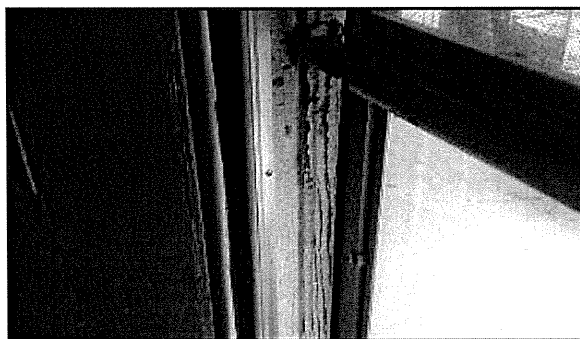
8.2. The window sill of the rear facing window was rotted under the metal cladding. I recommend repair by a qualified contractor. (\$250-\$350+)
