**Staff Report**  
**City of Richmond, Virginia**

**Commission of Architectural Review**

1. COA-126437-2023	<b>Final Review</b> <b>Meeting Date: 3/28/2023</b>
<b>Applicant/Petitioner</b>	Lizzie Drucker-Basch
<b>Project Description</b>	Replace wood windows with aluminum clad wood windows.
<b>Project Location</b>	
<b>Address: 604 St. James Street</b>	
<b>Historic District: Jackson Ward</b>	
<p><b>High-Level Details:</b></p> <p>Applicant proposes replacing 5 deteriorated wooden windows on the front façade of a detached, Italianate, masonry dwelling ca. 1900.</p> <p>Staff believes that the windows show significant signs of deterioration. The lower sashes of the second-story windows do not appear original to the building.</p> <p>Replacement windows will be aluminum clad wood and will match the historic pane configuration.</p>	
<b>Staff Recommendation</b>	<b>Approval, with Conditions</b>
<b>Staff Contact</b>	Alex Dandridge, 804-646-6567, <a href="mailto:alex.dandridge@rva.gov">alex.dandridge@rva.gov</a>

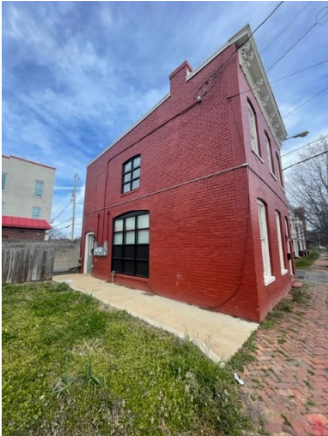
Figure 1. South side elevation. New windows  
Previously approved by CAR.

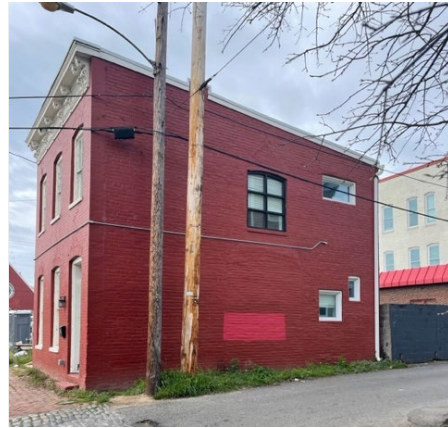
Figure 2. North side elevation. New windows  
previously approved by CAR.

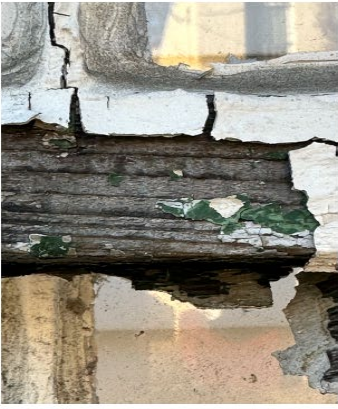
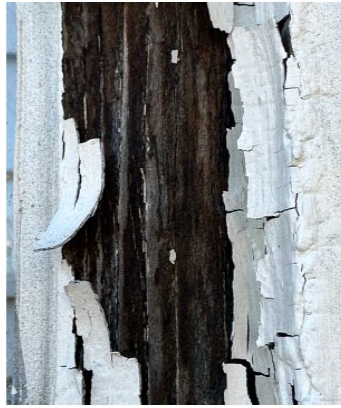
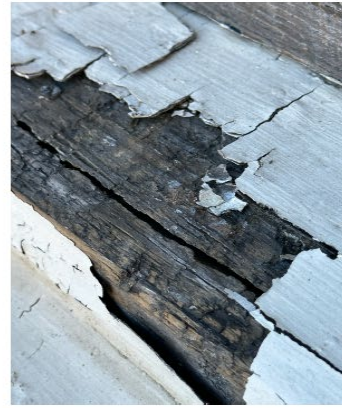
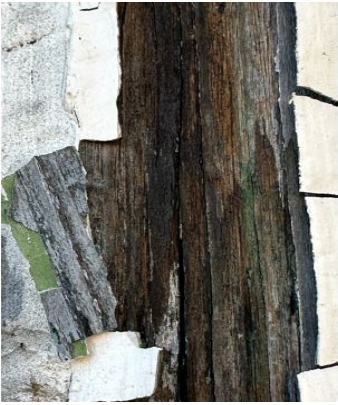
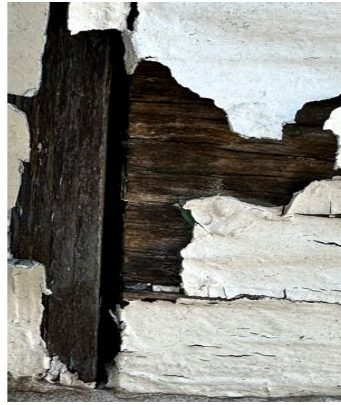
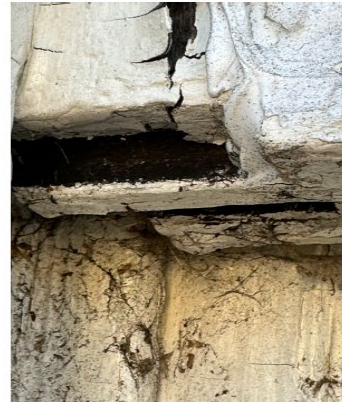
Figure 3. Deterioration details.
