Staff Report
City of Richmond, Virginia

Commission of Architectural Review

COA-098250-2021	Final Review	Meeting Date: 9/28/2021
Applicant/Petitioner	Justin Drumwright	
Project Description	Rehabilitation of a 2-story, detached, single-family home; construct a rear, 2 nd story addition	
Project Location		
Address: 810 Jessamine St.		
Historic District: Union Hill		
High-Level Details: <ul style="list-style-type: none"> The applicant proposes to construct a rear, 2nd story addition to a ca. 1870 Greek Revival house. The original front porch columns were replaced prior to the Union Hill City Old and Historic District Designation. Staff notes that the work has already been completed. 		
Staff Recommendation	Approval, with Conditions	
Staff Contact	Alex Dandridge, alex.dandridge@rva.gov , (804) 646-6569	
Previous Reviews	None.	
Conditions for Approval	<ul style="list-style-type: none"> Staff recommends that the rear second story addition be differentiated from the existing house using a different material or applying an exterior feature that gives reference to the historic roofline. Staff recommends that a material in-keeping with the guidelines be utilized, and that it be smooth and w

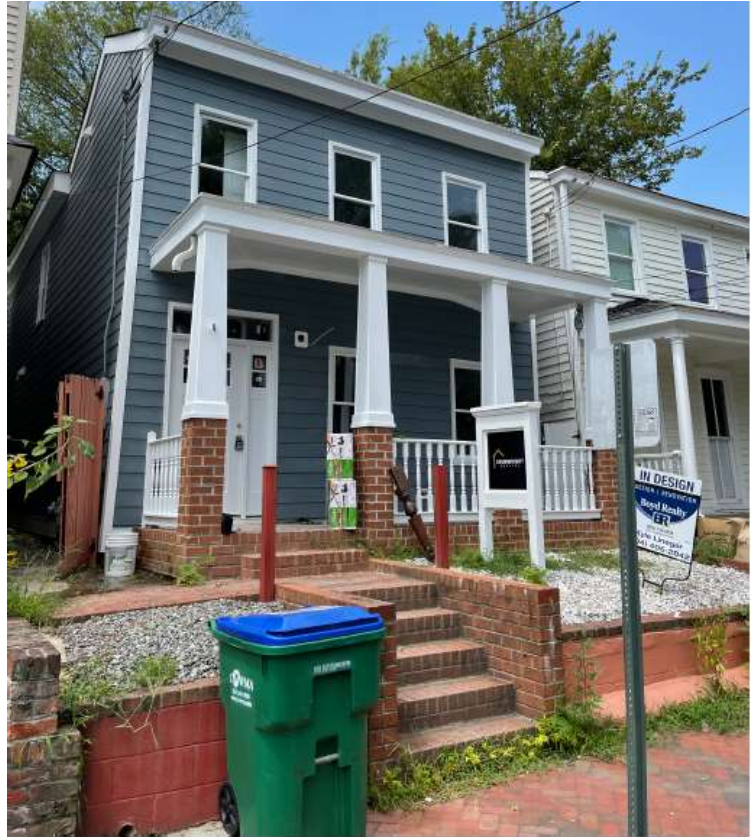
Figure 2. Current façade photo.

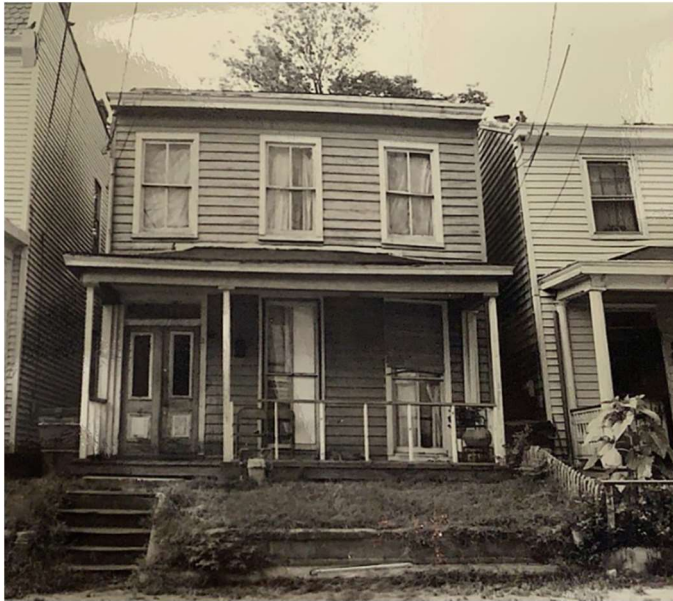
Figure 3. Historic photo from DHR records.

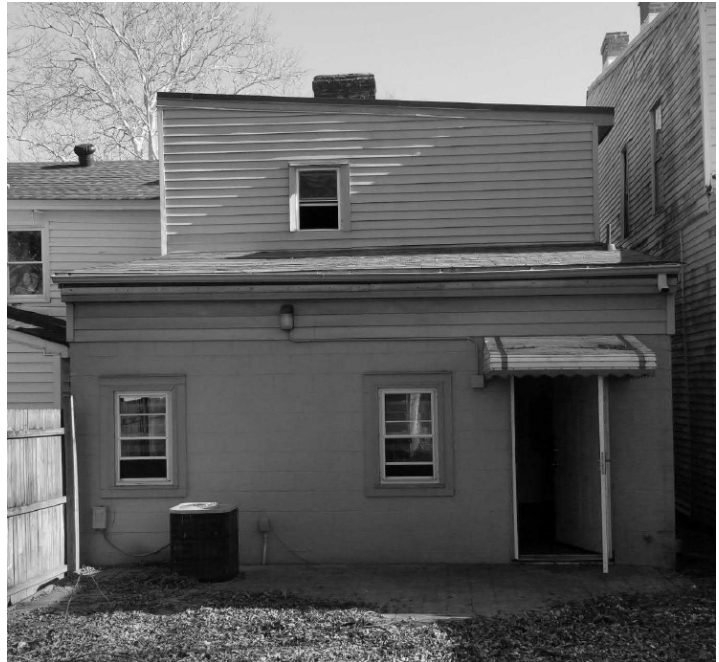
Figure 4. Previous rear elevation.

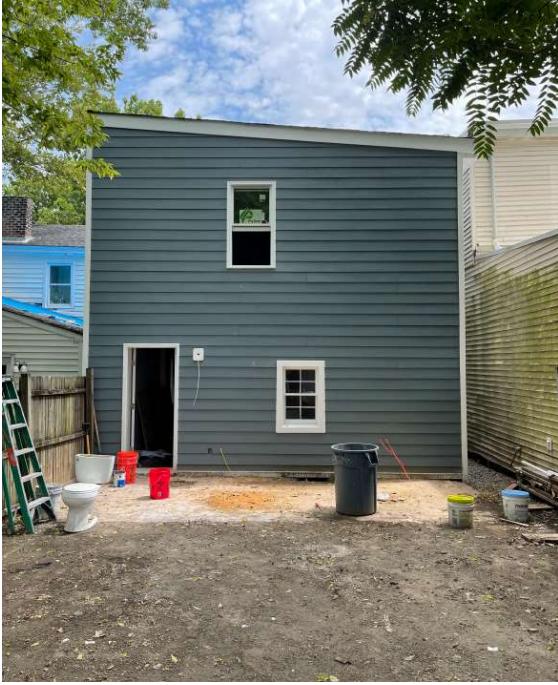
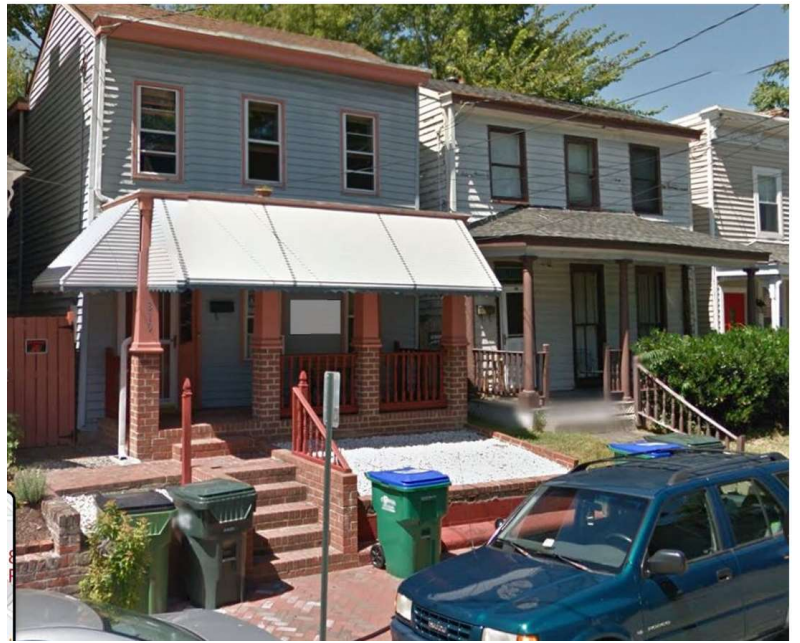
Figure 5. Existing rear elevation, showing the new addition.
