Staff Report  
City of Richmond, Virginia

Commission of Architectural Review

6.COA-137154-2023	<b>Final Review</b> <span style="float: right;"><b>Meeting Date: 10/24/2023</b></span>
Applicant/Petitioner	Todd Dykshorn
Project Description	Add new windows to a garage and paint exterior.
Project Location	
Address: 211 North 18 <sup>th</sup> Street	
Historic District: Shockoe Valley	
<b>High-Level Details:</b> <ul style="list-style-type: none"> <li>The applicant requests approval to alter the exterior of a rear garage by painting the exterior and adding windows.</li> <li>The existing building is located at the rear of a residential building. The garage is constructed of brick and features two garage doors (infilled with wood) facing a parking lot to the south. The garage has a stepped design, with each bay stepping down toward the alley.</li> <li>A brick portion with a gable roof was constructed as a second floor in 1994.</li> <li>The work outlined in the application has already been completed.</li> </ul>

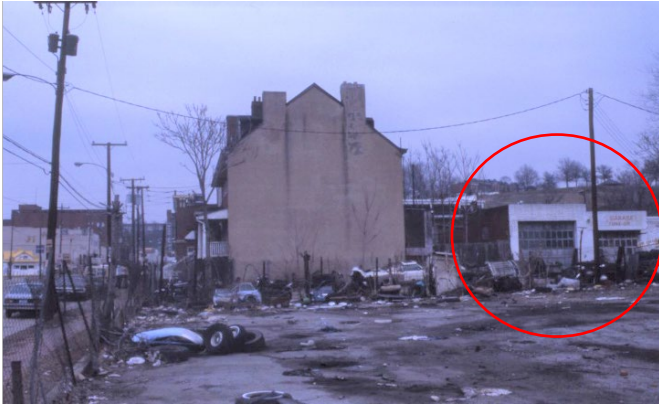
Figure 1. Rear garage at 211 N. 18<sup>th</sup> Street. 1986. Building painted. Second-story addition not yet constructed.

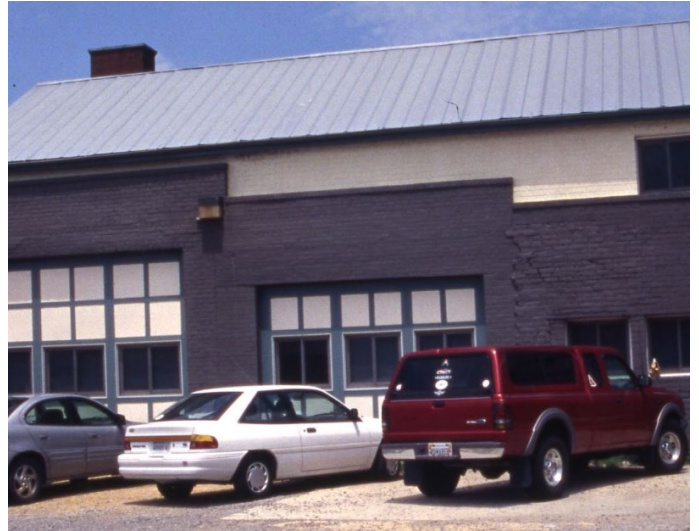
Figure 2. Rear garage at 211 North 18<sup>th</sup> Street. Second-story addition constructed without skylights.

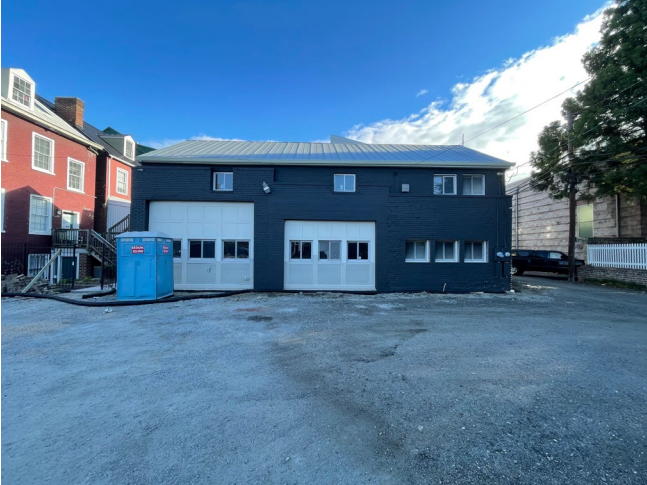
Figure 5. Existing Conditions, October 2023. New masonry openings added to the second floor and building painted a singular color.

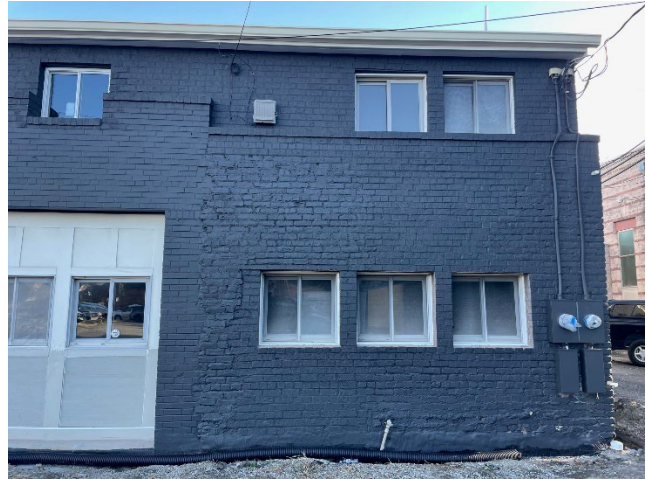
Figure 6. Existing Conditions, October 2023. New masonry openings added to the second floor and building painted a singular color. Three lower windows were completed as part of the 1994 rehabilitation.

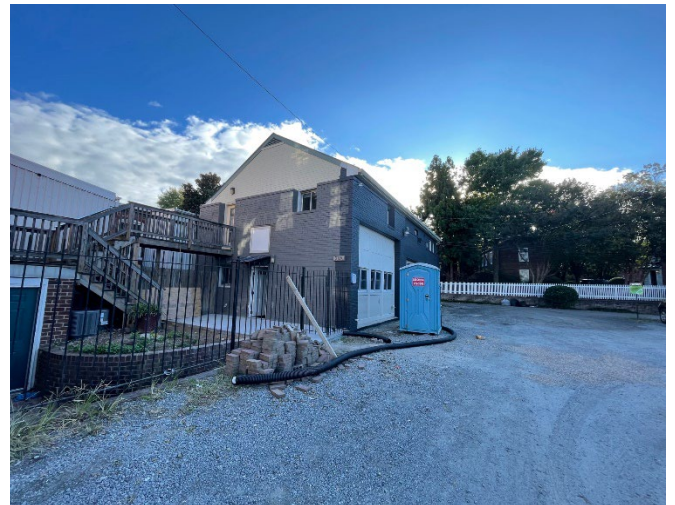
Figure 8. Existing Conditions, October 2023. New masonry openings added to the second floor and building painted a singular color.
