Staff Report
City of Richmond, Virginia

Commission of Architectural Review

6.COA-137154-2023	Final Review	Meeting Date: 10/24/2023
Applicant/Petitioner	Todd Dykshorn	
Project Description	Add new windows to a garage and paint exterior.	
Project Location		
Address: 211 North 18 th Street		
Historic District: Shockoe Valley		
High-Level Details: <ul style="list-style-type: none"> The applicant requests approval to alter the exterior of a rear garage by painting the exterior and adding windows. The existing building is located at the rear of a residential building. The garage is constructed of brick and features two garage doors (infilled with wood) facing a parking lot to the south. The garage has a stepped design, with each bay stepping down toward the alley. A brick portion with a gable roof was constructed as a second floor in 1994. The work outlined in the application has already been completed. 		
Staff Recommendation	Approval, with Conditions	
Staff Contact	Alex Dandridge, (804) 646-6569

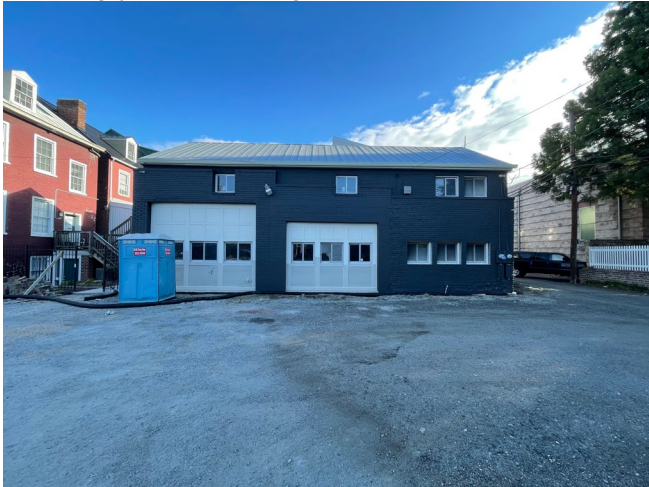
Figure 5. Existing Conditions, October 2023. New masonry openings added to the second floor and building painted a singular color.

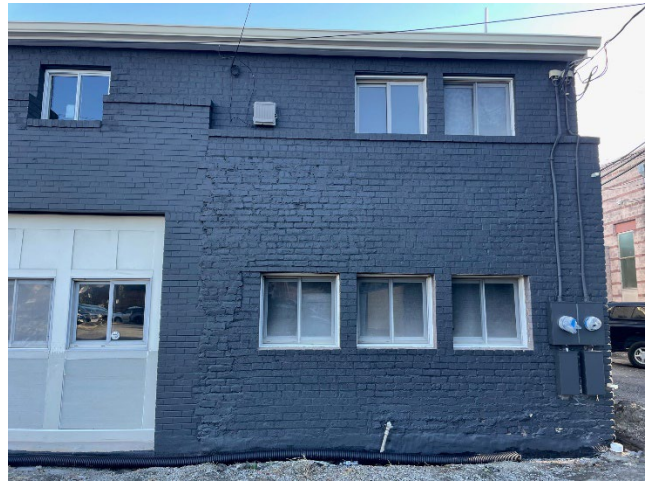
Figure 6. Existing Conditions, October 2023. New masonry openings added to the second floor and building painted a singular color. Three lower windows were completed as part of the 1994 rehabilitation.
