Staff Report  
City of Richmond, Virginia

Commission of Architectural Review

4. COA-134295-2023	Final Review	Meeting Date: 10/24/2023
Applicant/Petitioner	Daniel Leonard	
Project Description	Construct a pergola in a rear yard.	
Project Location		
Address: 2519 East Grace Street		
Historic District: St. John's Church		
<p><b>High-Level Details:</b></p> <ul style="list-style-type: none"> <li>The applicant requests approval to construct a pergola in the rear yard of a brick, Greek Revival dwelling circa 1862, otherwise known as the George A. Ainslie House.</li> <li>The pergola will be constructed of metal with a black finish and will be 15'x10'x10'. It will have a flat roof form with parallel, flush metal slats. The roof will be supported by simple square posts.</li> <li>The pergola will be visible from the public right-of-way, projecting above the rear brick wall. The applicant plans on planting evergreen shrubs to screen the pergola.</li> <li>In addition to the pergola, two new gates will be installed on the rear brick wall, one facing North 26<sup>th</sup> Street and one facing the rear alley. The gates will have a curved top and turned spindles on the upper half.</li> <li>The pe

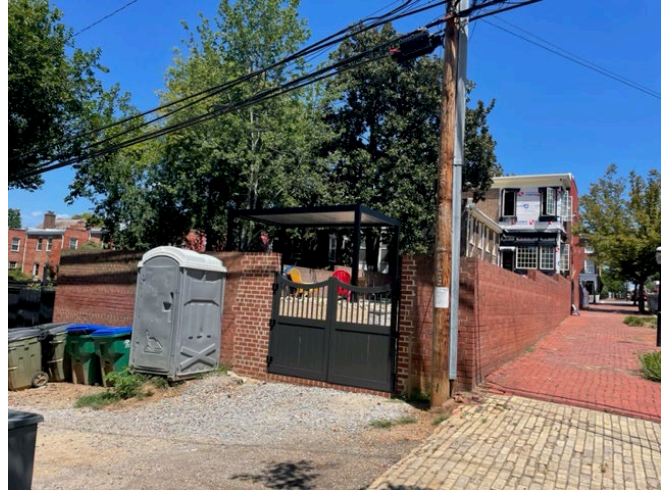
<p>Site Improvements, Fences &amp; Walls, pg. 51</p>	<p>1. Fence, wall, and gate designs should reflect the scale of the historic structures they surround, as well as the character of nearby fences, walls, and gates.</p>	<p>Two gates have been installed on the rear and side of the extant brick wall. The gates are traditional in design with curved tops. The lower halves of the gates are opaque, while the upper halves have small turned spindles. Staff finds that the gate design is in-keeping with the character of nearby gates.</p> <p>At the August meeting, the Commission recommended that the gates be taller or more opaque in order to further screen the rear yard site improvements. In the revised application, the applicant states that gates will not be redesigned, as the trellis proposal should increase the screening of the rear yard as seen from the alley.</p>
<p>Secretary of the Interior's Standards for Rehabilitation</p>	<p><i>2. The historic character of a property shall be retained and preserved. The removal of historic materials or alteration of features and spaces that characterize a property shall be avoided.</i></p> <p><i>5. Distinctive features, finishes and construction techniques or examples of craftsmanship that characterize a property shall be preserved.</i></p> <p><i>9. New additions, exterior alterations or related new construction shall not destroy historic materials that characterize the property. The new work shall be differentiated from the old and shall be compatible with the massing, size, scale and architectural features to protect the historic integrity of the property and its environment.</i></p>	<p>The 1990 National Register of Historic Places Amendment for St. John's Church lists the district as being significant under Criterion C. Architecture, specifically Greek Revival, Italianate, and Victorian.</p> <p>2519 East Grace Street is historically significant for its architectural style, which is Greek Revival with Italianate influences. When reviewing the impacts of the construction of the pergola against the Secretary of the Interior's Standards for Rehabilitation, Staff finds the pergola will not destroy historic materials that characterize the building. Staff also finds that the pergola will be adequately differentiated from the old materials and will have a rectangular form as seen in other auxiliary structures in the district.</p> <p>It is common in the St. John's Church City Old and Historic District for properties to have rear gardens enclosed by a brick wall. Some rear yards in the district do feature carriage houses or other auxiliary structures that are subordinate to the primary building on site. While most original auxiliary structures have the same materiality and design elements of the primary building, the new pergola's minimalist design does not match the traditional design of 2519 East Grace Street and this design choice will serve as a means of differentiation.</p> <p>Sanborn Maps from 1905 indicate that the subject site did historically feature rear auxiliary structures including a masonry 2-story structure and a few smaller frame structures. These structures were demolished long ago, but this information does confirm that other smaller structures have existed on the site in the past. (See figure 6)</p> <p><u>Staff finds that the installation of the proposed pergola does not negatively impact the integrity of the site's historic significance.</u></p>

Figure 2. View of pergola and rear yard looking north from rear alley. Newly installed gates partially obscure the rear yard.

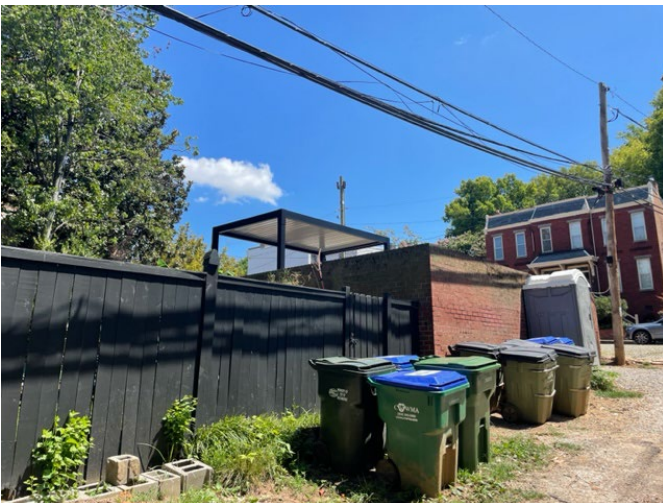
<p><i>factor for the installation of these structures. However, prefabricated structures will still be reviewed for compatibility using the criteria developed in this section.</i></p>	<p>building on-site. It is subordinate in size and located in the rear yard.</p> <p>Staff finds that the narrow, dark frame of the pergola does not clash with other materials on site.</p> <p>At the August 2023 Commission meeting, the Staff Report stated that the metal underside of the pergola roof was highly reflective. Reflective finishes are not common in City Old and Historic Districts. <u>Staff recommends that the ceiling of the pergola be finished or painted with a matte color/material; final solution to be submitted to staff for administrative review and approval.</u></p> <p>The applicant proposes to plant potted evergreen shrubs adjacent to the pergola as a means of screening. The landscape plan indicates that there will be significant plantings of large and small evergreen shrubs on the slope behind the pergola and in pots along the east wall.</p> <p>Evergreen shrubs will include fourteen dense Emerald Green Arborvitae trees along the east side wall spaced at approximately 3.5 ft. The shrubs will have a mature height of 12-14 feet. The applicant indicates that these shrubs have already been purchased and have a height of 6-9 feet. They will be planted in the coming weeks before winter.</p> <p>Since the August 2023 review, the applicant now proposes to construct a wooden trellis screening around the pergola, specifically adjacent to the south elevation and the N. 26<sup>th</sup> Street elevation. The trellis will be planted with ivy. <u>Staff recommends that the trellis be painted a color that compliments the pergola and primary building; final color selection and trellis design submitted to staff for administrative review and approval.</u></p>

Figure 3. View of pergola looking northeast from the rear alley. There is a steep grade change in this location. This image was taken standing quite low down a steep hill from the subject site. Reflectivity of the ceiling is apparent.

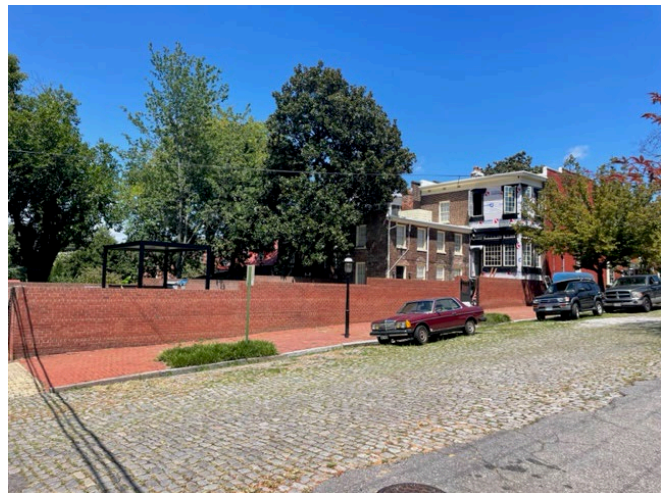
Figure 4. View of pergola from across 27<sup>th</sup> Street looking west. Pergola is situated quite far to the rear of the primary building.

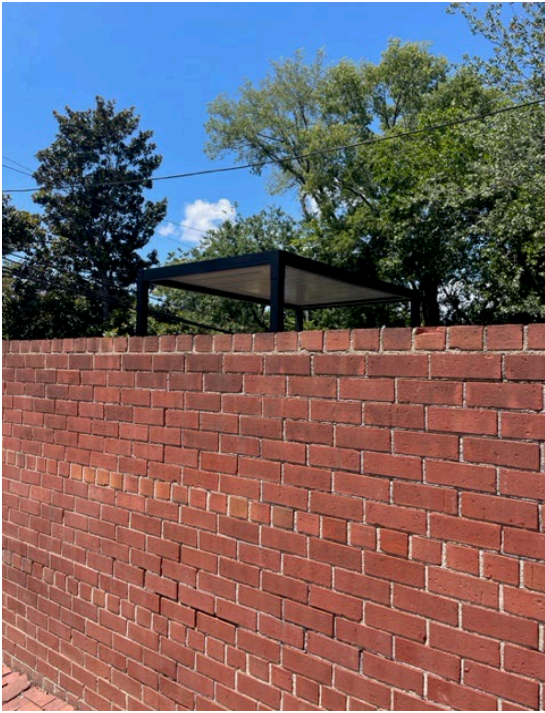
Figure 5. View of pergola from adjacent sidewalk.
