Staff Report
City of Richmond, Virginia

Commission of Architectural Review

3.COA-158358-2024	Final Review	Meeting Date: 1/28/2025
Applicant/Petitioner	David Franks	
Project Description	Reconstruct a covered front porch.	
Project Location

Address: 1809 West Grace Street		
Historic District: West Grace Street		
High-Level Details: The applicant requests approval to reconstruct a front porch which was removed in 2024 without review and approval by the CAR. The building is a masonry, three-story, colonial revival building circa 1908. There have been three documented front porch designs on the building. The porch that was removed was not the original. A notice of violation was issued to the property in April 2024. A code case (036818-2020) was issued to the property for deteriorating front porch columns in 2020.		
Staff Recommendation	Denial	
Staff Contact	Alex Dandridge, alex.dandridge@rva.gov, (804) 646-6569	
Previous Reviews	The Commission continued this item at the December 2024 meeting, as the applicant was not present to speak on their application.

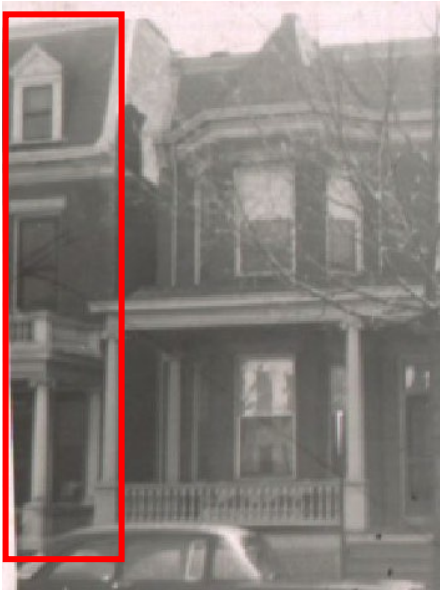
Figure 1. 1809 West Grace Street, 1950s. Original front porch with Scamozzi Columns atop square bases. Ornate entablature and balustrade with turned posts above the front porch. Similar to neighboring properties.

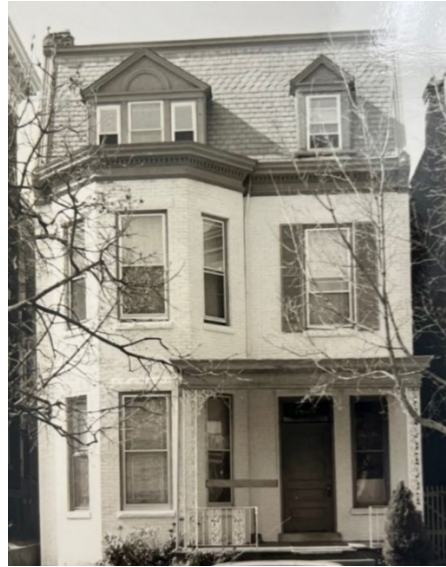
Figure 2. 1809 West Grace Street, 1977, HRF Survey. Original front porch has been removed and replaced with mid-century, decorative metal posts and railings. Original entablature appears to be in place. Building has been painted.

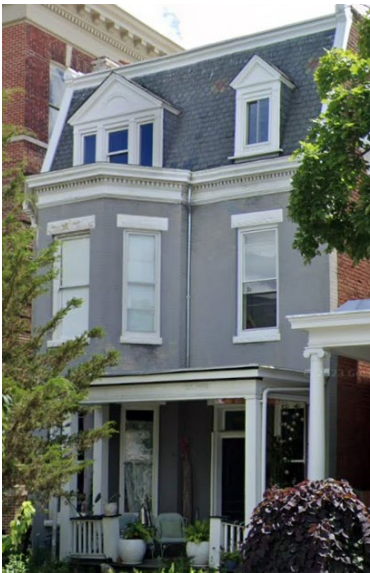
Figure 3. 1809 West Grace Street, 2023. Front porch with square posts, simple square newel posts, and a flat roof. This porch has since been removed.

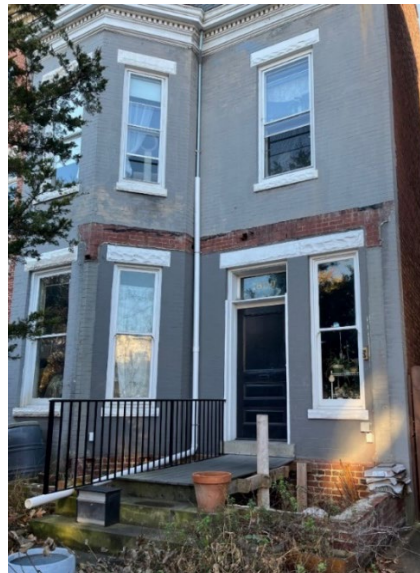
Figure 4. 1809 West Grace Street, existing conditions 2024.
