Commission of Architectural Review SUBMISSION APPLICATION

LOCATION OF WORK: 409 N. Boulevard DATE: 8/25/16

Attachment to Application for Certificate of Appropriateness

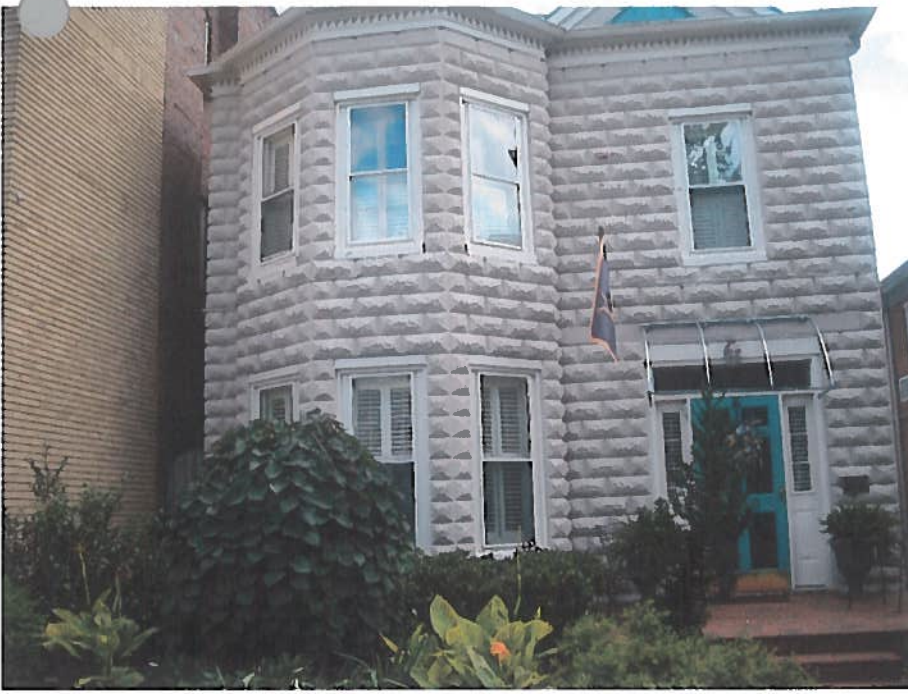
Figure 2: Front of 409 N Boulevard

Attached are pictures of the house. Figure 2 shows the front of the house and the 7 windows there that I want to replace. Figure 4 shows the north side of the house and you can see that there is only 3 to 4 feet between me and the neighboring apartment building.

My goal is to remove the existing aluminum storm windows and make all windows the same style of 0 over 0 using aluminum clad wood double pane Pella Architech series windows. The exterior of the windows will be factory painted in Pella's "Poplar White" color which matches the existing window trim paint. (A paint chip of this color is attached only to the original application.) Windows will be sized to the existing openings. Figure 1 shows the exterior detail of the new windows (the illustration is not the poplar white color). The windows will come with exterior screens that will cover the entire window.

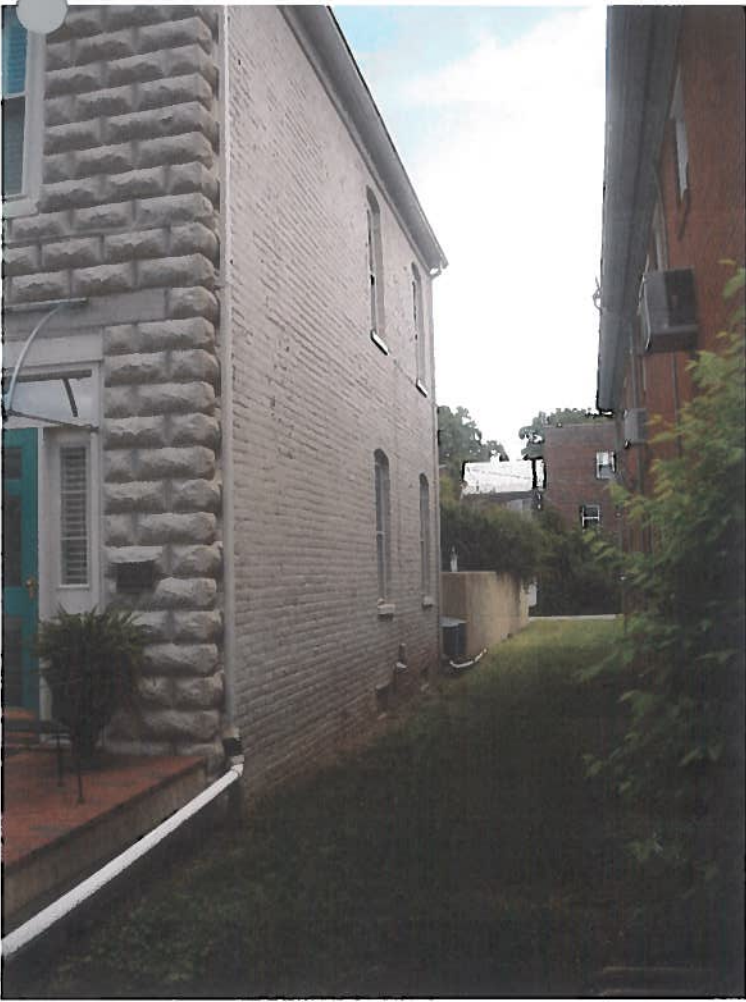
Figure 4: View of south side of building from the public right of way (sidewalk).

Figures 4 and 5 show the south side of the house from the front and rear public access points (front sidewalk and rear alley). As you can see, window details are not visible from these points.

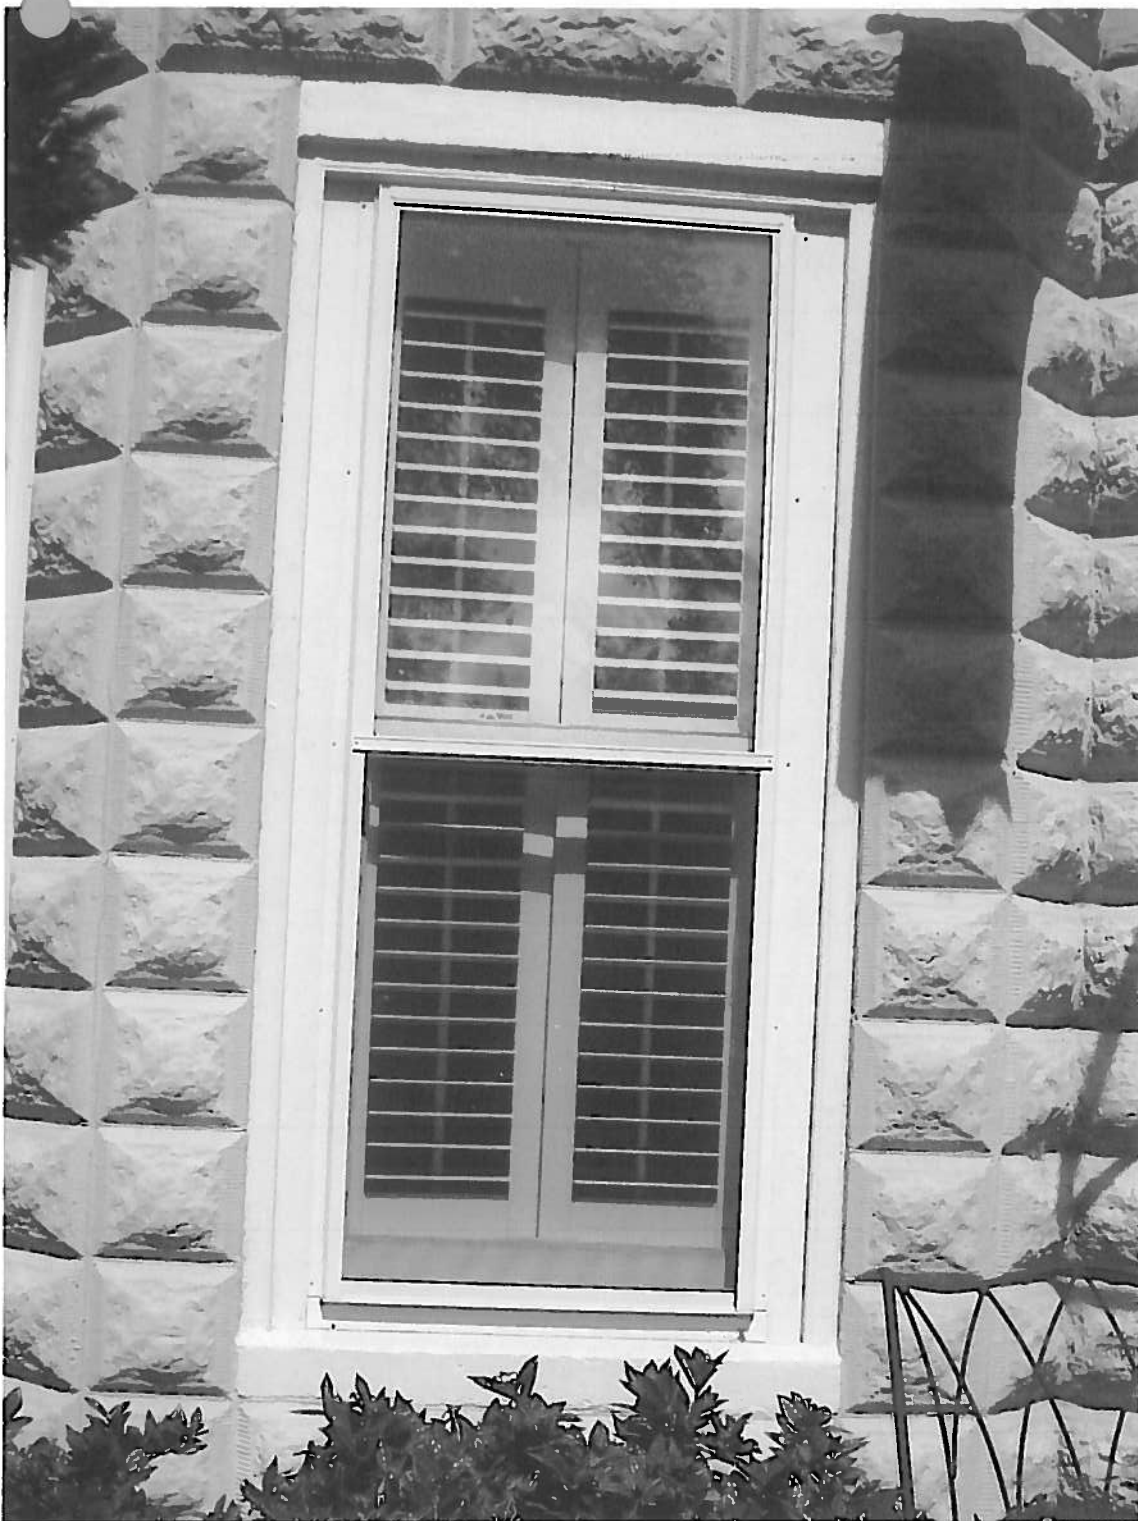
Figure 6: Close up of existing front window.

Figure 6 shows a close up of one of the front windows I want to replace.

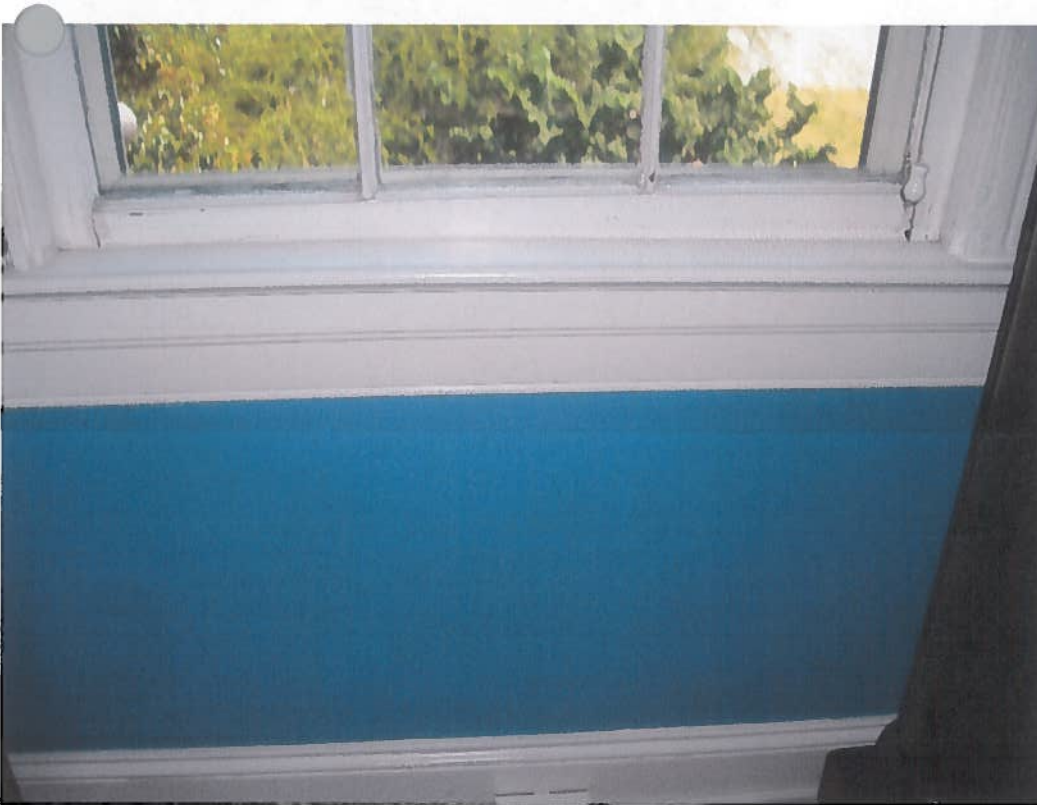
There are problems with many of the existing windows. Several are loose in the frame and in the winter, I need to use shims to close the gap between the upper and lower sashes to minimize cold drafts. Another window/frame is not squared up to the inside molding. See Figure 7. There are several other of these windows where the top and bottom sash are not aligned when closed. A previous owner used what looks like wood lathing strips on the upper sash so that the window locks could work (see Figure 8). This shows that over the last hundred years the house has settled/shifted enough so that the existing windows no longer fit or operate as they should. Fixing these problems would require rebuilding the frames and the windows themselves so I want to replace rather than repair.

Figure 7: The window sill is level but note the how the window itself is tilted up on the right side.

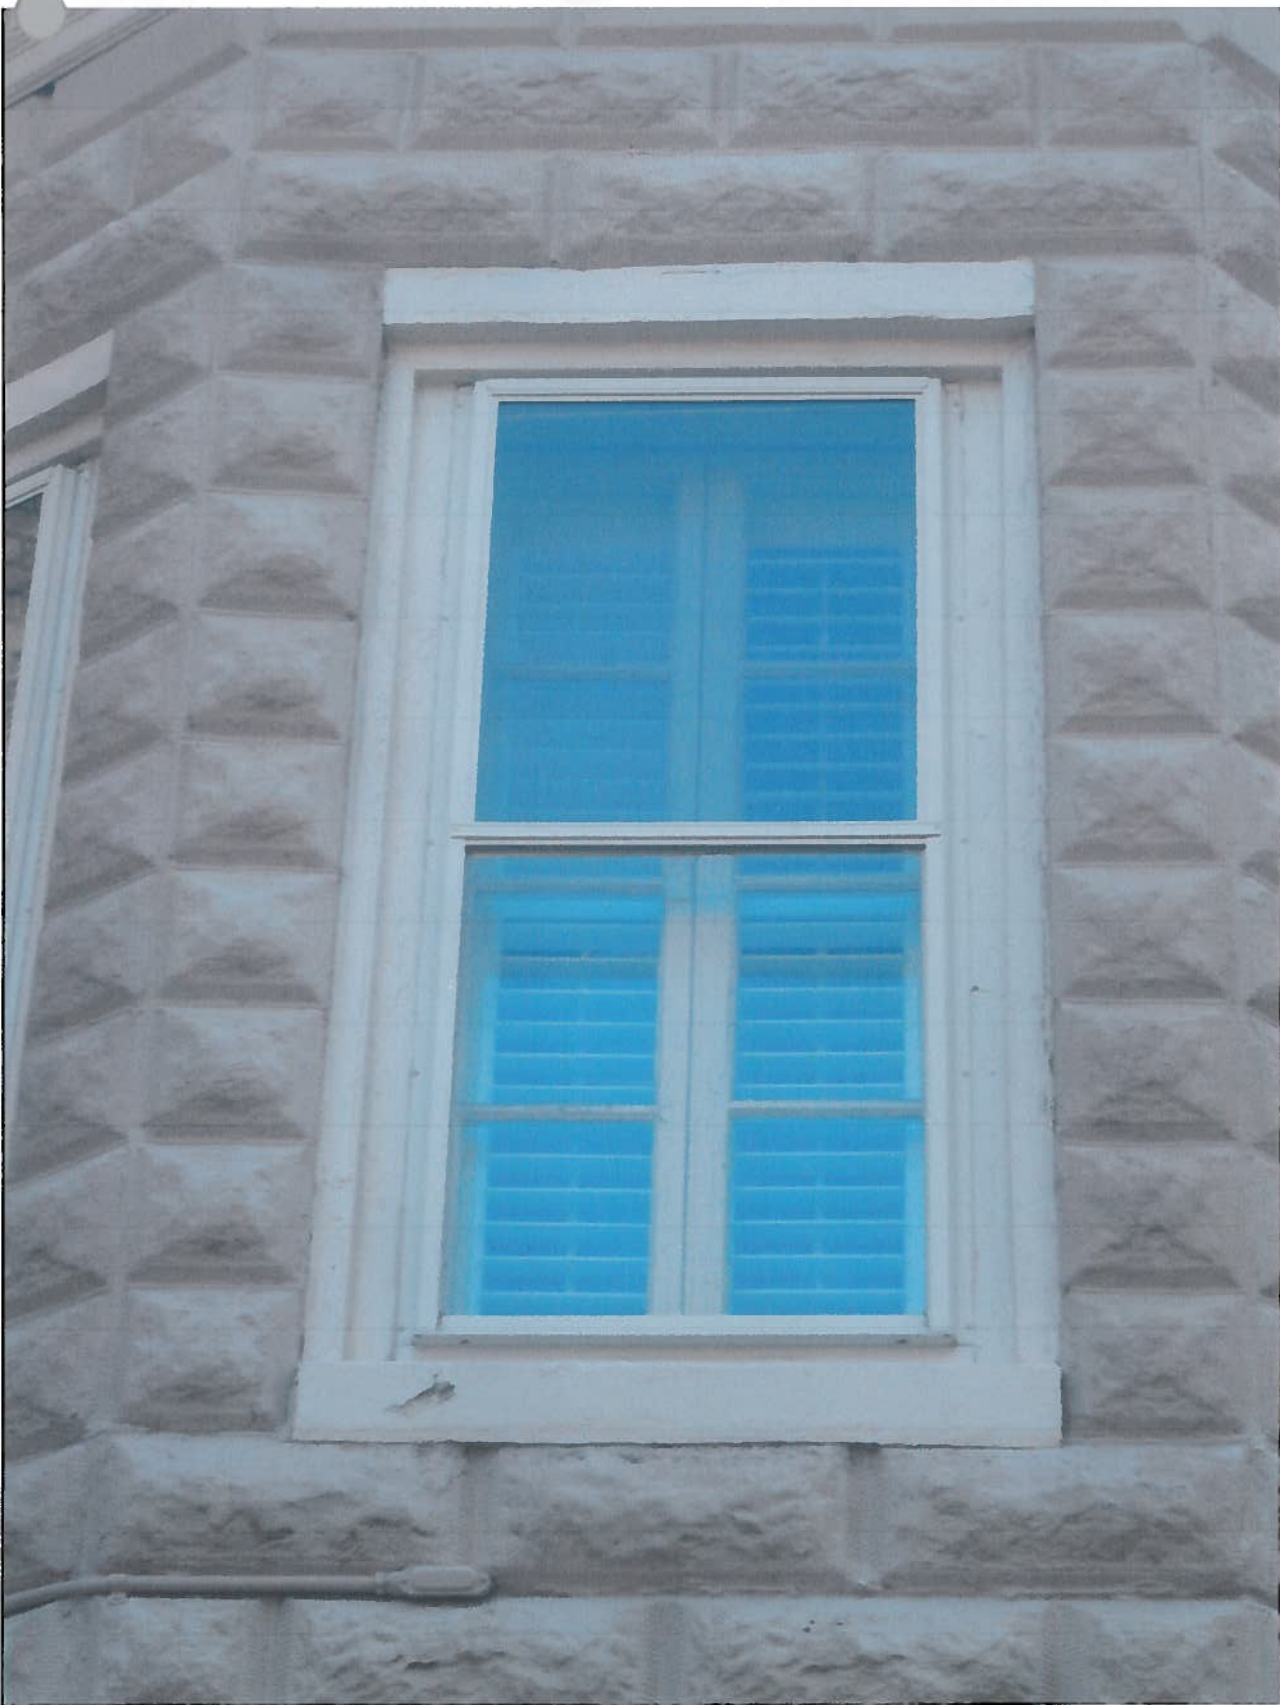
Figure 9: Existing second floor center bay window

4. Not sure what to call this one. From the street it looks like a 2 over 4 divided light but is actually two separate windows designed to open inward (like shutters open outward). It is inoperable at this time as the inside plantation shutter frame was screwed directly onto the windows by a previous owner. This is the center window in the second floor front bay. My preference for this window is to replace it with a double hung window just like the other six front windows to keep a consistent appearance. See the last paragraph of this attachment if you feel the center window should have the same look as it does now.

Instead of replacing it with a double hung 0 over 0 functioning window, I could replace it with a single window (not double hung) that would fit in the existing opening. It would have a 2 inch wide vertical divider and three horizontal dividers that would be 7/8" wide. The dividers would be on both sides of the window with a filler inside the double pane to give it the same look as now. Because the new window would be fixed in place, it wouldn't need to have a screen except to look more like its neighbors. Figure 9 is a picture of the current window and Figure 10 illustrates what this alternative would look like.
