**13. COA-053588-2019**

106 East Clay Street

Commission of  
Architectural Review

STAFF REPORT

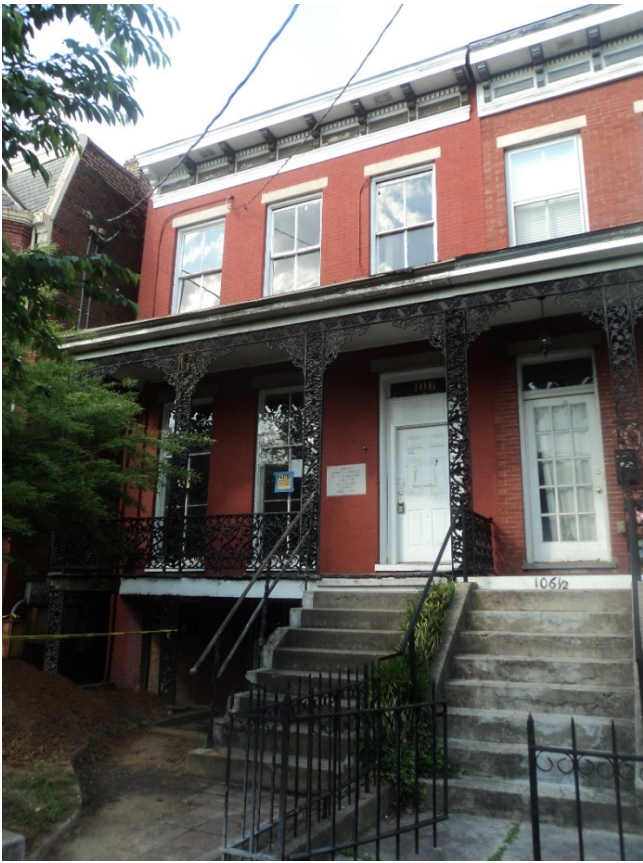
Figure 1. Facade of 106 East Clay Street.

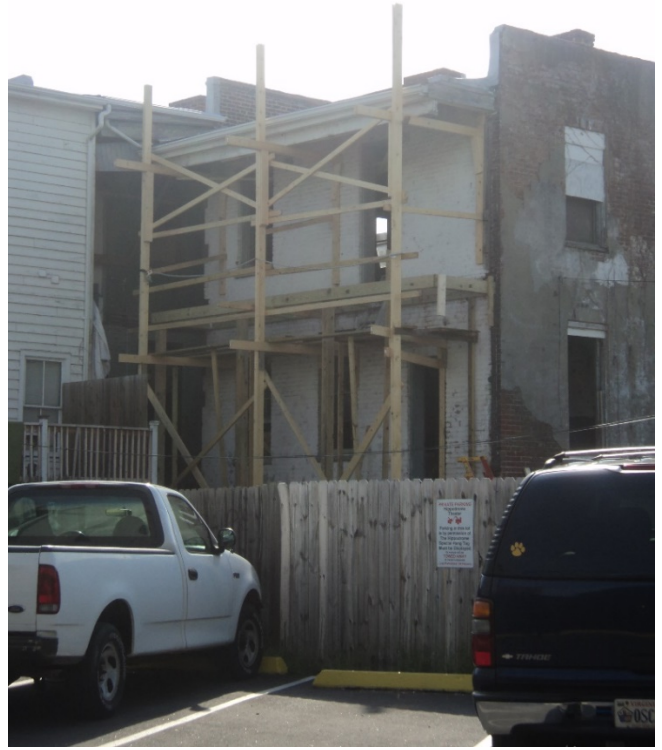
Porches, Entrances & Doors #5, pg. 71	<i>The entire porch should only be replaced if it is too deteriorated to repair or is completely missing; replacements should match the original as much as possible.</i>	The applicant is proposing to reconstruct the two-story rear porch which had collapsed. <u>Staff recommends the new porch be constructed of wood, be painted or stained a neutral color to be administratively approved by staff, and utilize a Richmond Rail.</u>

Figure 2. Rear porch, 2019.

- The new rear porch be constructed of wood, be painted or stained a neutral color to be administratively approved by staff, and utilize a Richmond Rail.

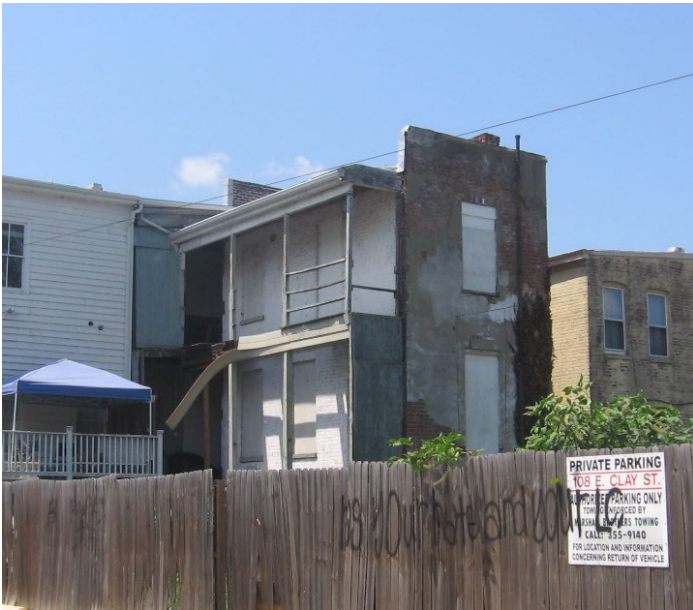
Figure 3. Rear porch, 2012.

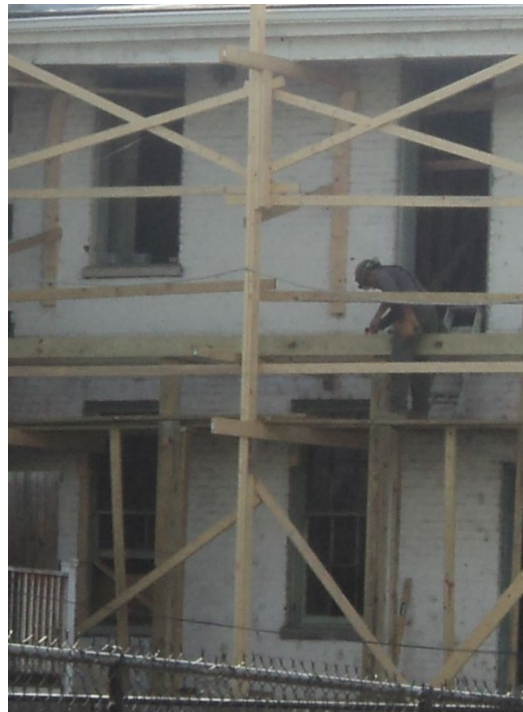
Recent photographs of the rear of the building indicate that the surviving windows in the rear have a 6/6 light configuration. Previously approved plans for this property also indicate that the rear windows were 6/6. Staff recommends the rear windows visible from the public right of way be 6/6 windows with true or simulated divided lights.

Figure 4. Rear windows, 2019

- The rear windows visible from the public right of way be 6/6 windows with true or simulated divided lights.
- The rear door openings be enclosed from the interior in a manner that could be reversed in the future and maintains the exterior appearance of the entrances.
