Staff Report
City of Richmond, Virginia

Commission of Architectural Review

4.COA-158351-2024	Final Review	Meeting Date: 12/17/2024
Applicant/Petitioner	Richard L. Buchanan Jr.	
Project Description	Remove a rear, deteriorated, standing seam metal roof and install a new asphalt shingle roof.	
Project Location		
Address: 2609 East Leigh Street		
Historic District: Church Hill North		
<p>High-Level Details:</p> <p>The applicant proposes to replace a deteriorated metal roof on a rear one-story wing of a frame building circa 1847, otherwise known as the Frederick Elliot House.</p> <p>The applicant requests approval to install a new asphalt shingle roof in place of the deteriorated standing seam metal roof.</p> <p>The portion of roof in question is minimally visible from East Leigh Street, and highly visible from the alley.</p> <p>The existing metal roof is deteriorated to the point of causing severe interior damage. The applicant has received an improvement grant from the Historic Richmond Foundation to assist with the roof replacement.</p> <p>Based on historic maps and documentation, the primary portion of the dwelling was constructed around 1847, and the rear, one-story portion with

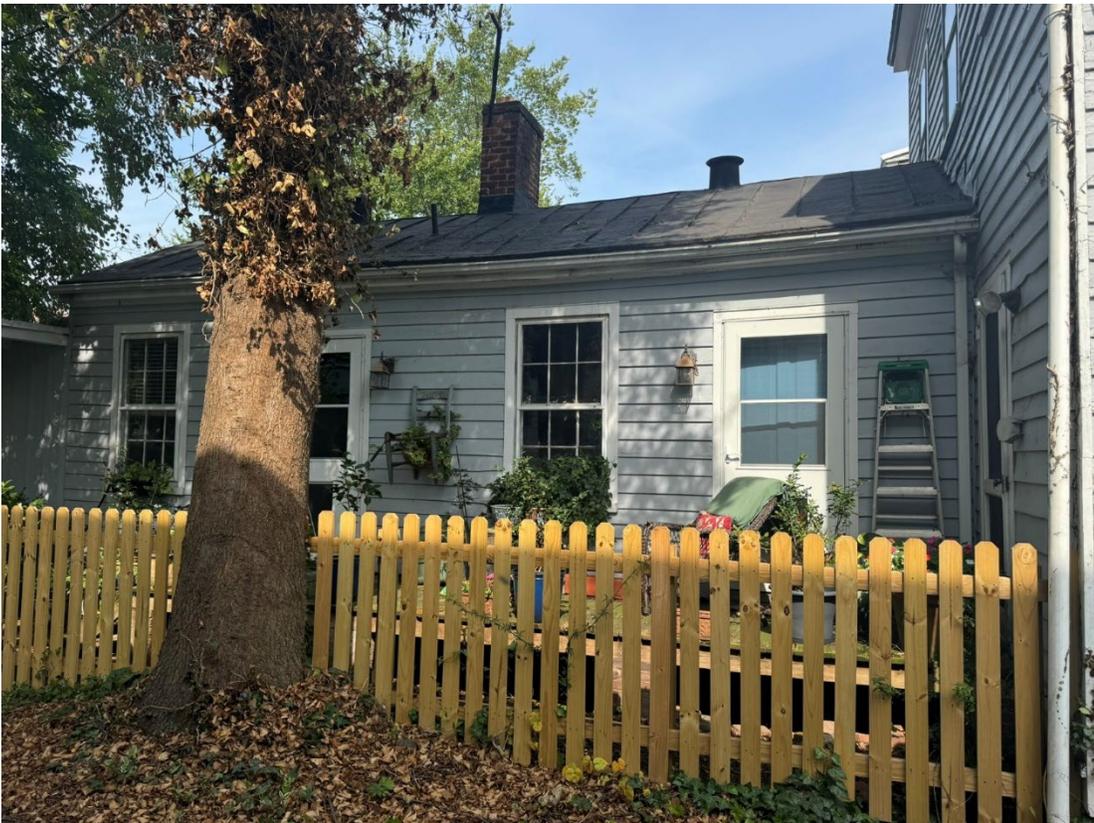
3. Rear wing. Existing metal roof in question.

Staff Recommendation	Partial Approval	
Staff Contact	Alex Dandridge, alex.dandridge@rva.gov, (804) 646-6569	
Previous Reviews	None.	
Conditions for Approval	<p>Staff recommends approval of:</p> <ul style="list-style-type: none"> the replacement of the existing metal roof with a new standing seam metal roof that matches the profile of the existing as closely as possible. Final roofing material and color must be submitted to staff for administrative review and approval.

<p>Staff recommends denial of:</p> <ul style="list-style-type: none"> • Replacement of the existing metal roof with asphalt shingles.
--	---

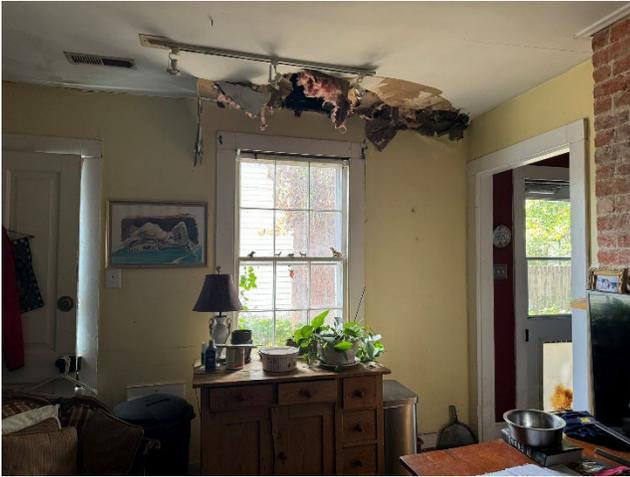
4. Interior damage from leaking metal roof.

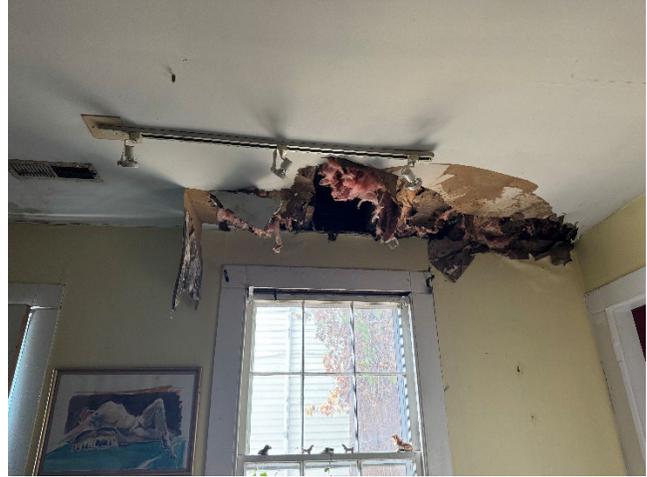
5. Interior damage from leaking metal roof.
