**COMMISSION OF ARCHITECTURAL REVIEW
STAFF REPORT
July 22, 2014 Meeting**

2. **CAR No. 14-69** (E. Akarkarasu)

**720 N. 25th Street
Union Hill Old & Historic District**

Project Description: **Replace front porch columns and railing**

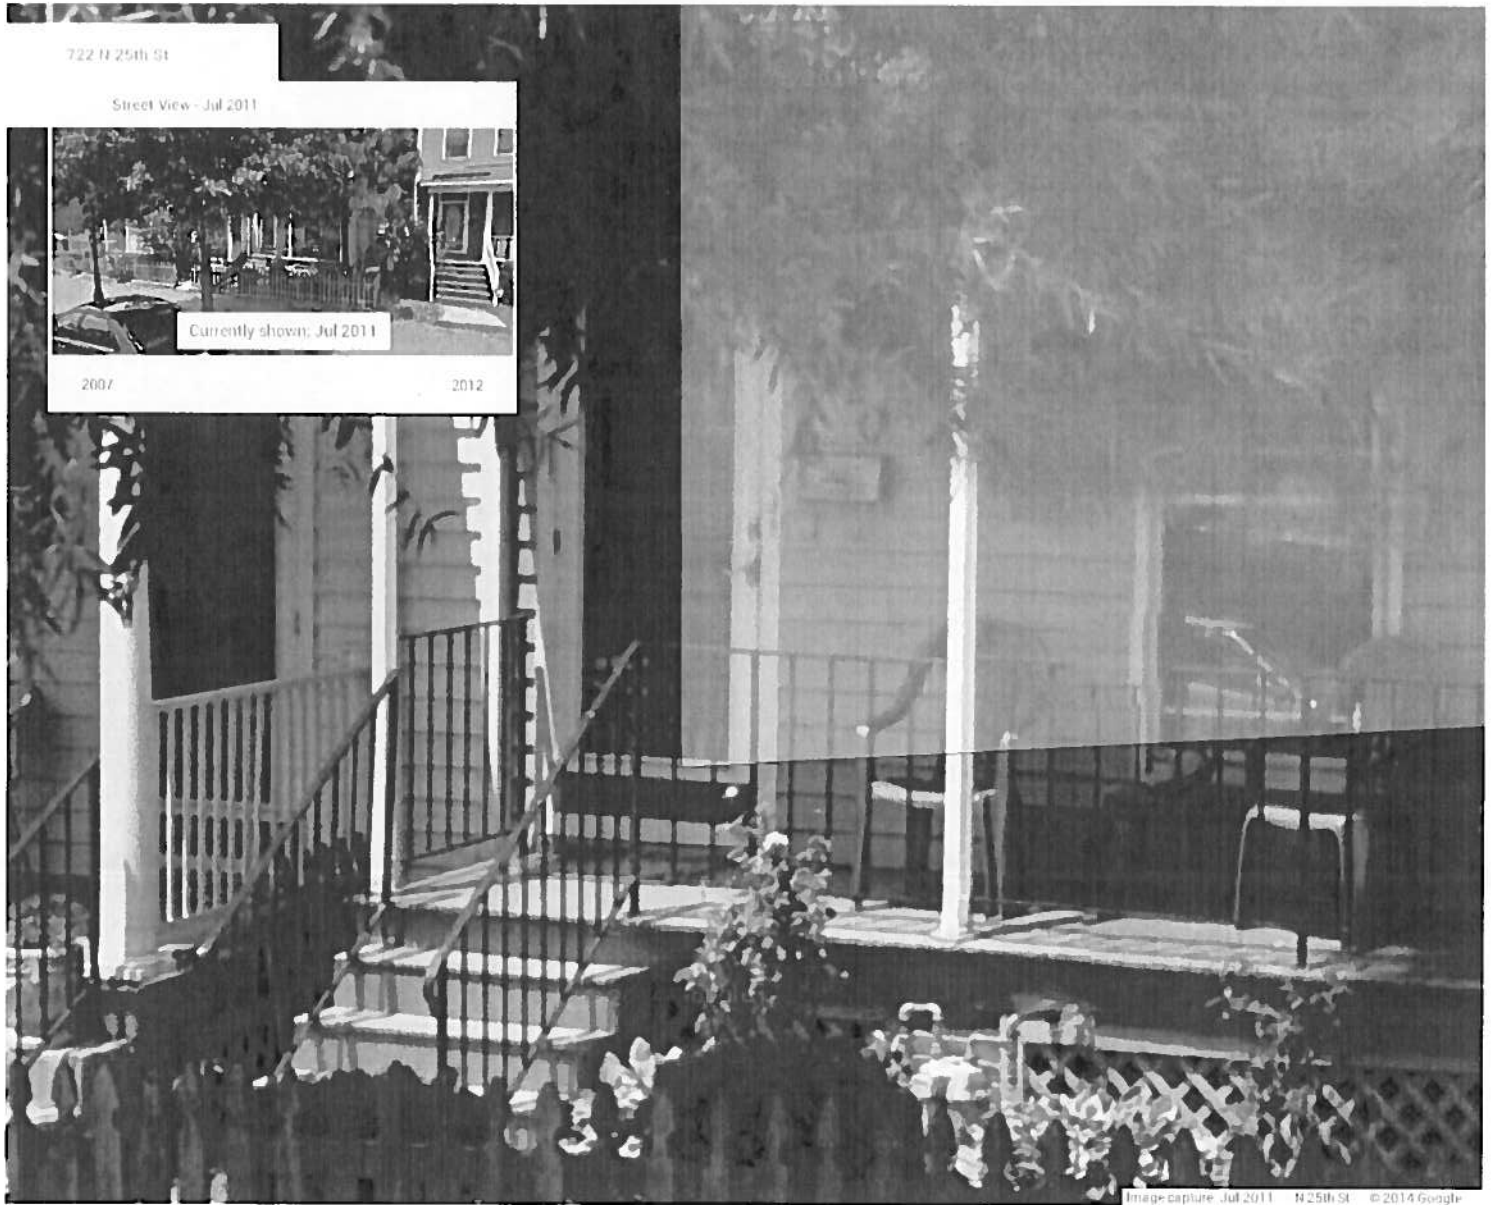
Exhibit A

A photograph of the property from 2011 (see exhibit A) depicts the porch with slender, multi-sided posts and non-historic metal railings. The National Register nomination for Union Hill states that the porch had “octagonal, delicate thin columns with metal railings.” A 1977 survey photograph of the property shows the building with the slender columns and a railing with thin pickets that might or might not be turned (see exhibit B).

Staff recommends partial approval of the project. The Standards for Rehabilitation outlined on page 51 of the *Richmond Old and Historic District Handbook and Design Review Guidelines* note that original porch elements such as columns and other decorative features should be retained and repaired. The additional guidelines for the treatment of porches and entrances on page 61 of the *Guidelines* emphasize that porch elements are important in defining a building’s overall historic character, and that deteriorated porch features should be retained and repaired or replaced in kind. The previous metal railing at this property was not historic, and as the pickets resemble those depicted in the 1977 survey photograph, staff recommends that the applicant be allowed to retain the new railing system. The new turned posts do not appear to match the appearance of the earlier porch posts. If the Commission can confirm that octagonal porch posts were likely original to the property, staff recommends that the applicant replace the existing posts with ones that match the originals.
