Staff Report
City of Richmond, Virginia

Commission of Architectural Review

5. COA-105889-2022	Final Review	Meeting Date: 2/22/2022
Applicant/Petitioner	Austin Ross Philips	
Project Description	Enlarge existing windows to match the historic masonry openings and replace existing vinyl windows with new vinyl windows.	
Project Location		
Address: 2323 Venable		
Historic District: Union Hill		
High-Level Details: <ul style="list-style-type: none"> The applicant requests permission to enlarge existing windows to match the size of the historic masonry openings, and to replace existing double-hung, vinyl windows with vinyl casement windows with transoms and vinyl casing and trim on the front façade of an attached dwelling. The work has been completed without review and approval by the Commission of Architectural Review. 		
Staff Recommendation	Partial Approval	
Staff Contact	Alex Dandridge, alex.dandridge@rva.gov , (804) 646-6569	
Previous Reviews	Staff issued a notice of violation to the property for alteration of existing window openings and the installation of new windows without review and approval by the Commission of Architectural Review on December 10 th , 2021.

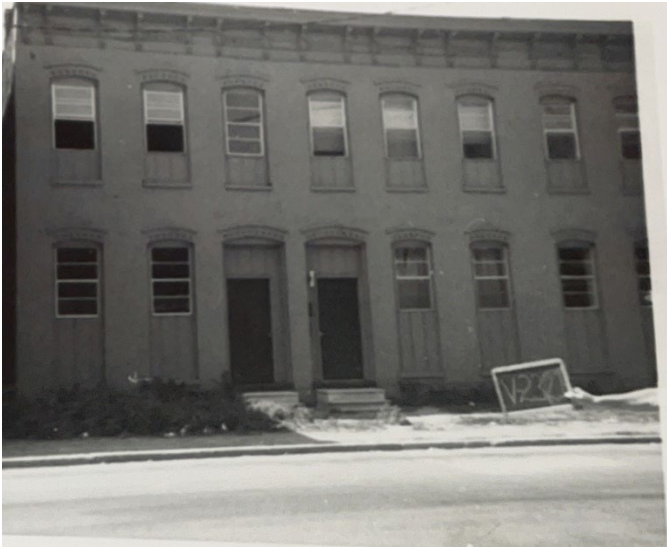
Figure 1. Historic Photo 1950s

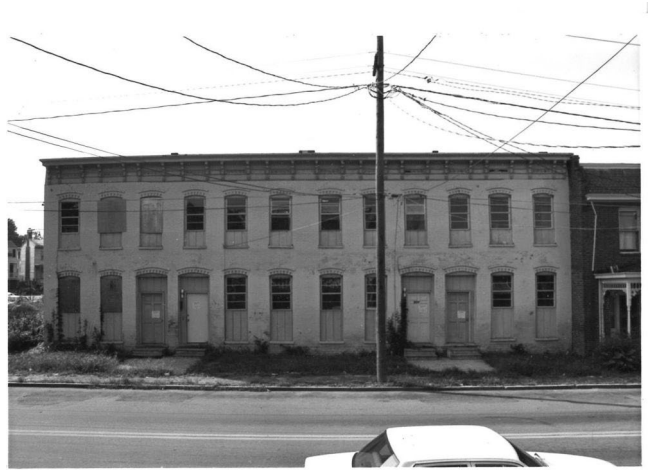
Figure 2. Historic Photo date unknown

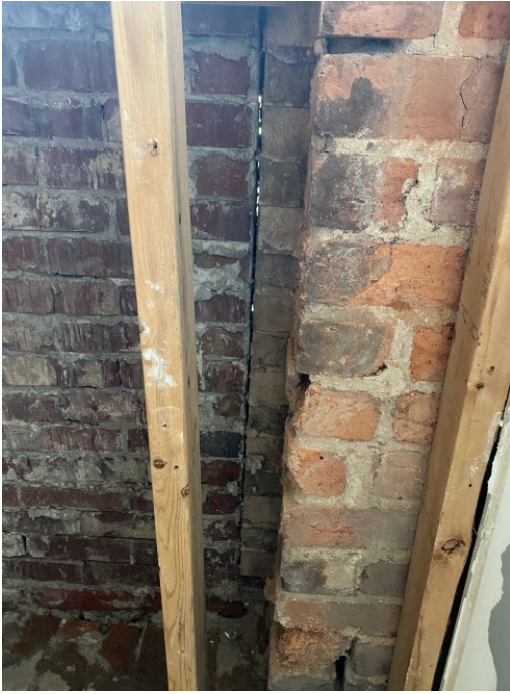
Figure 3. Brick infill separating from original masonry opening. Exposed to outside

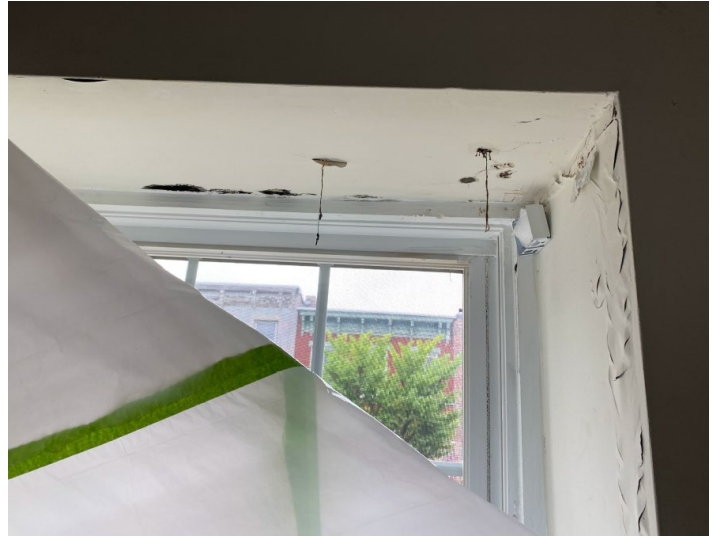
Figure 4. Interior water damage and mold

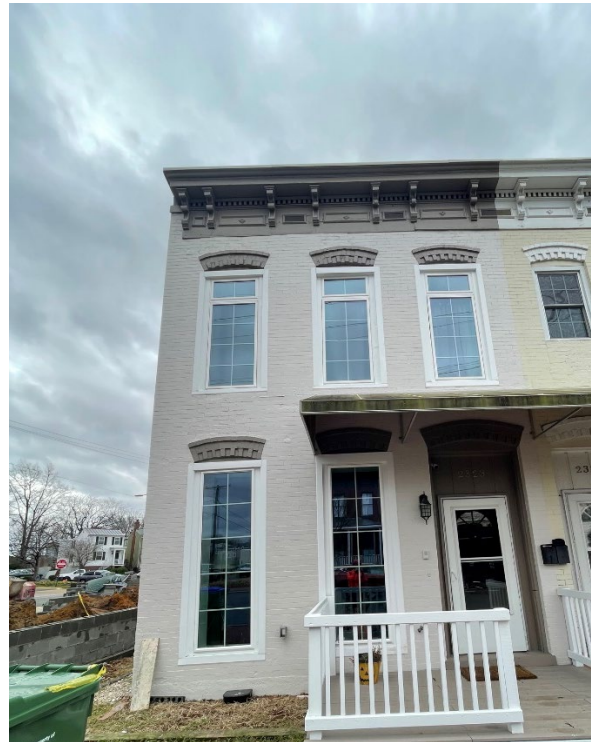
Figure 6. Front facade, 2323 Venable
