Staff Report
City of Richmond, Virginia

Commission of Architectural Review

6. COA-146156-2024	Final Review	Meeting Date: 7/23/2024
Applicant/Petitioner	Michael Fisher	
Project Description	Install fiber cement siding and perform various exterior repairs.	
Project Location

Address: 2802 East Clay Street		
Historic District: Church Hill North		
<p>High-Level Details:</p> <p>This application is the result of a violation. On April 2, 2024, staff observed the removal of wood siding and the installation of new fiber cement siding on the façade of the building.</p> <p>The applicant did not apply for a permit or notify the Commission of Architectural Review.</p> <p>The property was built circa 1850.</p> <p>It has been discovered that much of the wood siding that was removed was not original to the property.</p>		
Staff Recommendation	Approval, with Conditions	
Staff Contact	Alex Dandridge, alex.dandridge@rva.gov ; (804) 646-6569	
Previous Reviews	<p>Staff issued an administrative approval for this property on May 7, 2024, for the following work: Remove newly installed wood grained HardiPlank siding on the side and rear of the home and replace with a smooth Hardiplank siding. Install smoo

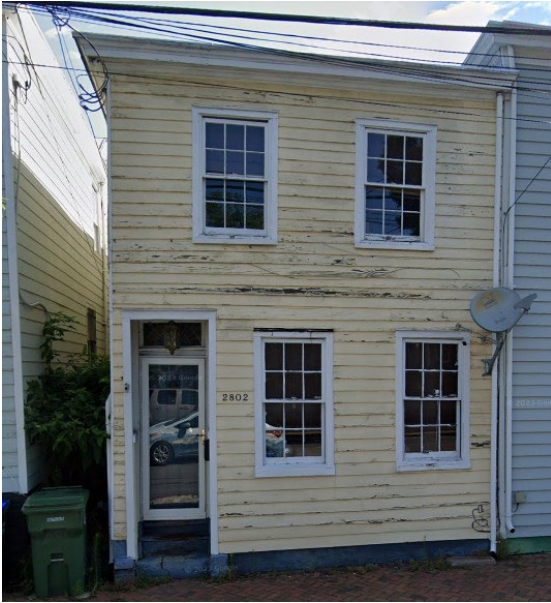
Figure 1. View of the property with historic wood siding, August 2023.

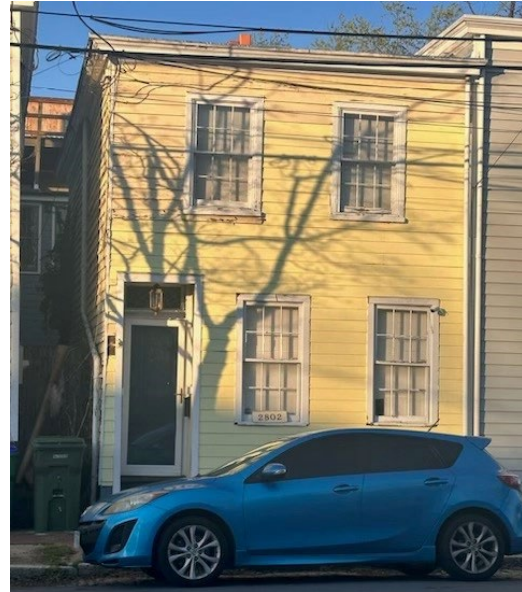
Figure 2. View of the HardiPlank siding which had been applied to the majority of the façade in September 2023. The Commission of Architectural Review did not receive any notification of this work.

Conditions for Approval	<ul style="list-style-type: none"> Staff recommends approval of the use of smooth hardiplank siding on the primary elevation. Staff recommends that the fiber cement siding match the width of the previous wood siding and that any wooden window trim be retained and repaired and not wrapped in another material like aluminum or vinyl.
-------------------------	---

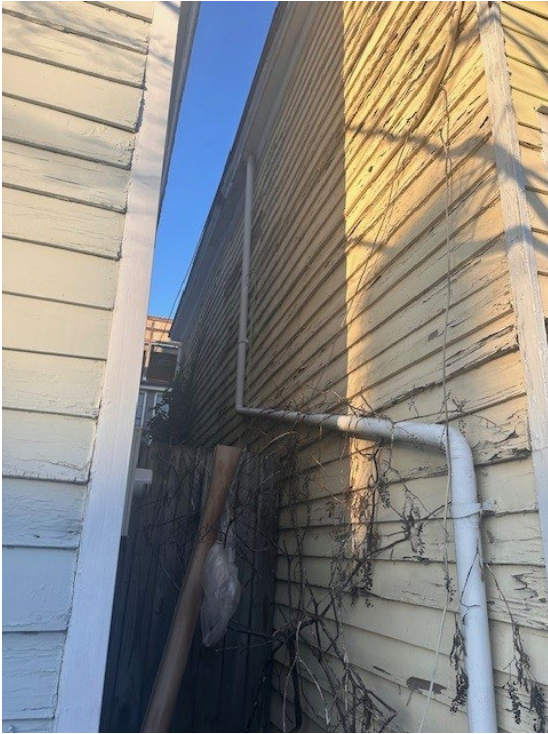
Figure 3. View of the west elevation, before the application of new siding, March 2024.

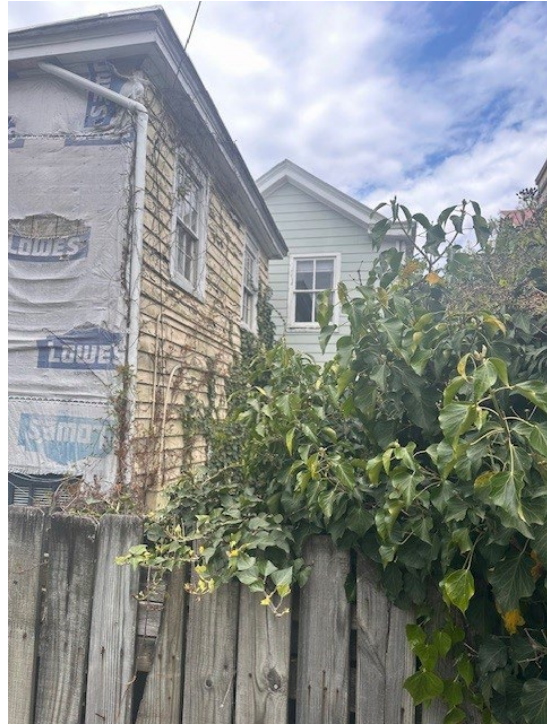
Figure 4. View of the rear and west elevations, before the application of new siding, March 2024.

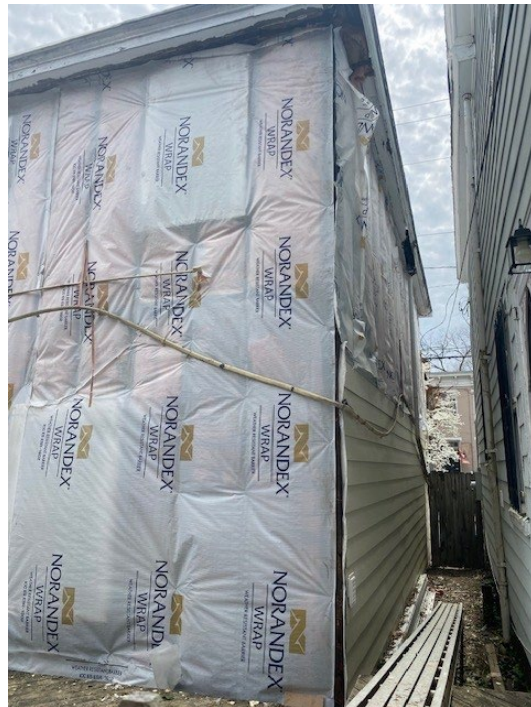
Figure 6. View of the rear elevation and the west elevation with new HardiPlank siding, April 2024.

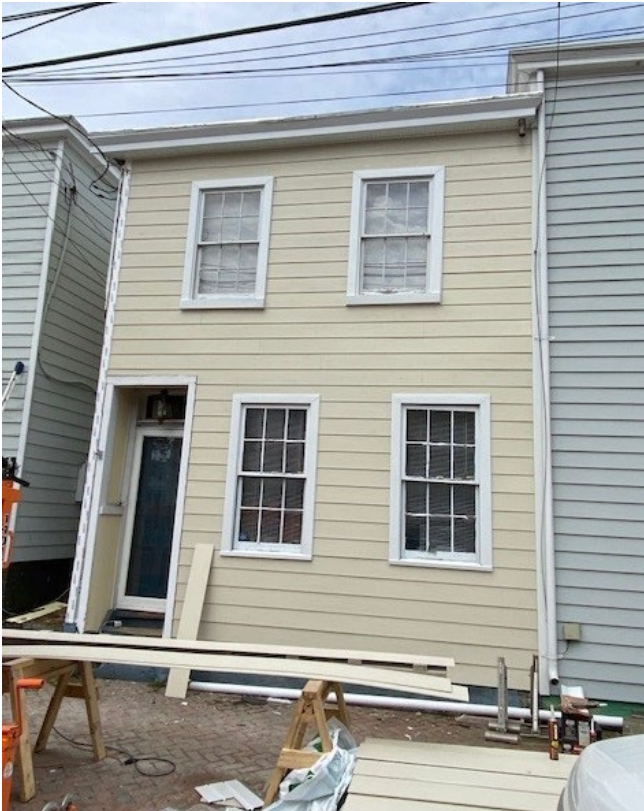
Figure 7. View of the façade of 2802 East Clay Street with new HardiPlank siding, April 2024.
