**COMMISSION OF ARCHITECTURAL REVIEW
STAFF REPORT
May 23, 2017 Meeting**

6. **COA-016768** (H. Wilson) **520 W. Marshall Street
Jackson Ward Old and Historic District**

Project Description: **Replace five windows on front façade.**

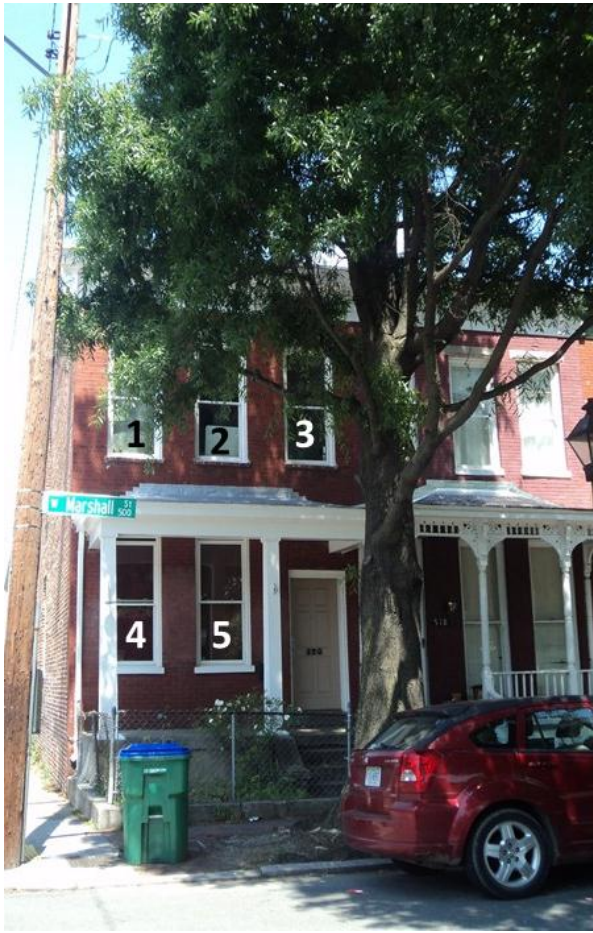
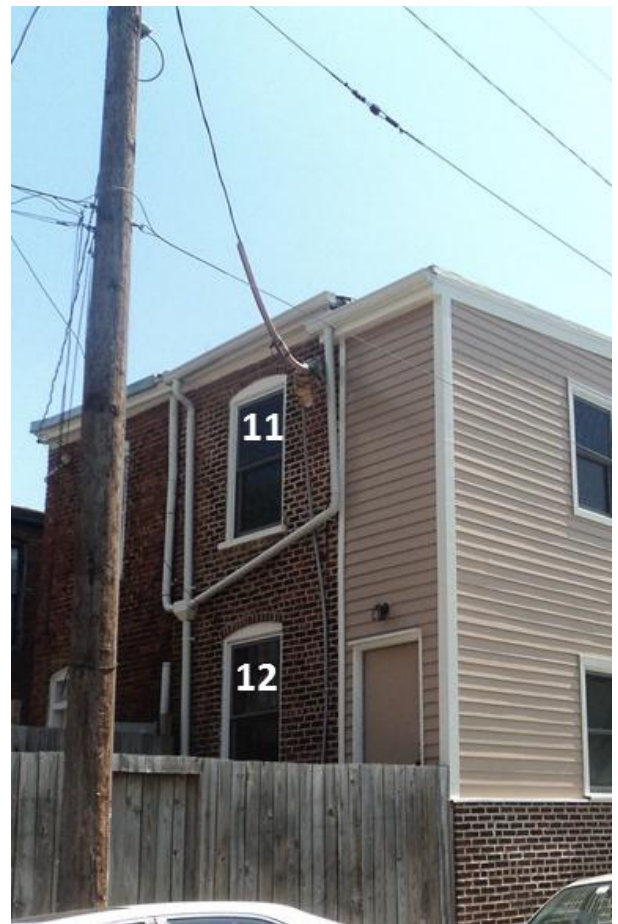
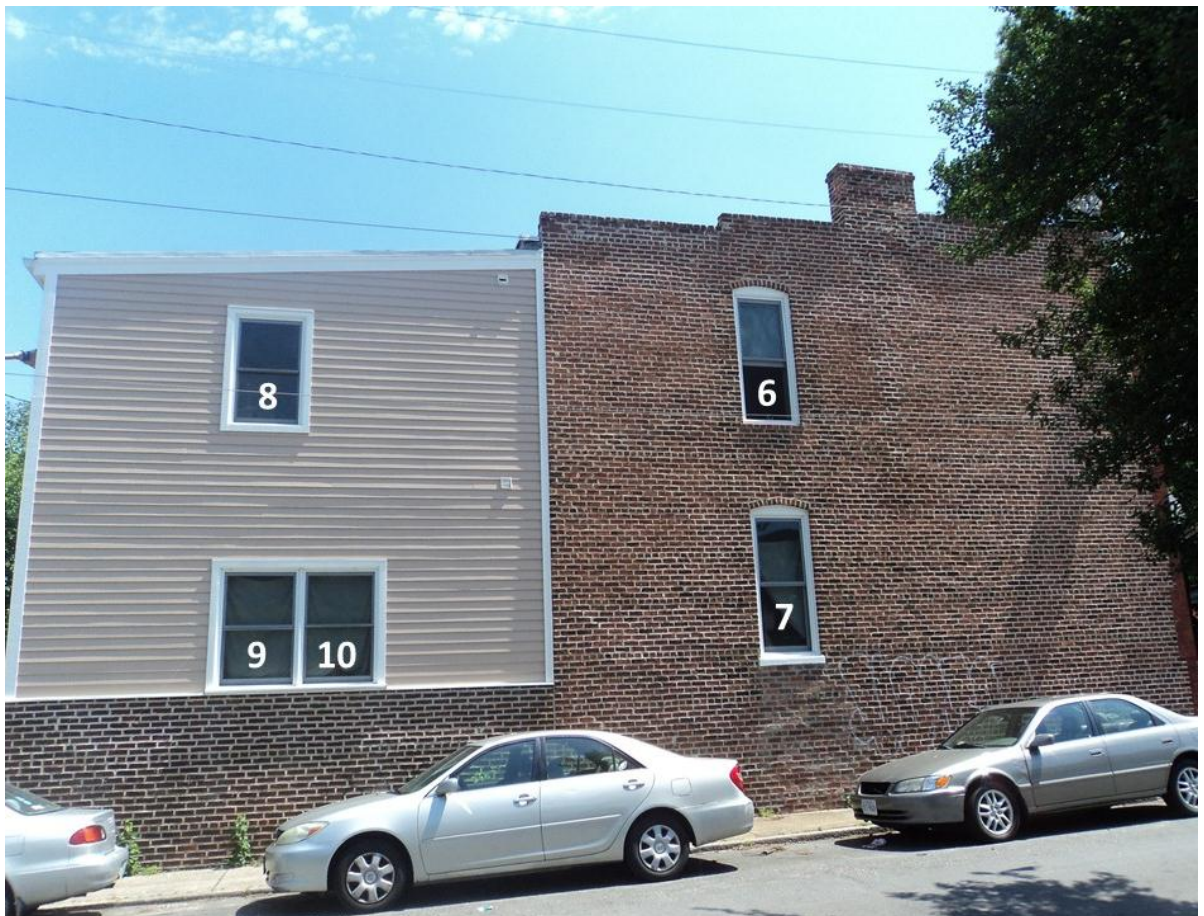
520 West Marshall Street, May 10, 2017

This application is the result of enforcement activity as the windows were replaced without prior review and approval. In addition, the applicant received approval to modify the windows on the side and rear of the structure in August of 2010. The front windows were not included in this prior application. The conditions of the 2010 approval were not met as the applicant replaced all windows on the side and rear of the structure with one-over-one aluminum clad wood windows. Photographs of the windows from 2017 and 2010 are included at the end of this report.

The pictures from the 2010 application show that the windows on the façade were 1/1 windows and the three upper story windows (Windows 1-3) included ogee lugs. Staff recommends approval of the replacement of the five front windows (Windows 1-5), provided that ogee lugs to match the previous windows be added to Windows 1-3.

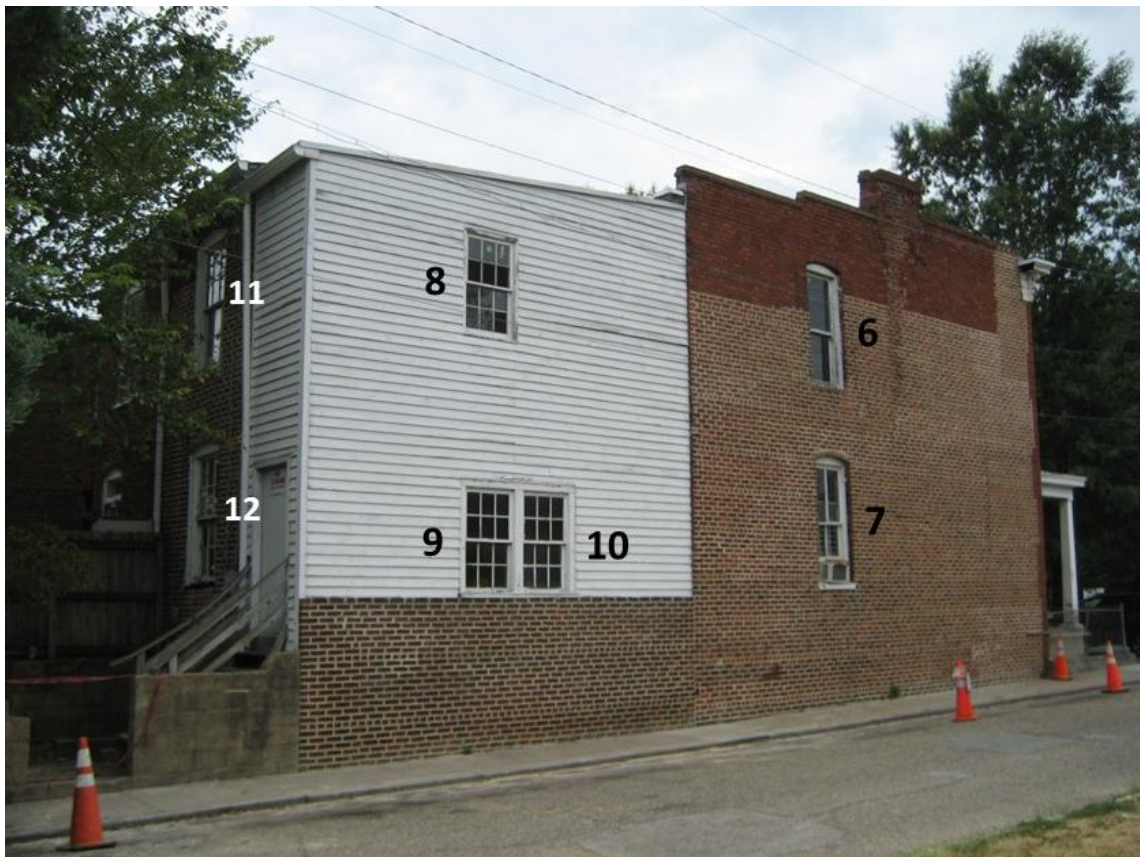
2010 Condition of Approval: The window casings shall be retained and repaired. The sash and sills may be replaced with the specified product provided that the windows are six-over-six sash with true or simulated divided lites.

Existing Conditions: The windows were replaced with one-over-one aluminum clad wood windows.

Recommendation: Staff recommends that the sashes of Windows 11 and 12 be replaced with aluminum clad wood six-over-six true or simulated divided lites with interior and exterior muntins and a spacer bar between the glass.
