**COMMISSION OF ARCHITECTURAL REVIEW
STAFF REPORT
October 27, 2015 Meeting**

9. CAR No. 15-132 (A. Gardner)

**508 North 26th Street
Church Hill North Old and Historic District**

Reconstruct front gable

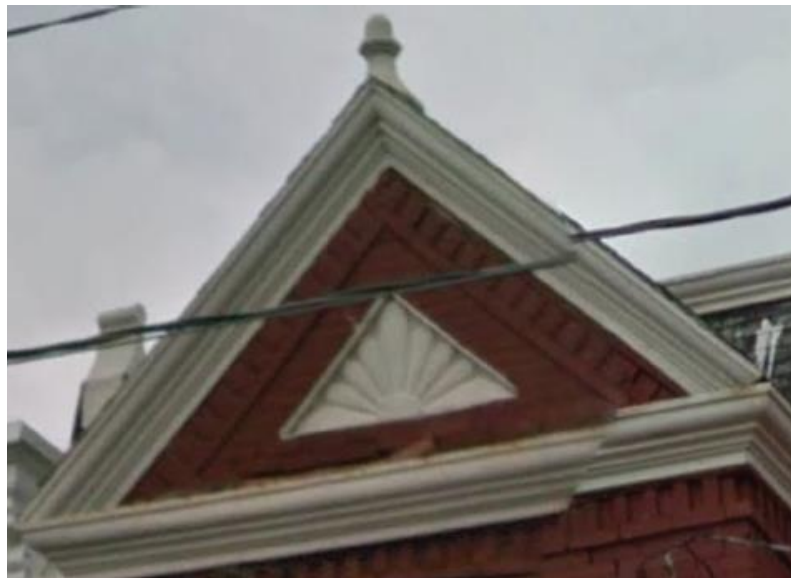
Gable of 508 N. 26th Street in April 2014 (Source: Google Maps)

The sunburst panel and the brick construction of the gable are distinctive original features of this historic structure and should both have been retained and repaired as needed. The *Guidelines* state that “when the severity of deterioration requires replacement of a distinctive feature, the new feature shall match the old in design, color, texture and other visual qualities and, where possible, materials” (pg. 5, #6). Additionally, the *Guidelines* note that the purpose of replacing lost or

irreparable architectural features is to create a visual match to the original feature and that substitute materials should only be used when there is an unavailability of historic materials, unavailability of skilled craftsmen, or poor quality original materials (pg. 56-57). The proposed plywood gable does not effectively convey the same visual appearance as the historic brick gable as the historic gable had a distinctive brick pattern for the border. Using a substitute material for brick is not appropriate as brick is an available material of which a qualified craftsman can install. Staff recommends approval of the proposed reconstruction of gable to include the reinstallation of the sunburst panel with the condition that the gable be constructed of brick to match the historic gable not plywood.
