Staff Report City of Richmond, Virginia

Commission of Architectural Review

4. COA-105887-2022	Final Review Meeting Date: 2/22/2022
Applicant/Petitioner	Louise Lockett-Gordon
Project Description	Replace existing concrete roofing tiles with asphalt shingles and enclose a rear porch.
Project Location	4004 3907 1627 1623 1621
Address: 3833 Hermitage	• 3905 • 3903 • 1628 1626 1622
Historic District: Hermitage Road	• 3501
High-Level Details:	Claremont Ave
 The applicant request approval to rehabilitate the exterior of a ca. 1923 Craftsman style residence 	4000 • 3837 • 1623 1621 1621
 The applicant proposes to remove the original concrete tile and replace with asphalt shingles, and to enclose a rear, inset porch. Staff notes that this work has already been completed. 	3835 1623 1621 1625 1623 1623 1621 1625 1623 1623 1623 1623 1623 1623 1623 1623
 Original windows are proposed to be repaired and replaced as necessary 	3901

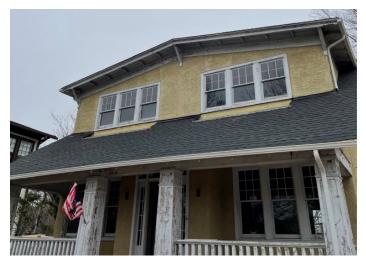
#3, pg. 59 hoods and hardware and the color a finish of all original materials.			Based on photographs of the original roof's condition, staff believes that the original concrete tiled roof was deteriorated beyond repair, and the concrete tiles may have reached their useful lifespan.
			The applicant has replaced the concrete tile with asphalt shingles without CAR approval.
Building Elements, Roofs, Roof Replacement/ Reconstruction, #3 pg. 6	Substitute materials may be used if the same kind of material is not technically feasible because the material is no longer being made. Substitute materials should match the original style and form as much as possible Asphalt shingles or ceramic tiles are common substitute materials intended to duplicate the appearance of wood shingles, slates, or tiles. Fire-retardant, treated wood shingles are currently available. The treated wood tends, however, to be brittle, and may require extra care (and expense) to install. In some instances, shingles laid with an interlay of fire-retardant building paper may be an acceptable alternative.		Staff finds that the asphalt shingles installed on the visible portions of the roof do not resemble the historic appearance of the original concrete tile and recommends denial of the use of asphalt shingles on the visible portions of the roof.

Figure 2. Deteriorated Concrete Tile Roof, 3833 Hermitage Road. Before

• Staff recommends that a roofing material that more closely resembles the original in style and form be installed on the visible portions of the roof, such as a clay or concrete tile with a French profile. (See Figure 7).
