Staff Report
City of Richmond, Virginia

Commission of Architectural Review

4. COA-139549-2023	Final Review	Meeting Date: 12/19/2023
Applicant/Petitioner	Steven Brett Kemp	
Project Description	Replace non-original wood fiber/ pressboard siding and damaged wood siding on visible elevations.	
Project Location		
Address: 2219 M Street		
Historic District: Union Hill		
<p>High-Level Details:</p> <p>The applicant proposes exterior alterations to a Late 19th Century, one story, frame cottage ca. 1891. Exterior alterations include siding repair and replacement.</p> <p>Non-original siding will be replaced with fiber cement siding. Salvageable wood siding will be relocated to the façade.</p> <p>Most of the original wood siding has been removed over time and replaced with wood pressboard siding which has deteriorated.</p> <p>The original wood siding still existing on the left side of the dwelling underneath the pressboard, however, appears to be in poor condition.</p>		
Staff Recommendation	Approval, with Conditions

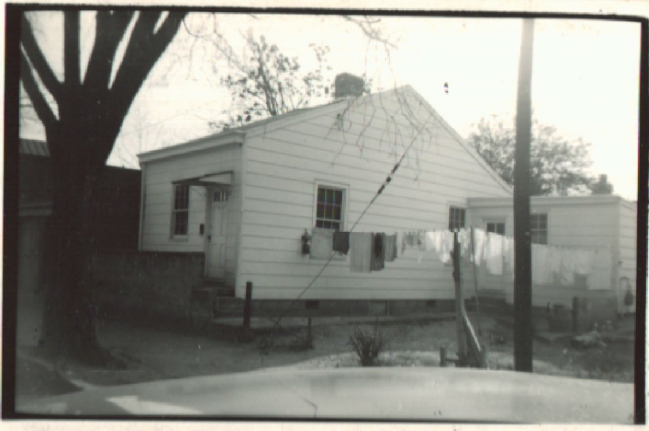
Figure 1. 2219 M Street, 1950's. Wide pressboard siding appears to have already been installed on the dwelling.

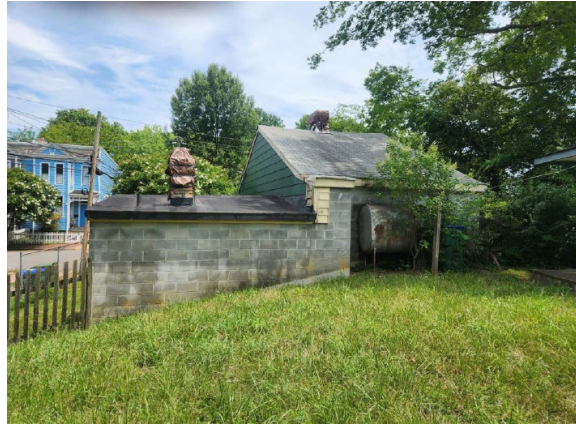
Figure 2. The rear of 2219 M Street looking north. Rear of building is constructed out of an unpainted CMU wall.

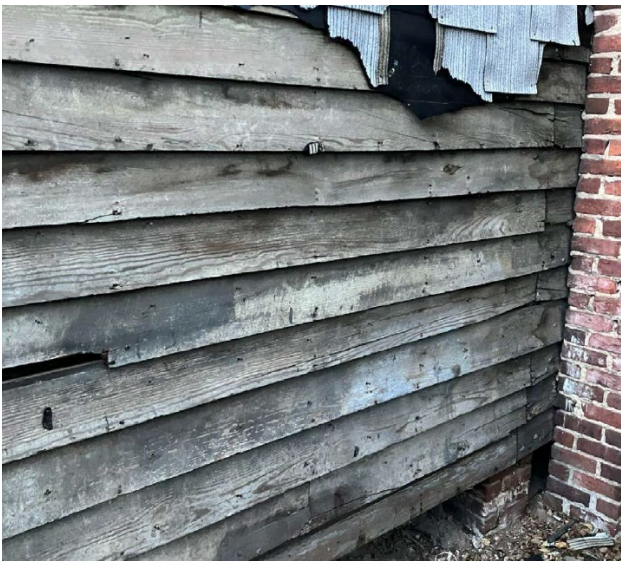
Figure 3. Original wood siding still present on the left (east) elevation of the dwelling which will be relocated to the façade.

Substitute Materials, pg. 61	<i>Repair damaged elements instead of replacing them. Use materials that match the original in type, or use physically and chemically compatible substitute materials that convey the same appearance as the surviving elements or sections. Use available documentation when reconstructing missing elements. Pictorial, historical or physical documentation can be helpful.</i>	<p>The applicant proposes to relocate salvageable original wood siding to the façade of the dwelling. Staff finds this to be an appropriate solution. <u>If there isn't enough lap siding to salvage from the left side of the dwelling, then Staff recommends that wood siding with the same reveal and profile as the historic be installed on the façade. Staff recommends that final exterior materials and colors be submitted for administrative review and approval.</u></p>
Secretary of the Interior's Standards for Rehabilitation, pg. 59	1. Retain original features and materials that define the building style, including but not limited to wood siding, shingles, stucco and masonry	The original wood lap siding from the left (east) side of the dwelling will be retained and relocated to the façade.
