## Commission of Architectural Review

| 4. COA-186154-2026 | Final Review | Meeting Date: 7/28/2026 |
| Project Description | Exterior rehabilitation of extant building, to include alterations to rear and existing masonry openings | |
| Address: 606 N 1st St | | |

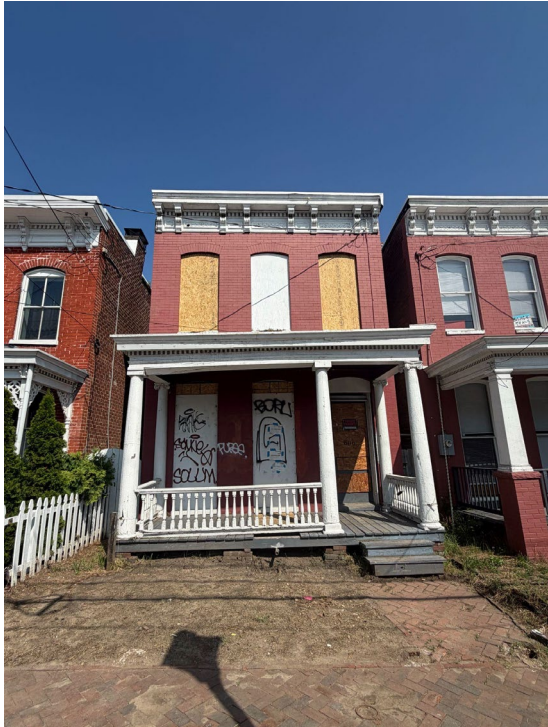
Figure 1. Existing conditions. Facade of 606 North 1st Street.

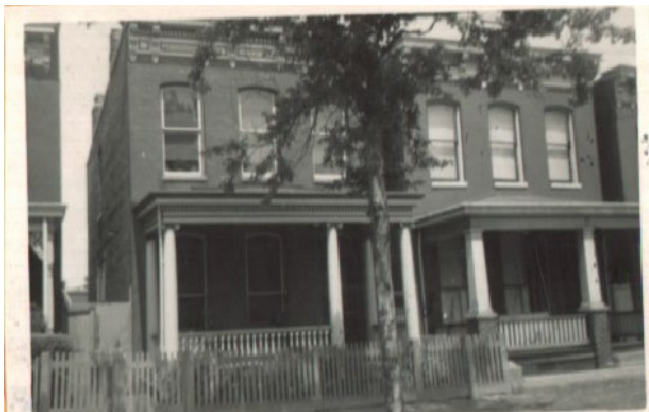
Figure 3. Photographic documentation showing arched one-over-one windows and Scamozzi columns. City Assessor records, 1950s.

| | | <p>of window sashes). This photographic and physical documentation shows that the façade originally featured double hung, arched, one-over-one windows.</p> <p>For the façade, staff recommends that <u>new wood or aluminum clad wood double hung, arched, one-over-one windows be installed within the existing openings, matching the original windows proportions, without adding infill trim.</u></p> <p>For the sides and rear of the building, the fenestration is inconsistent. There are varying styles and some windows are beyond repair or missing. On the side and rear elevation, <u>staff recommends that new windows be wood or aluminum clad wood, double hung windows with either a six-over-six or one-over-one configuration with simulated divided lights, and fit within the existing openings, matching the original windows proportions without adding infill trim.</u></p> <p>Photographic documentation of the rear and side windows was not obtained, however physical evidence does exist, showing that some windows had a six-over-six configuration while a few features a nine-over-nine configuration. Staff notes that most historic buildings in this district featured divided lights on the sides and rear.</p> <p><u>Staff recommends that all final window specifications be submitted for admin approval, and should include dimension, material, and design.</u></p> <p>The applicant has submitted documentation that demonstrates that the original wooden, double-hung, arched windows located on the façade are being repaired/rebuilt to be reinstalled.</p> |

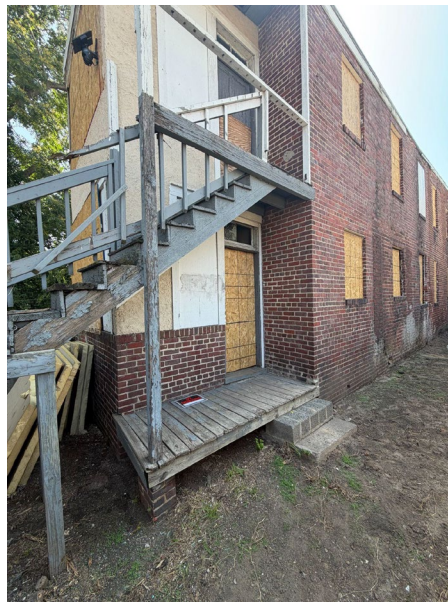
Figure 4. Existing condition of south elevation of 606 North 1st Street, including deteriorated decking and doors on the rear sleeping porch enclosure.

| | | <p><b><u>Decking</u></b></p> <p>The application states that the existing decking boards will be retained, and several boards replaced that are currently missing. <u>Staff recommends that the decking be replaced/repaired in-kind.</u></p> <p><b><u>Balustrade</u></b></p> <p>The application states that the extant, original balustrade will be repaired in-kind. <u>Staff recommends that the balustrade be scraped and repaired in-kind as needed.</u></p> <p><b><u>Porch Roof</u></b></p> <p>Staff administratively approved the replacement of the front porch roof with TPO in a previous application.</p> <p><b><u>Chimneys</u></b></p> <p>To speak to the history of the building's original heating systems, <u>staff recommends all exterior chimney stacks must be repaired and retained and shown on the final building plans.</u></p> <p>The application indicates that the applicant will retain, repair, and cap all extant exterior chimney stacks.</p> <p><b><u>Front Steps</u></b></p> <p>The applicant proposes to reconstruct the front wooden steps to match the width of the extant brick sidewalk (5.5'). Staff supports this alteration.</p> |

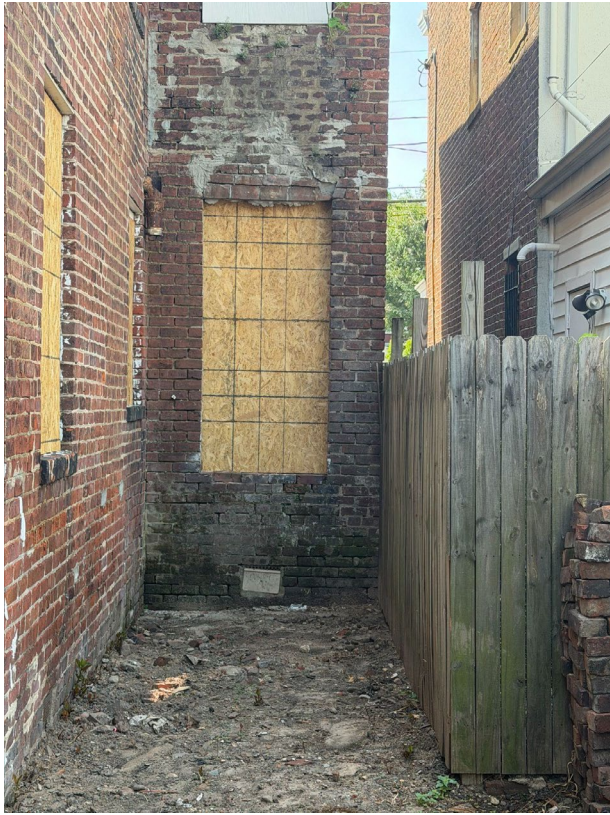
*Figure 5. Existing opening to be converted to door for rear yard access.*

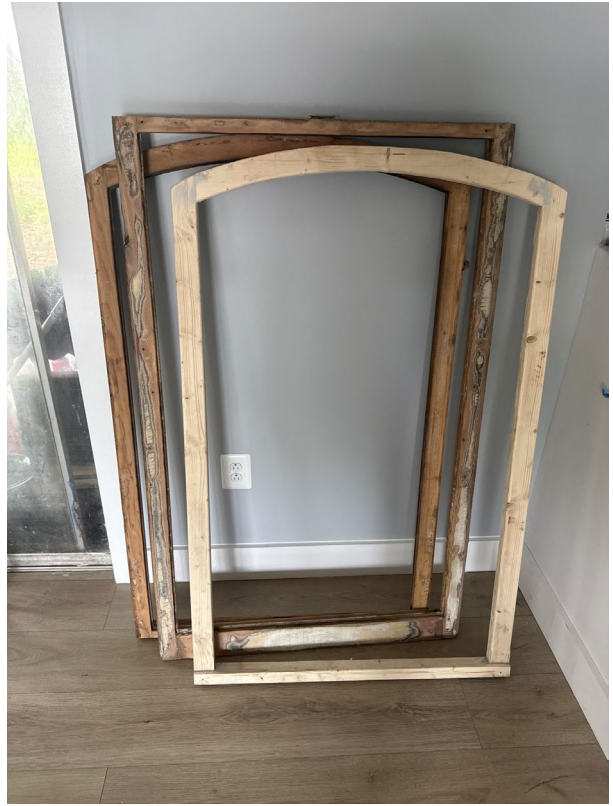
*Figure 6. Arched windows being reconstructed to be reinstalled on the facade.*
