Staff Report
City of Richmond, Virginia

Commission of Architectural Review

8.COA-147332-2024	Final Review	Meeting Date: 5/28/2024
Applicant/Petitioner	Christopher Wingfield	
Project Description	Restore, repair, and replace elements on the façade in need of repair.	
Project Location

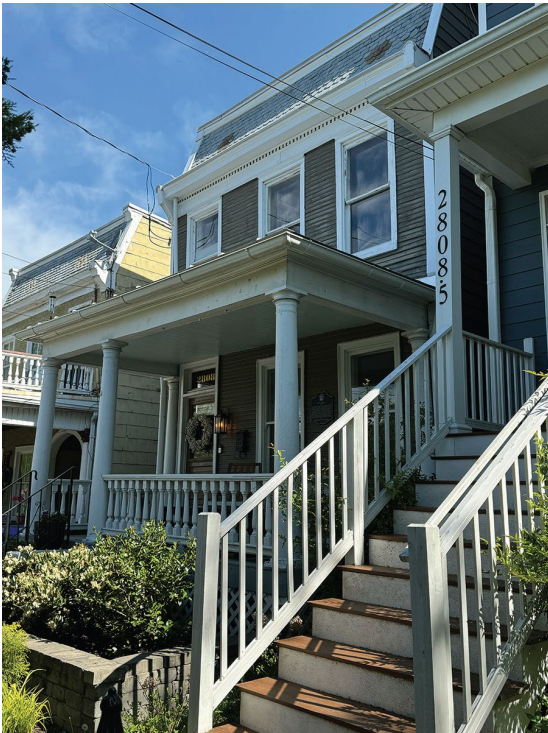
Figure 1. Front Façade with narrow siding.

<ul style="list-style-type: none"> • The wood siding on the façade be replaced with new wood “bb” siding. • decking boards be installed perpendicularly to the face of the building. <p><i>Staff recommends denial of:</i></p> <ul style="list-style-type: none"> • using a five – seven-inch reveal siding on the front façade. • Replacing the front banister and balustrade with a new design.
--	---

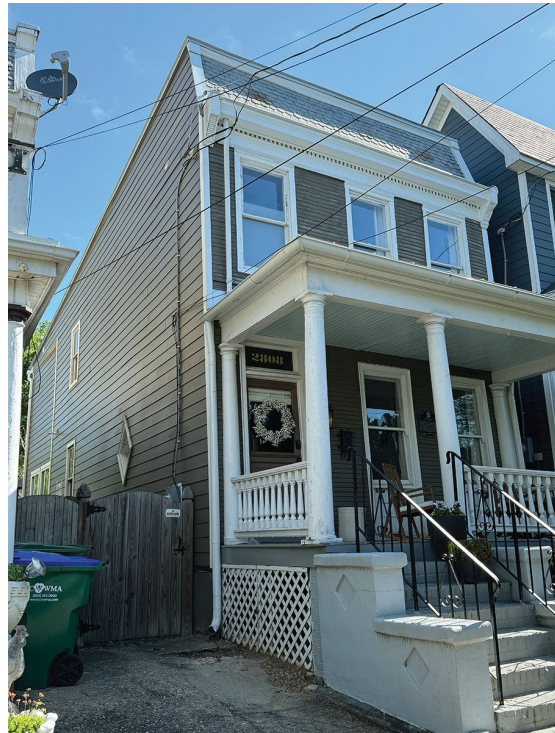
building in 2017. The building has been clad in novelty siding for many years which had led to the degradation of the wooden siding beneath.
--	--	--

Figure 2. Side façade with replacement siding.
