6. COA-084318-2021

Commission of Architectural Review

STAFF REPORT

Replace slate tile with synthetic slate.

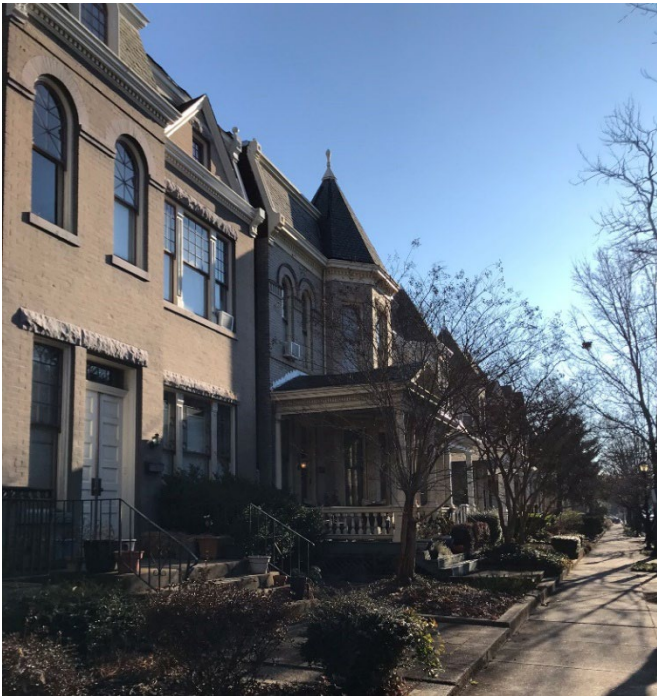
Figure 1. 1634 West Grace Street, as viewed from the sidewalk

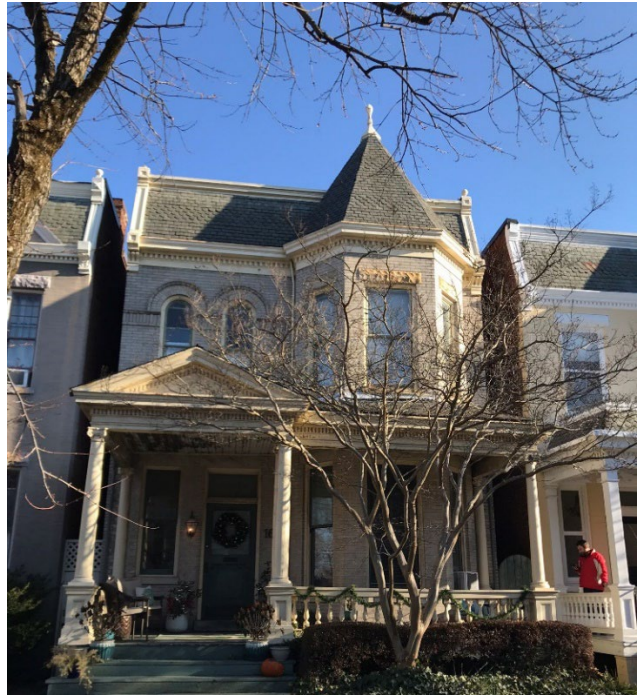
Staff finds that the front porch roof is highly visible from the street and recommends denial of the installation of synthetic slate on the front porch roof. Staff finds that the proposed Eco Star majestic slate does not effectively replicate the appearance of historic slate in this highly visible location. In addition, staff has concerns regarding the durability of the synthetic slate, which can be easily damaged, which in turn would further reduce its resemblance to historic slate.

Figure 2. 1634 West Grace Street, façade

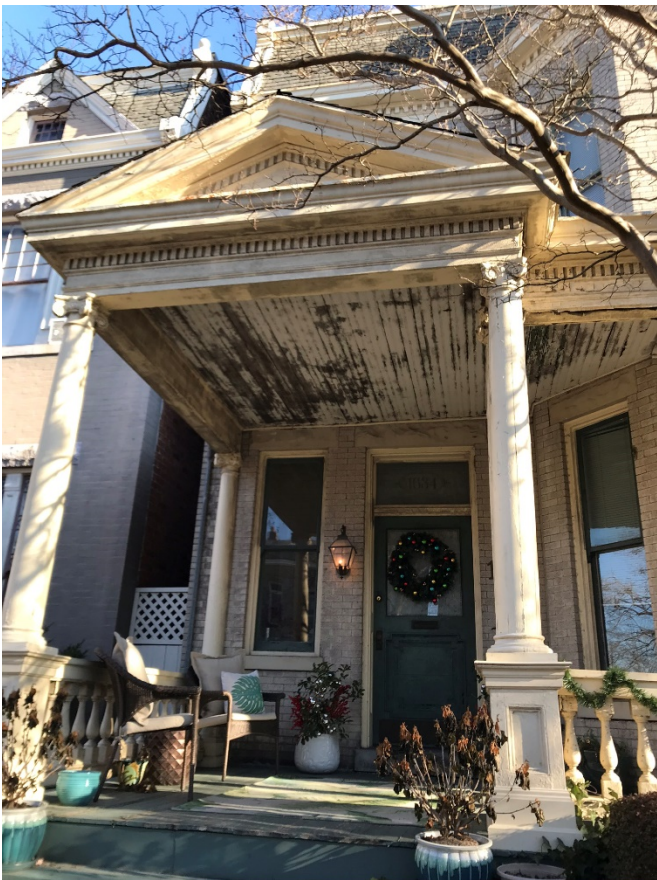
The application does not include any other proposed repair work. However, on a site visit, staff observed that the front porch is in disrepair, including the ceiling and columns. Staff further notes the property has been cited for a property maintenance violation and repairs must be made. Staff recommends the applicant work with staff to obtain administrative approval for the repair work required for the front porch.

Figure 3. Front porch disrepair
