COMMISSION OF ARCHITECTURAL REVIEW

APPLICATION FOR CERTIFICATE OF APPROPRIATENESS

Address 3209 Monument Ave.

Re: project 3209 Monument Av. Richmond, Va.

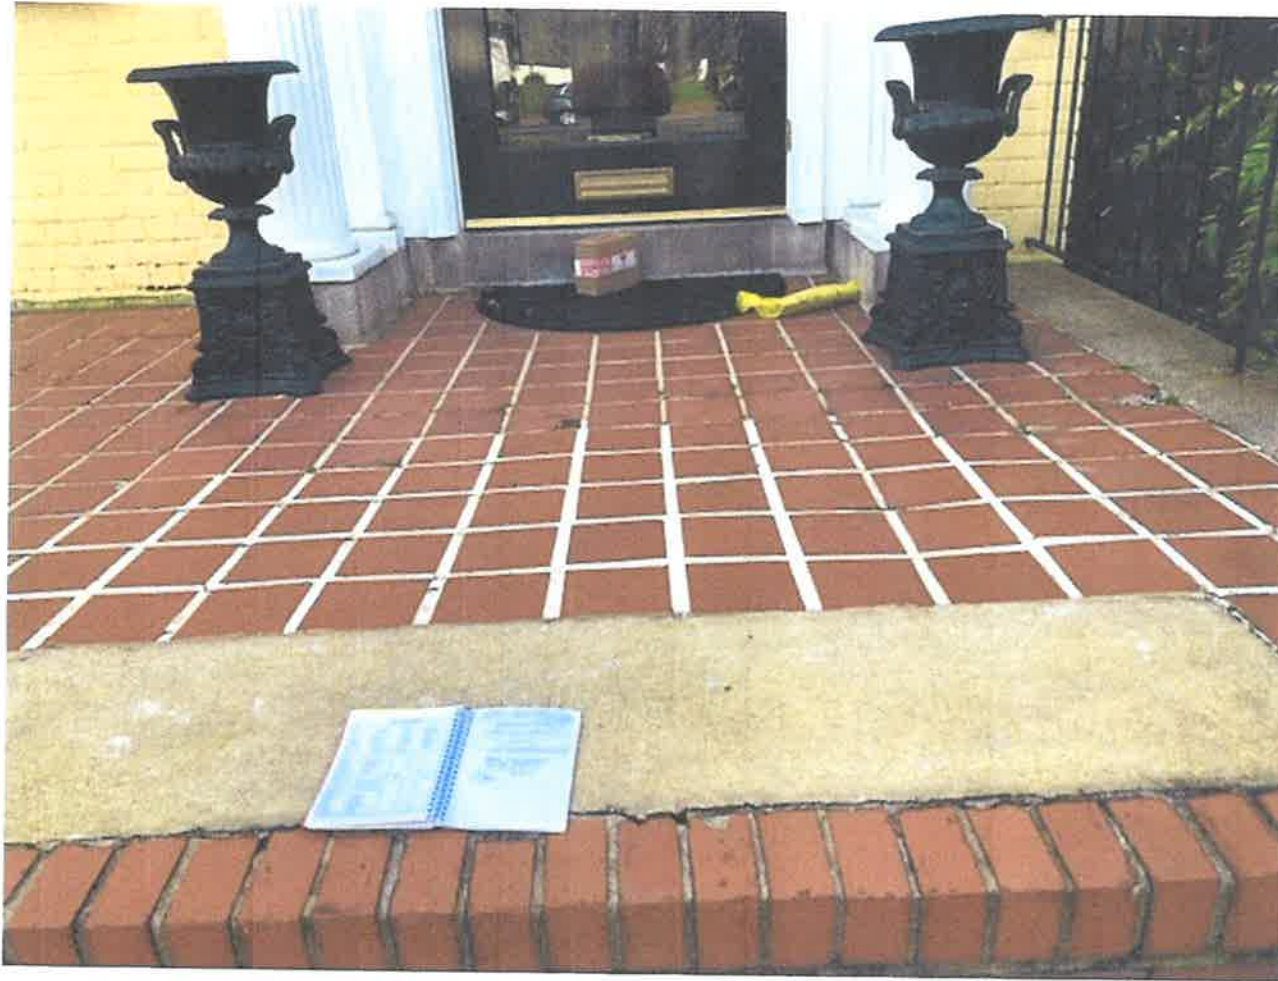
①

Existing porch

Remove concrete border around top of porch & tile and cement top

Lay approved brick border around top of porch and pattern 2 blue stone paving in middle see picture page 1 of existing porch and sketch on page 3 of proposed pavers on top

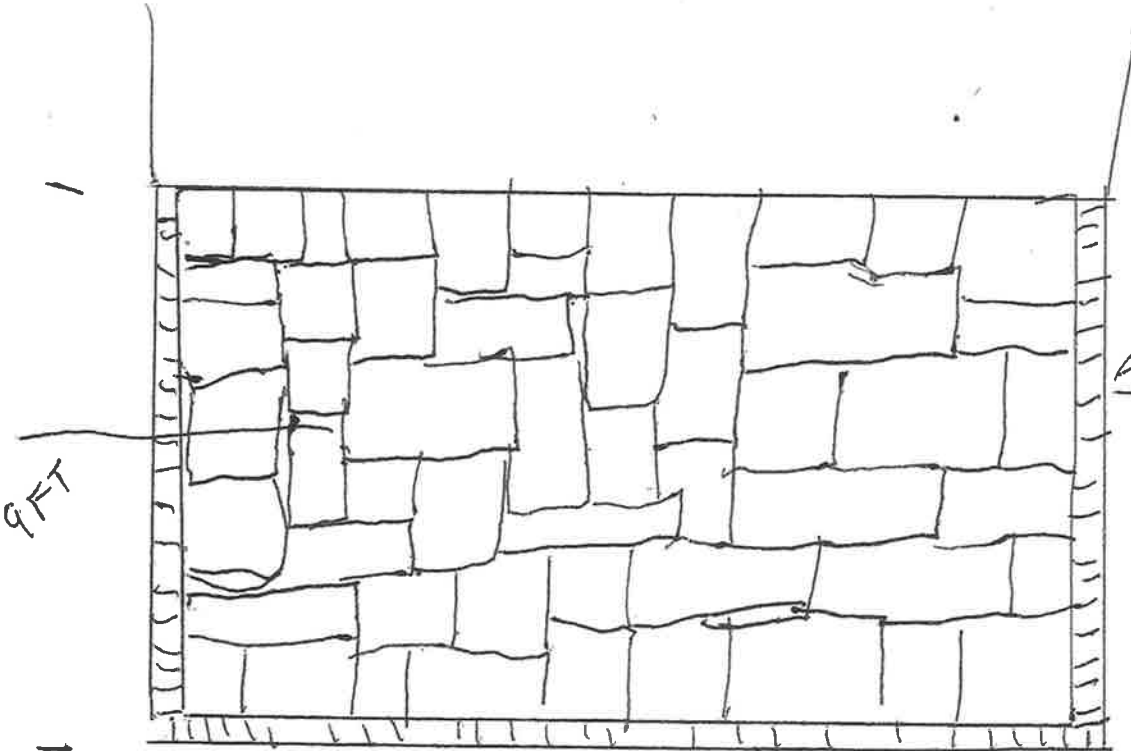
3
New Top

Blue Stone
Pattern II
Top

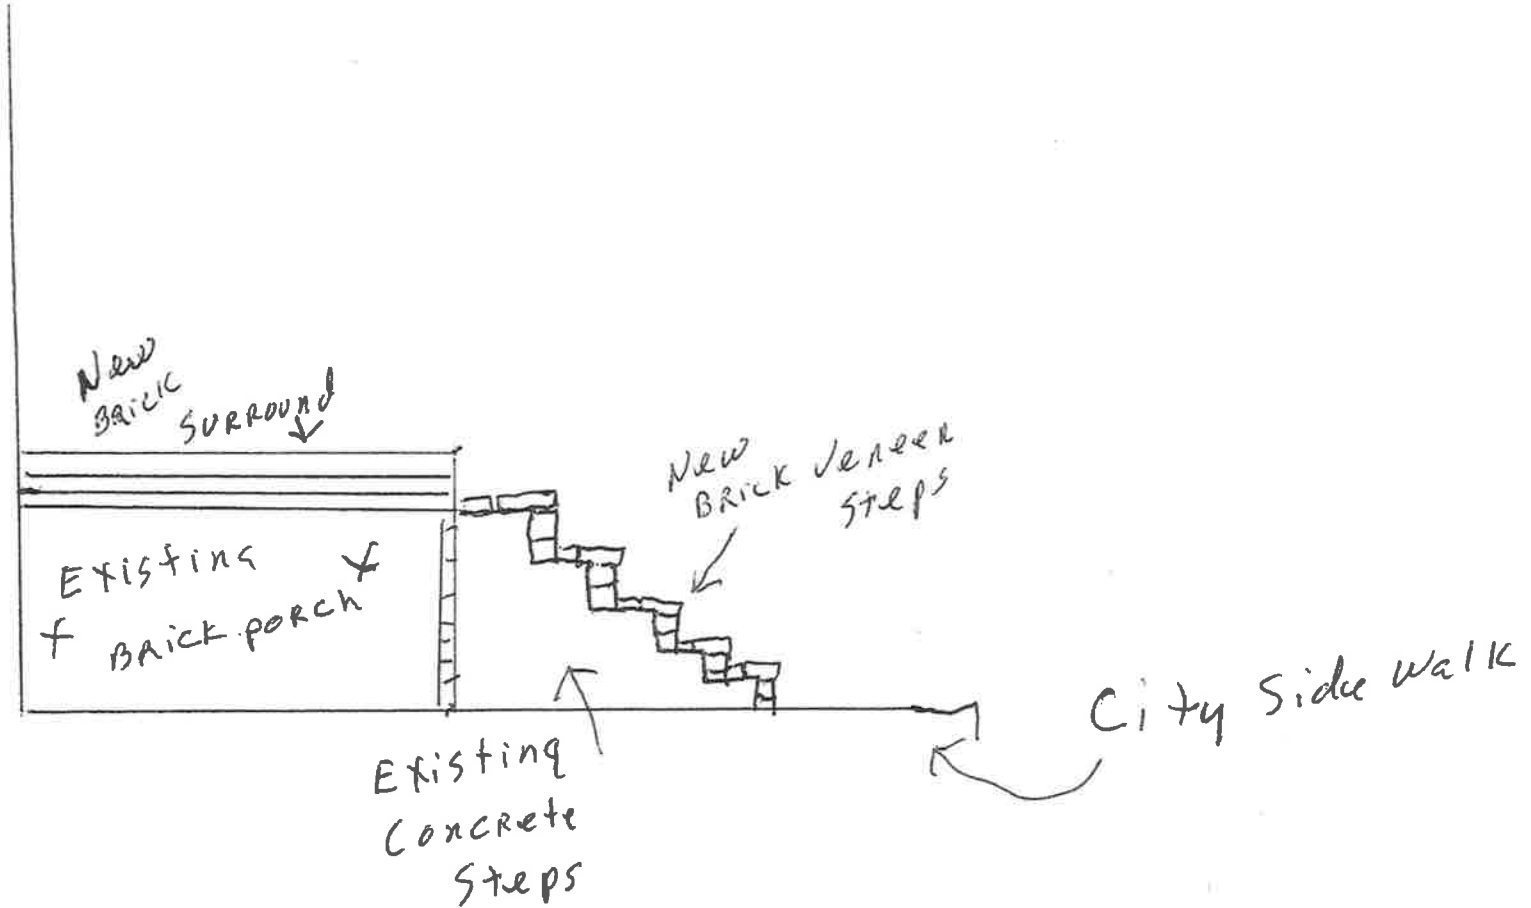
New BRICK
SURROUND

Existing Concrete
Steps

Brick veneer existing concrete steps

See page 2 picture of existing steps and on page 4 sketch of proposed brick veneer steps

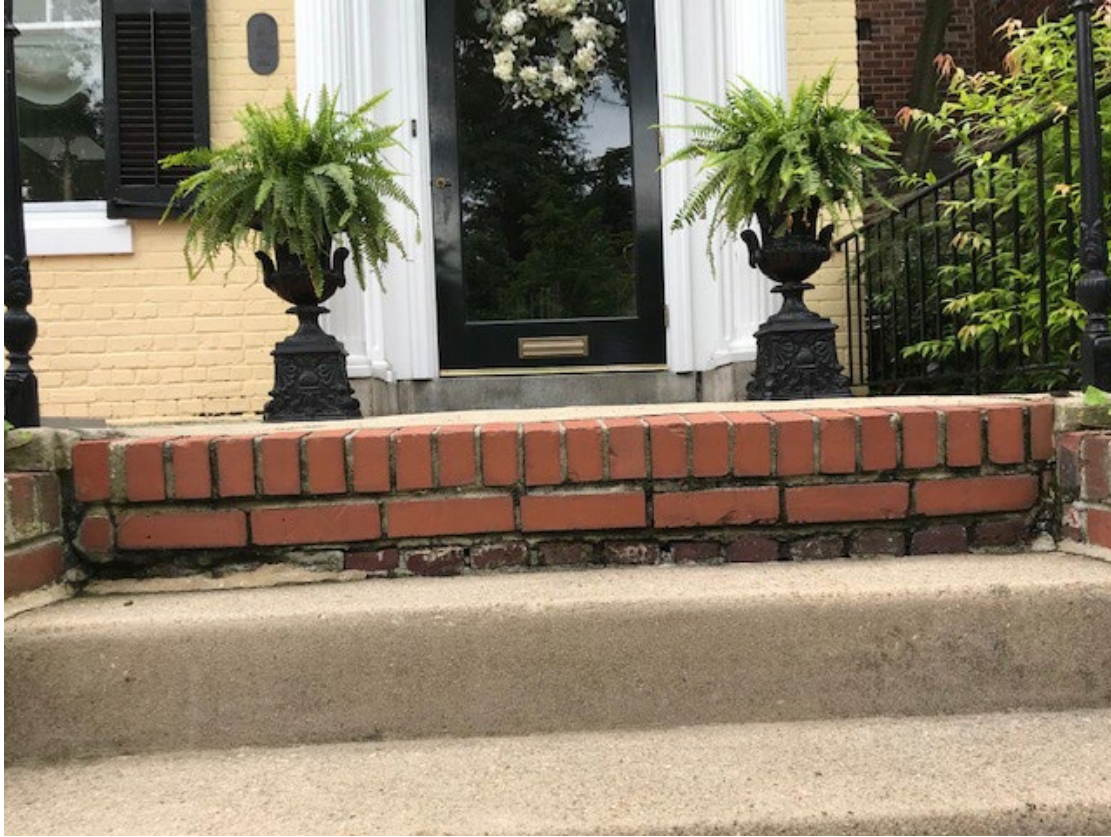
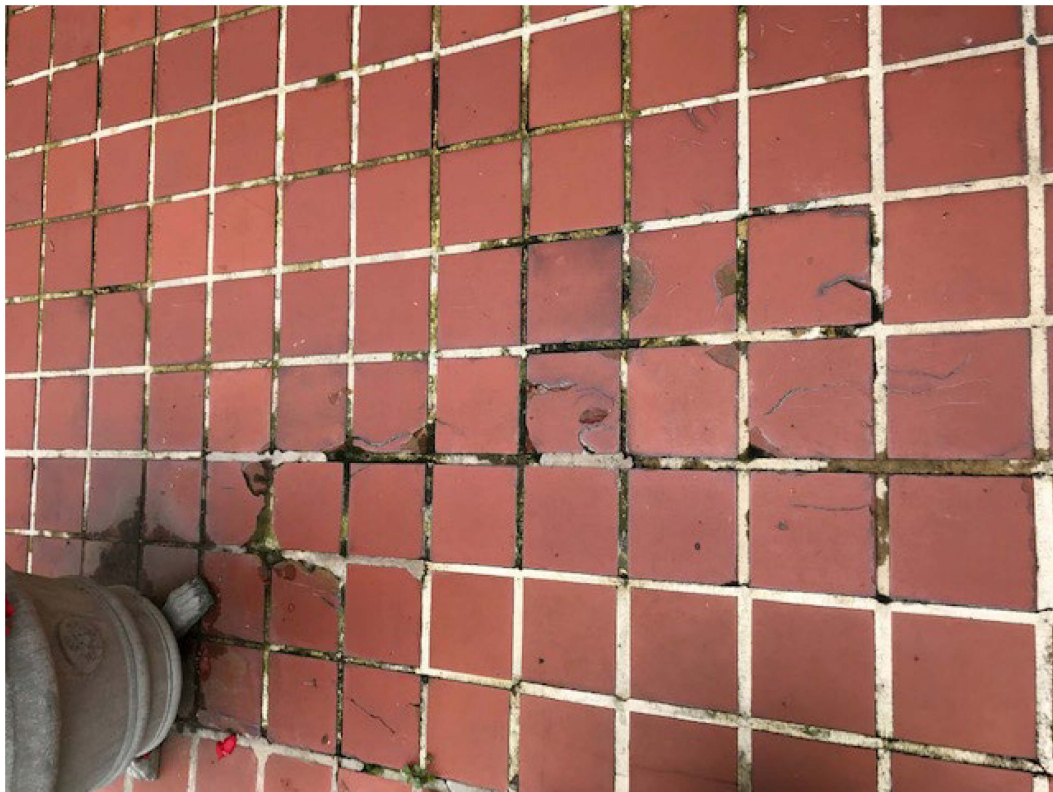
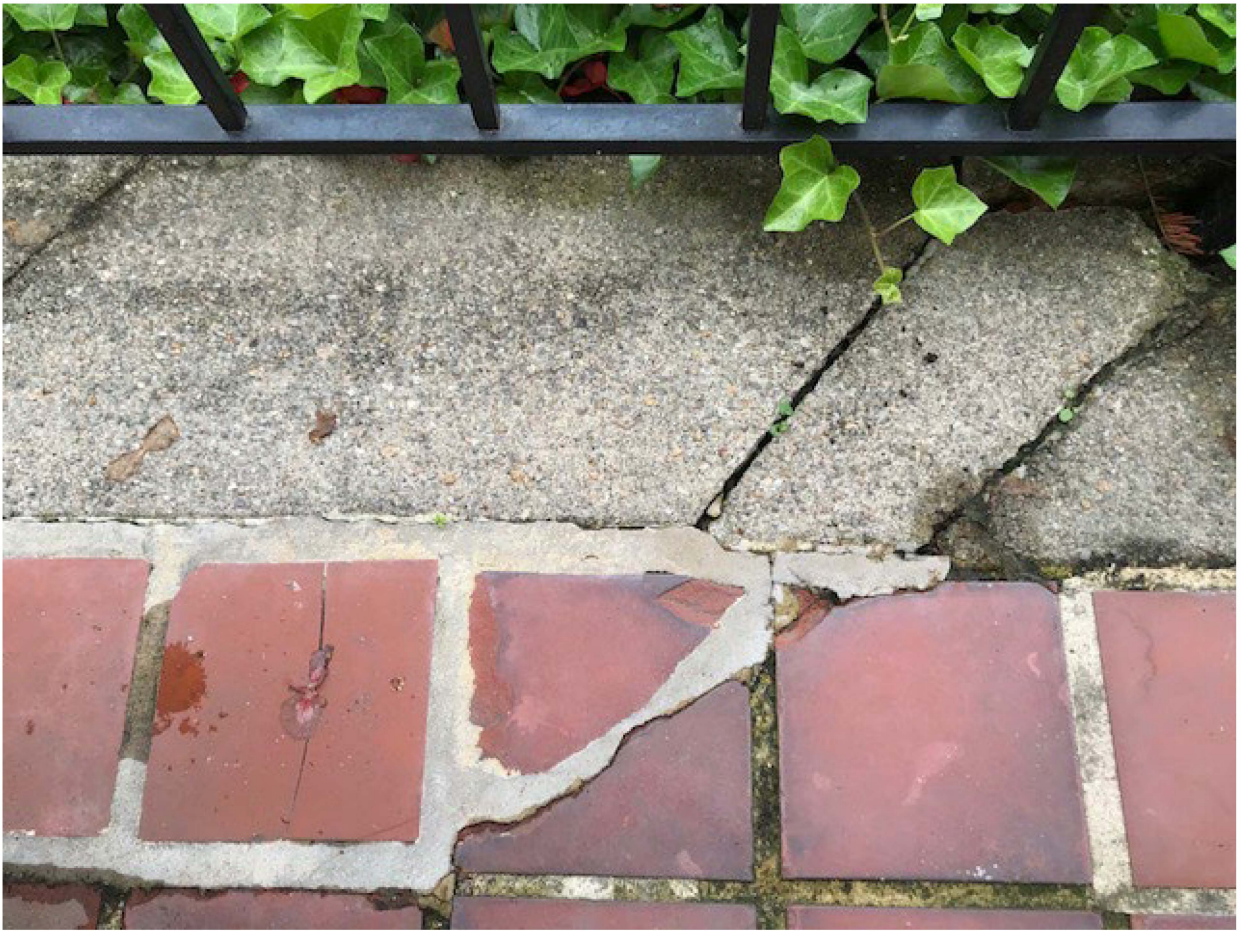
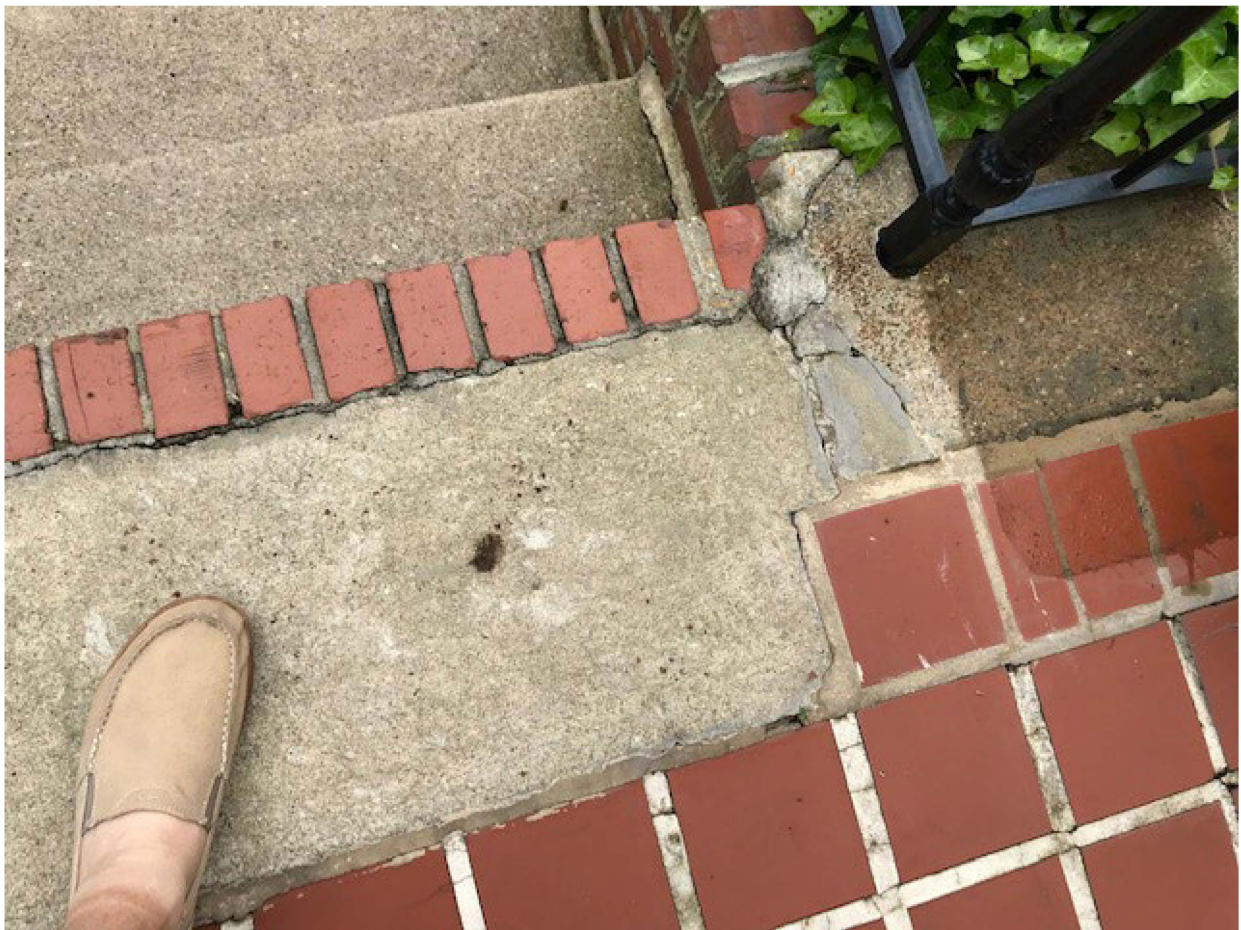
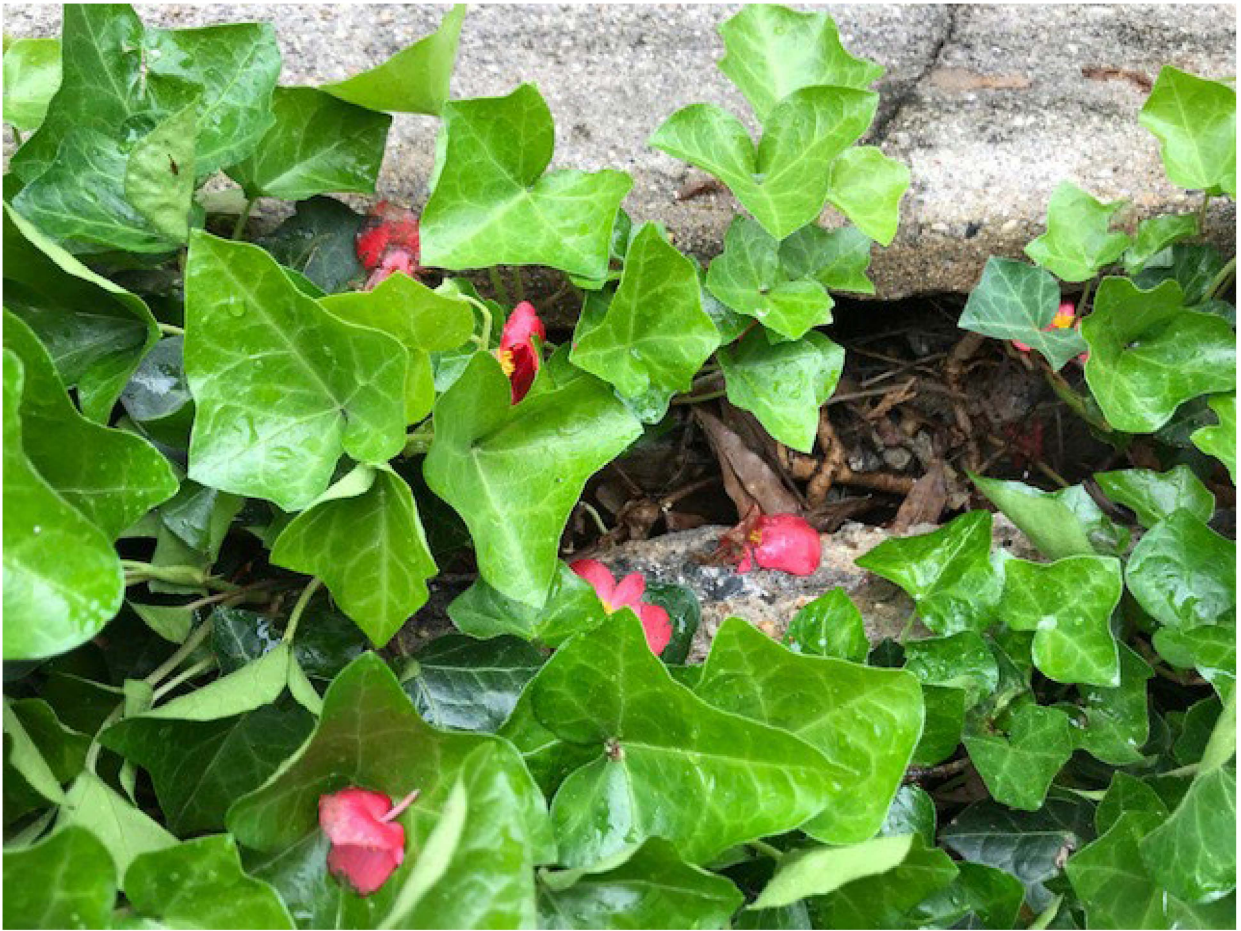
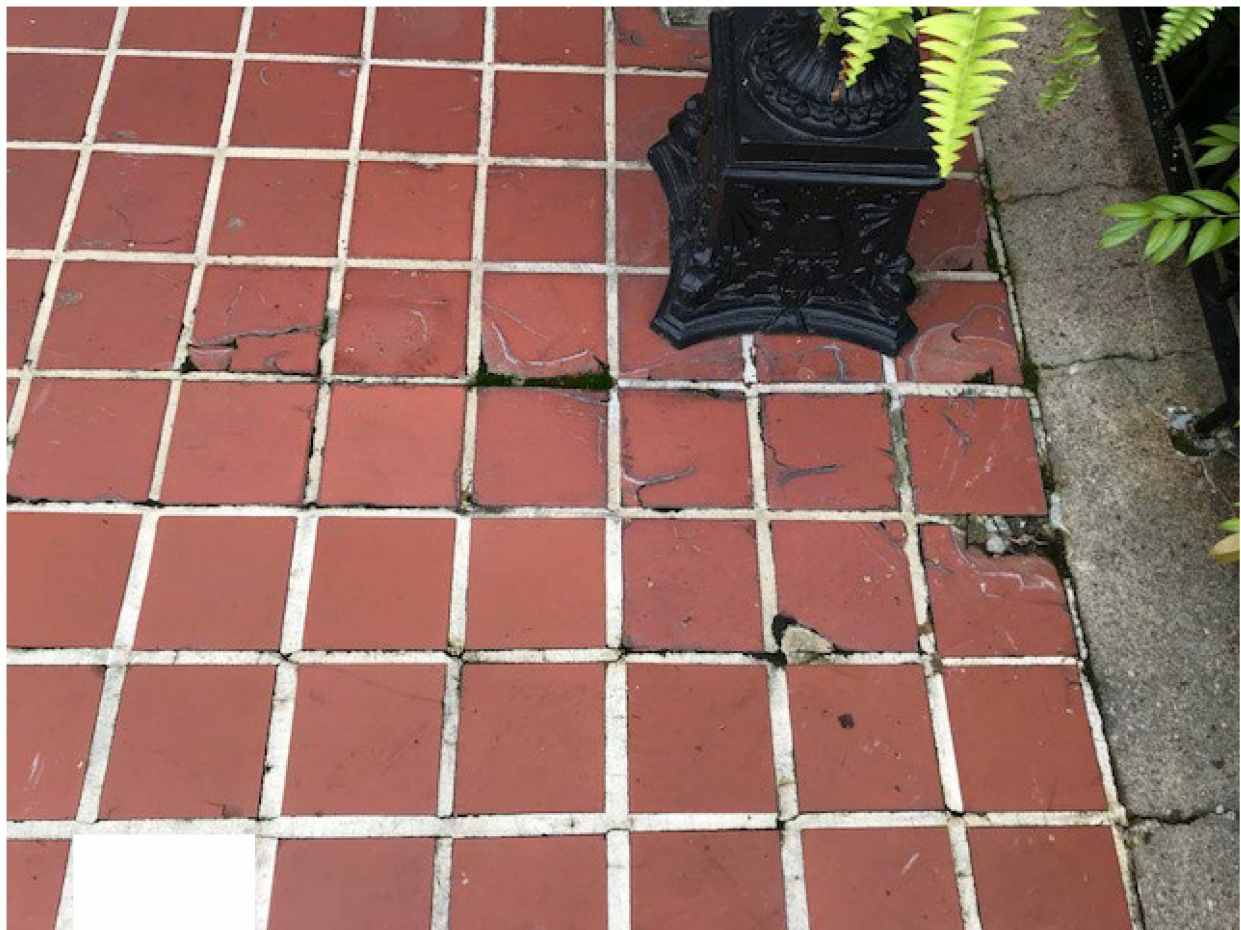
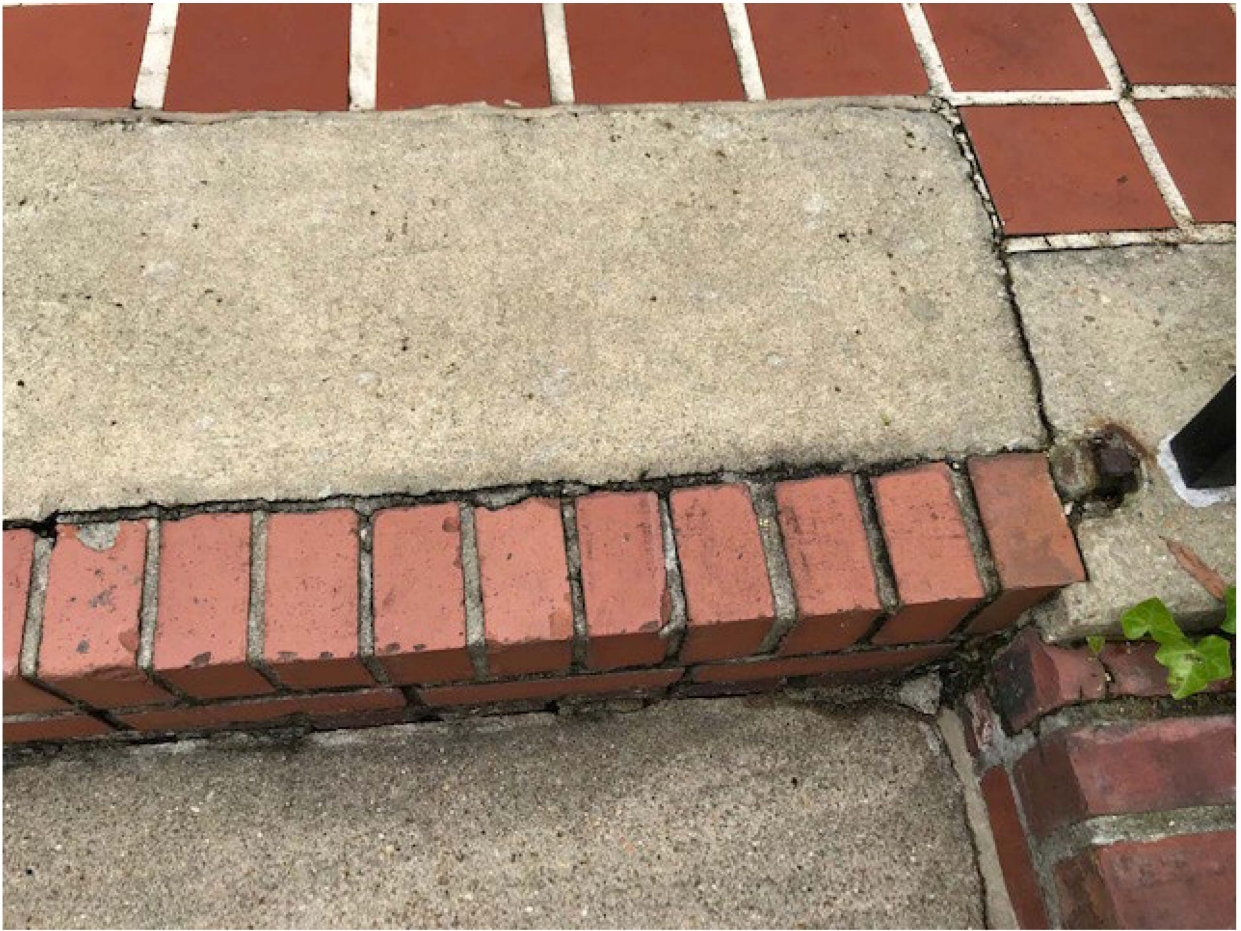
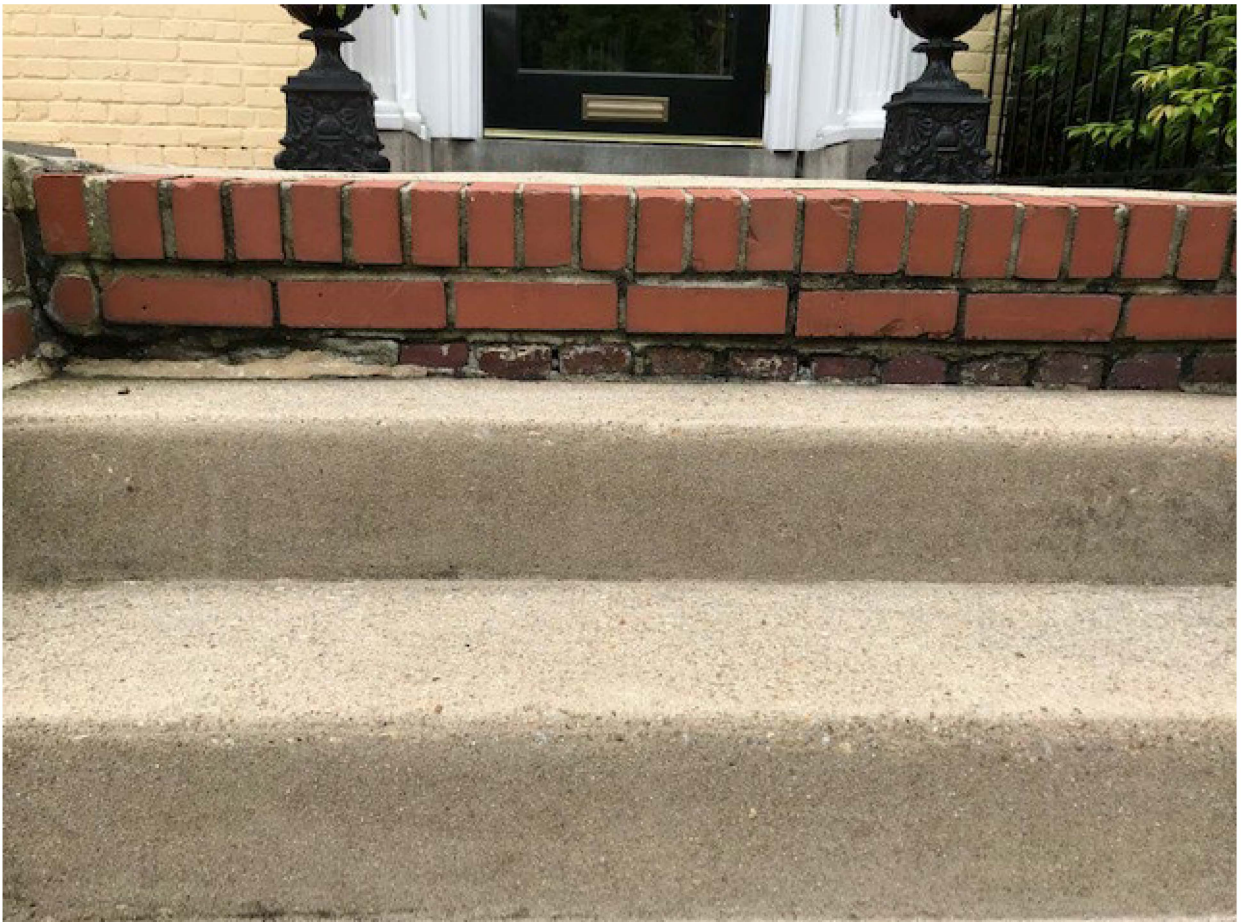
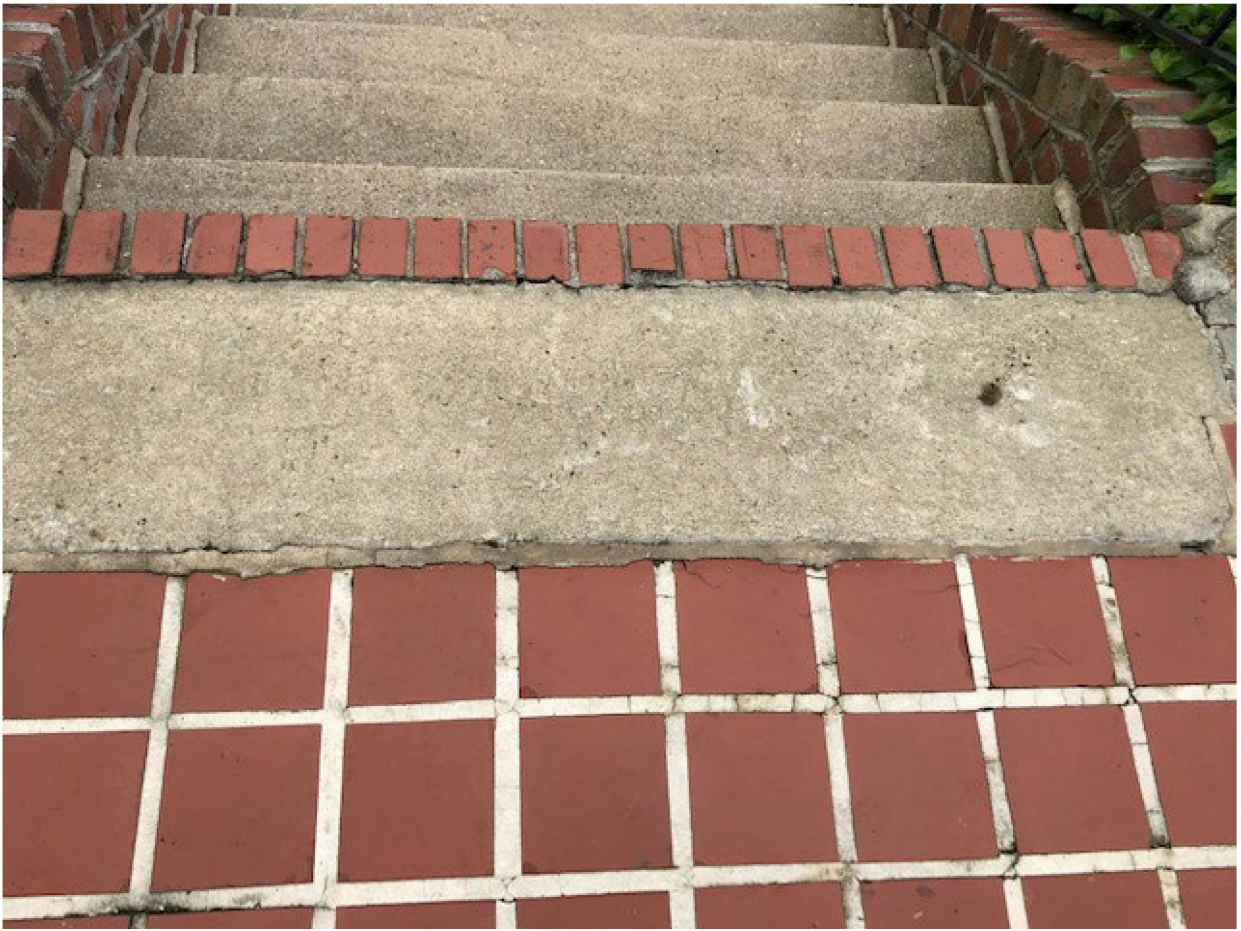
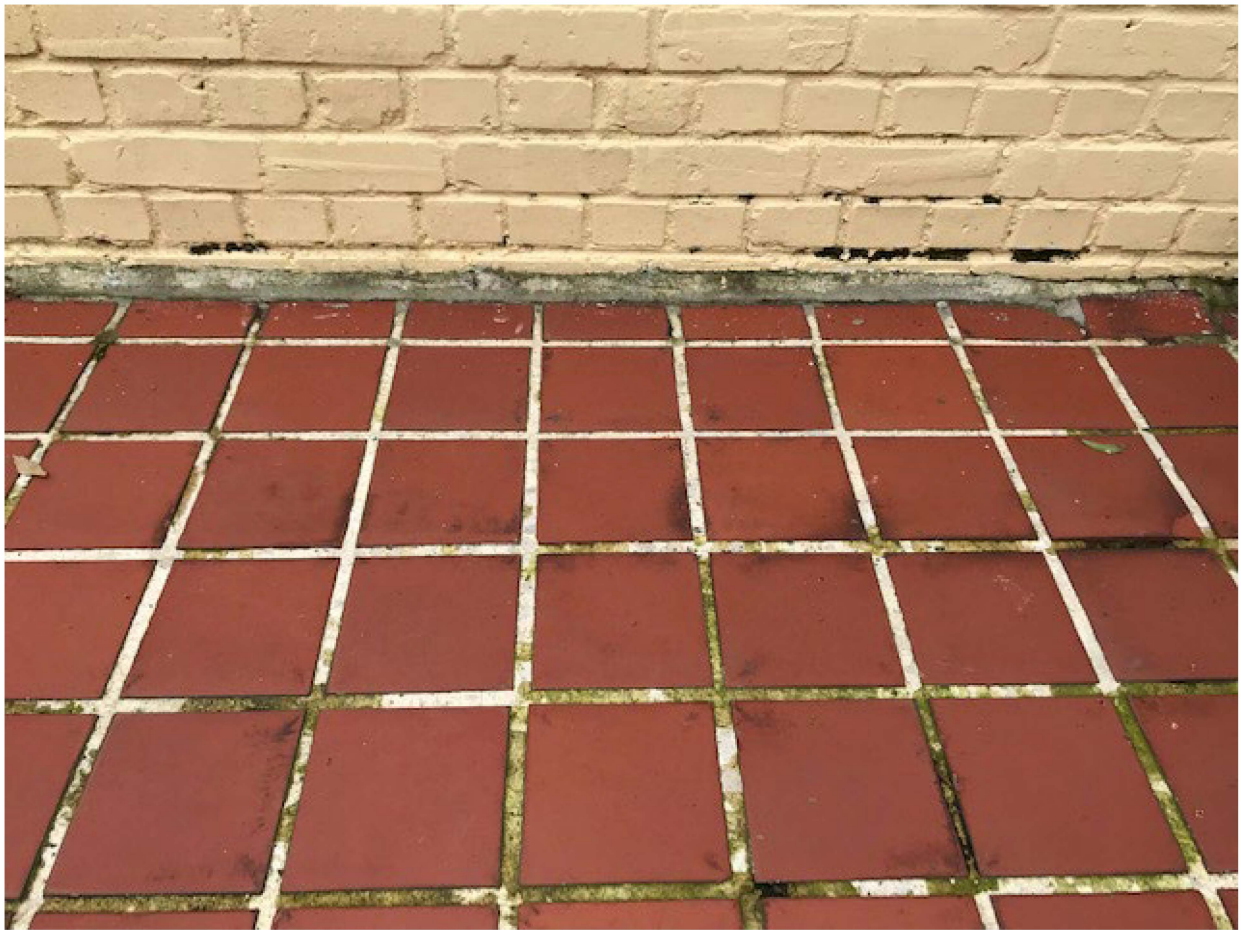
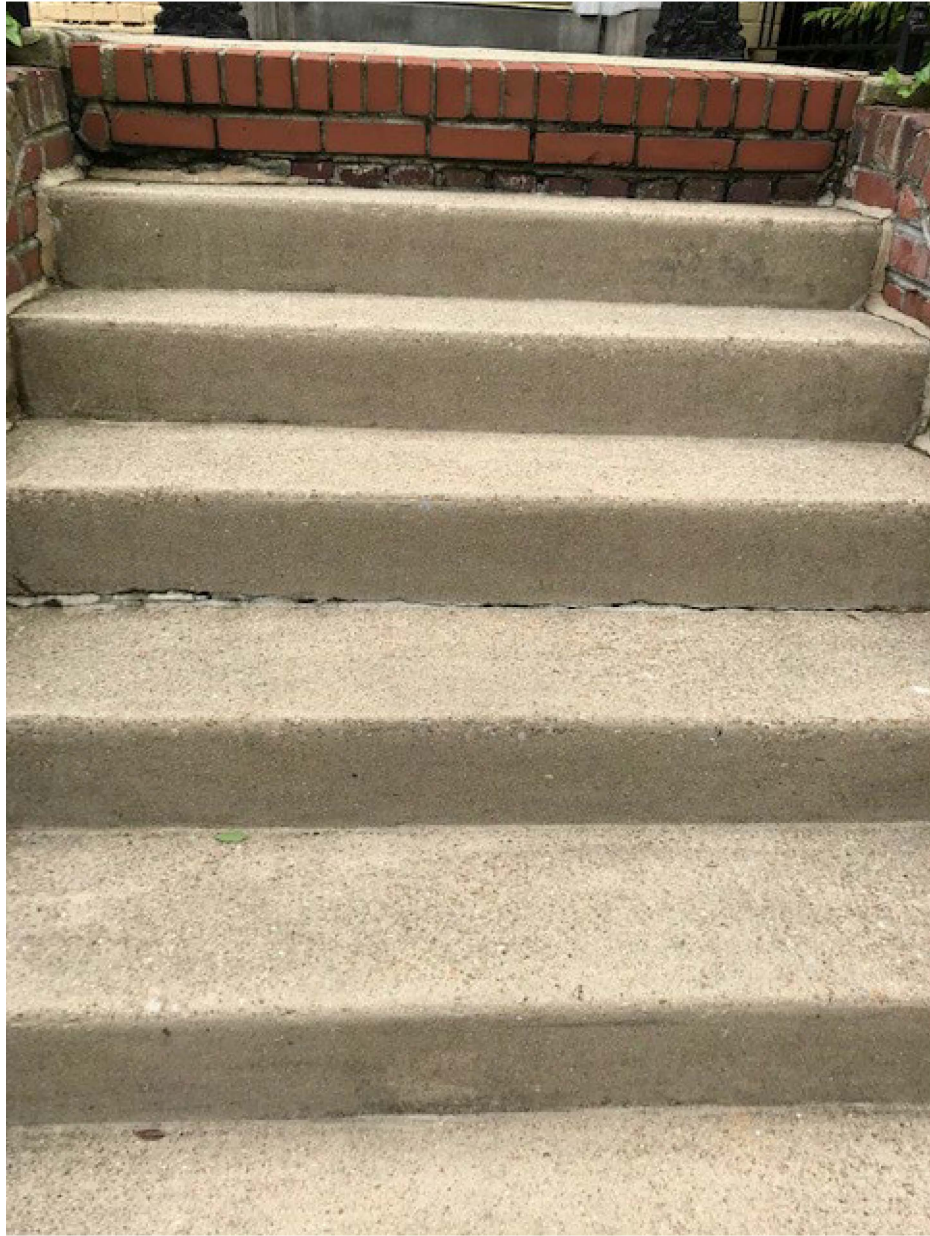
Thank you for your inquiry as to the need for our porch restoration. The attached pictures show the poor condition of the concrete border, including the broken and decaying areas. The red tiles on top are cracked and broken, having been repaired many times with little success, and the mortar is broken or missing allowing water to seep through. Also, those tiles are very slippery when wet. The top step of the stairs has shifted forward, making it a safety hazard as it is approx. 11" above the step below. All in all, a deteriorating porch in need of a restoration to make it safe and functional.
