Staff Report City of Richmond, Virginia

Commission of Architectural Review

5.COA-161197-2025	Final Review	Meeting Date: 2/25/2025
Applicant/Petitioner	Chris Coiner	
Project Description	Rehabilitate the exterior of an existing building.	
Project Location	- 080 2100 2100 E	2100
Address: 2211 Venable Street	807 2120 2205 2216 2222 2216 2220 805 2410 2114 2116 2210 2210 2210 2210 2210 2210 2210	
Historic District: Union Hill	803 21172 Venable St	
High-Level Details:	2 2 2 2 2 2 2 2 2 2 2 2 2 2 2 2 2 2 2	2223 2225 2225 2235 2235
The applicant proposes to rehabilitate an Italianate single dwelling circa 1876-1888. This 2-story, 3-bay frame dwelling has a raised brick foundation and a replacement porch with iron rails and supports, and a wood deck. The wood porch rests on brick piers.		815 (817 817 817 817 817 817 816 816 816 816 816 815 816 815 816 815 816 815 816 816 816 816 816 816 816 816 816 816
The building has replacement aluminum siding, front porch posts, and vinyl windows.		807

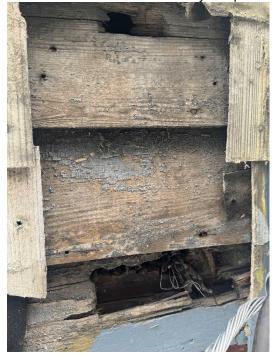
It is unknow how much, if any, original wood siding is located beneath the aluminum siding.

Figure 3. Original siding under aluminum siding. Poor condition with some rot and many nail punctures.

Staff recommends that, if it exists, any salvageable wood siding be relocated to the façade. Documentation of the salvageable siding submitted to staff for review. If there is no original siding left, or it is deteriorated beyond repair, staff recommends approval of the installation of the Allura fiber cement siding on the façade.

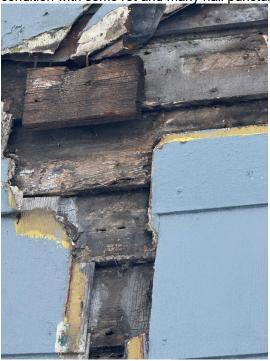
Figure 4. Original siding under aluminum siding. Poor condition with some rot and many nail punctures.
