## Commission of Architectural Review

5. COA-178058-2026	Final Review Meeting Date: 1/27/2026
Applicant/Petitioner	Thom Revay
Project Description	Repair and/or remove four deteriorated chimneys
Project Location	
Address: 1101 West Grace	
Historic District: West Grace Street	
<p><b>High-Level Details:</b></p> <p>The applicant requests guidance/approval on the repair and/or replacement of four chimneys on a two-story stucco building circa 1920.</p> <p>The four chimneys in question appear to be clad in stucco and in poor conditions. The application states that significant wanted infiltration is happening and causing interior damage.</p> <p>The application outlines different approaches to alleviating the issue such as complete demolition of the chimney and repair.</p>	
Staff Recommendation	Approval, with Conditions
Staff Contact	Alex Dandridge, Alex.Dandridge@RVA.gov, (804)646-6569
Previous Reviews	<ul style="list-style-type: none"> <li>Review</li> </ul>

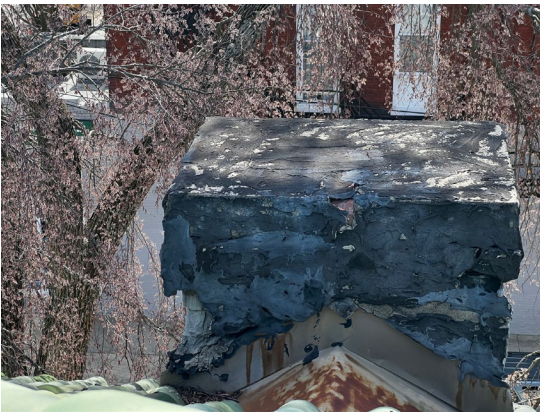
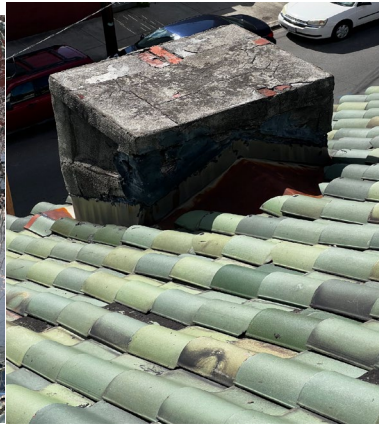
<p>would be appropriate, as these chimneys have already been altered in size and appearance, and a copper wrap would maintain the existing shape of the chimneys, preserve the remaining historic materials, and is an appropriate material for the district.</p> <p>Because the westernmost chimneys are still intact and contribute to the overall character of the building, Staff recommends that the westernmost chimneys be retained and repaired in-kind with new stucco that matches the existing in color, texture, and design. Staff recommends that these two chimneys be properly flashed and have new coping installed on their tops if necessary.</p> <p>Staff recommends that if any of the chimneys must be reconstructed, they must be reconstructed based on the physical and photographic documentation available, matching the existing in height, materials, and design.</p>
Building Elements, Roofs, pg. 66	<i>10. Original chimneys, skylights and light wells that contribute to the style and character of the building should be retained, as their removal could alter the overall character of the structure.</i>	Staff finds that the original chimney contributes to the overall character of the building and the history of the buildings past heating systems. The chimneys should be maintained and repaired as best as possible.

Figures 2&3. Altered Chimneys on the Eastermonst (Ryland Street) Elevation.

Staff Recommendations	<p>Staff finds that</p> <ul style="list-style-type: none"> <li>Previously altered, east elevation (Ryland Street) Chimneys be repaired and flashed/wrapped in true copper as needed.</li> <li>Westernmost chimneys be retained and repaired in-kind with new stucco that matches the existing in color, texture, and design.</li> <li>Westernmost chimneys be properly flashed and have new coping installed on their tops if necessary.</li> <li>If any of the chimneys must be reconstructed, reconstruction must be based on the physical/photographic documentation available, matching the existing in height, materials, and design. Any reconstruction details submitted in a subsequent</li> </ul>

Guideline Reference	Reference Text	Analysis
<p>Standards for Rehabilitation, Residential Construction, pg. 59</p>	<p><i>4. Retain original roof shape, size, materials and related elements including cupolas, chimneys and weather vanes; if replacement is necessary, consideration for use of slate, wood and metal, with respect to color and patterns, should be given.</i></p>	<p>The extant building features four chimneys. The two chimneys on the east side (Ryland Street elevation) have been altered sometime after 1950, being shortened in height. The other two chimneys on the west side of the building are clad in stucco with an indented square/rectangular design. These two chimneys appear to be in their original design and height.</p> <p><b><u>East Chimneys Condition – Ryland Street (2)</u></b></p> <p>The eastern most chimneys are not in their original conditions, being shortened sometime after 1950. The city assessor cards indicate that there was a fire loss in 1971; however, it is unclear where the fire loss was on the building. The chimney located at the corner closest to West Grace and Ryland appears to have been coated in several layers of tar/patch work, while the chimney further south appears to be parged with concrete. The tar/sealant and concrete parge coat appear to be previous attempts at repairing the chimneys; however, are now failing with many areas exposing the underlying brick chimney stack.</p> <p><b><u>West Chimneys Condition (2)</u></b></p> <p>The western-most chimneys still maintain their original design and height; however, the stucco on the chimney closest to W. Grace Street is in poor condition, as it is buckling and flaking off. The southernmost chimney on the west elevation appears to have some cracks in the stucco but appears relatively intact with patch work on the back side.</p> <p>Chimneys are a character-defining feature of historic buildings that should be maintained and repaired.</p> <p>Staff recommends that the four chimneys be maintained and repaired and recommends the following treatment options:</p> <p><u>Staff recommends that the East Elevation (Ryland Street) Chimneys be repaired and flashed as needed, and finds that wrapping these chimneys in true copper</u></p>

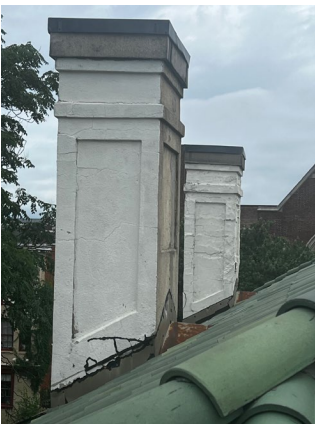
Figures 4. Westernmost, intact chineys.
