**COMMISSION OF ARCHITECTURAL REVIEW
STAFF REPORT
June 26, 2018, Meeting**

5. **COA-034571-2018** (A. Smith & S. Mullen-Smith) **3422 East Broad Street
Chimborazo Park Old and Historic District**

Project Description: **Alter two window openings
and add an opening in the rear.**

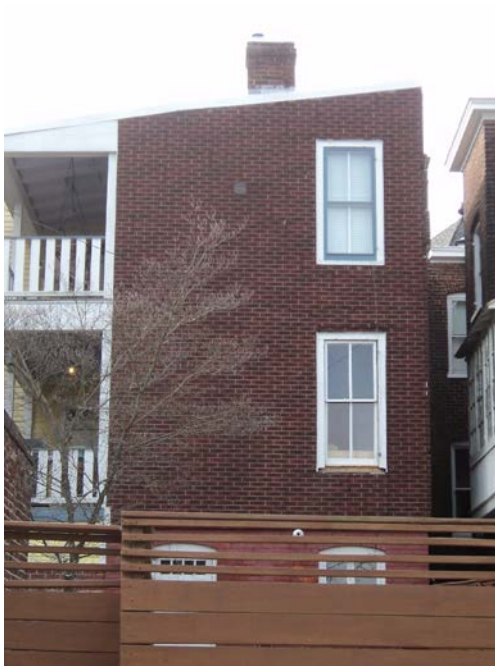
February, 2018

The applicant requests approval to alter the fenestration on the rear elevation of a two story frame Queen Anne dwelling constructed ca. 1900. The applicant proposes to enlarge two existing window openings by replacing 33"x79" wood windows with 48" x 71" double casement vinyl windows and add a window opening on the first floor.

- On March 16, 2018 staff observed exterior work being performed at the property while conducting site visits.
- A Notice of Violation was issued March 19, 2018. The window installation was completed on March 19th.

Staff recommends denial of the project.

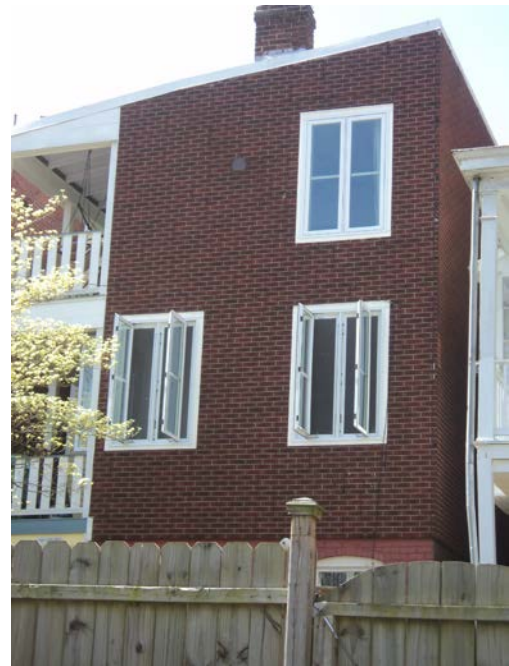
June, 2018

The *Guidelines* also provide guidance for window replacement. They state that the number, location, size, or glazing pattern of windows should not be changed by installing replacement sash that do not fit the original window (pg. 69, #8) and changes in the sash, depth of reveal, muntin configuration, frame or glazing is strongly discouraged (pg. 69, #10). The proposed replacement windows do not match the original in size, glazing pattern, muntin configuration, sash, frame, material, or design as they are double vinyl double casement windows replacing 2/2 wood double hung windows. Staff recommends denial of the proposed window replacement.

The *Guidelines* state that replacement materials should convey the same appearance as surviving elements (pg. 59, #7), further asserting that that vinyl windows are not appropriate for historic buildings in historic districts because the material cannot be manufactured to model effectively the appearance of historic windows (pg. 69, #11). Staff recommends denial of the proposed vinyl replacement windows.

The proposed new window opening does not match the original windows in size, design, material, or glazing pattern. Staff recommends denial of the proposed new window opening.

In addition to the modifications listed in the application, staff has observed that openings in the first bay on the east elevation of the dwelling have also been modified. A historic 2/2 wood double hung window was replaced with the same vinyl replacement window on the second floor. In addition, a door on the first floor was converted to a window and the same vinyl replacement product was installed in this opening. Staff recommends denial of the changes to the openings on the east elevation and recommends the applicant return to the Commission with a complete application that meets the *Richmond Old and Historic Districts Handbook and Design Review Guidelines*.
