## Commission of Architectural Review

| #8 COA-170382-2025 | Final Review | Meeting Date: 8/26/2025 |
| Address: 2426 Venable Street | | |

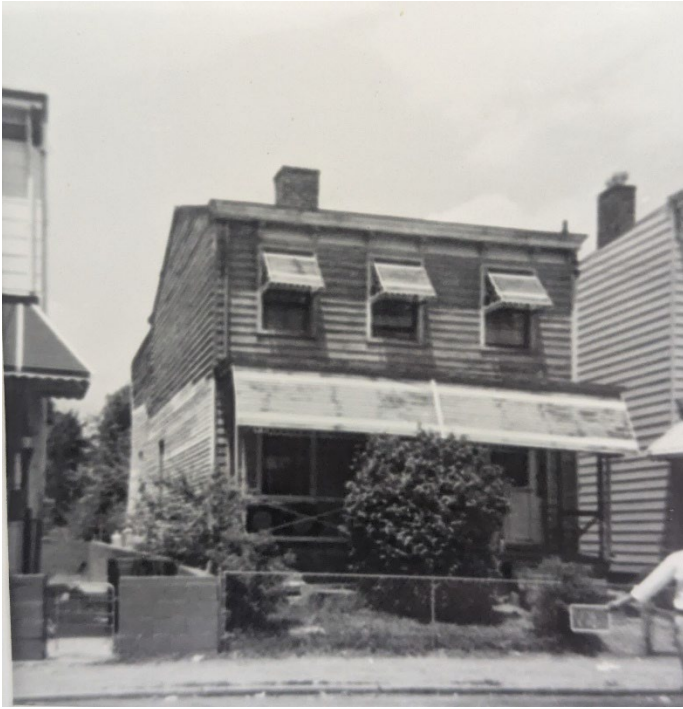
Figure 1. 2426 Venable Street, 1950s.

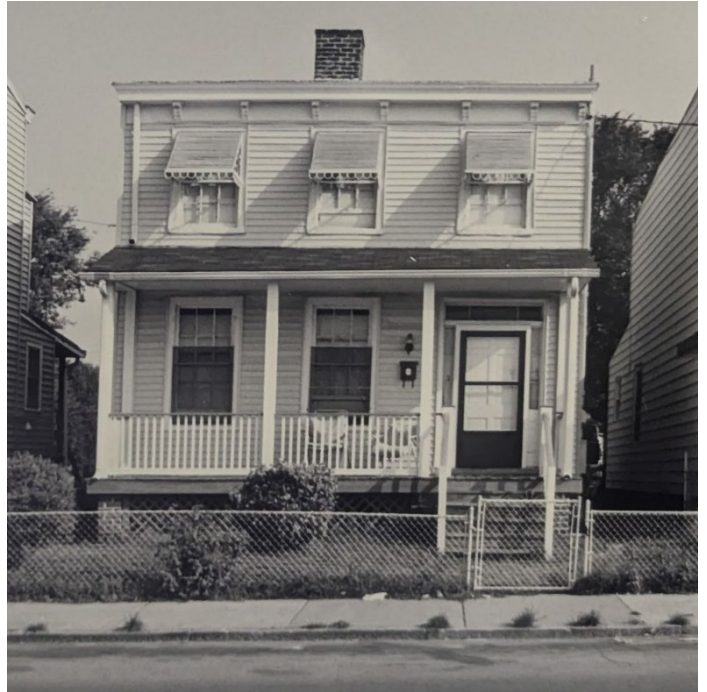
Figure 2. 2426 Venable Street, 2000s.

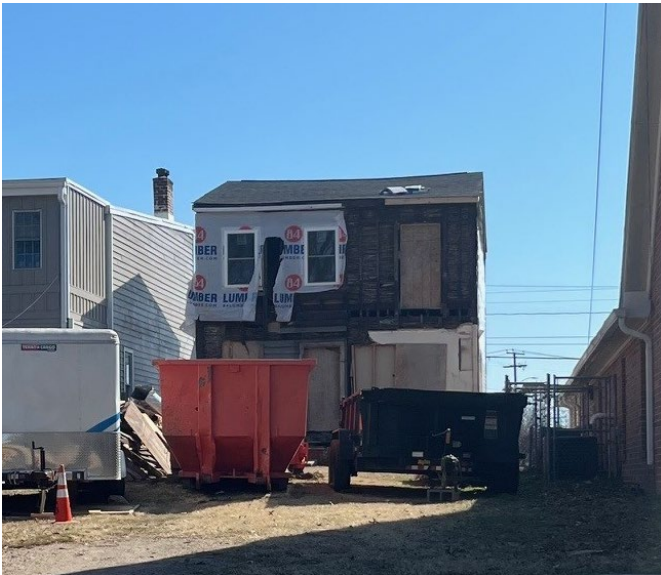
Figure 3. 2426 Venable Street, rear, March 2025, rear portion removed.

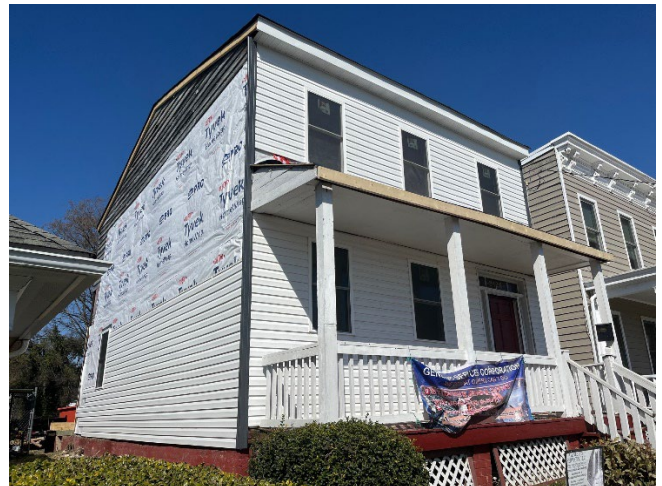
Figure 4. 2426 Venable Street, side elevation and facade, March 2025, some wood siding visible on side elevation.

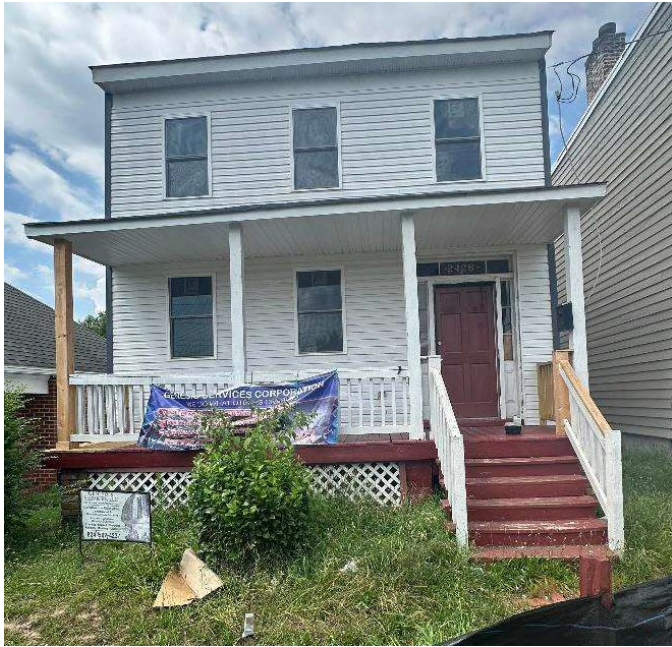
Figure 5. 2426 Venable Street, Façade, July 2025.

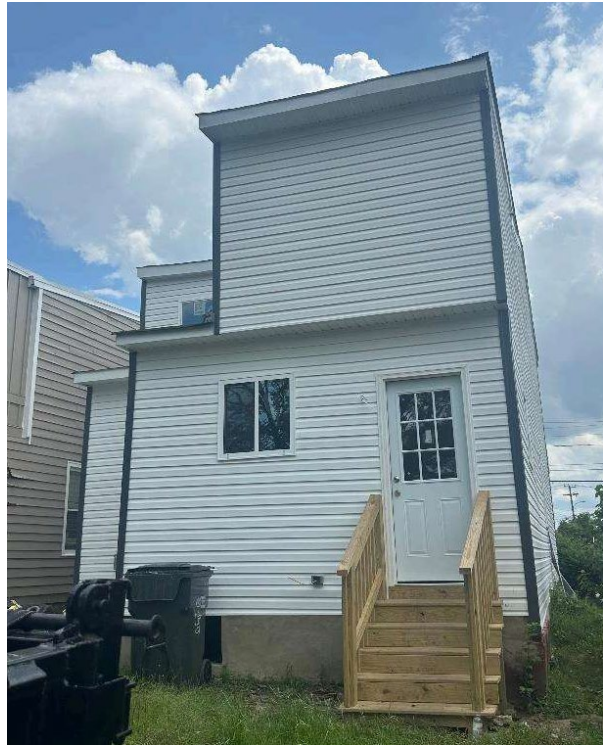
Figure 6. 2426 Venable Street, rear, July 2025.
