Staff Report
City of Richmond, Virginia

Commission of Architectural Review

| 2. COA-141067-2024 | Final Review | Meeting Date: 1/23/2024 |
| Project Description | Replace a non-original, front porch railing with composite materials. | |

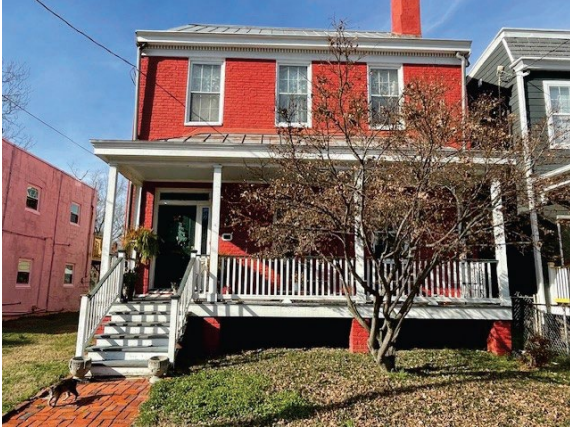
Figure 1. 510 North 29th Street Existing Conditions.

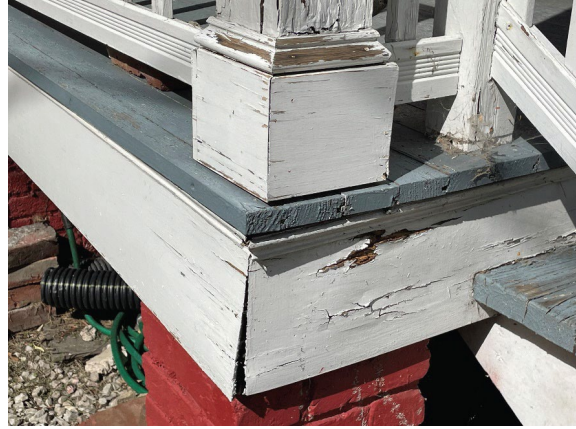
Figure 2. 510 North 29th Street Existing Conditions. Deteriorating column base, railings, and skirt board.

| | <p><i>3. Replacement of poor-quality materials.</i></p> | <p>more susceptible to decay and pests due to its widely spaced growth rings.</p> <p>The Intex Millwork Solutions product proposed for the new porch railing is a paintable material that will have hidden fasteners. The balusters will be 1-1/4" with a square edge.</p> <p>Staff believe that the proposed substitute materials visually resemble the appearance of wood.</p> <p>Fypon polyurethane flat lumber proposed for the square columns will have a smooth finish and is a paintable material.</p> <p>Because the historic material has been lost, as well as to ensure the longevity of the new columns and railings, <u>Staff recommends approving the use of the substitute material on the front porch.</u></p> |

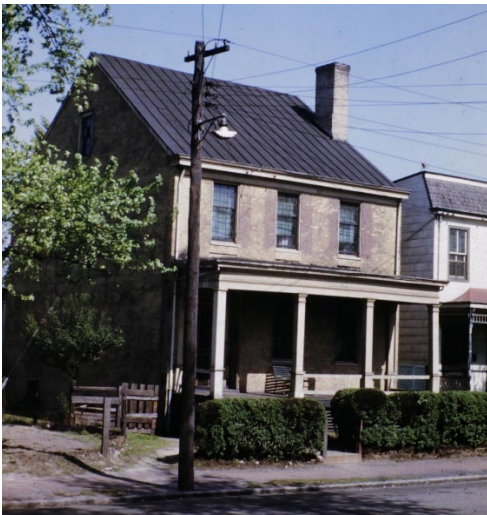
Figure 3. 510 North 29th Street, circa 1941-1949. Valentine Archives, accessed January 16, 2024. Original Greek Revival style, covered front porch still present.

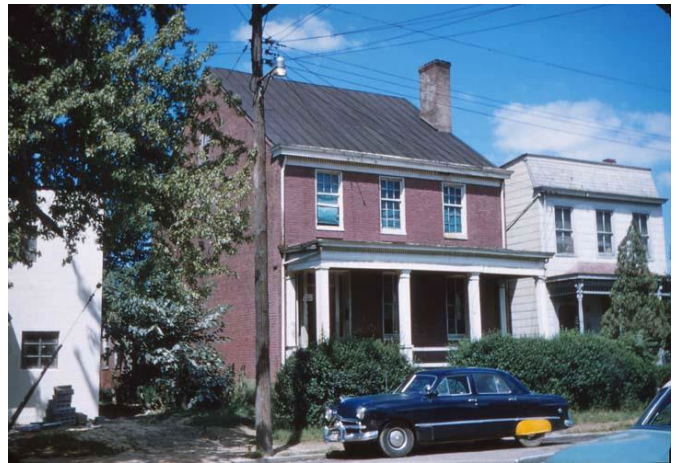
Figure 4. 510 North 29th Street circa 1956. Valentine Archives, accessed January 16, 2024. Original Greek Revival style, covered front porch still present.

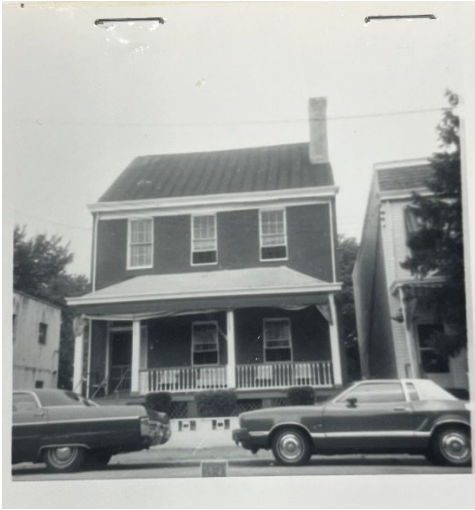
Figure 5. 510 North 29th Street circa 1977. Historic Richmond Foundation Survey. Original Greek Revival style, covered front porch has been removed and replaced. Front porch railings appear to be turned posts.

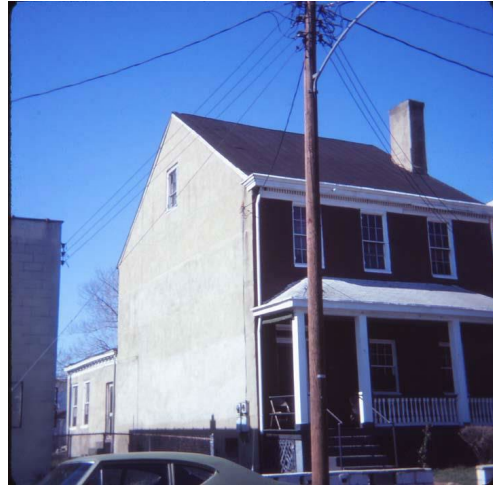
Figure 6. 510 North 29th Street. Original Greek Revival style, covered front porch has been removed and replaced. Front porch railings appear to be turned posts.
