10. COA-060013-2019

614 North 27th Street

Commission of Architectural Review

STAFF REPORT

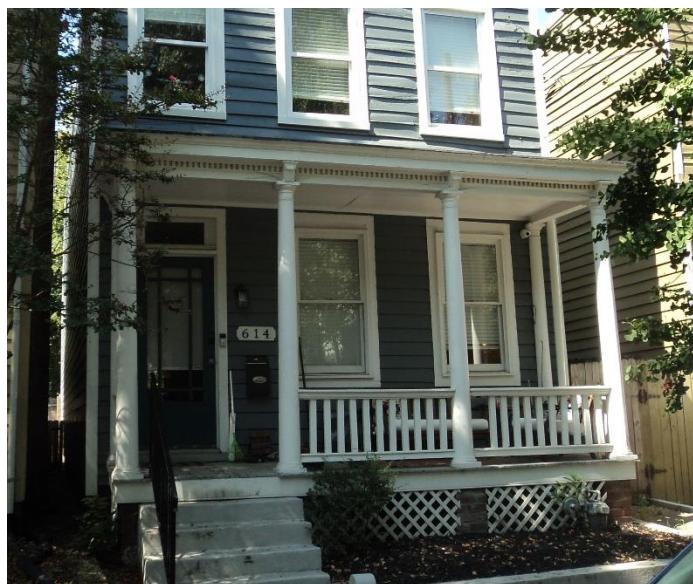
Porches, Entrances & Doors, pg. 71 #8	<i>Do not strip entrances and porches of historic material and details that should be retained in any repair or partial replacement.</i>	Staff finds that the pictures submitted with the application indicate that the porch railings are in disrepair. Staff notes that a picket is missing but does not see evidence of extensive disrepair or rot. <u>Staff recommends the existing railing be selectively repaired in-kind with new wood, stripped and repainted.</u>
Maintenance and Repair, Wood, pg. 91	<i>The repair of leaking roofs, gutters and downspouts will mitigate problems associated with excessive moisture.</i>	The application indicates that the porch has experienced water damage. <u>Staff recommends that the applicant investigate the source of the</u>

Figure 1. Front porch, September 2019

- The historic columns remain in place and be repaired and repainted.
- The existing beadboard be removed. If the historic porch ceiling is not existing beneath the beadboard, staff recommends a new tongue-and-groove ceiling that matches the 2016 photograph be installed.
- The applicant investigate the source of the water infiltration and work with staff to develop a plan to address any drainage issues, to include roof, gutter or downspout repair or replacement.
- The decking be cleaned by the gentlest means possible with a low-pressure wash. Any damaged boards should be replaced in-kind with new wood tongue-and-groove.

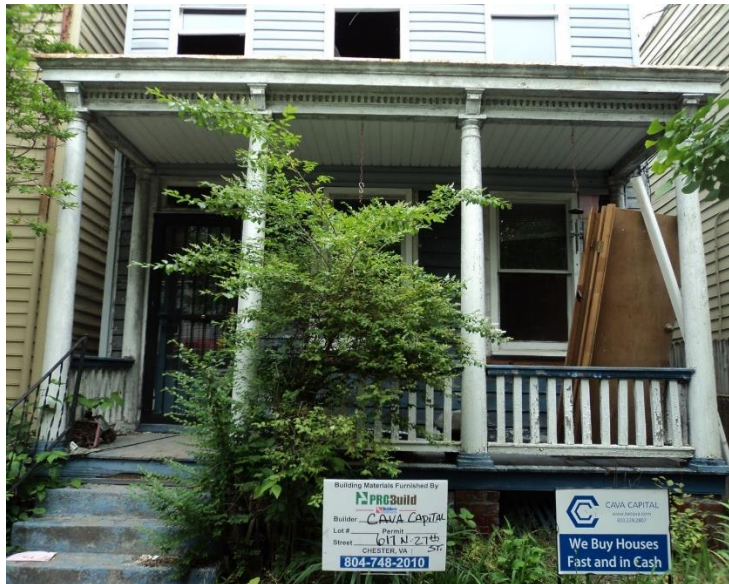
Figure 2. Front porch, May 2016
