**Staff Report**  
**City of Richmond, Virginia**

**Commission of Architectural Review**

6.COA-158358-2024	Final Review	Meeting Date: 12/17/2024
Applicant/Petitioner	David Franks	
Project Description	Reconstruct a covered front porch.	
Project Location		
Address: 1809 West Grace Street		
Historic District: West Grace Street		
High-Level Details:		
<p>The applicant requests approval to reconstruct a front porch which was removed in 2024 without review and approval by the CAR.</p> <p>The building is a masonry, three-story, colonial revival building circa 1908. There have been three documented front porch designs on the building.</p> <p>The porch that was removed was not the original.</p> <p>A notice of violation was issued to the property in April 2024. A code case (036818-2020) was issued to the property for deteriorating front porch columns in 2020.</p>		
Staff Recommendation	Denial	
Staff Contact	Alex Dandridge, alex.dandridge@rva.gov, (804) 646-6569	
Previous Reviews	None.	
Staff Recommendations	<p><b>Staff recommends denial</b> of the use of metal posts and railings on the new porch and recommends that the porch feature elements and materials that either reference the historic

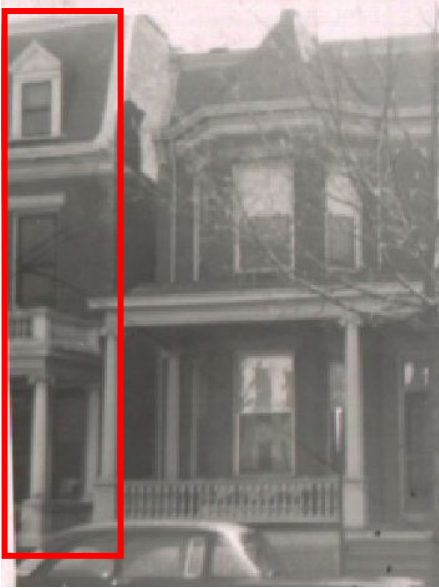
Figure 1. 1809 West Grace Street, 1950s. Original front porch with Scamozzi Columns atop square bases. Ornate entablature and balustrade with turned posts above the front porch. Similar to neighboring properties.

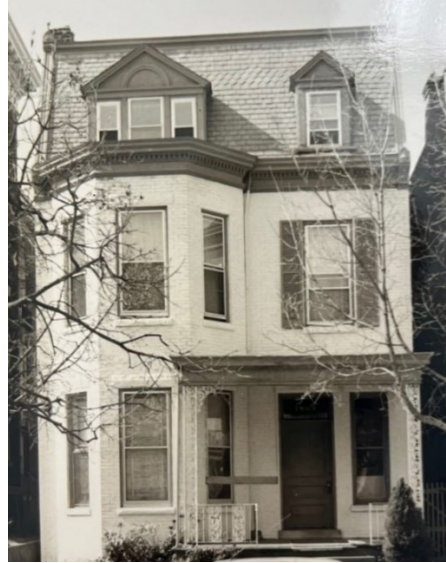
Figure 2. 1809 West Grace Street, 1977, HRF Survey. Original front porch has been removed and replaced with mid-century, decorative metal posts and railings. Original entablature appears to be in place. Building has been painted.

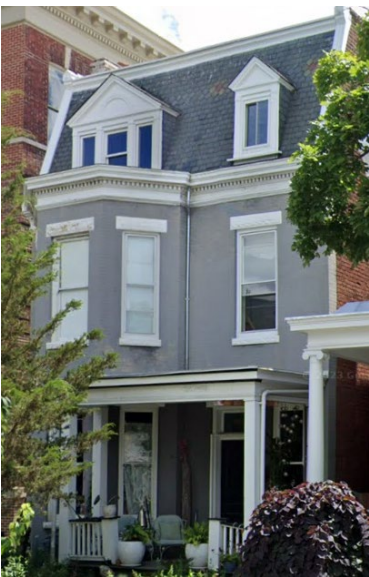
Figure 3. 1809 West Grace Street, 2023. Front porch with square posts, simple square newel posts, and a flat roof. This porch has since been removed.

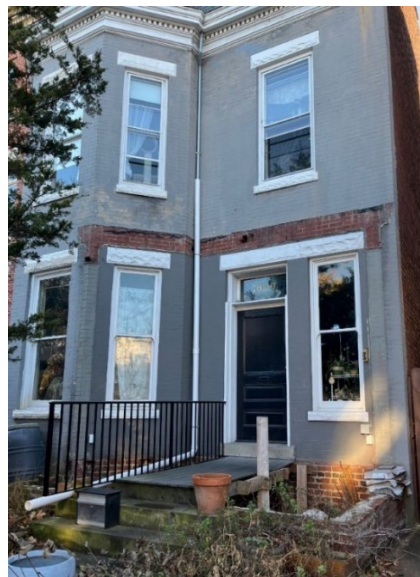
Guideline Reference	Reference Text	Analysis
<b>Building Elements, Porches,</b>	4. Do not remove or radically change entrances and porches important in defining the building's overall historic character. Front and side porches are	The entire front porch was removed in early 2024. This front porch was not original to the building. The roof may have been original as seen by ghosting on the face of the building.

Figure 4. 1809 West Grace Street, existing conditions 2024.
