Commission of Architectural Review SUBMISSION APPLICATION

LOCATION OF WORK: 409 N. Boulevard DATE: 8/25/16

Additional Information for Application No. 16-37 for 409 N. Boulevard

Attachment to Application for Certificate of Appropriateness

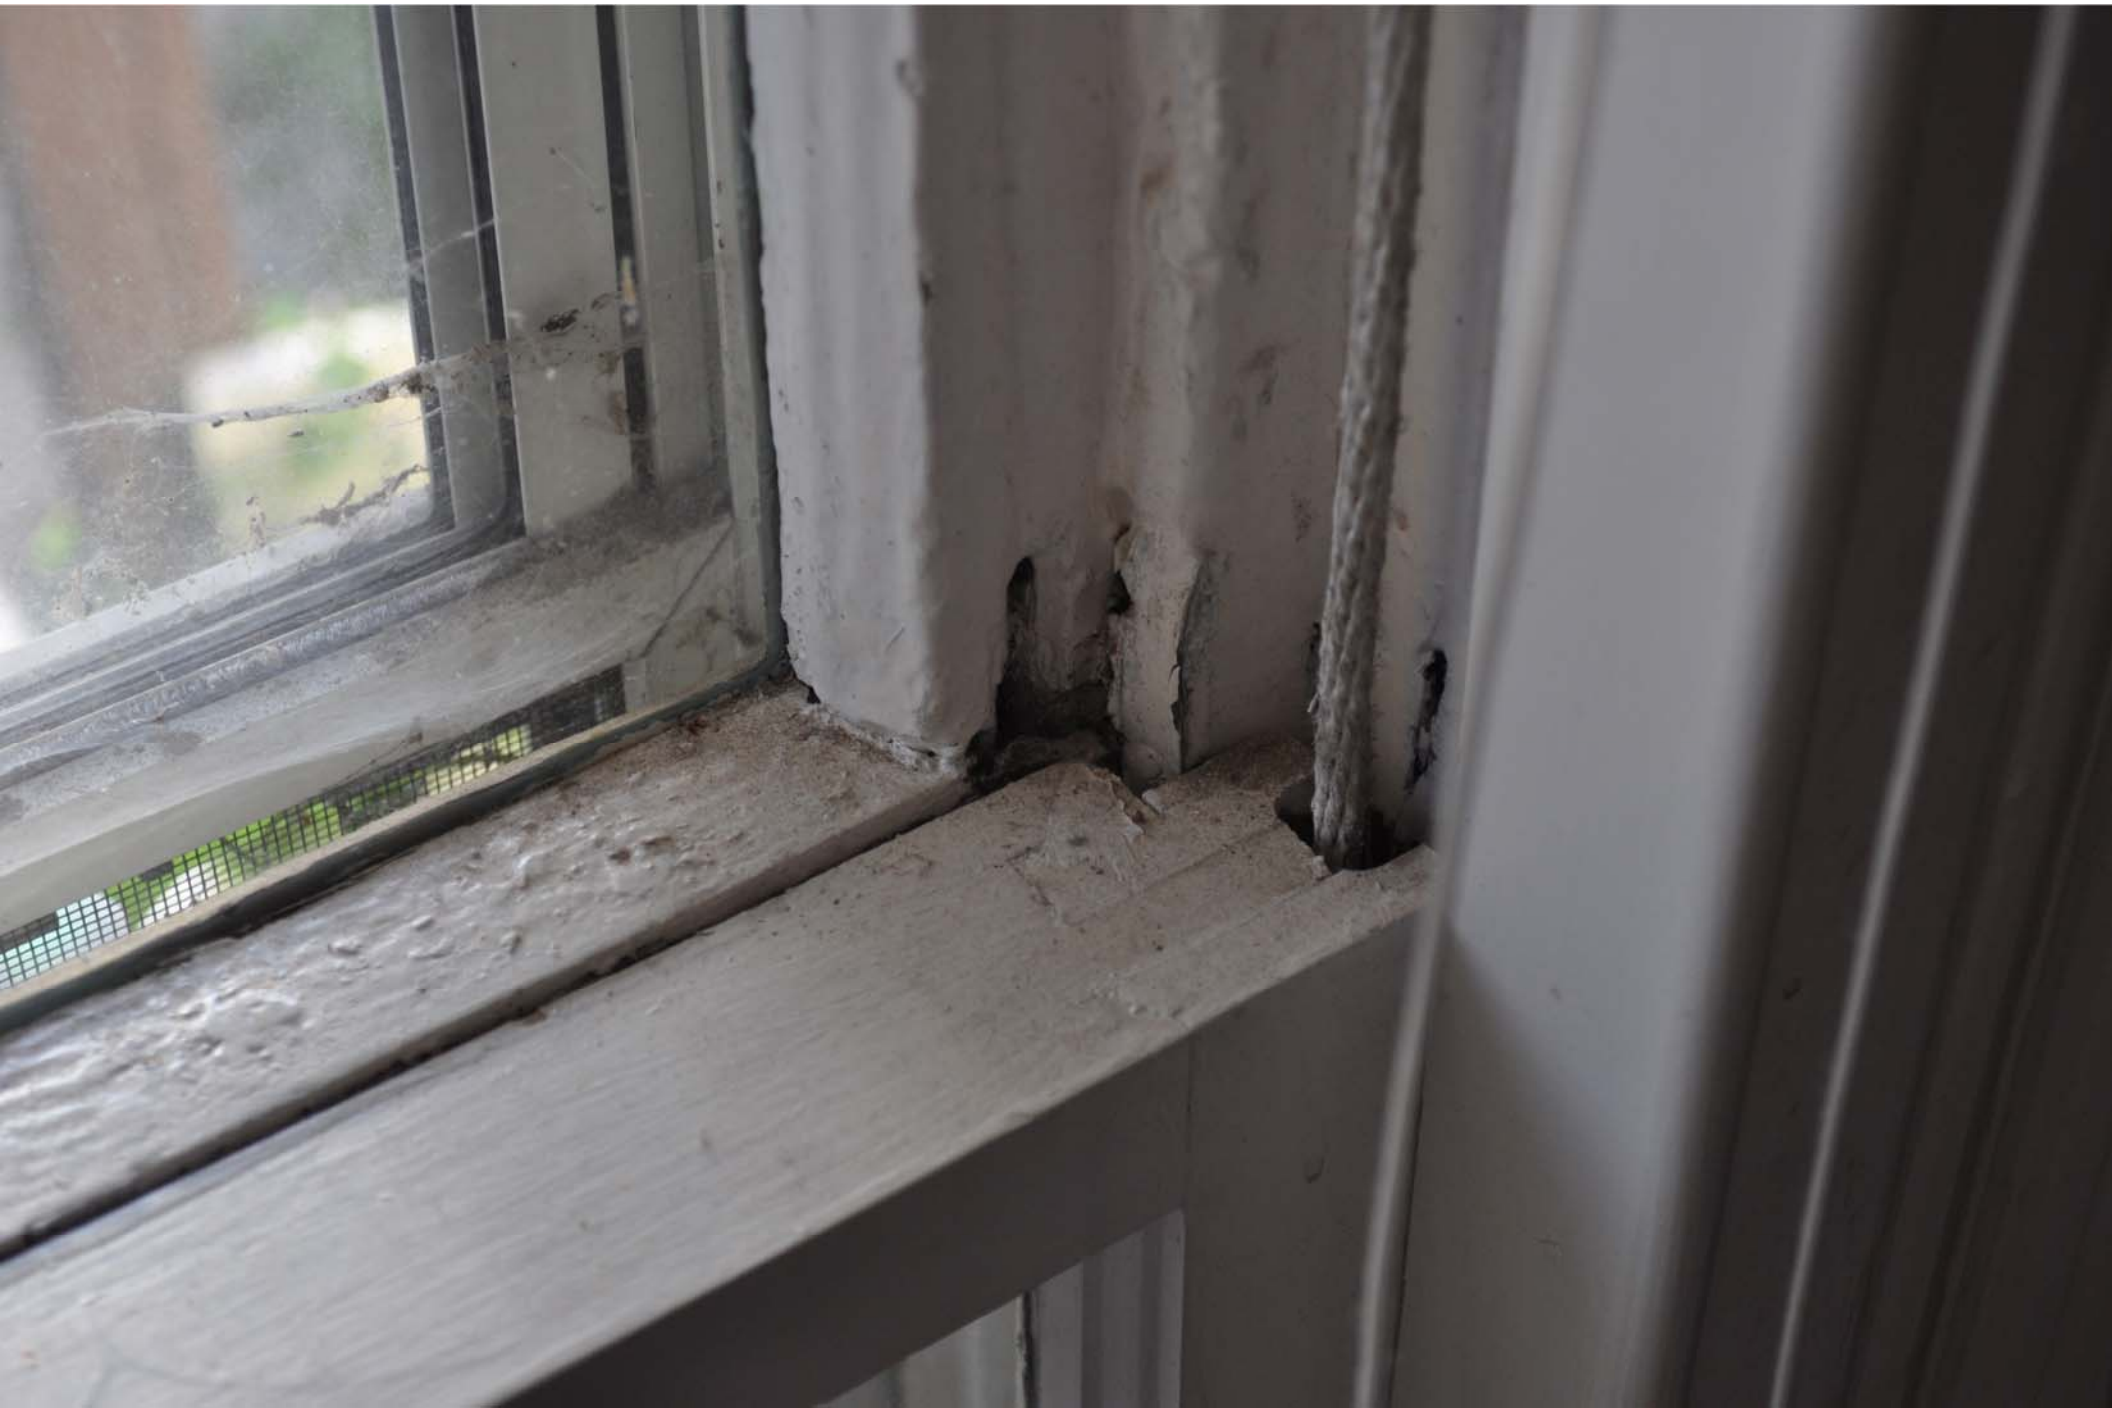
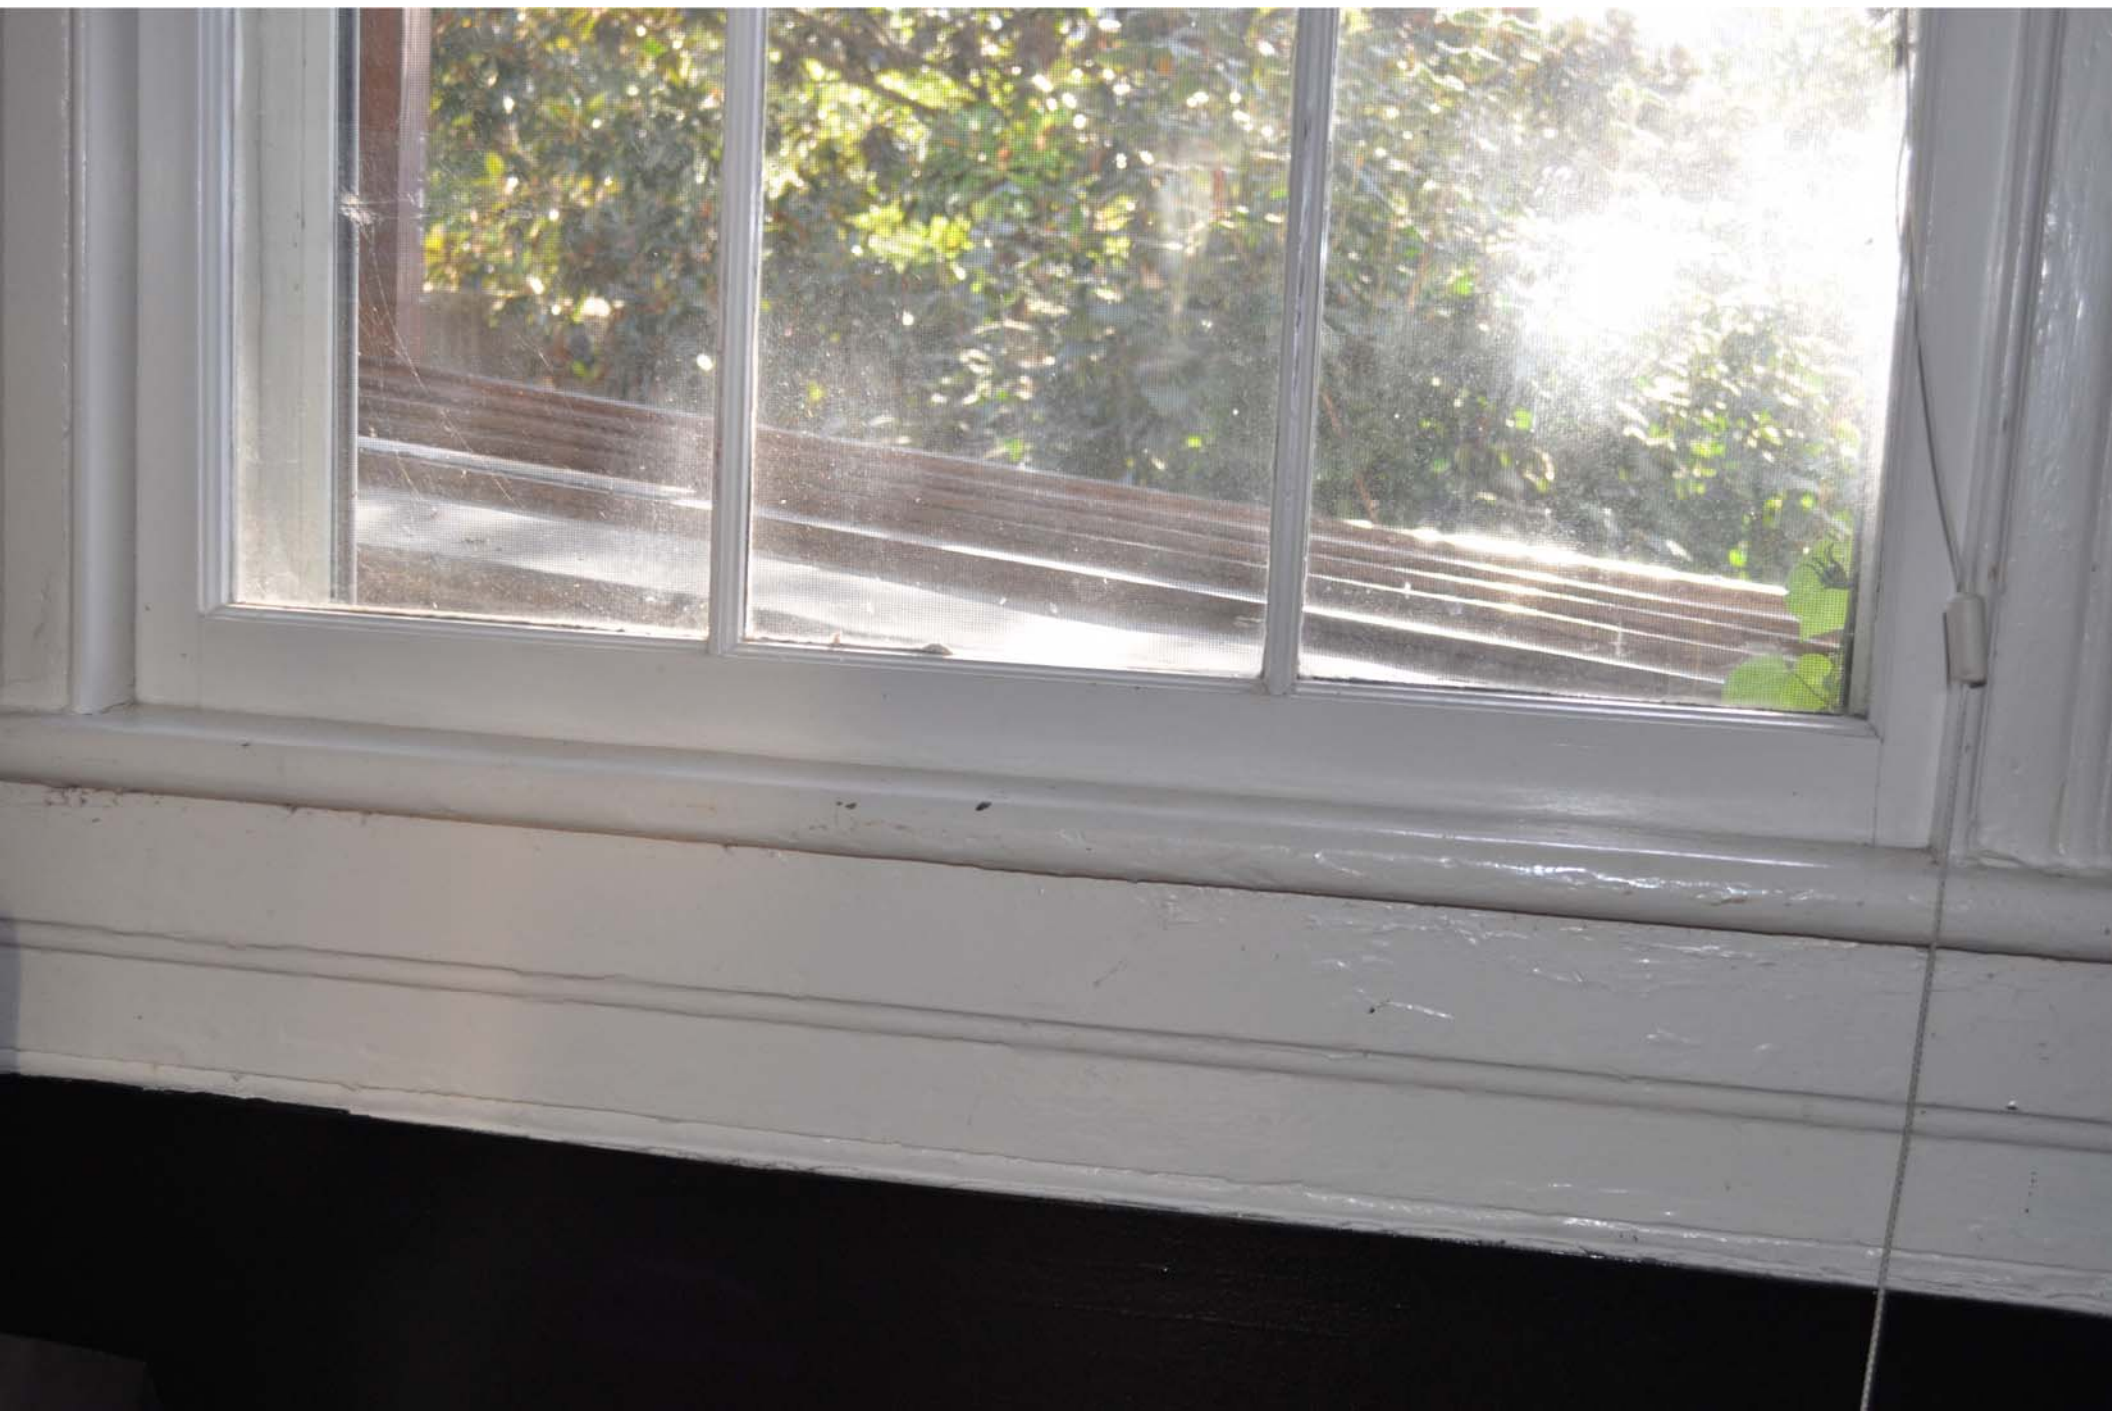
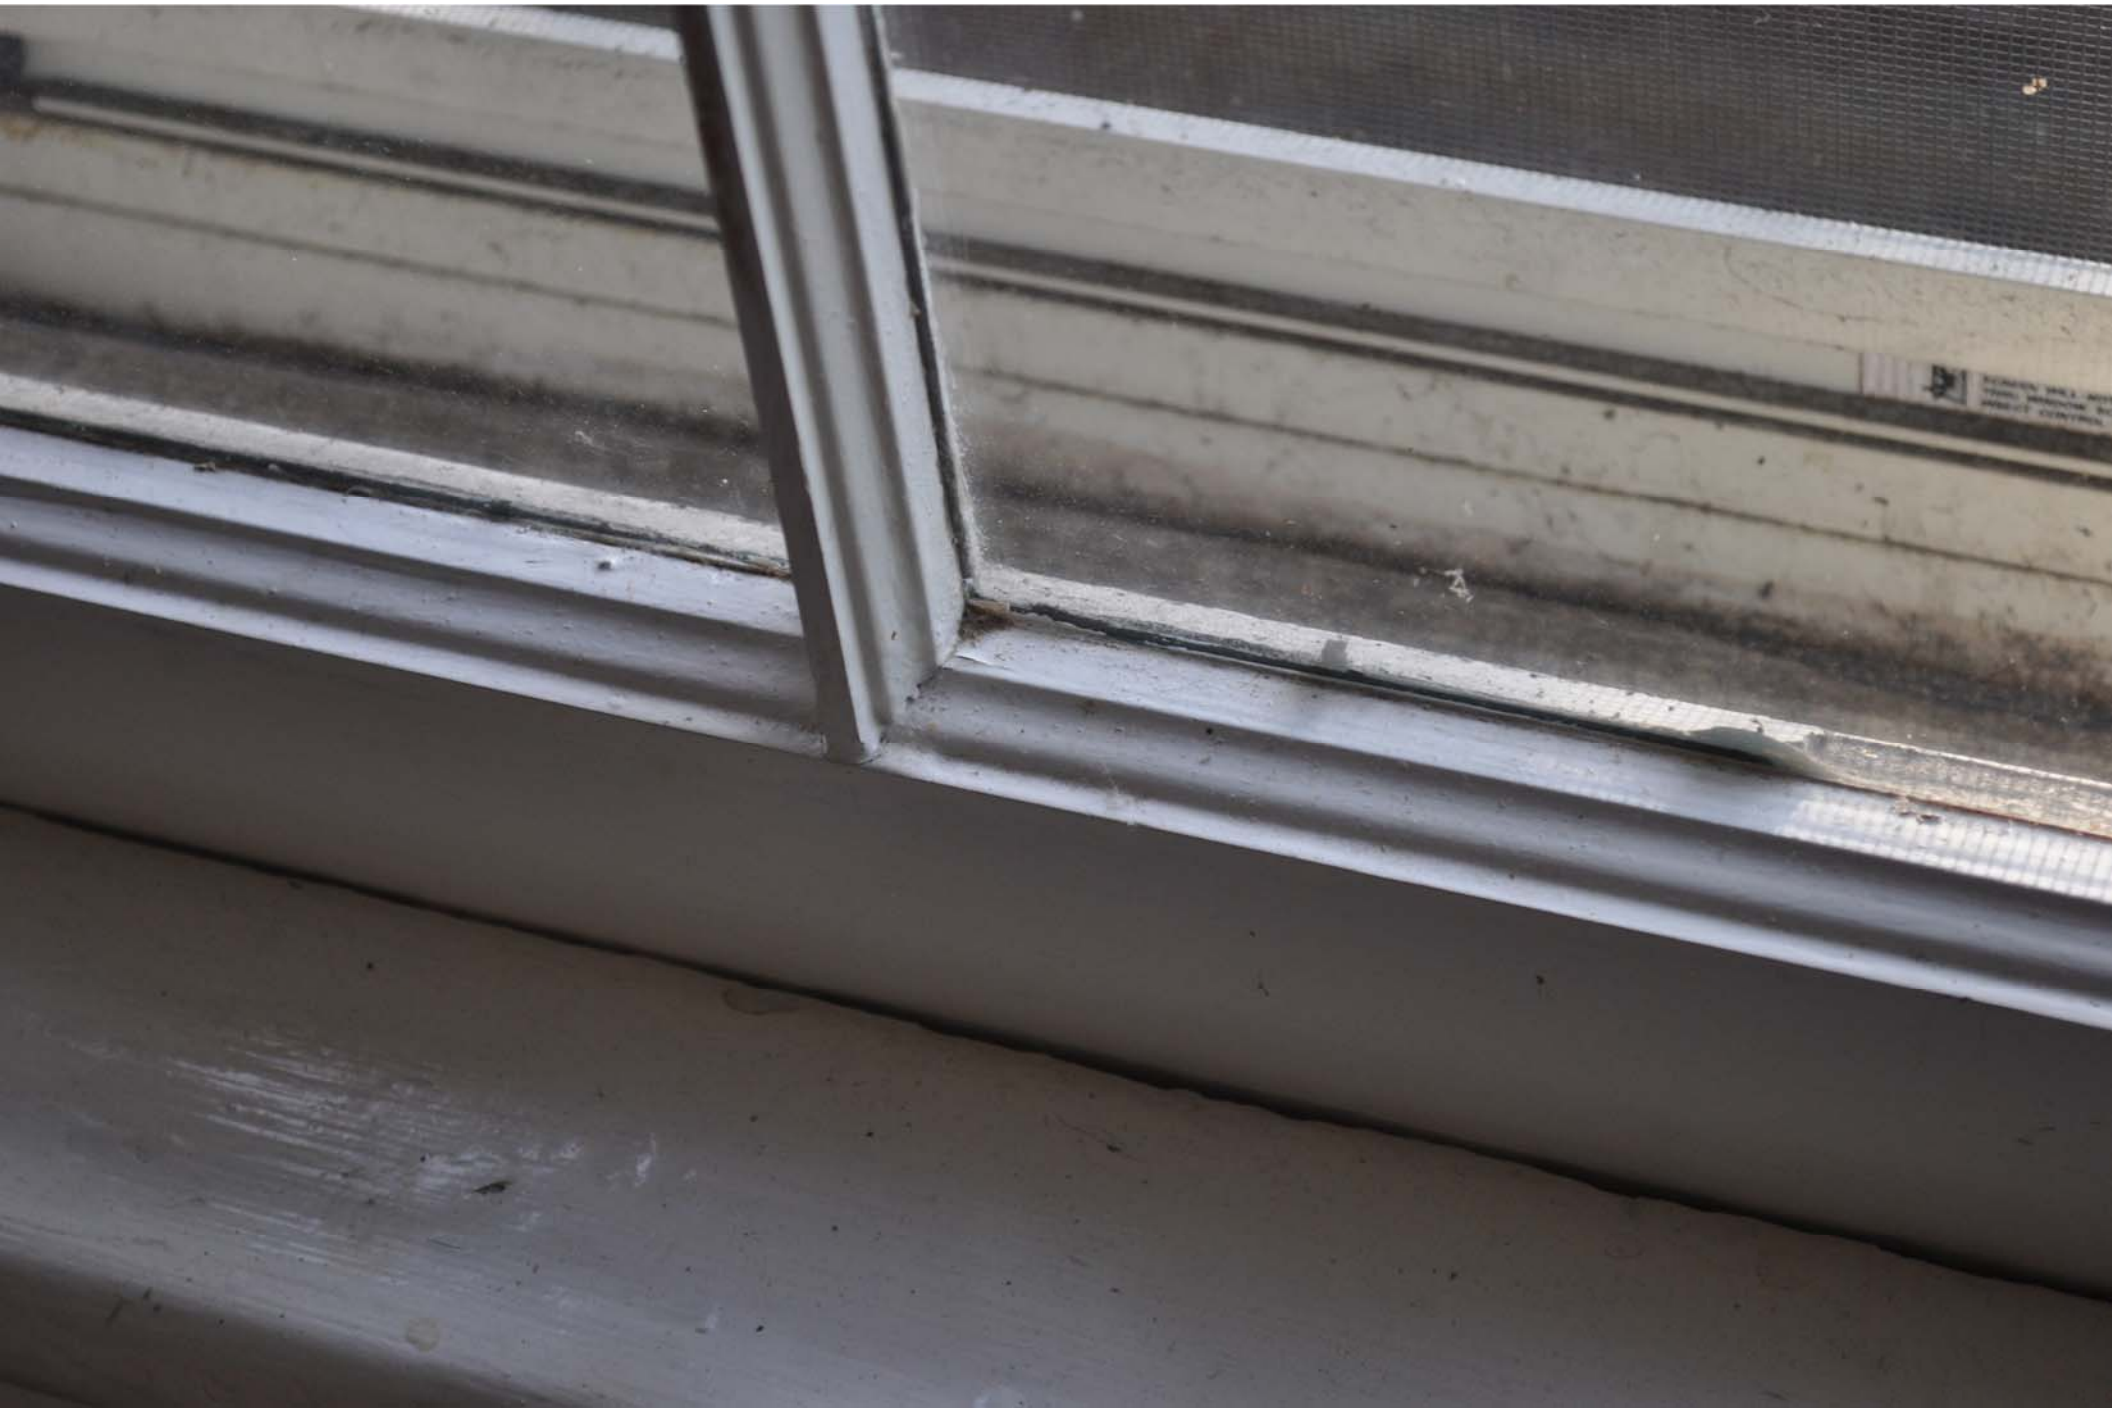
Window #10

Visible damage to upper/lower sash (#7, #9, #10)

Window is skewed in frame (#9, #10)

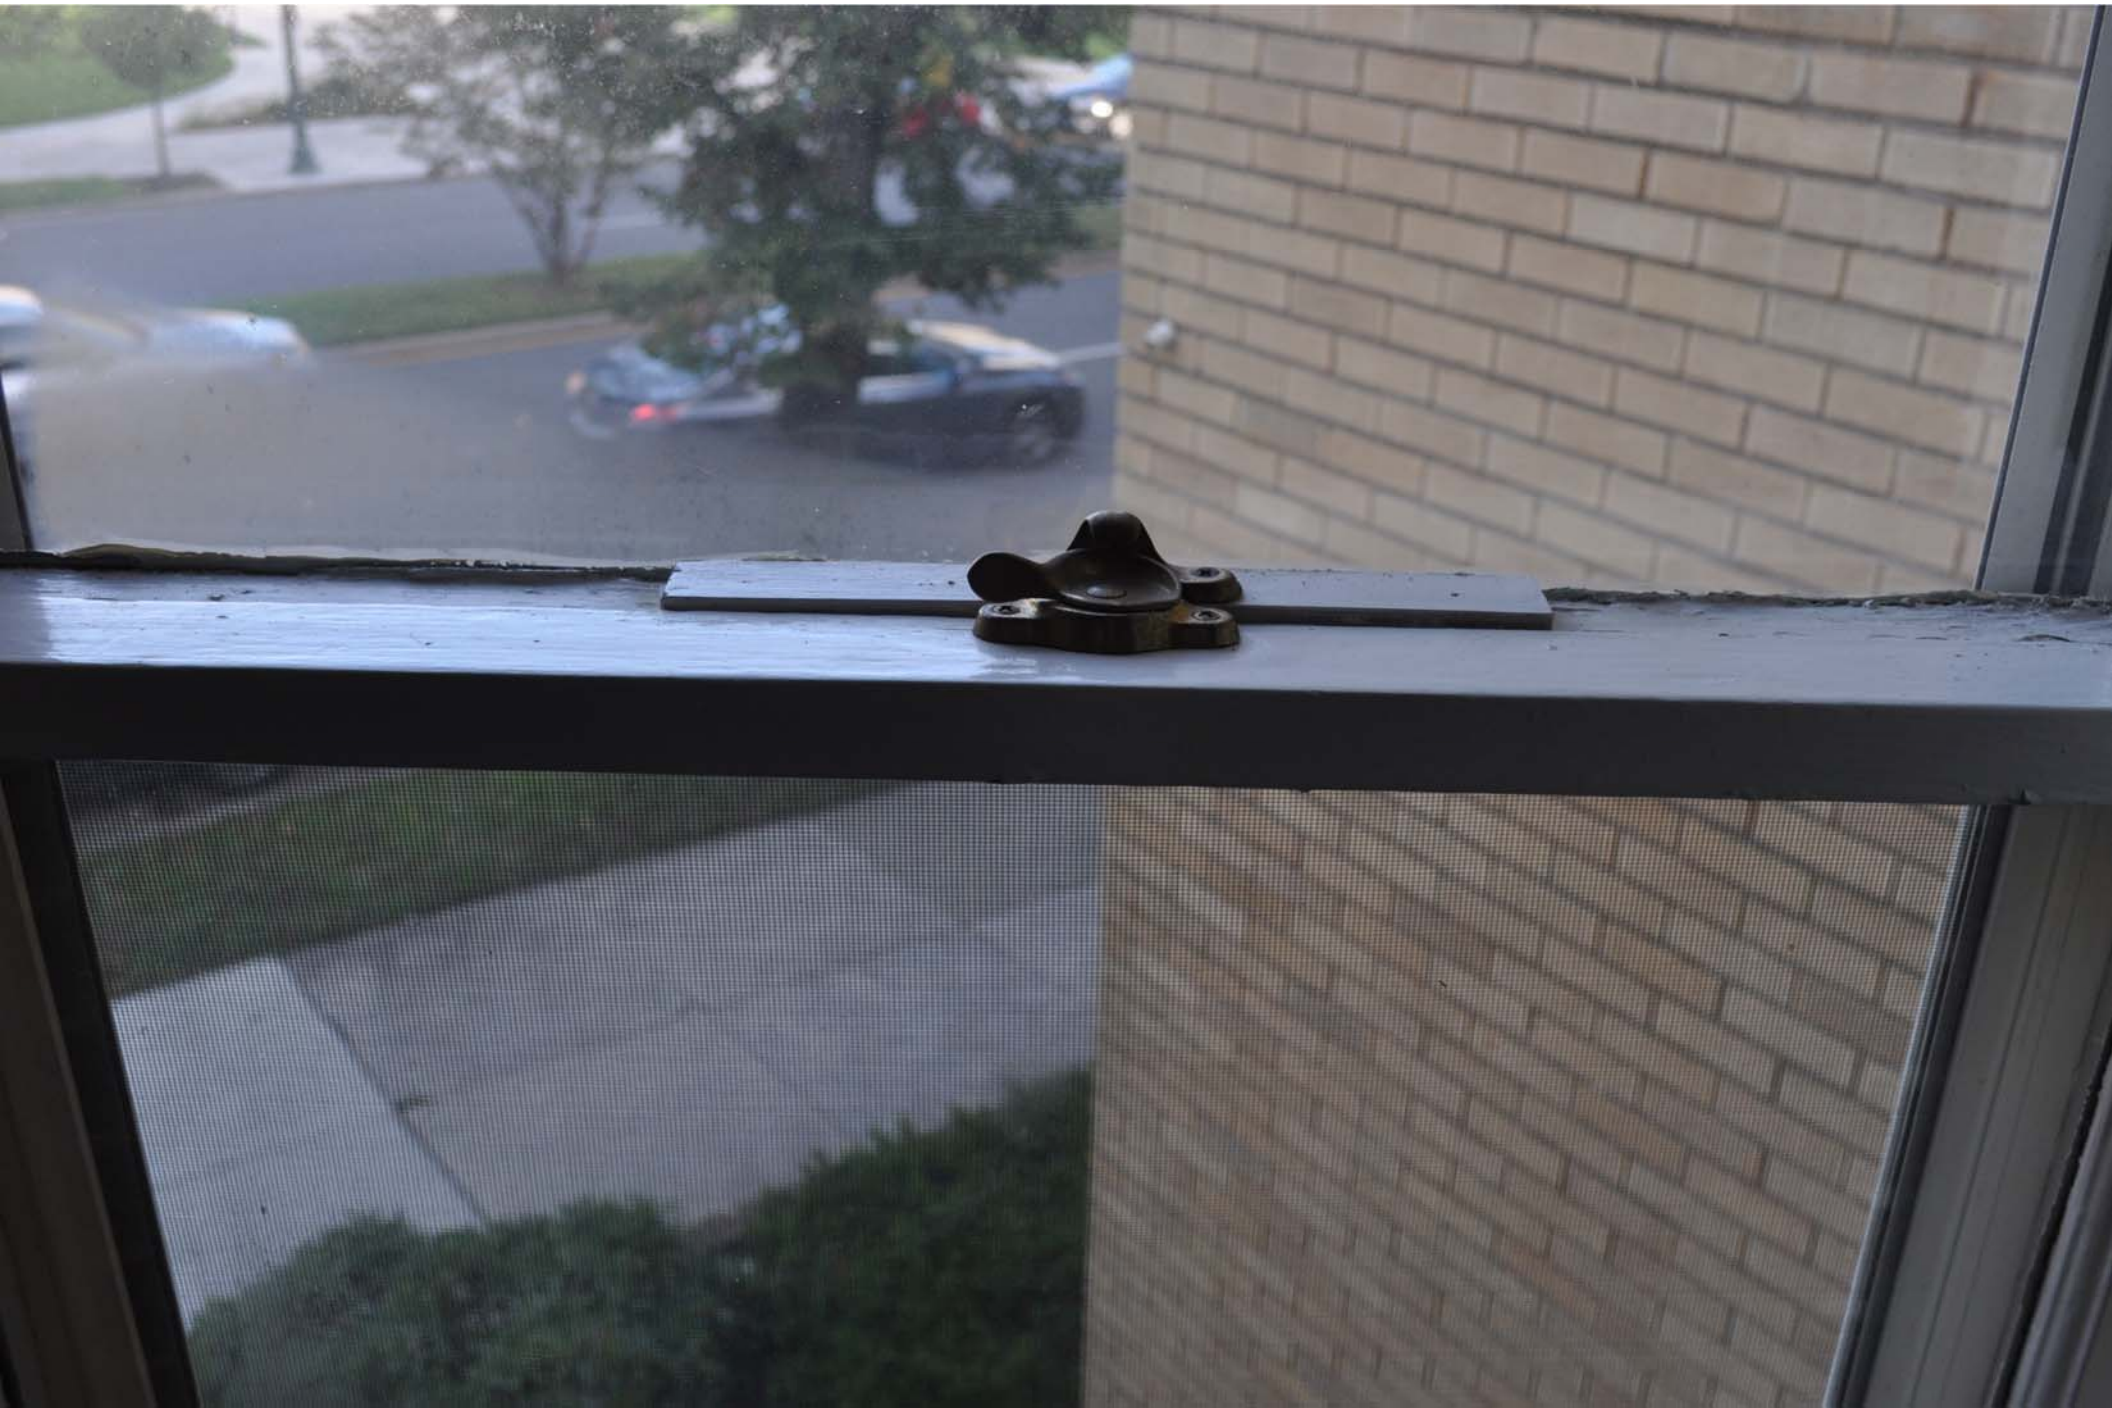
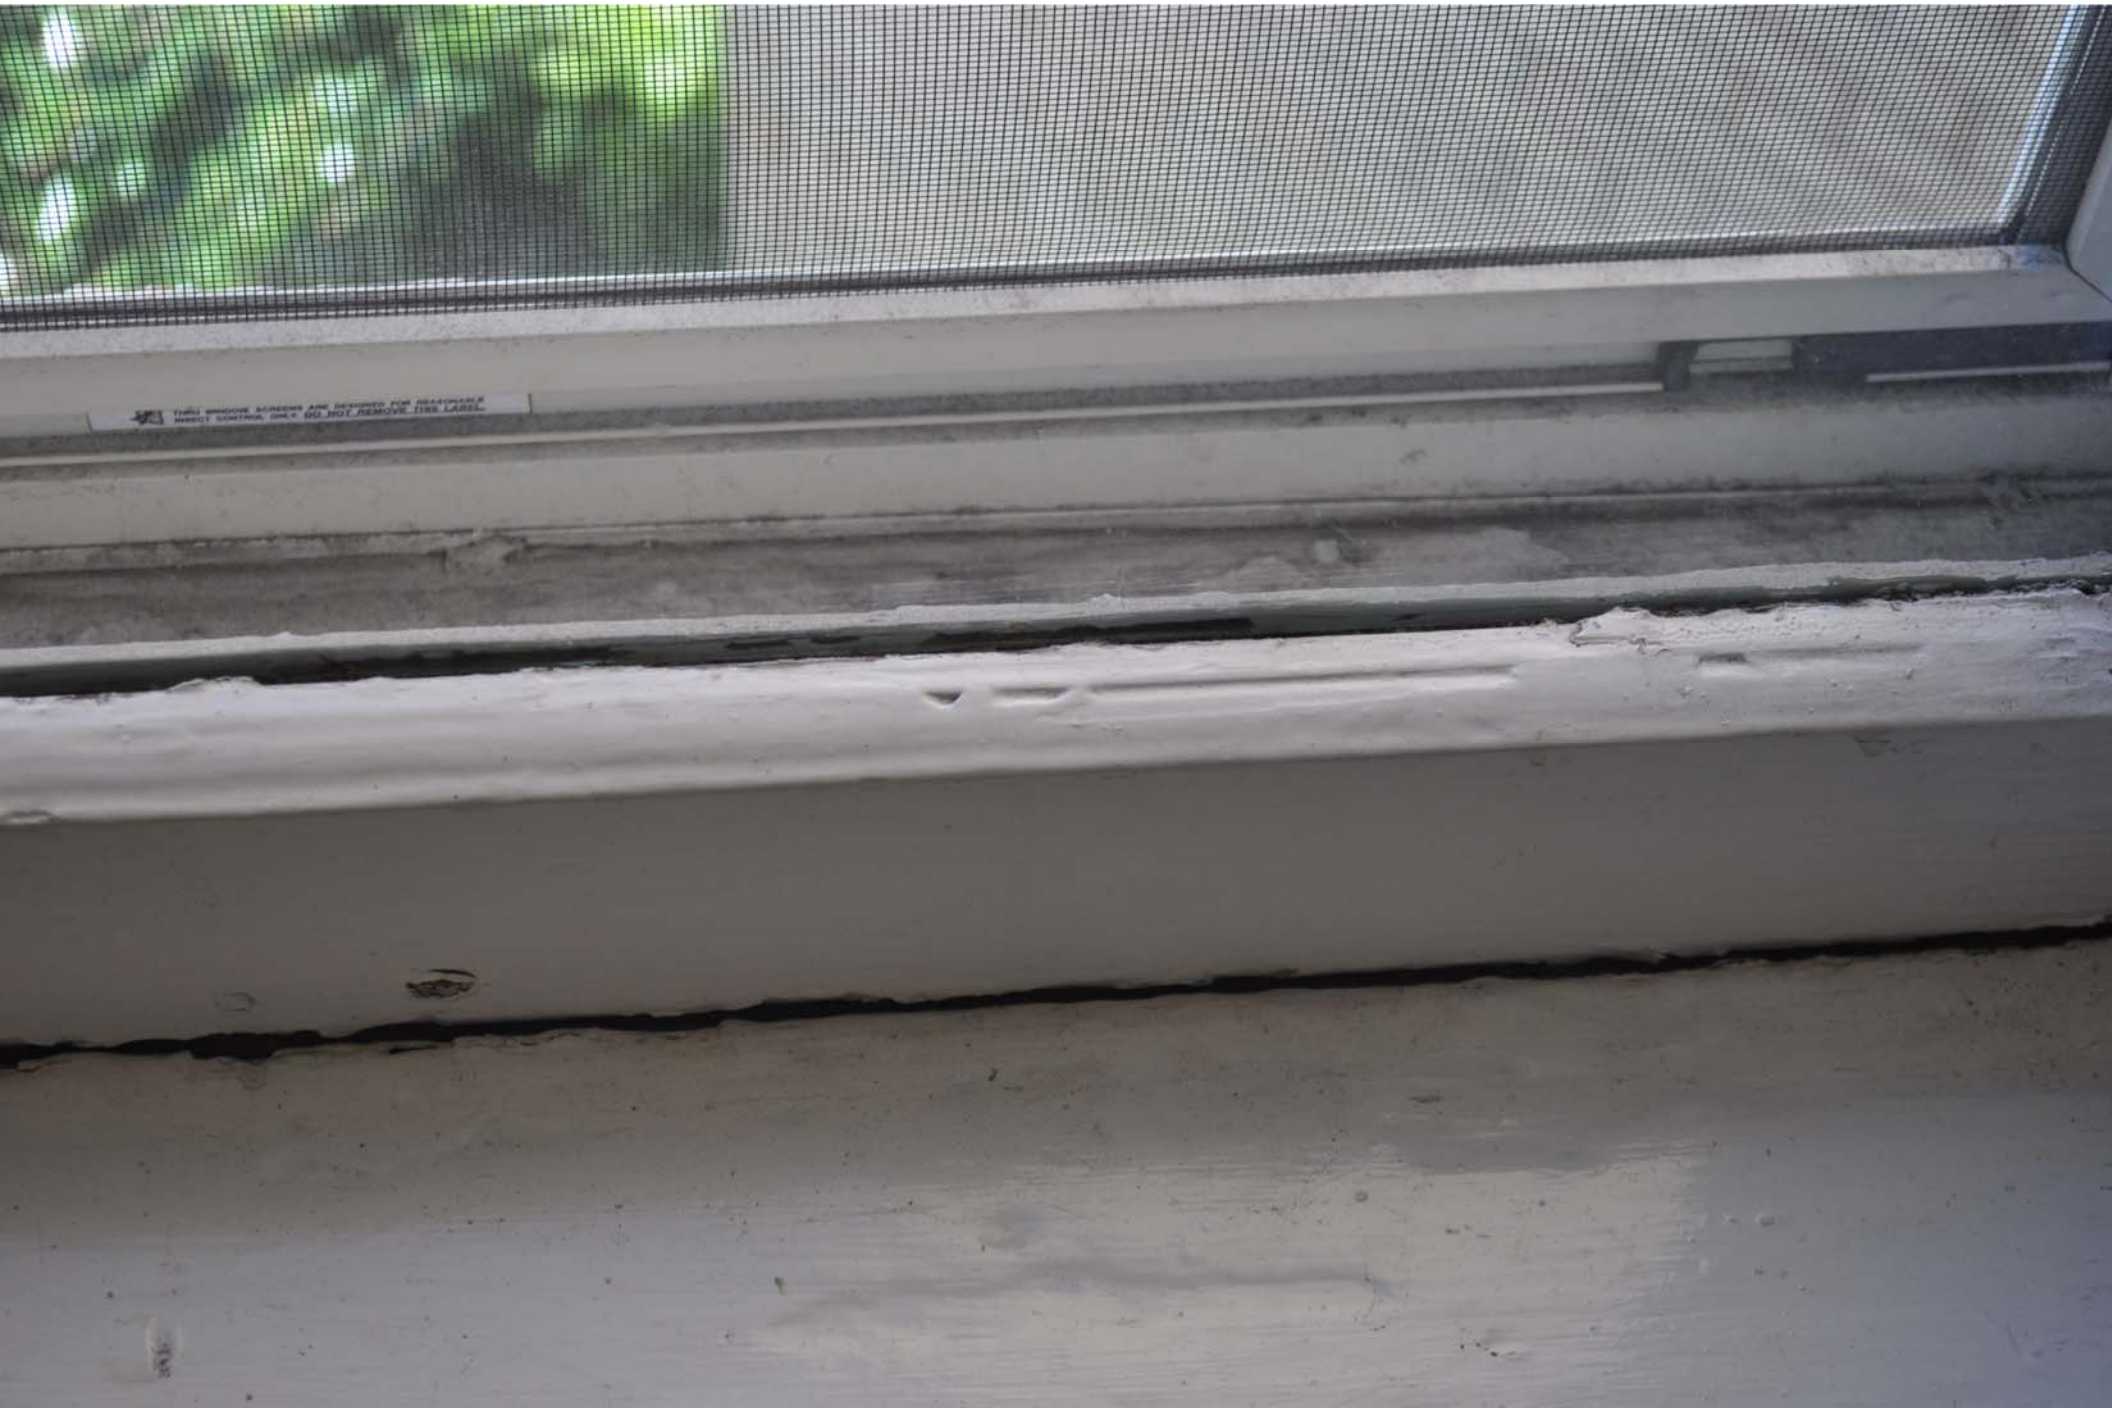
Window #4

Sashes to not align when closed, wood lathe attached to upper sash to raise the latch so it could be locked (windows #4, #6, #7, #8, #9)
