Commission of Architectural Review SUBMISSION APPLICATION

LOCATION OF WORK: 409 N. Boulevard DATE: 8/25/16

Additional Information for Application No. 16-37 for 409 N. Boulevard

Attachment to Application for Certificate of Appropriateness

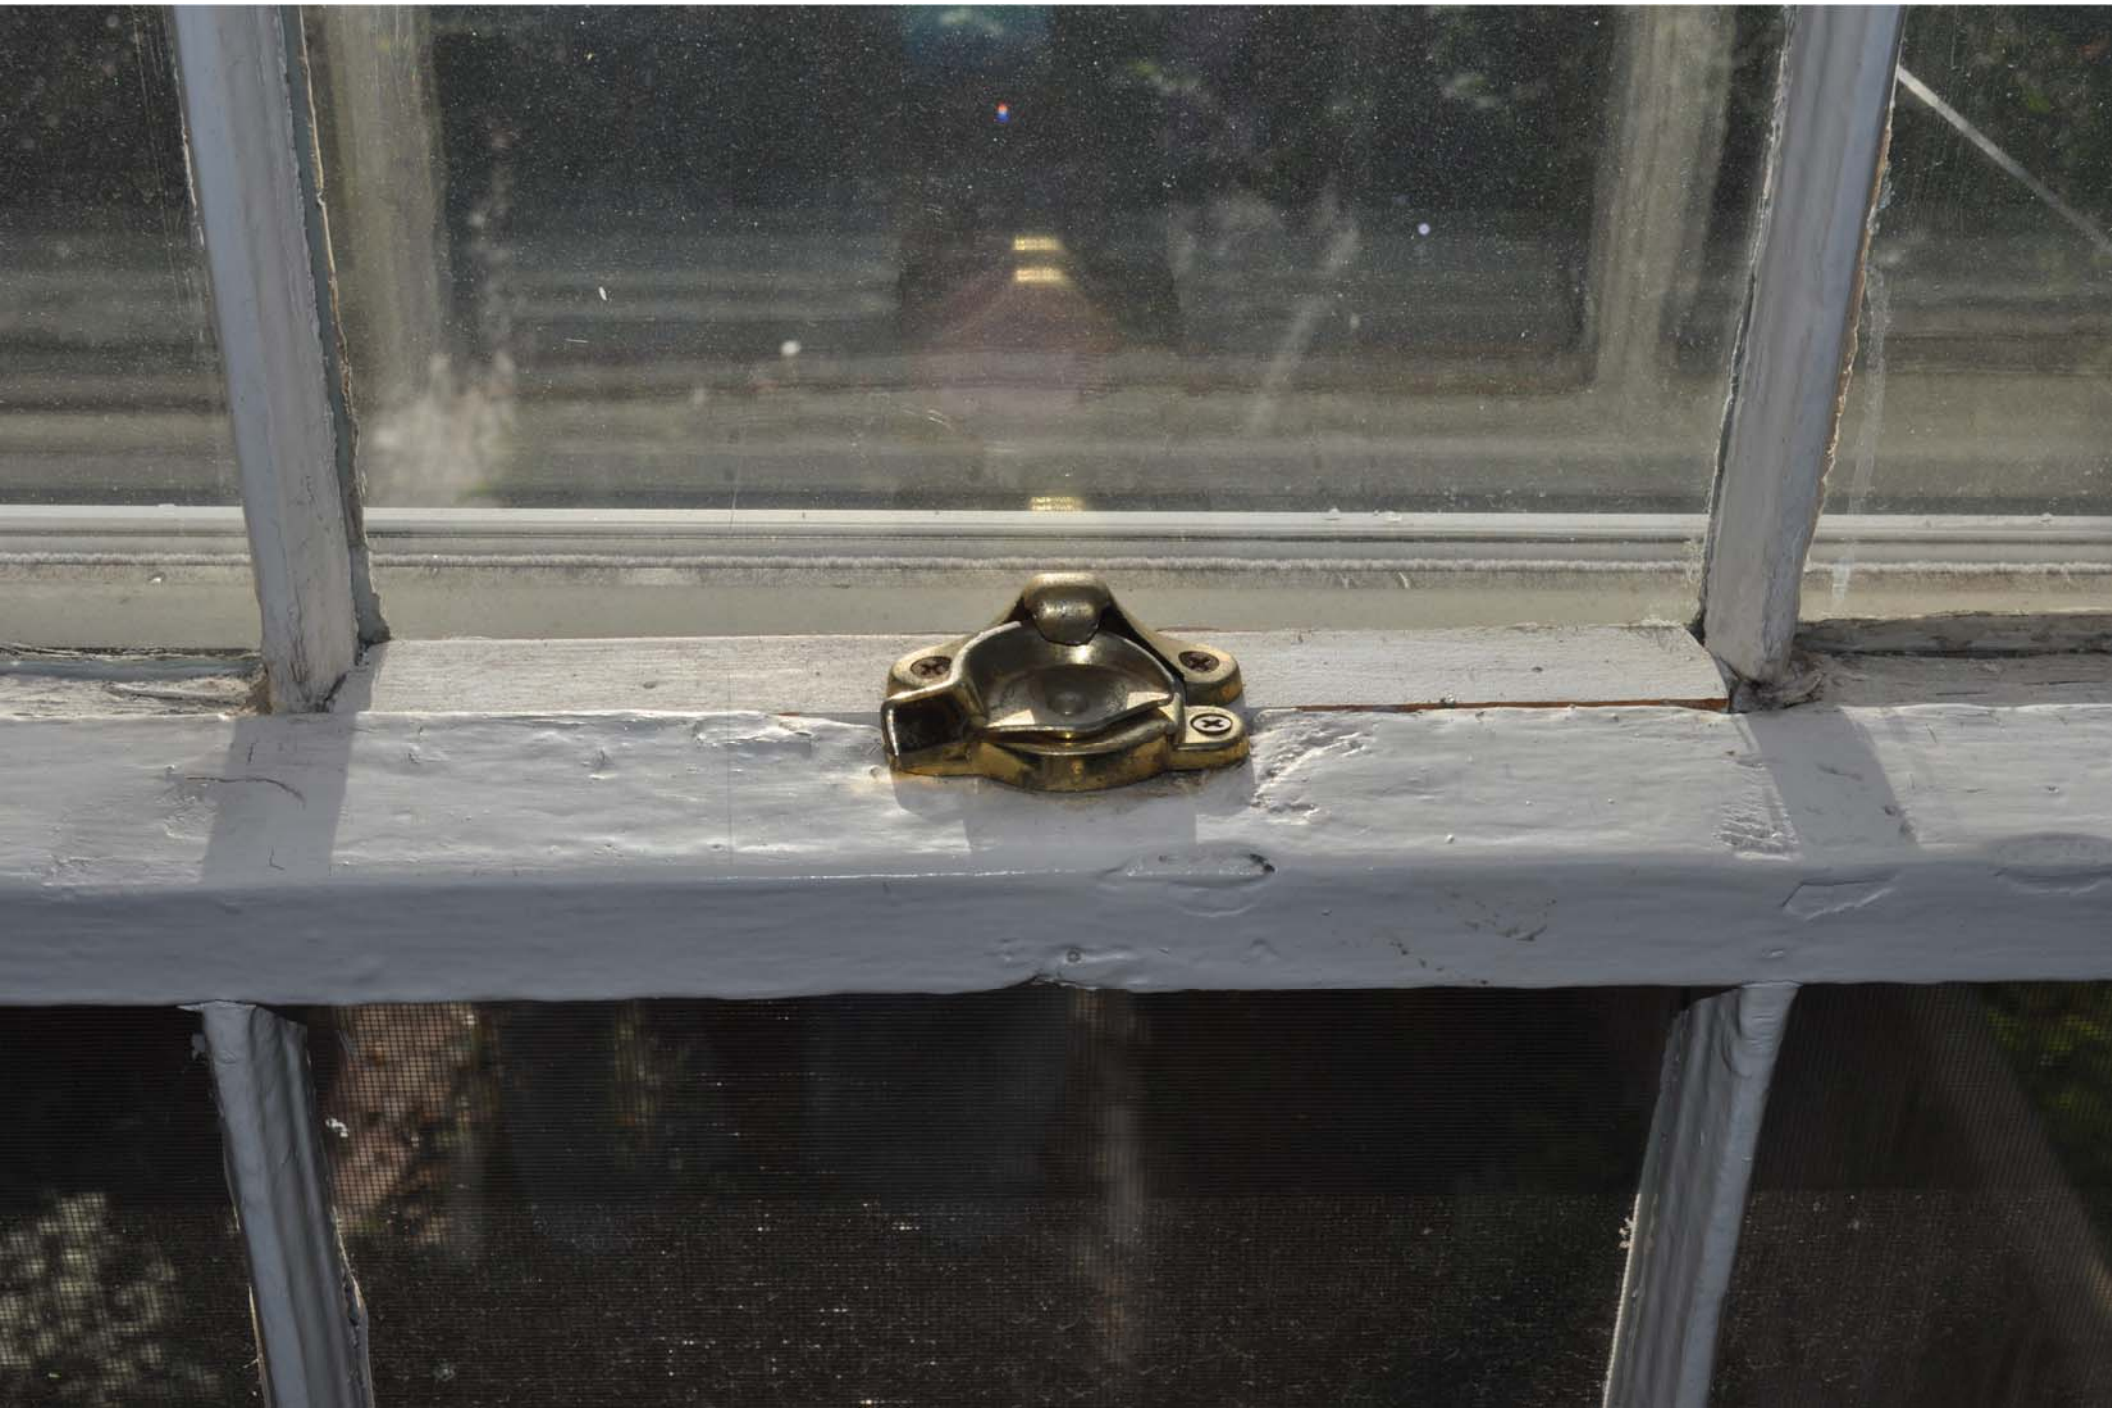
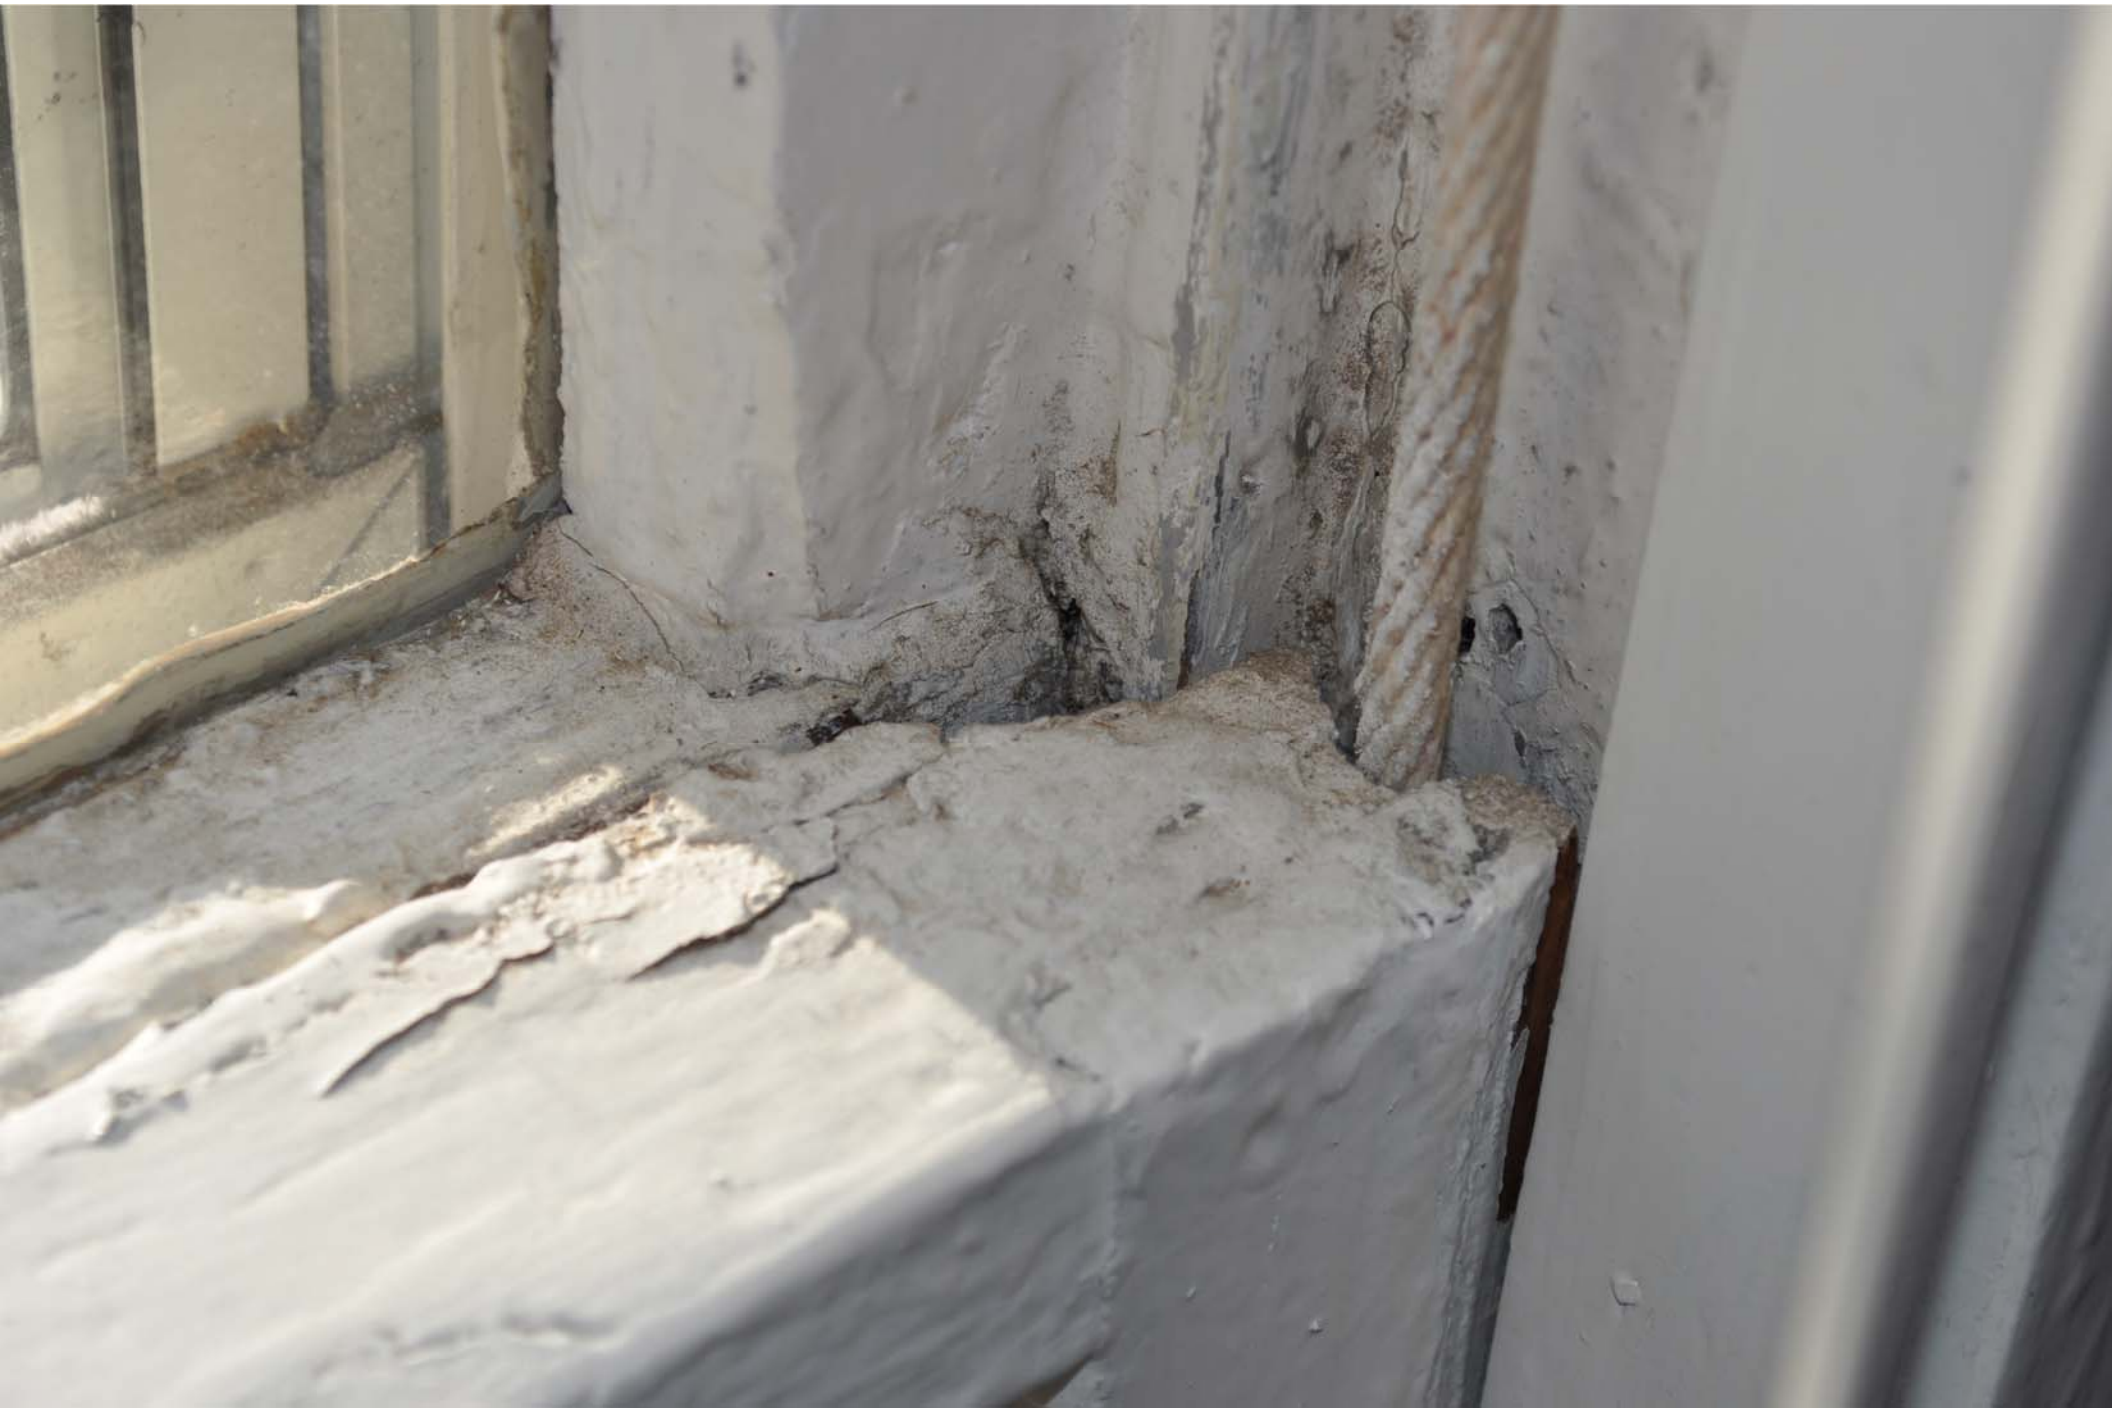
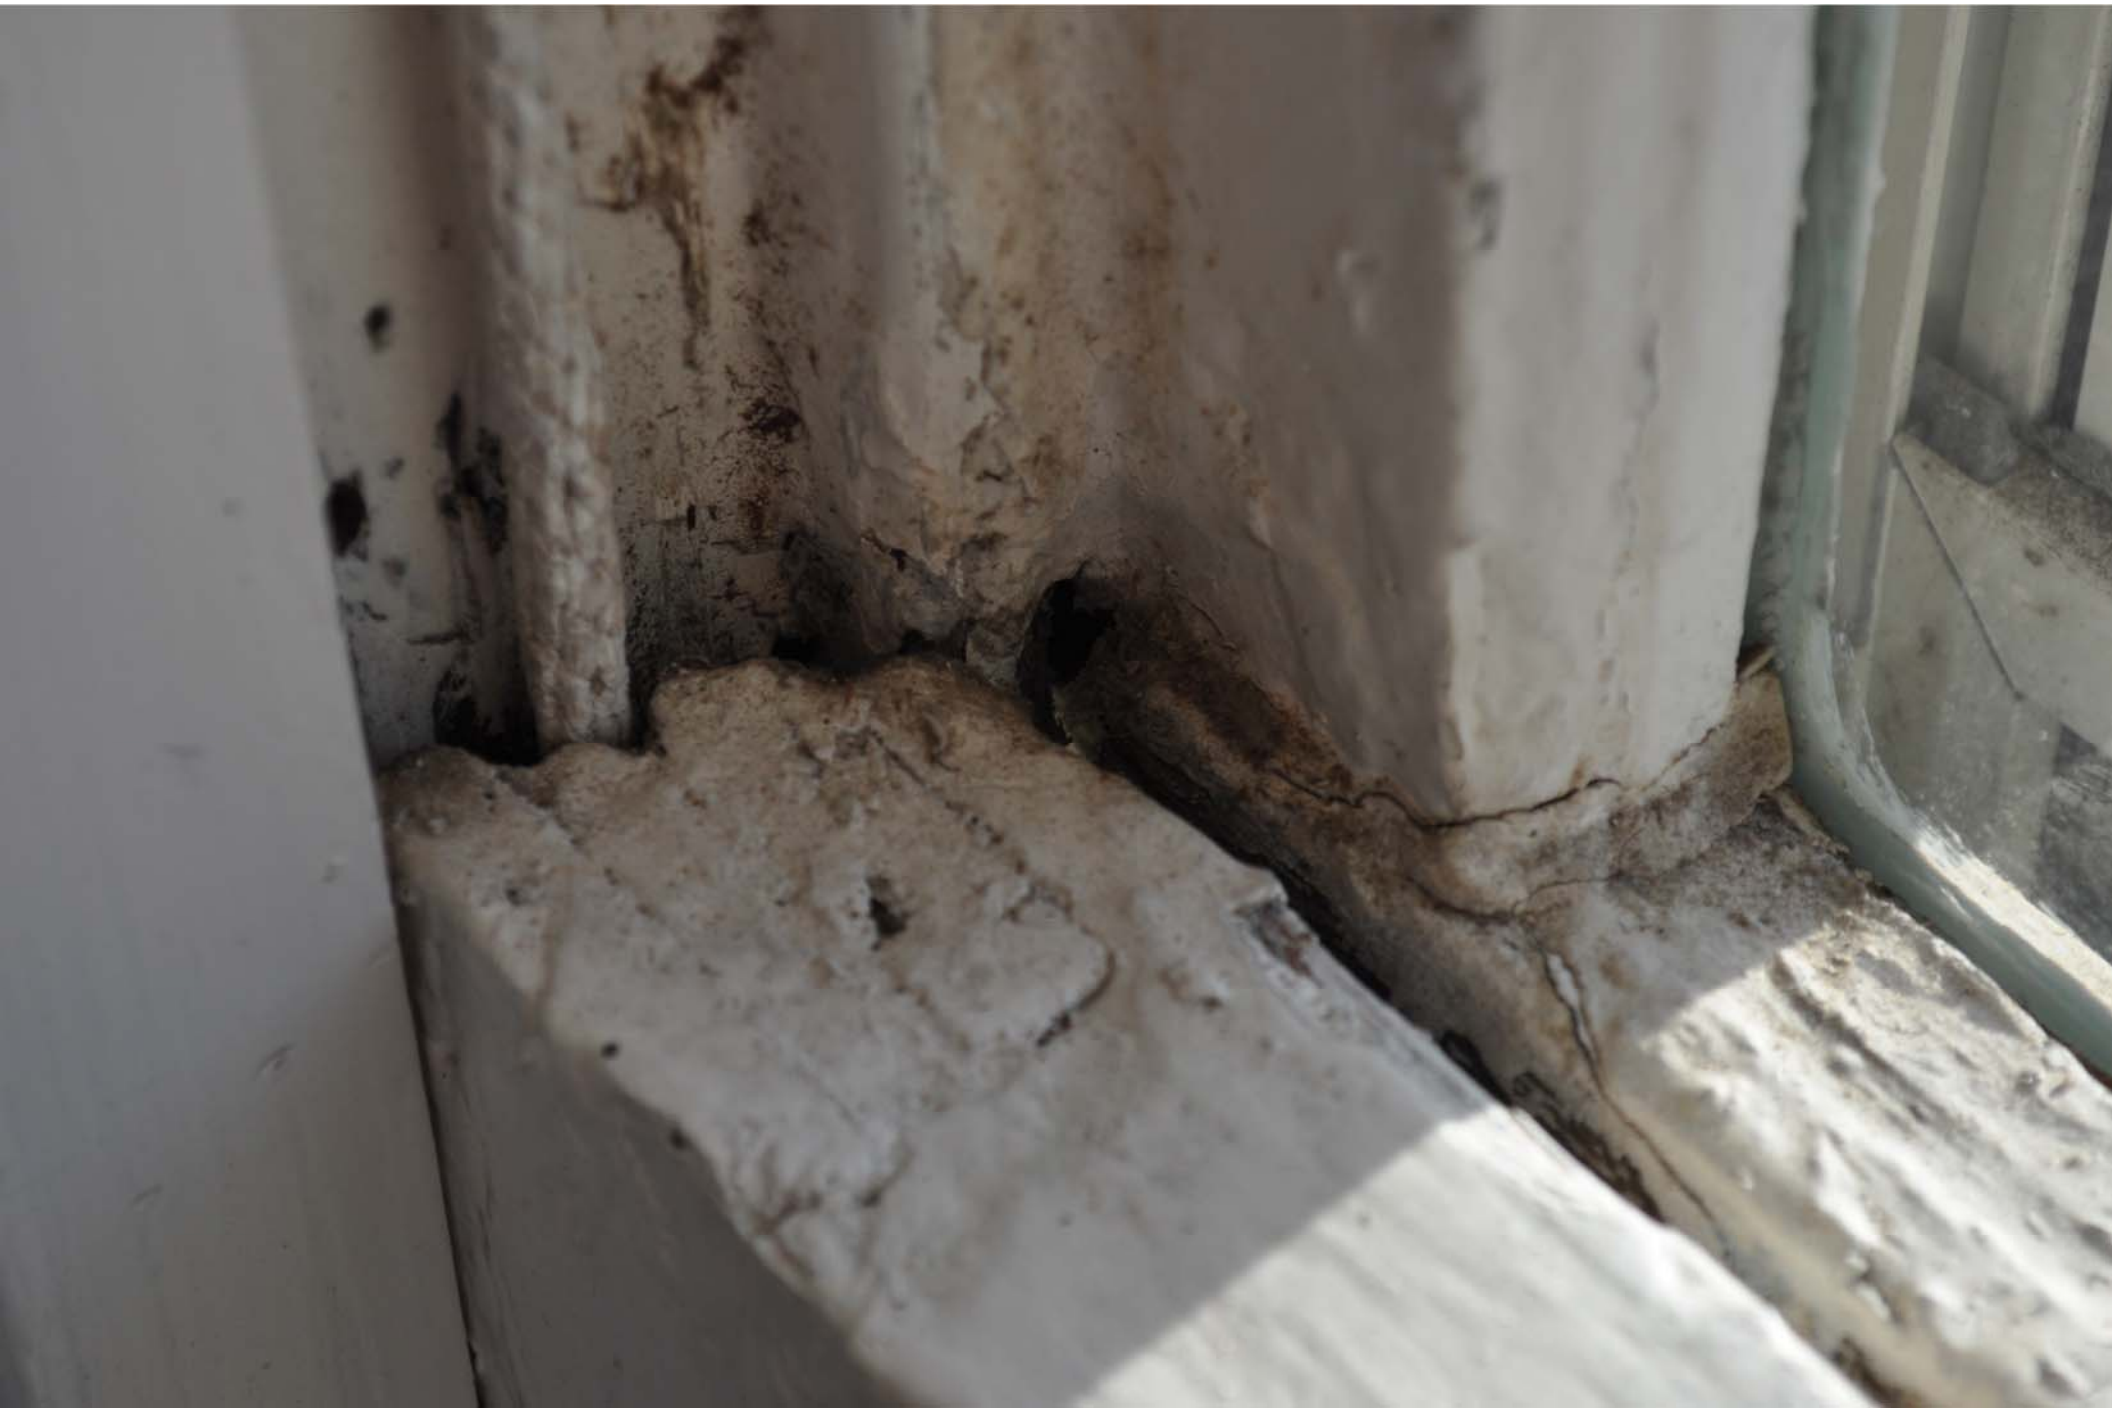
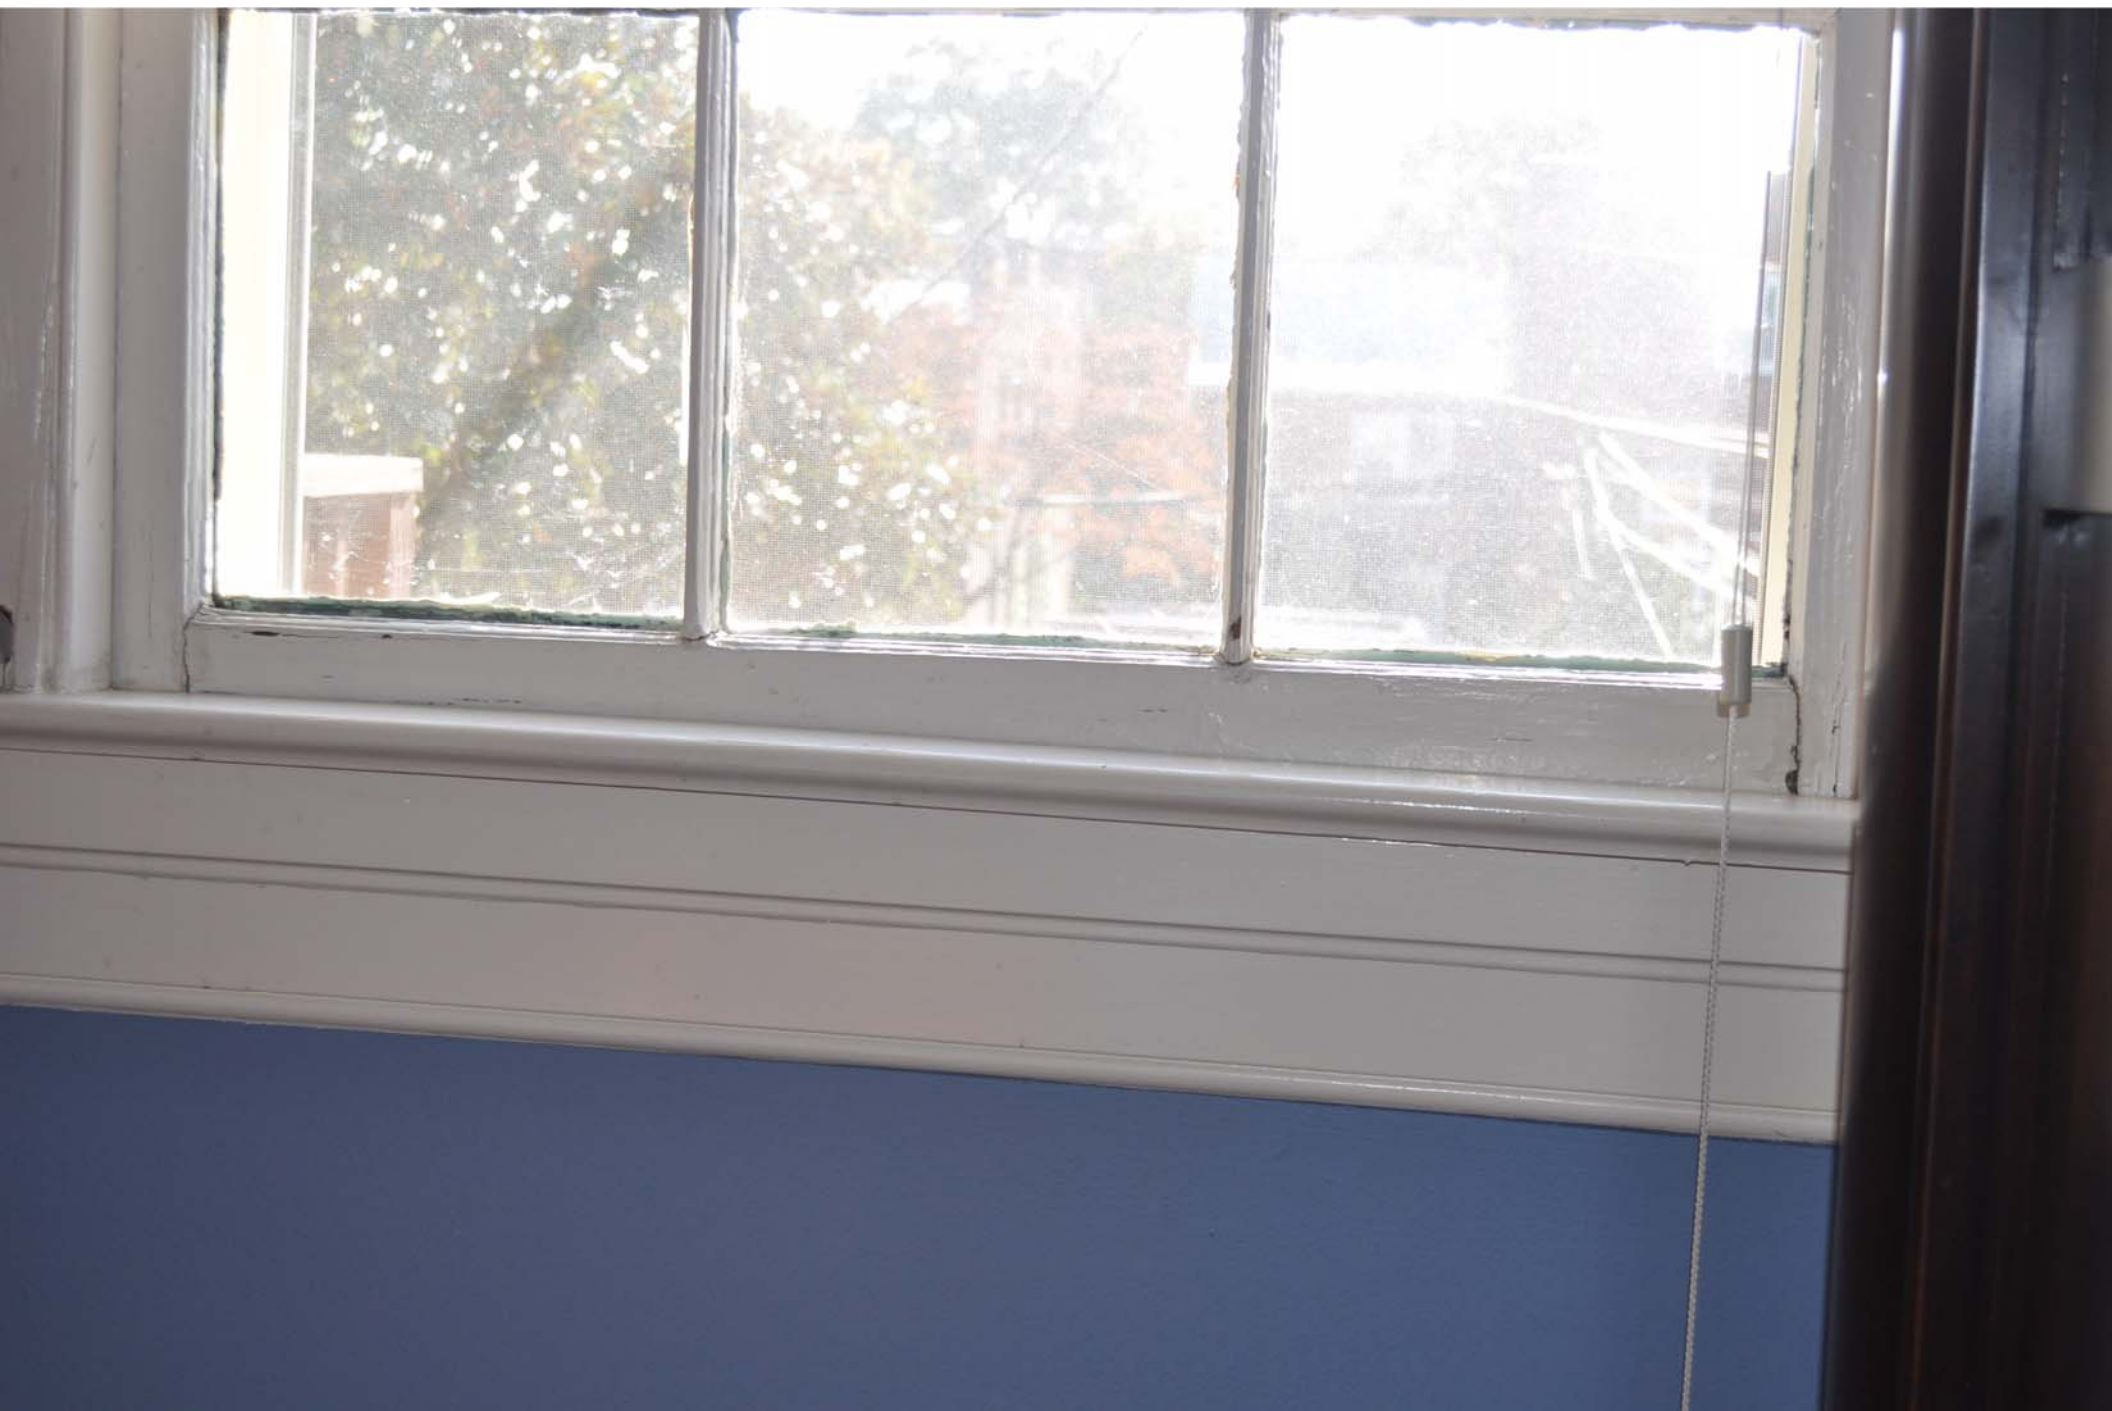
Window #9

Sashes to not align when closed, wood lathe attached to upper sash to raise the latch so it could be locked (windows #4, #6, #7, #8, #9)

Visible damage to upper/lower sash (#7, #9, #10)

Window is skewed in frame (#9, #10)

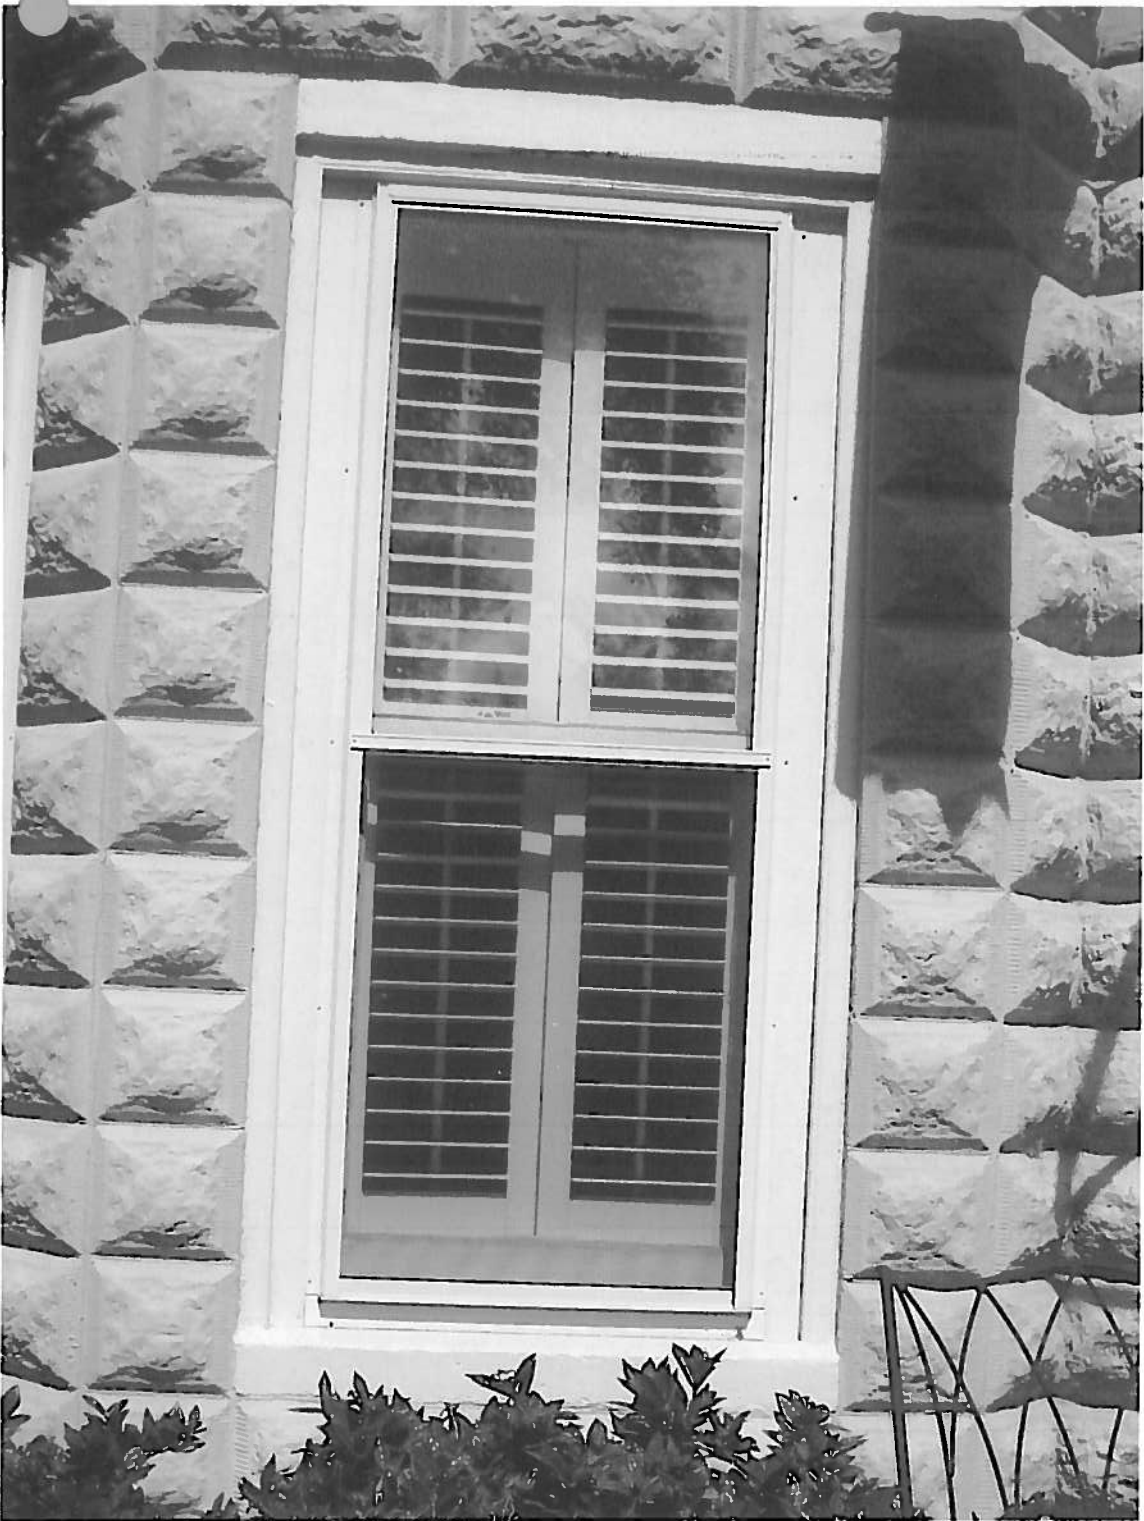
Figure 6: Close up of existing front window.

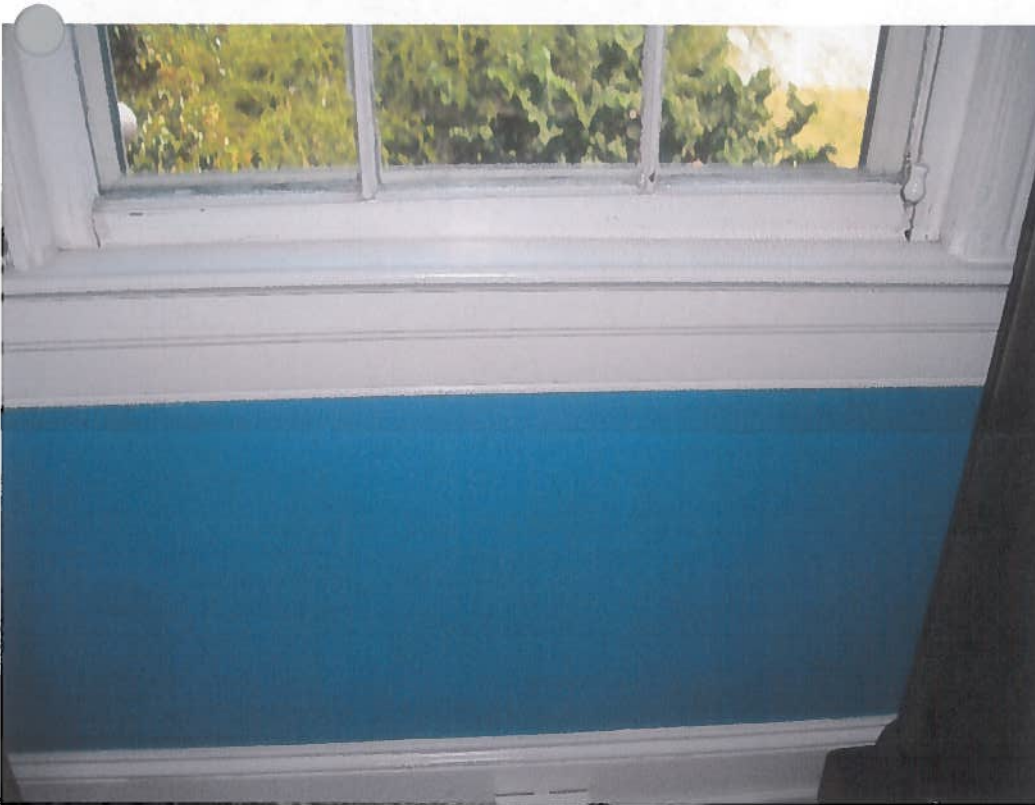
There are problems with many of the existing windows. Several are loose in the frame and in the winter, I need to use shims to close the gap between the upper and lower sashes to minimize cold drafts. Another window/frame is not squared up to the inside molding. See Figure 7. There are several other of these windows where the top and bottom sash are not aligned when closed. A previous owner used what looks like wood lathing strips on the upper sash so that the window locks could work (see Figure 8). This shows that over the last hundred years the house has settled/shifted enough so that the existing windows no longer fit or operate as they should. Fixing these problems would require rebuilding the frames and the windows themselves so I want to replace rather than repair.

Figure 7: The window sill is level but note the how the window itself is tilted up on the right side.

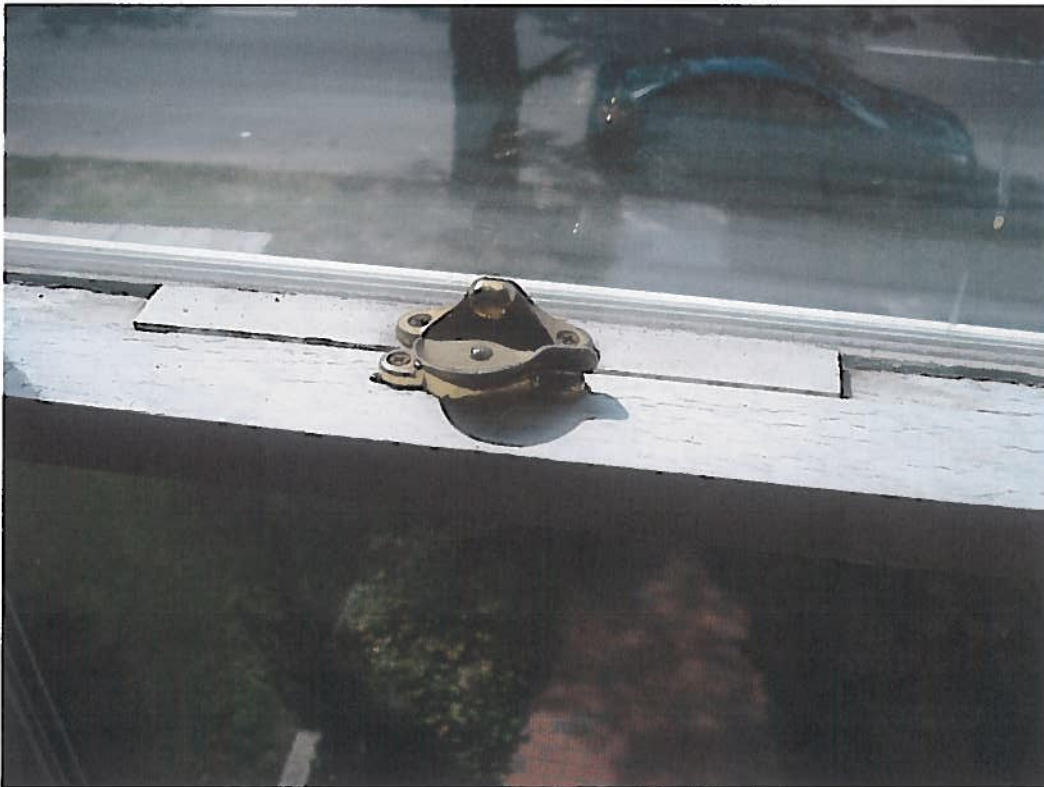
Figure 8: this is also one of the windows that needs to be shimmed to keep out the cold air in winter.
