Commission of Architectural Review

#5 COA-169071-2025	Final Review	Meeting Date: 7/22/2025
Applicant/Petitioner	Jean Carlos	
Project Description	Rehabilitate an existing building and construct a new rear addition	
Project Location		
Address: 3104 East Broad Street		
Historic District: St. John's Church		
<p>High-Level Details:</p> <p>The applicant proposes to rehabilitate an extant masonry, Queen Anne Style dwelling circa. 1897. The building is in poor condition and some exterior work, including demolition, has already taken place without a COA or the necessary building and demolition permits.</p> <p>A notice of violation and a stop work order have been issued to the property for building, CAR, and Property Maintenance & Code Enforcement (PMCE).</p> <p>While the building is in poor condition and many elements need to be repaired/replaced, a rear masonry and frame addition has already been demolished, as well as a large section of the elevation, which is minimally visible from the public right-of-way.</p>

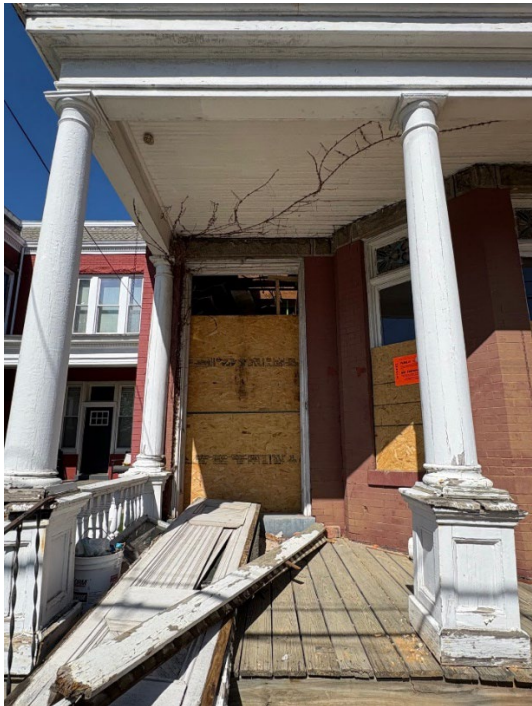
Figure 3. 3104 East Broad. Front Porch

<p>the color and finish of all original materials.</p> <p>4. Retain original roof shape, size, materials, and related elements including cupolas, chimneys and weathervanes; if replacement is necessary, consideration for use of slate, wood and metal, with respect to color and patterns, should be given.</p> <p>5. Retain original windows including both functional and decorative elements such as frames, sash, muntins, glazing, sills, hood molds, paneled or decorated jambs and moldings, shutters and exterior blinds.</p> <p>6. Retain original entrances and porches including doors, frames, fanlights, sidelights, steps, balustrades, pilasters, entablatures, columns and decorative features.</p> <p>7. Repair damaged elements instead of replacing them. Use materials that match the original in type or use physically and chemically compatible substitute materials that convey the same appearance as the surviving elements or sections. Use available documentation when reconstructing missing elements. Pictorial, historical or physical documentation can be helpful.</p> <p>9. Do not remove or radically alter fundamental architectural features such as windows, roofs or porches.</p>	<p>While the building has been in poor condition for quite a while, the primary entrance was identical to the neighboring seven houses to the east. The primary entrance featured a vestibule and then a front door. It appears that the vestibule has been lost, and the only remaining element defining the primary entrance is the actual masonry opening itself, and the paneled door jamb. While the original vestibule will not be reconstructed, the application indicates that a new wood and glass door with a sidelight will be reinstalled into the existing masonry door opening. <u>Staff recommends that a new front door and side light fit within the existing, original masonry opening behind the face of the paneled door jambs, and the existing, original paneled door jambs be retained and repaired as necessary.</u></p> <p>The application shows that the proposed front door and sidelight will have divided lights. The drawing of the door assembly doesn't appear to be in character with the district.</p> <p><u>Staff recommends that the new front door reflect historic documentation or one of the configurations seen on 3106-3116 East Broad Street which are either double doors with a transom, or a single door with a transom and sidelight.</u></p> <p><u>Staff recommends that the new front door, transom and sidelight not have any divided lights for a simplified design. Final front door assembly submitted for administrative approval.</u></p> <p>3116 East Broad Street is identical in design to 3104 East Broad Street and features its original front door and vestibule unobscured by a storm door. This door could be used as a reference when reconstructing the primary entrance of 3104 East Broad Street.</p> <p>The building features iron cresting along the roofline line. Some areas of the cresting are bent, and there appears to be evidence of corrosion seen as rust staining on the gutters. <u>Staff recommends that the extant iron cresting be retained and repaired and painted.</u></p> <p>The application states that most of the front porch elements will be replaced in-kind. The front porch has Tuscan columns that sit on top of paneled newel posts and there is a robust railing with a ide banister and turned balusters. Staff noticed on a site visit that the extant front porch was in poor condition. There were signs of</p>

<p>deterioration and the center of the porch had been completely removed; however, the decking did not appear to be original.</p> <p><u>Staff recommends that any salvageable front porch elements including the columns, newel posts, and railings be retained and repaired.</u></p> <p><u>Staff recommends that any replacement columns, newel posts, or railing match the existing in material and design, final materials selections submitted for administrative approval.</u></p> <p><u>Staff recommends that new front porch decking boards be tongue and groove and be installed perpendicular to the face of the building.</u></p> <p><u>If the columns must be completely replaced, Staff recommends retaining the extant engaged columns attached to the face of the building to serve as physical documentation.</u></p> <p>The front mansard roof features hexagonal slate pieces, as well as slate cut into triangles to create a star motif, as well as colored slate pieces. <u>Staff recommends that the slate on the front mansard roof be repaired and preserved.</u></p> <p>There is iron cresting atop the building that appears to be in good condition except for a few areas that are bent/dislodged. <u>Staff recommends that the iron cresting be cleaned, repainted, and repaired as necessary.</u></p>

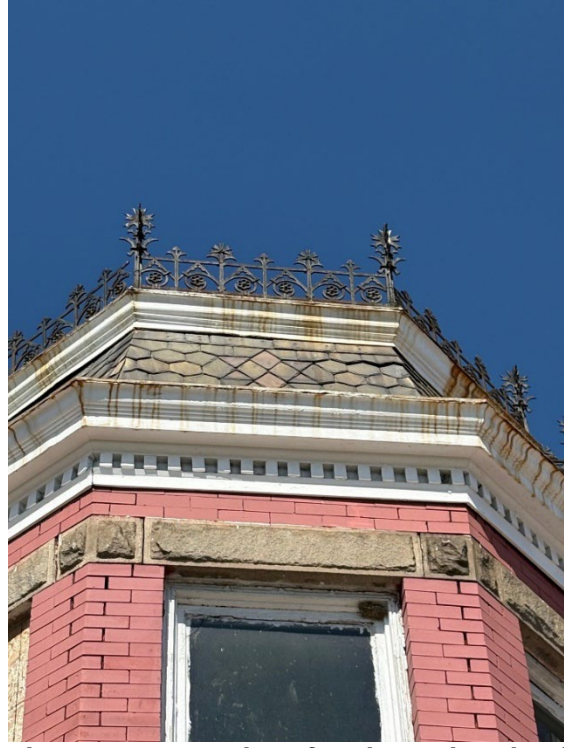
Figure 6. Mansard roof and crested detail.

Guideline Reference	Reference Text	Analysis
Secretary of the Interior Standards for Rehabilitation – Residential Construction, pg. 59	<p>1. Retain original features and materials that define the building style, including but not limited to wood siding, shingles, stucco and masonry.</p> <p>2. Retain original wood features such as cornices, brackets, window and doorway surrounds, sashes and doors. Maintain the historic reveal or exposure of the siding and trim, as it is an important character-defining feature.</p> <p>3. Retain original metal features such as cast-iron porches and steps, metal cornices, roofs, roof cresting, window sash, entablatures, columns, capitals, window hoods and hardware and</p>	<p>The building features ornate woodwork and trim. A built-in gutter with crown molding and dentils follows the perimeter of the front porch roof, as well as the second-story roof line above and below the mansard roof. On a site visit, staff observed these elements and noted that they appear to be in good condition. <u>Staff recommends that the existing crown molding and dentils around the perimeter of the front porch roof, and the mansard roof be retained and repaired. If deteriorated beyond repair, elements should be replaced in-kind; materials submitted for staff approval.</u></p> <p>Either side of the mansard roof on the façade features ornate battens with circle, diamond, and crescent motifs. These are character defining elements. <u>Staff recommends that battens on either side of the façade's mansard roof be retained and repaired.</u></p>
